INVESTIGATION OF SHIMANO CRANKSET FAILURES

Two Shimano Crankset failures were investigated.

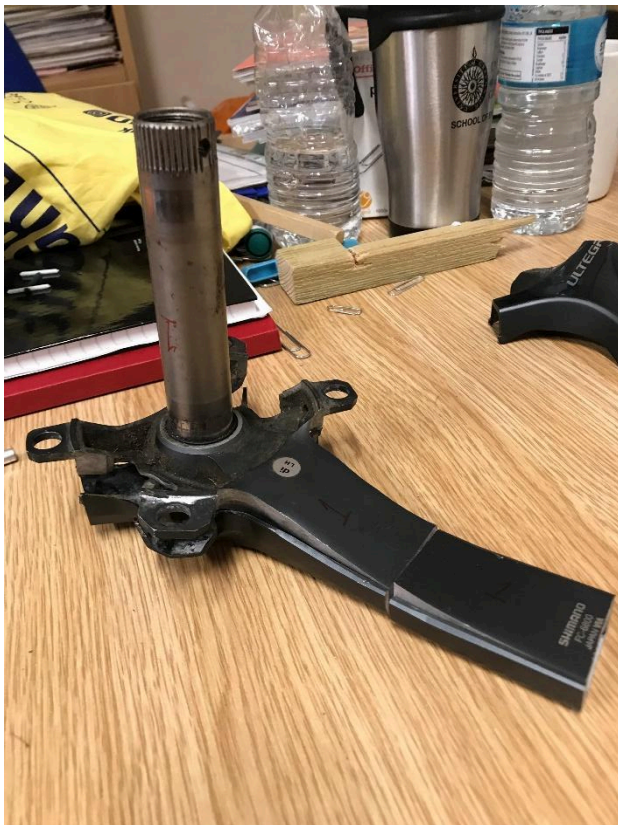
Figure 1:

Failure 1: Bending of the Crank Arm (Figure 1)

Appearance of Failure 1. Crank arm has been partly sectioned in preparation for investigation, but bending of inner/upper channel section is clear.

In Failure 1 (Figure 1) the inner U-shaped channel was bent inwards separating it from the outer U-shaped channel. The bending deformation caused the widespread separation of the inner and outer U-shaped channels along most of their length, in addition to some distortion (twisting) of the channel sections as seen in the cross-sectional view of Figure 4. Adhesive remains attached to the inside surface of the outer channel only (Figure 5). This indicates that during final failure the fracture path followed the interface between the adhesive and the metal substrate. No evidence of corrosion was found in the area of separation on either the inner or outer channel.

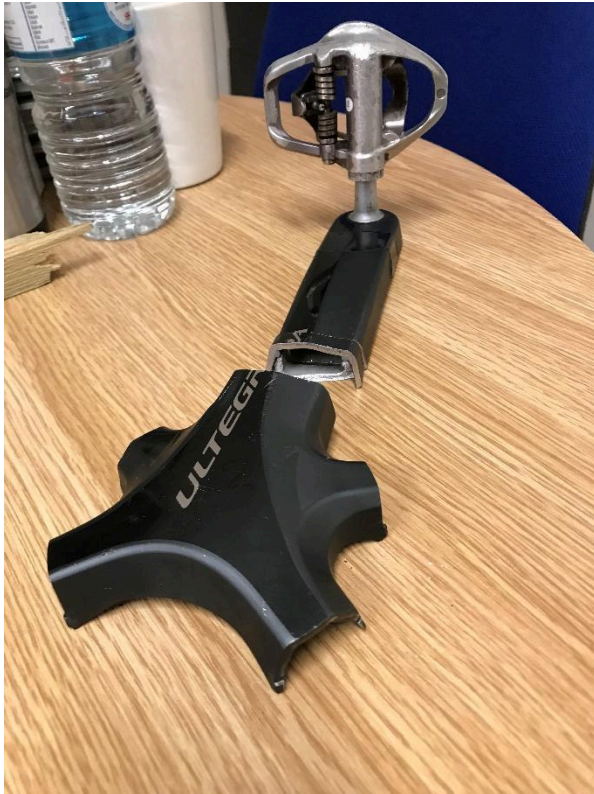
Figure 2:

Failure 2: Complete fracture of the Crank Arm (Figure 2)

Failure 2 indicating complete fracture of crank arm

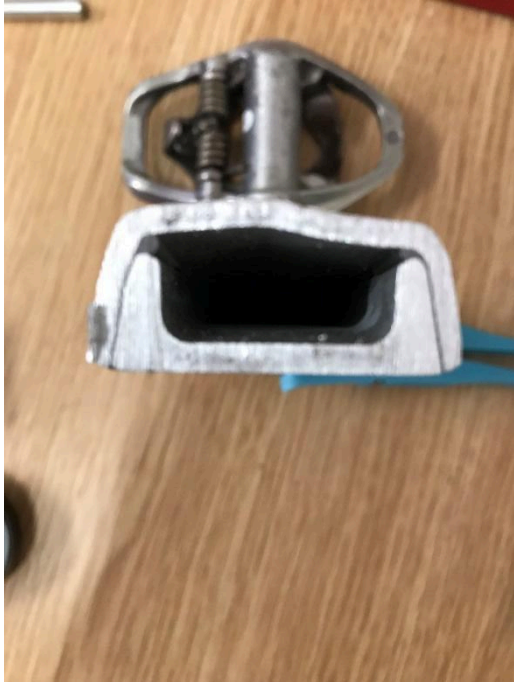
Figure 3:

The Shimano crank arm has a hollow construction. It consists of two U-shaped channels interlinked to form a rectangular cross-sectioned tube as indicated in Figure 3. Investigation show that the two channels are adhered together to form the tube.

The rectangular tube section comprised of two interlinked U-shaped channels

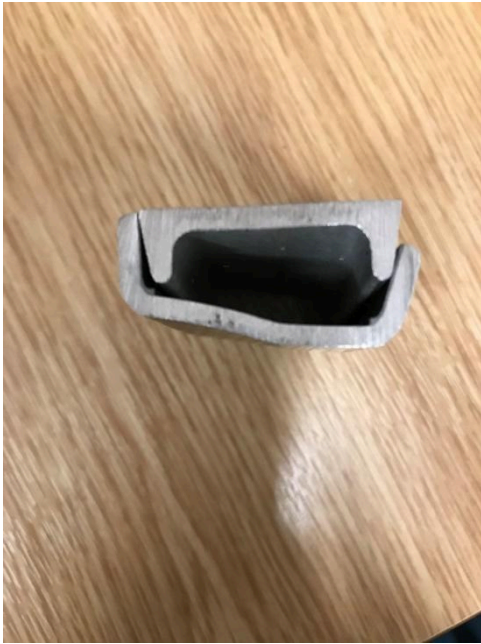
Figure 4:

Bending of the crank arm resulted in some distortion (twisting) of the component channels as clear on this cross-sectional view.

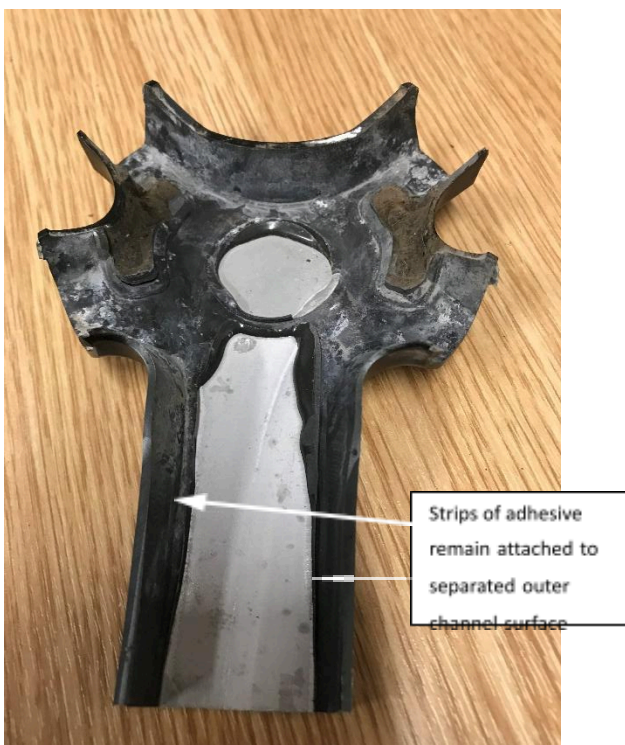
Figure 5:

Outer (undeformed) channel still retains strips of black adhesive after the failure and its separation from the inner channel.

The bending of the inner channel involved significant plastic deformation. The energy to accomplish this is far greater than that required to separate the adhered surfaces. That being so, it seems likely that the greater part of the inner and outer channel separation occurred through the bonded interface being “unzipped” during the bending of the inner channel. However, it was notable that the outer channel remained undeformed during this failure process. The indication, therefore, is that the full rectangular-box section of the crank arm is strong enough to resist deformation during normal loading conditions, and that plastic deformation of the inner U-channel can only occur if it first of all becomes detached from the outer channel along at least part of the bonded length. That is to say, that if the inner and outer channels become separated along part of their length the overall structure is weakened. The inner channel is then vulnerable to bending failure under subsequent loading which will cause it to separate further from the outer channel in the manner observed.

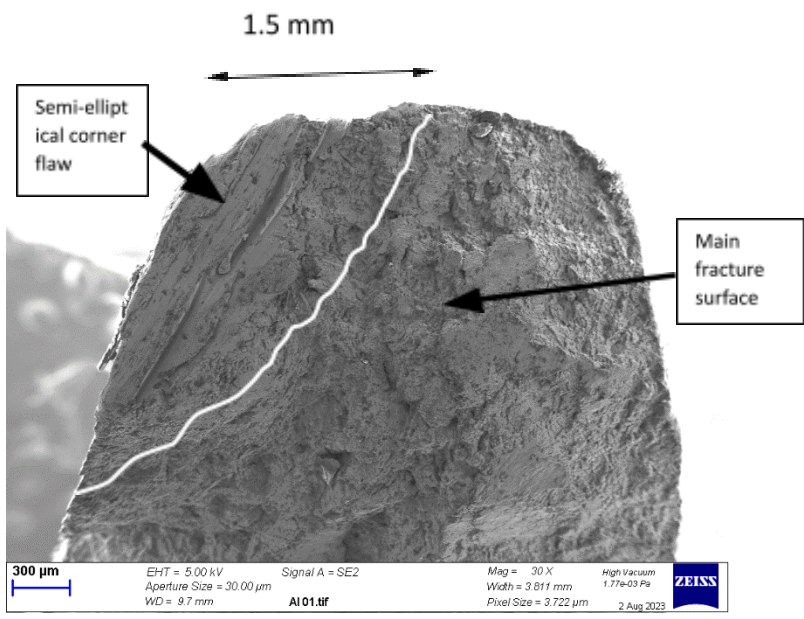
Visual examination of the failed inner channel indicated what appeared to be a flaw at the tip of one of the arms of the channel. This was examined further by SEM. Investigation revealed a semi-“elliptical” corner crack (Figure 6) with a major length of around 4.5 mm and a depth of around 1.5 mm (see figure). There was some evidence of what appeared to be fatigue striations on the surface of the elliptical crack, typical of a fatigue failure (Figure 7). Unfortunately, this was inconclusive, as there was also some damage to this surface, which may have occurred during or post-fracture, that partially obscured the features present. It is also possible that the crack was a casting defect. Such casting defects are common at sharp corners and can occur for a variety of reasons.

Figure 6:
Semi-elliptical flaw at the corner of one of the arms of the upper U-shaped channel (SEM photo)

Whatever the source of the flaw it is undoubtedly the reason for the failure of the part. The remainder of the fracture surface has features typical of a failed aluminium alloy.

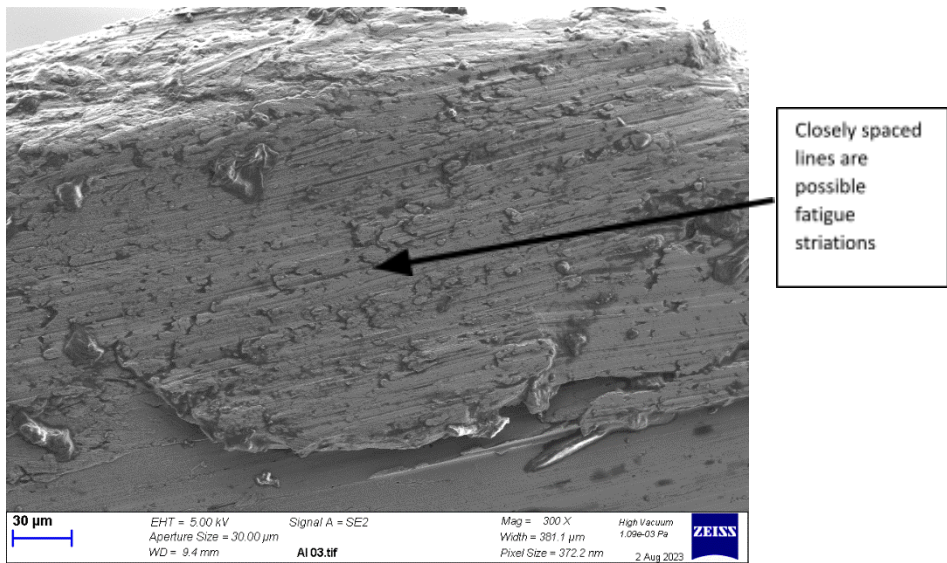
Figure 7:
Possible fatigue striations on surface of flaw
