## Stormwater Inquiry Form

Site Address: 330 Oak Haven Dr., Melbourne

Concern: Reinspection of stormwater system with attention to erosion and pond health

Date Investigated: 3-18-24

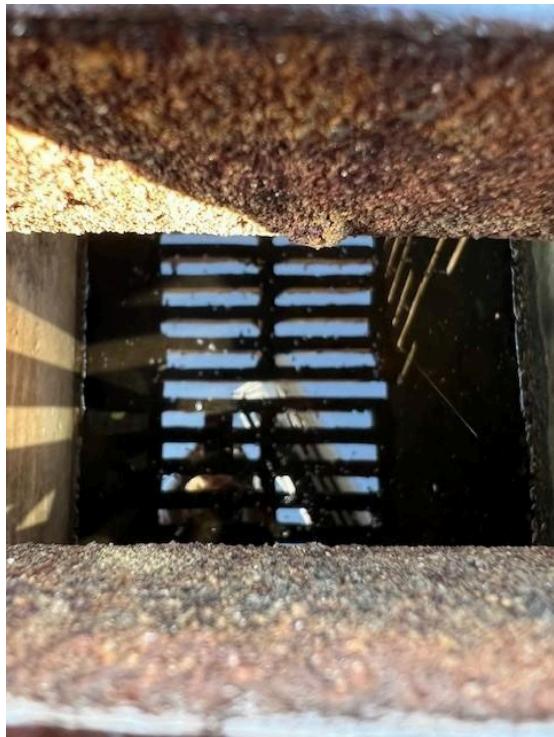
As for the stormwater system in general, everything is maintained and properly functioning. Trench drains had some sediment build-up, however it was not impacting water flow. The sediment traps/structure boxes beside 201 and 273 Oak Haven Dr. had some debris and sediment inside, however the depth did not impair the water flow. The structure box behind 201 Oak Haven Dr. had a substantial elevation change as JT approached the grate, indicating either an intentional or unintentional topographic change, and highly recommended watching for future changes. JT also highly recommended budgeting for a replacement grate here; the grate was very corroded and will need to be replaced soon.

Outfall chamber behind  
273 Oak Haven Dr. (some sediment)

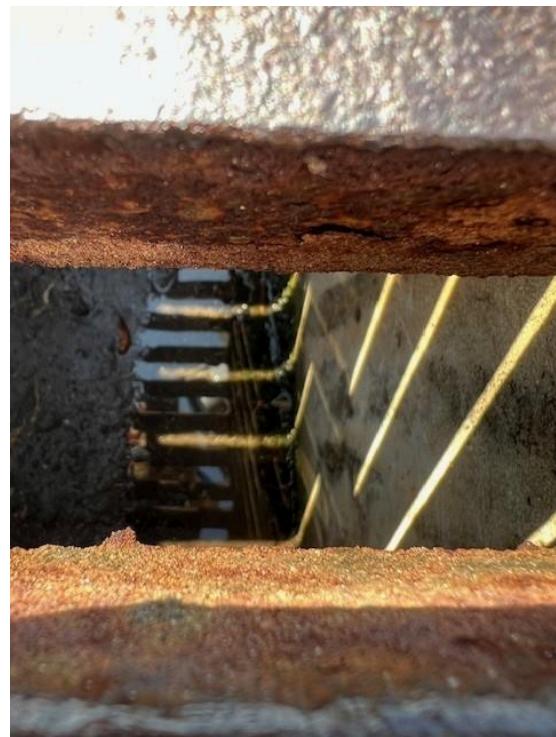
Trench drain (some sediment)

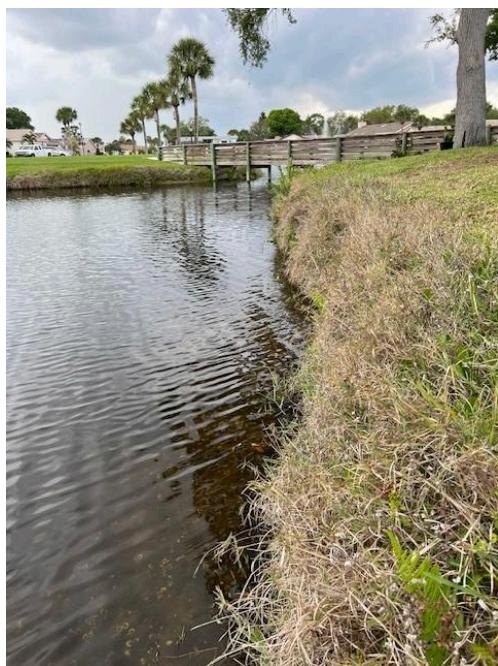
Erosion has increased along the northeastern shoreline beside the pool, carving out the bottom portion of the soil and creating an unsafe walking area along with slanted sidewalks. Most areas around the detention pond have 90 degree drops into the water instead of the original slope of 1:4, allowing for a littoral zone of growth. JT recommended looking into more erosion control (more plants, expanding the jute and riprap modules, and possibly manufactured options like ShoreSox). The aquatic vegetation and western revetment area is an improvement from previous inspections, but the entire pond still needs more to protect and stabilize the soil.

Bank erosion along north bank  
and evidence of spraying (dead grass)

Naturally growing vegetation (groundcover) used as a buffer zone has started to hold the bank together. This should also further minimize erosion, however JT recommended the buffer be at least two feet from the water's edge and about twelve inches tall to be more effective. There was an immense diversity of wildlife in the pond; ducks, small fish, wading birds, and juvenile dragonflies were seen during the inspection. The ducks were actively eating submerged vegetation during the 60-minute inspection. If large vegetation is going to be planted around the pond, JT recommended planting vegetation where the root system grows horizontal and to not plant too close to the shoreline (this will disturb the soil and potentially cause erosion). Furthermore, JT recommended residents plant Florida-friendly plants to reduce the need for fertilizer and frequent watering. Overall, the pond health is better than in July 2022. The water column has turned a slightly darker color but is clear, indicating growth instead of just sediment, another indicator the water quality is increasing. JT recommends not spraying,

especially when new plants have been installed, and reassess the health after at least 3 months when temperatures rise and invest towards erosion control. Several agencies like The IRL Council, FWC and Save Our IRL have small grants for communities to implement erosion control and plant aquatic vegetation to help water quality. Measuring water quality before submitting for a grant is helpful, especially phosphorus and nitrogen, so the grant agency knows how much of an impact could be made. Residents raised concerns about a parking area on the south side of the detention pond. JT agreed that permeable parking should not impact the pond or erosion with Truegrid Grass Pavers as presented, though she did not have first-hand knowledge of projects using this material.
