Updated 5th April, 2017

Some MH370 Right Flaperon Separation Mechanics

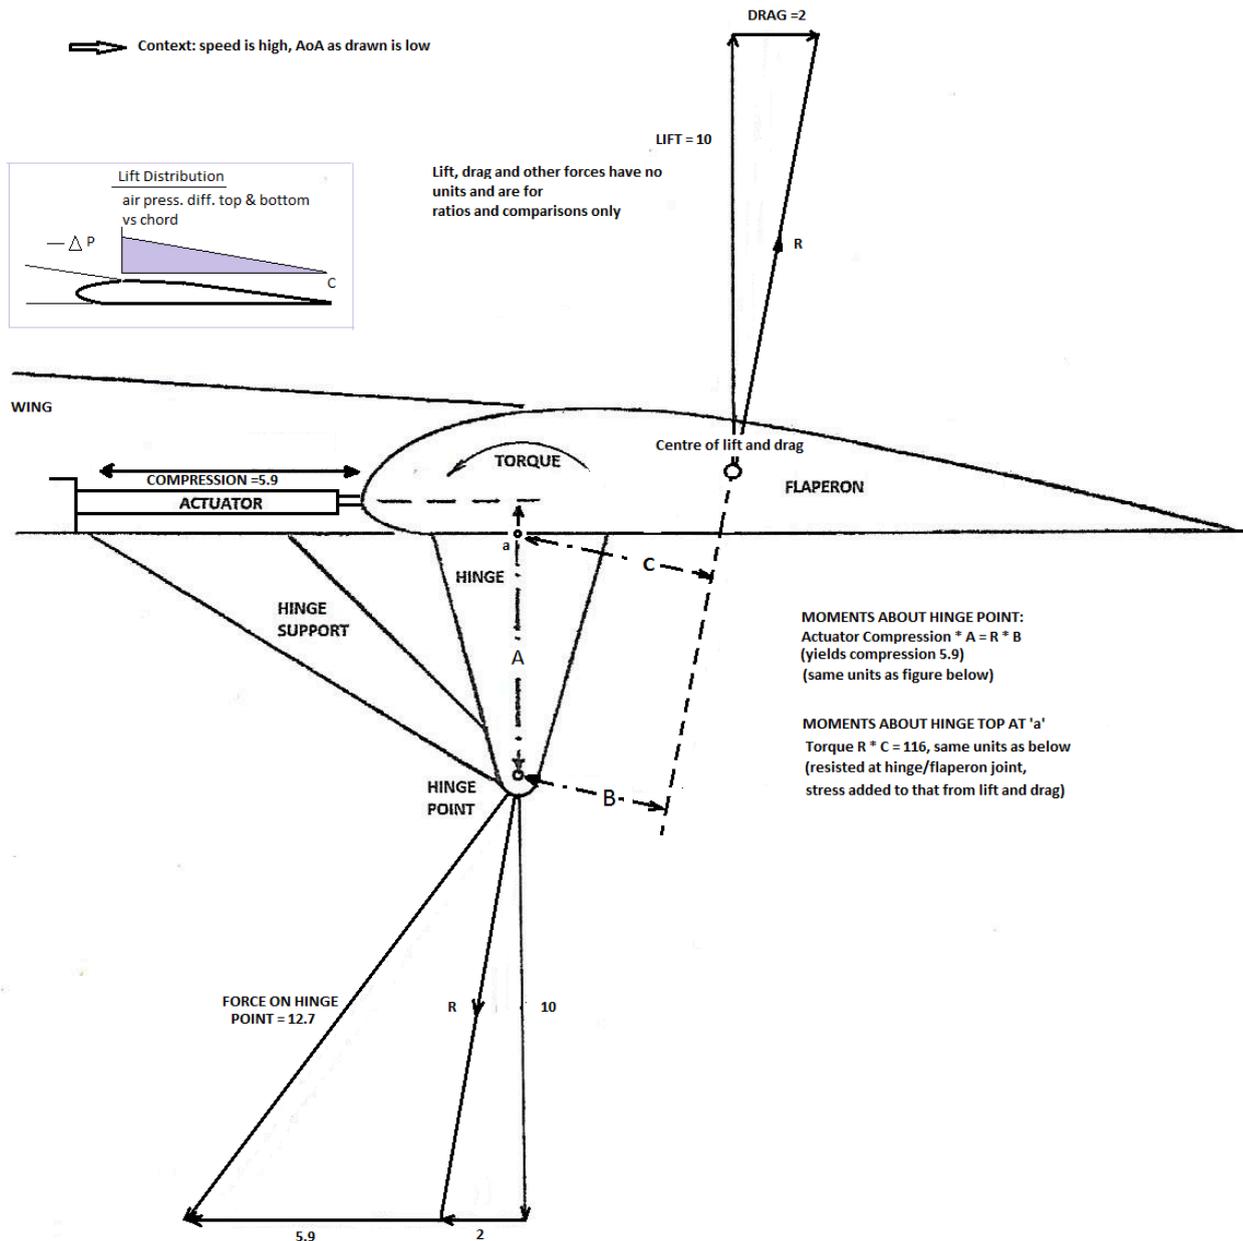
Below is a diagram of the normal loading experienced by a flaperon.

The drawing is intended to be representative of the actual flaperon, inboard end, its principal dimensions having been deduced from various depictions and photographs. The position of the centre of lift supposes (see insert) the lift to be highest where the flaperon is exposed to upper wing airflow towards its front. It is taken to be zero at its trailing edge and linear between the two. That leads to the centre of flaperon lift being almost 0.3 of its exposed length from the lift front.

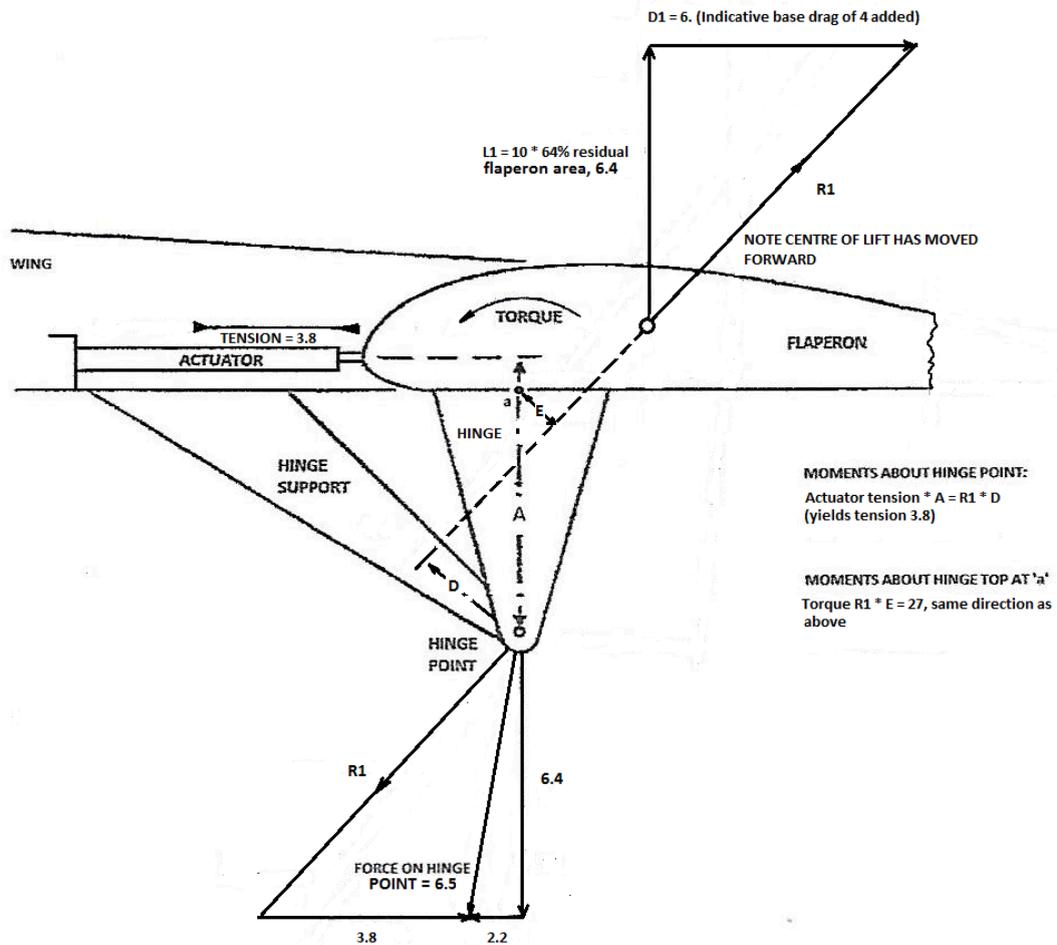
The second diagram below is of flaperon loading after loss of a representative portion of trailing edge.

The centre of lift has moved forward, remaining at almost 0.3 of the residual exposed length. The lift is reduced proportionately to its smaller area, other parameters being as before. Drag has been multiplied by an indicative three to allow for base drag at the break. The earlier lift drag ratio of an indicative 5 to 1 (high speed, low AoA) has been reduced accordingly.

The two hinge failures, one either side, were close to their attachment to the flaperon. A major contributor to stress there will be the torque illustrated. Aside from these examples indicating the likelihood that loading at the hinge pivot would be lessened by trailing edge failure, the same applies to the torque loading¹. This would reduce maximum stresses at their attachments, the highest loading most likely being tensile at the hinge brackets' rear.

Please notice that while the force at the actuator has decreased also, it is now in tension.
