Weymouth's Ralph Talbot Street (MA Route 228) School Cautionary Area - Safety Walkthrough 12/18/2025

Part 1 – Field Reference Table (East → West Walk)

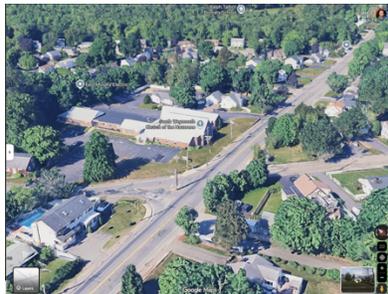
Aerial View – Pine St & Ralph Talbot

Observe:

- Complex and very unordinary multi-road convergence
- Telephone pole in the middle of the intersection
- Heavy AM cut-through traffic
- No traffic calming entering the cautionary area.

Impact: Sets unsafe speed expectations before reaching school zone; recommended as starting point for walkthrough.

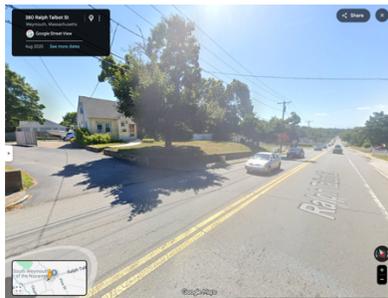
380 Ralph Talbot
Retaining Wall / Narrow Walk

Observe:

- Extremely narrow school-side sidewalk
- Bags, trash barrels, appliances regularly blocking path
- Utility pole centered in walkway
- Pre-school traffic into the church lot.

Impact: Forces pedestrians (incl. strollers) into roadway;

Note: Recent location of a stroller tip-over incident

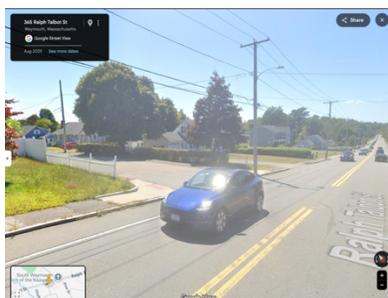
365 Ralph Talbot
Elizabeth Ln Intersection

Observe:

- No stop signs
- No painted crosswalk
- Blind corner due to fencing and bushes
- High vehicle turning speed risk.

Impact: Uncontrolled intersection in the middle of the cautionary area; dangerous for morning walkers.

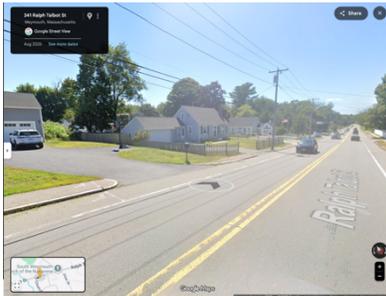
341 Ralph Talbot
Failing Curb & Steps

Observe:

- Major curb discontinuities
- 4–6 inch vertical steps at driveways
- Utility pole “pinch point”
- Inconsistent sidewalk grade.

Impact: Walkers, bikes, strollers – all of which are frequently forced into street;

Note: *this is immediately adjacent to the location of Eric’s (this document’s author) own truck vs. pedestrian accident.*

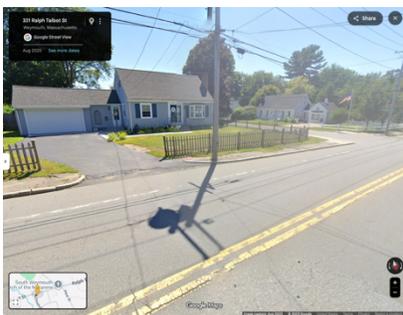
331 Ralph Talbot
Broken Pavement / No Crosswalk

Observe:

- Cracked walkway
- No stop signs
- Ramps with Truncated dome for the visually impaired but no painted crosswalk

Impact: Pedestrian path is functionally unusable for wheels; hazard is systemic not incidental.

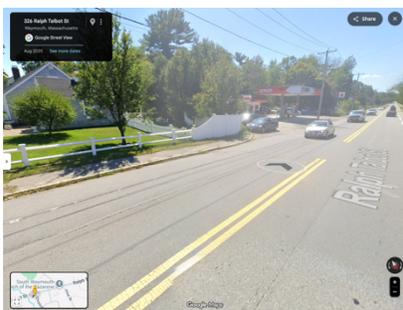
326 Ralph Talbot
Citgo Blocked Sidewalk

Observe:

- Cars from the business often fully blocking sidewalk
- Cars pulling across walkway without visibility
- Large puddling
- Rounded, low curb invites encroachment.

Impact: Walkers routinely enter roadway; high-risk conflict point.

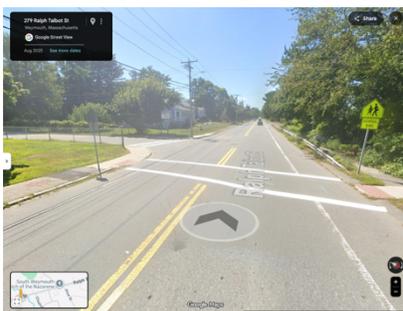
279 Ralph Talbot

Observe:

- Main crosswalk lacks interior striping
- RTPS Driveway crosswalk is properly marked but the significantly lesser used crosswalk
- Opposite-side sidewalk heavily used
- Shoulder parking contributes to breakdown-lane conflicts.

Impact: Center of PSA video but only covers a fraction of the safety issues; good discussion anchor for short-term fixes.
