## 16 Bayview Road

We were not given permission to scan the entire yard. We scanned the main line although we knew where it was from the valve system discovery. 14 Bayview Road Gas was tracked and it crosses into 16 Bayview Road and out to the road. It is 3' 9" below grade. Should not be an issue for a new service if/when needed.

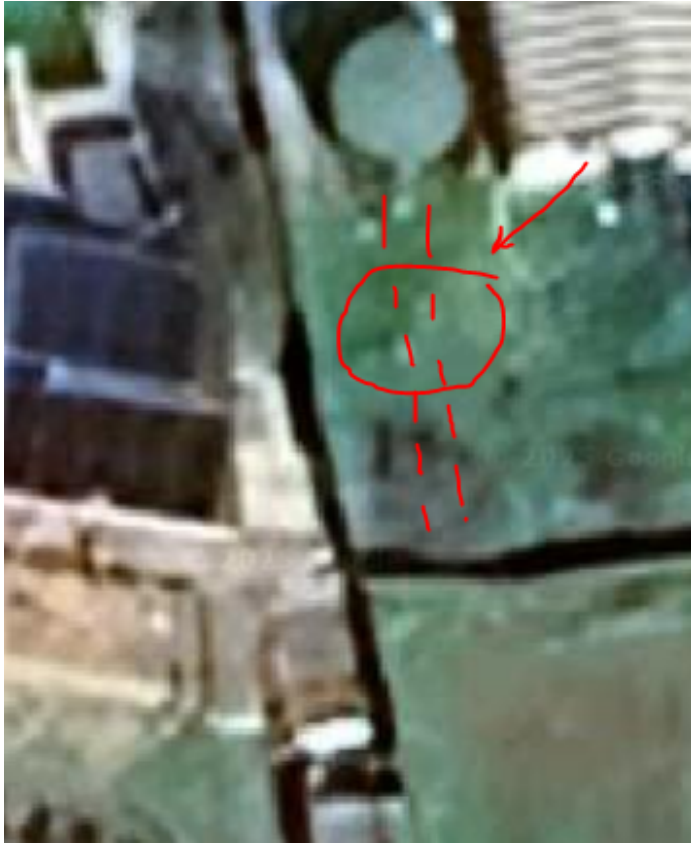
Rear yard below tank and above pasture

2' 10" deep -- it was a wide area because ground was wet and radar was less accurate

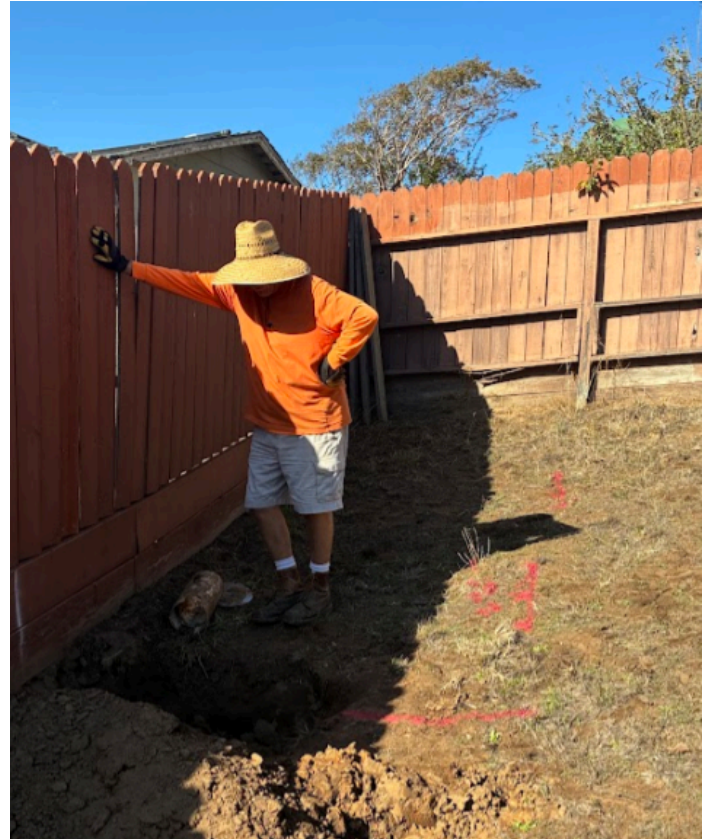
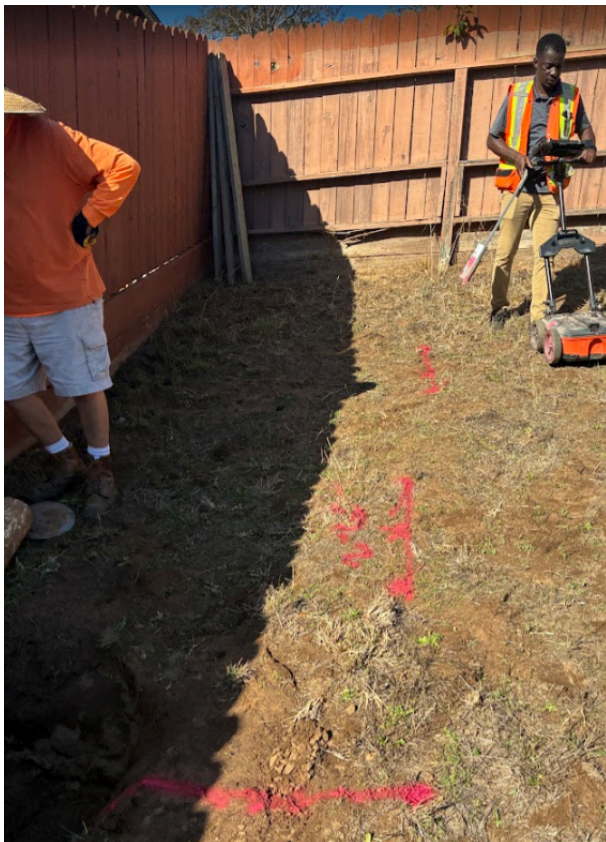
Lower Pasture

That is 2' 2" or 2' 6"

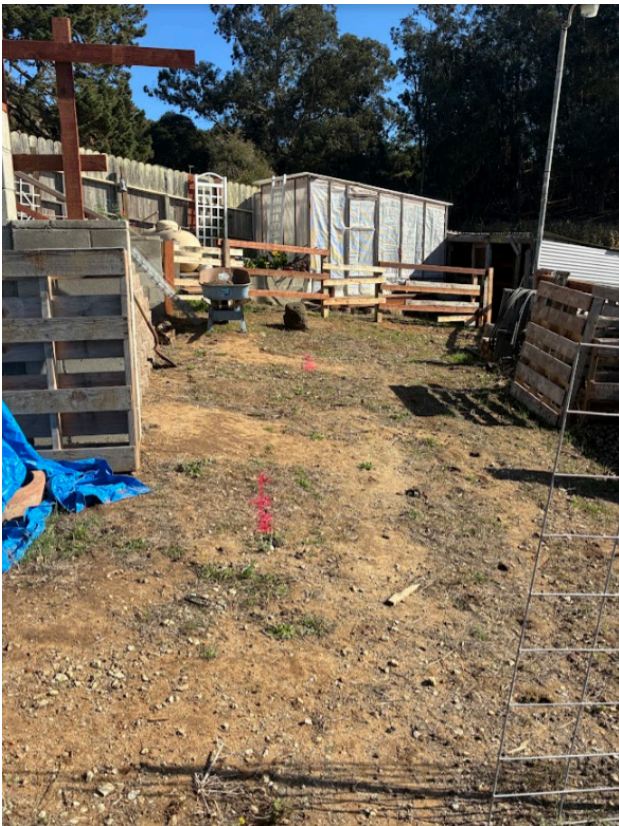
It crosses over the septic pit. It must be fairly shallow there.

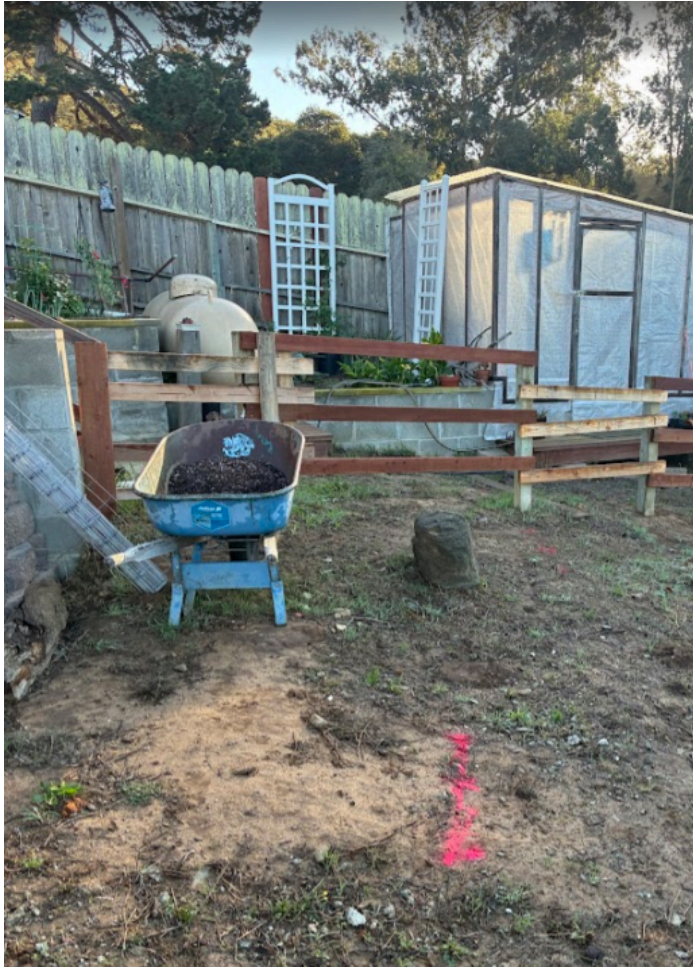
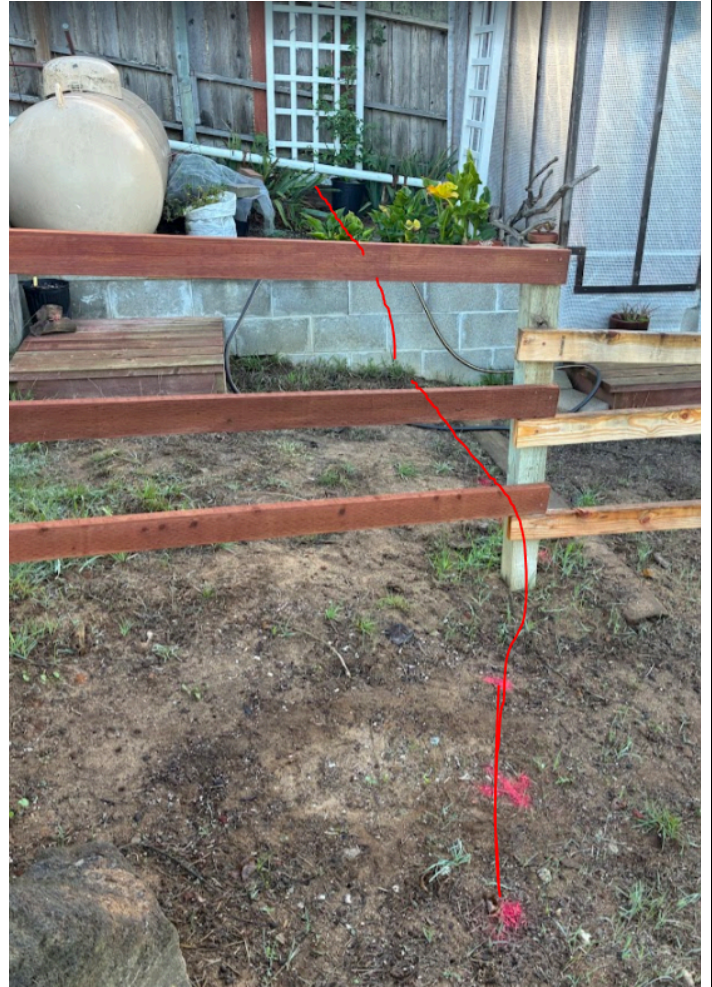
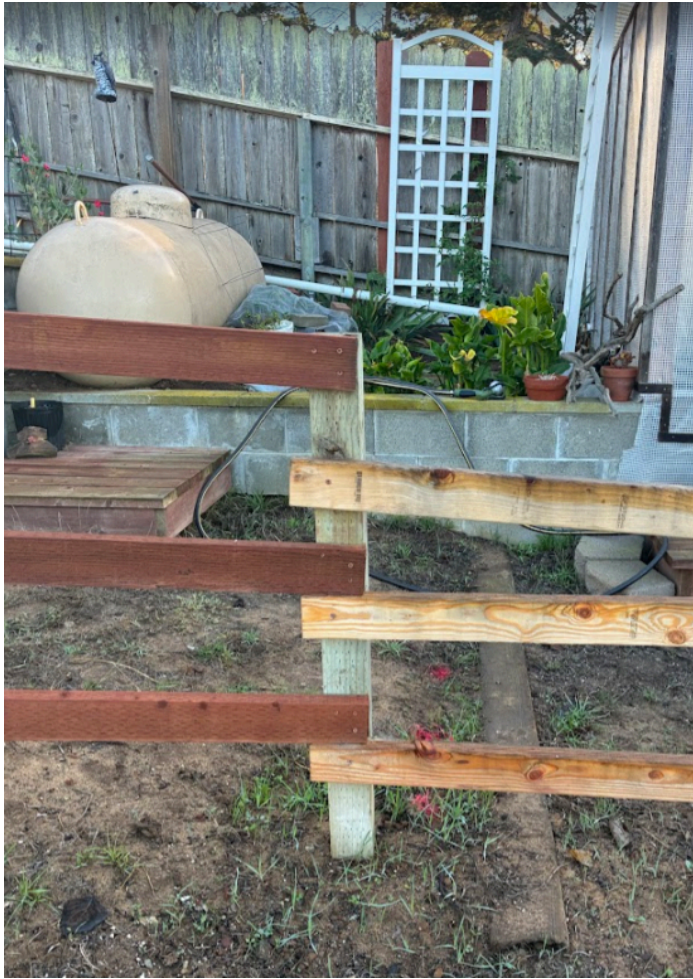
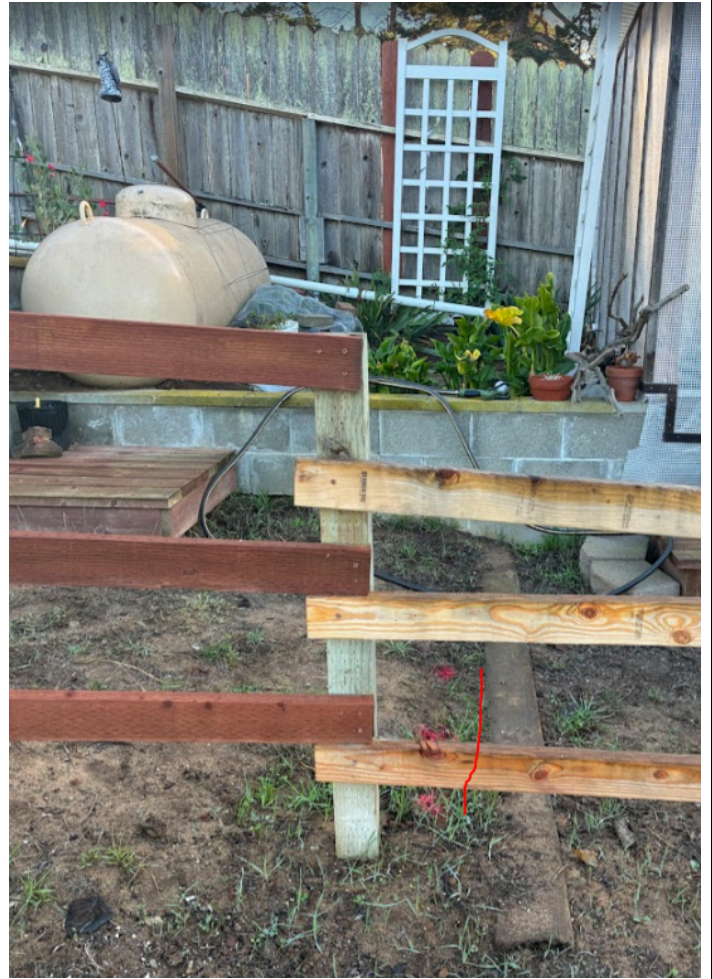
We could not find the well supply line  
On the backside of the head, there is a short area about 6" deep of something we are thinking it may be electrical.

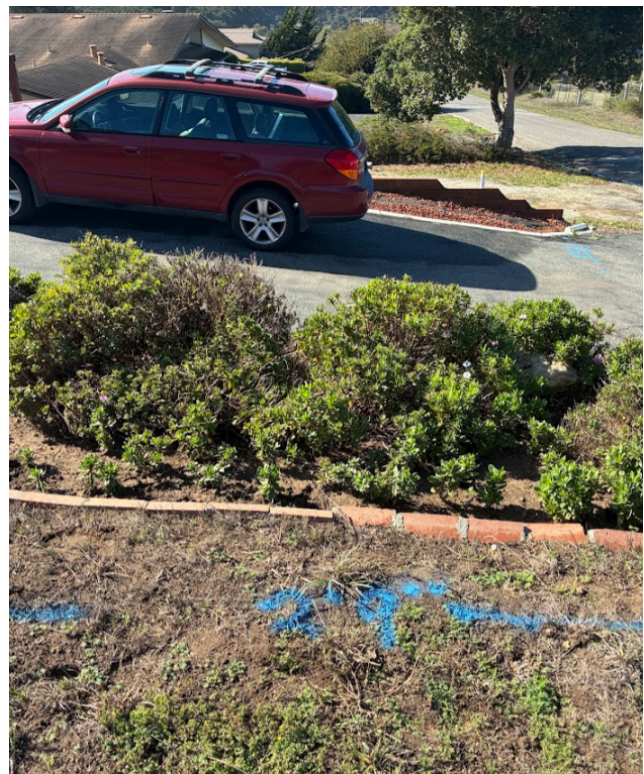
Pump house to Bayview Road

2' 9"

| <p data-bbox="110 848 769 919">This is in driveway about 4' from edge that drops to elbow 4'3" deep.</p> | |

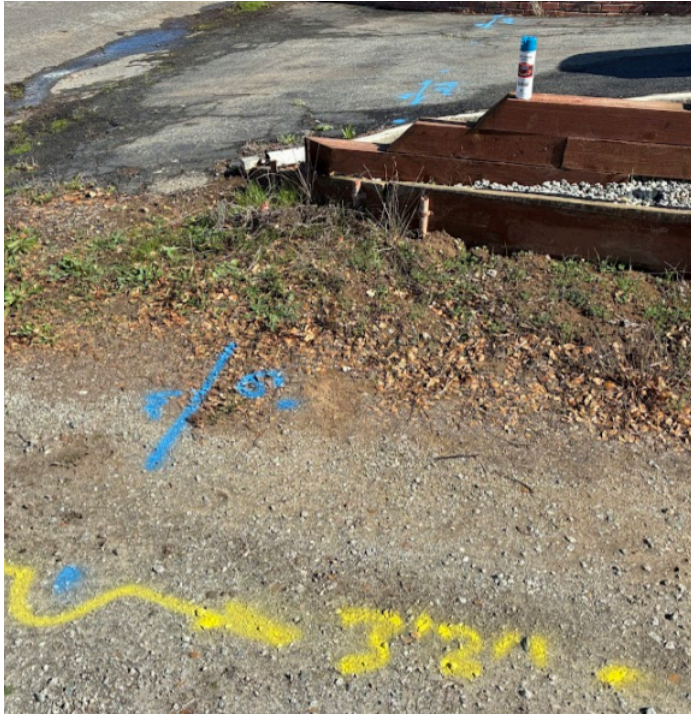
6' under the secondary driveway on the left side... on the right side the signal disappeared at 7' deep....

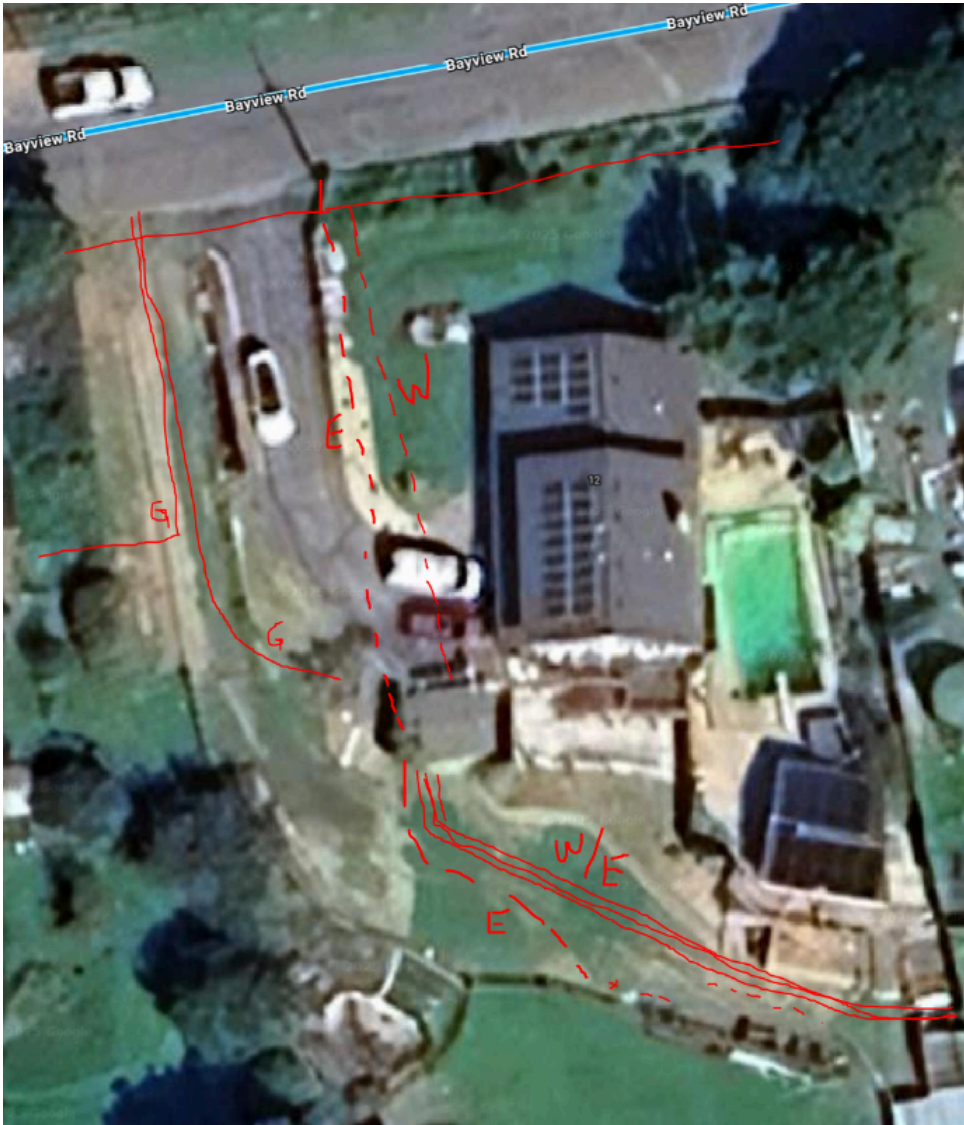
## Electric

There are 3 electrical lines:

- Power pole at driveway to pump house (220v 3 phase)
- Pump house to well
- Pump house to tank (pressure pump and float)

NOTE: The electrical lines on map are estimated. They were not mapped. (yet)

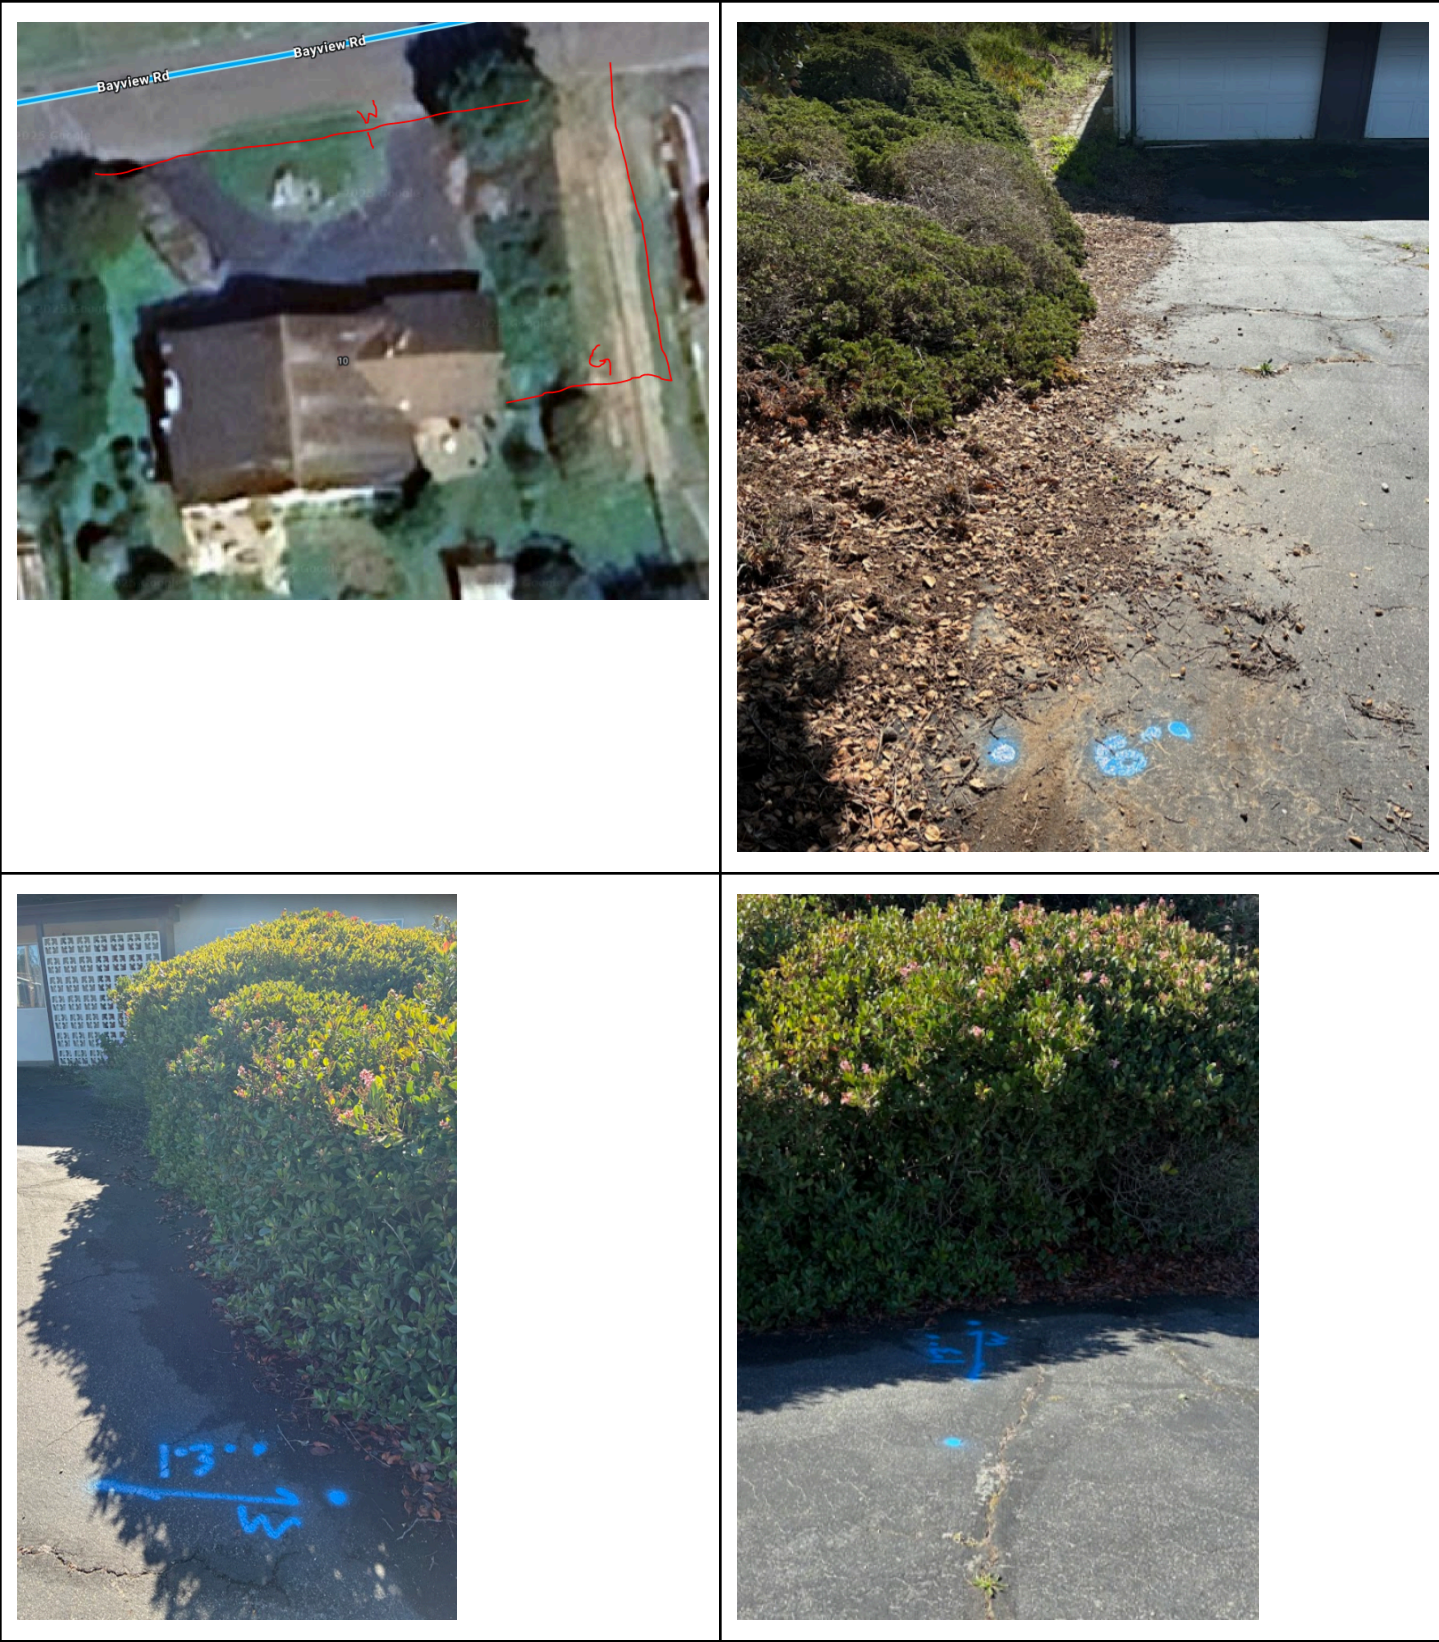
10 Bayview Road  
Water

This is approaching Deirdre's side driveway from her yard, where it was only 6" deep at the edge of driveway

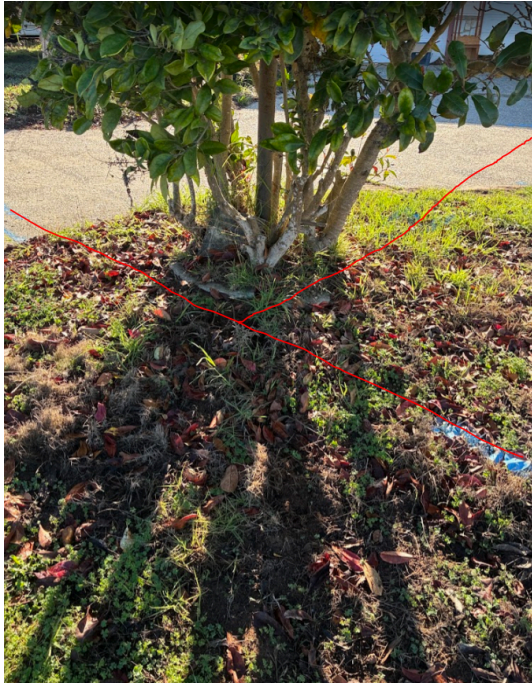
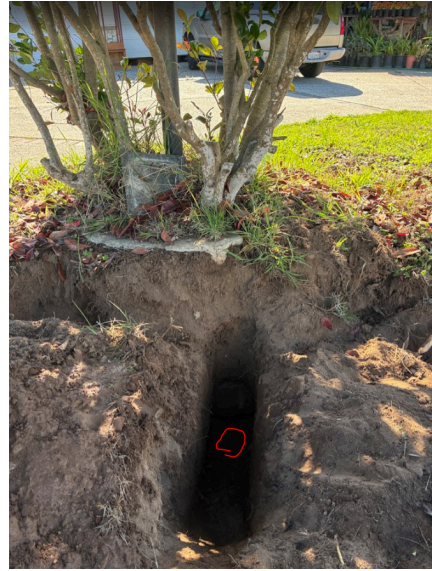
The T for the mainline was found about 22" below grade right under edge of ring around tree

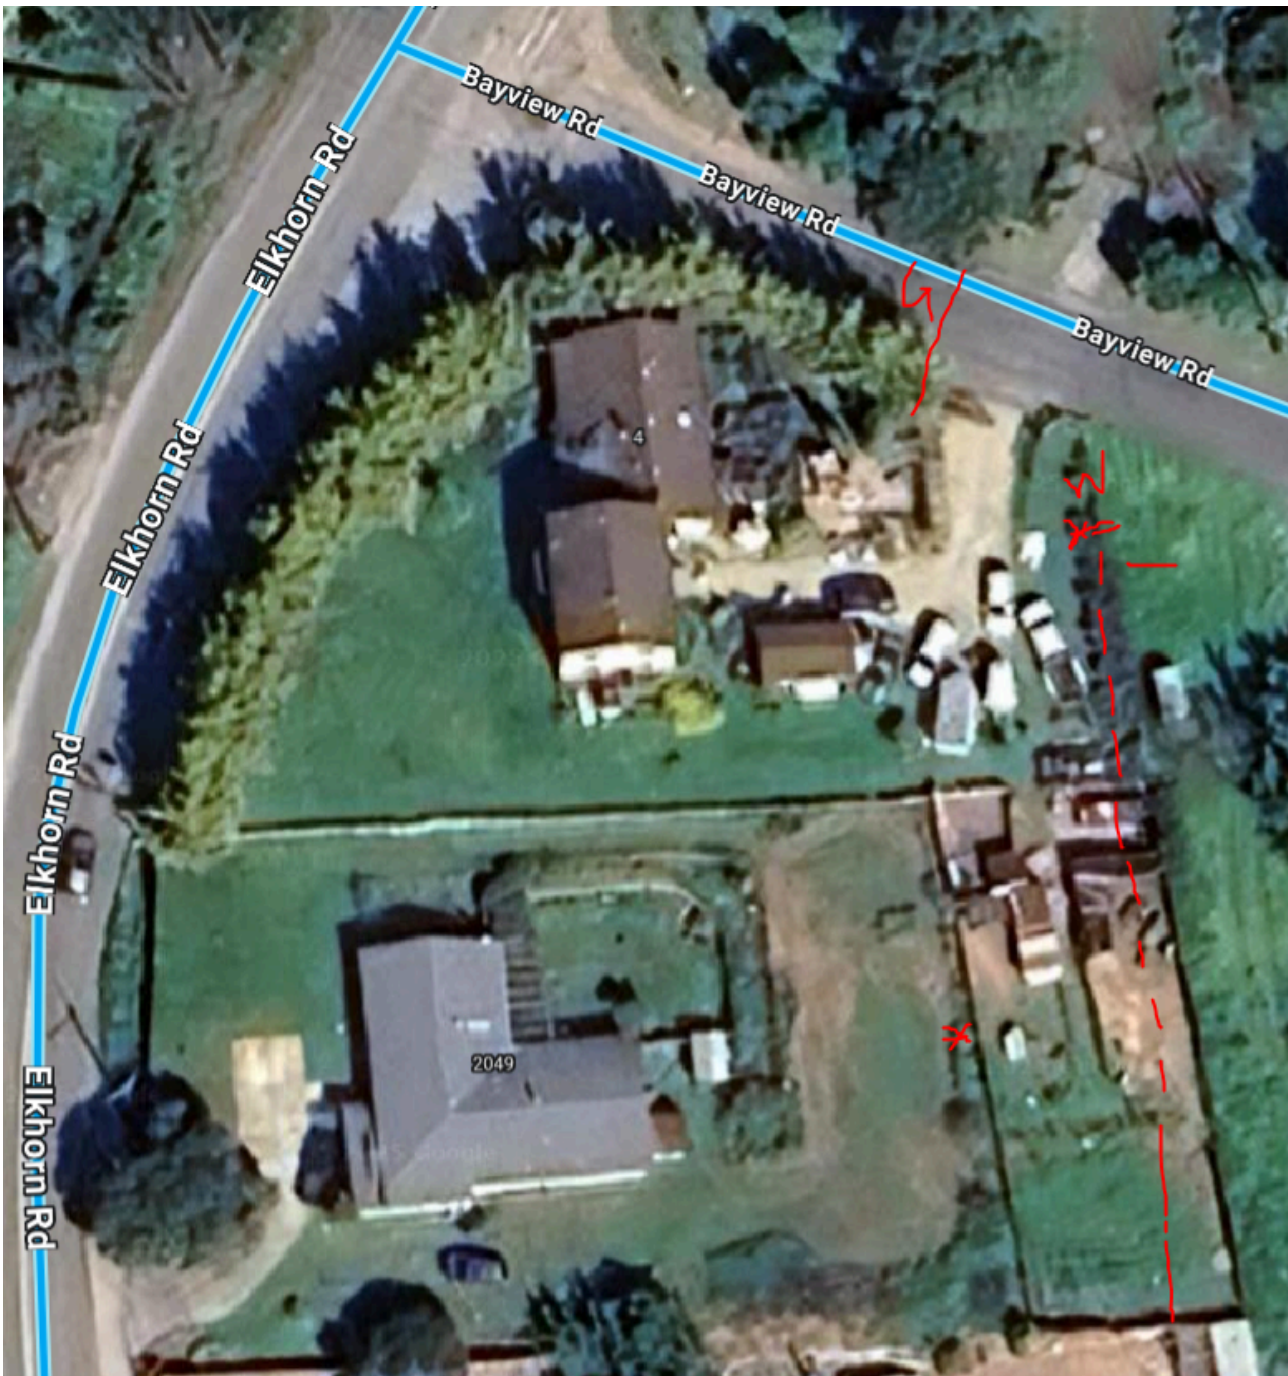
### Water

Inaccessible for maintenance or repair

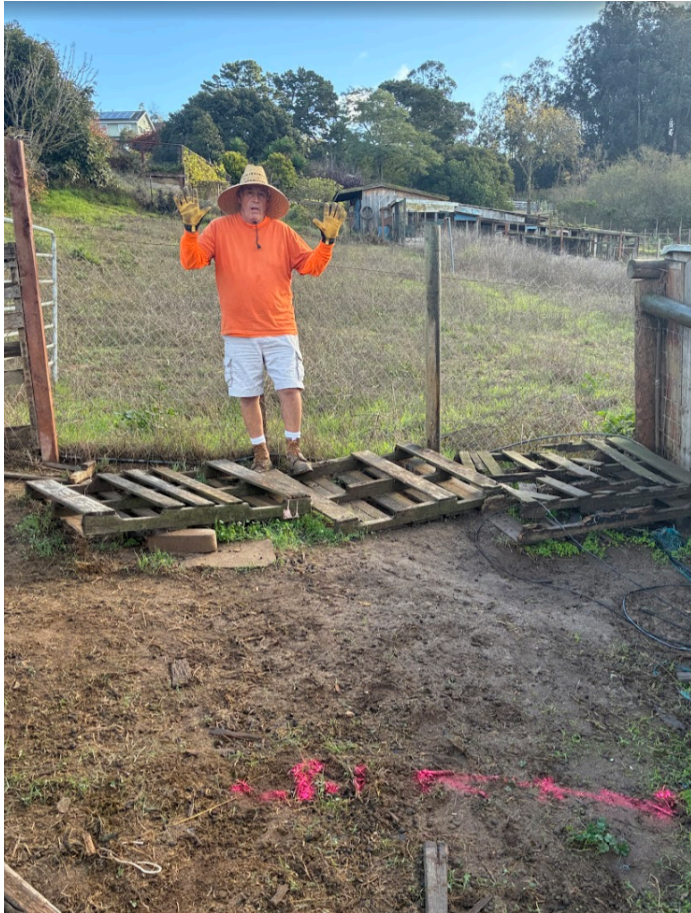
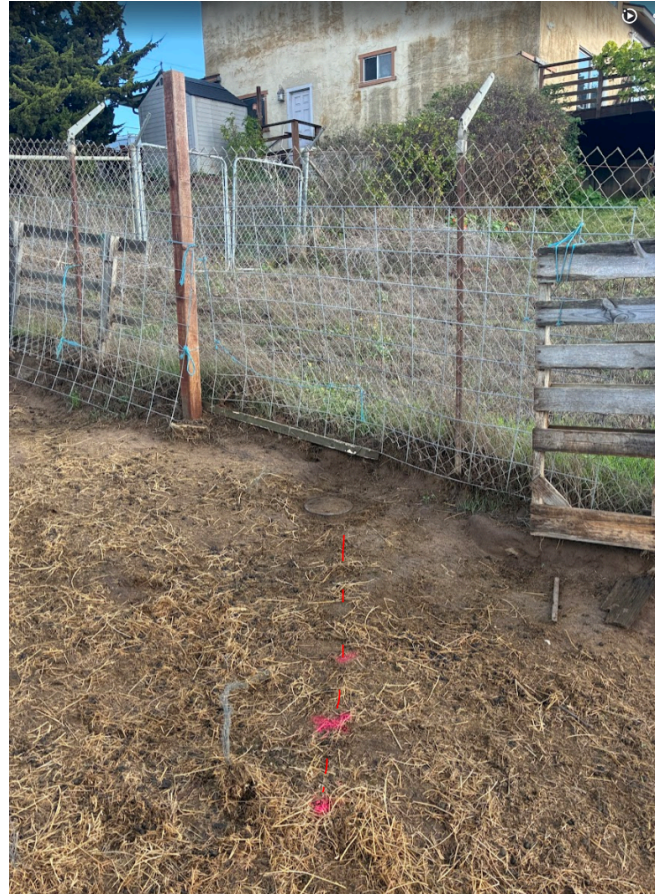
PVC line where riser broke -- and it's been capped,  
but it is not controlled by shut off on 4 Bayview.  
Controlled by one of the 2 on Elkhorn Road

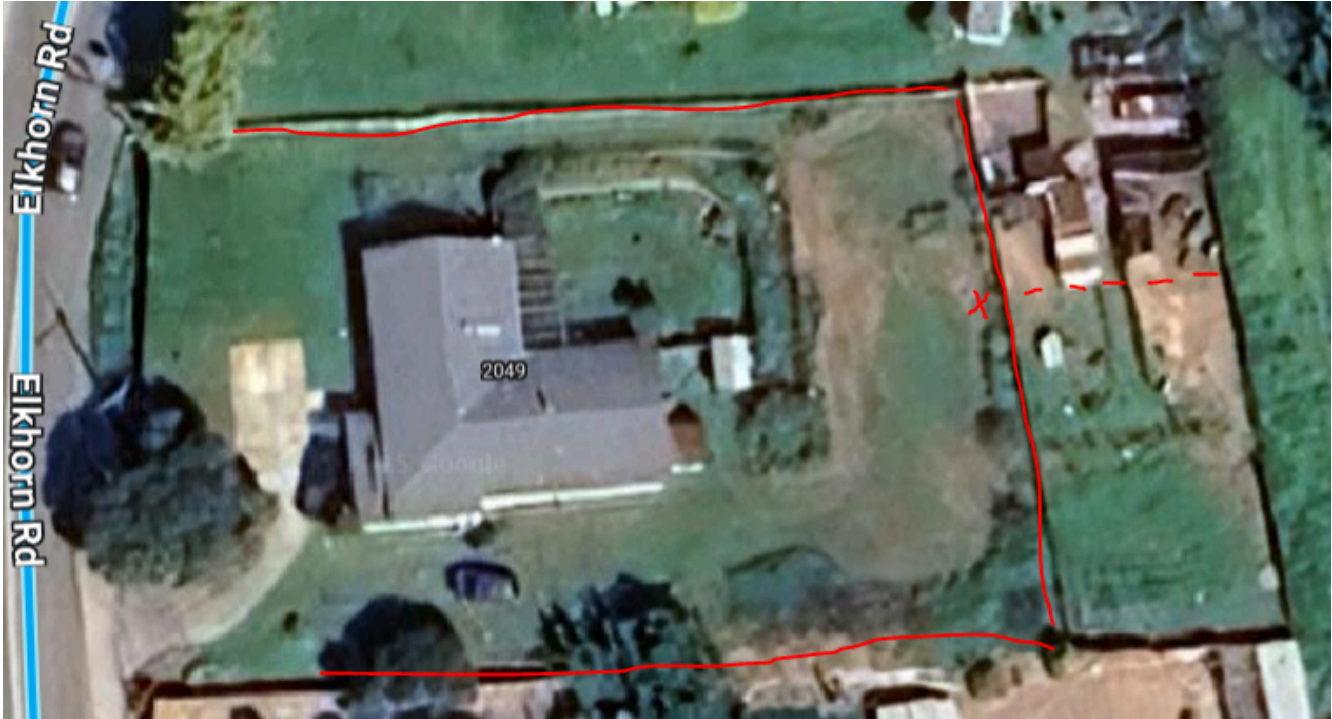
## 2049 Elkhorn Road

The back portion of 2049 Elkhorn Road was sold to 4 Bayview at some time in the 1990s. The problem now is that the portion that would have been his to care for or make accessible , to and including his main shut off now is on someone elses property and that property is inaccessible easily due to livestock.

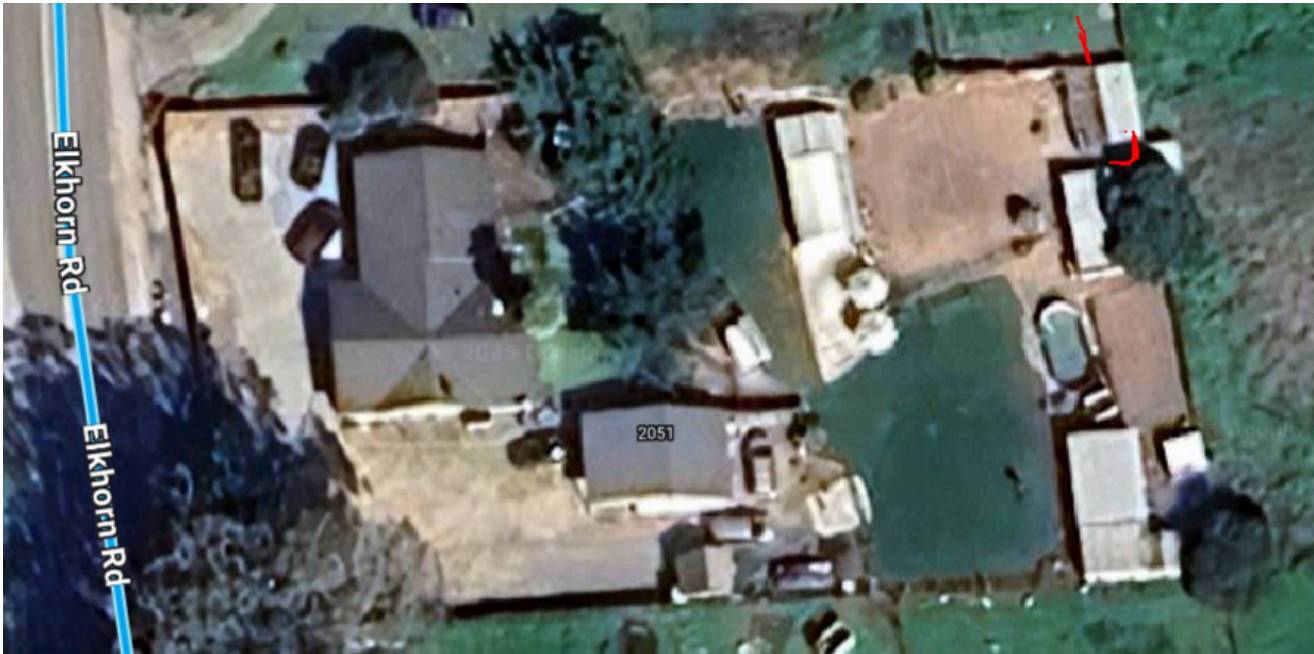
## 2051 Elkhorn Road

The water main comes in 10'-12' from rear of property but the shut off exposed is only about 6' from end of property. It's as if the shut off in view does not align with the incoming supply.
