Park Avenue Bicycle Audit

May 18th, 2025

Libbytown Neighborhood Association
Parkside Neighborhood Association
Portland Bicycle and Pedestrian Advisory Committee

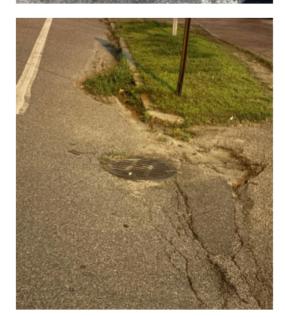
Broken Pavement presents
