Park Avenue Bicycle Audit

May 18th, 2025

Libbytown Neighborhood Association
Parkside Neighborhood Association
Portland Bicycle and Pedestrian Advisory Committee

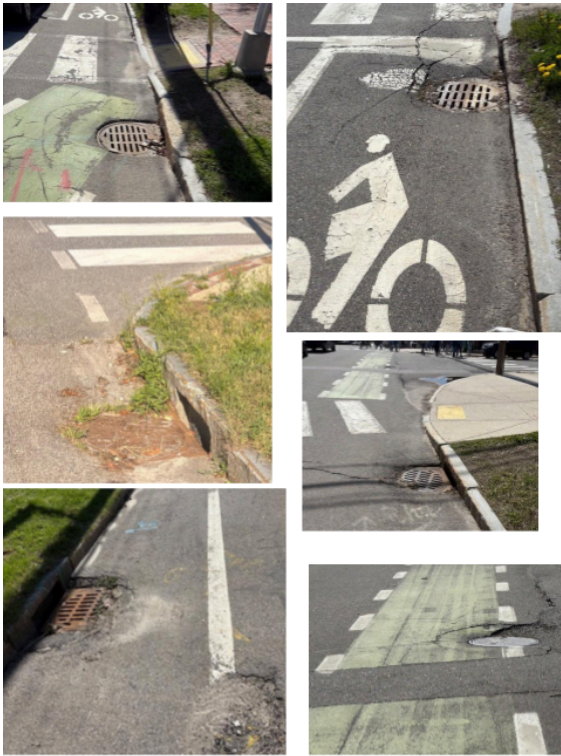
Storm Drains. Sewer grates & manholes - create depressions in the lane surface and are slippery when wet:

Storm drains often take up half or more of the bike lane, forcing cyclists into the buffer zone

- a. Better maintenance would alleviate these hazards. However, the facility is challenging from an operational perspective. For example, it is difficult to get people to stop putting their blue bins into the bike lane. If you can even get a plow to fit in the lane it still presents the problem of where to actually put the snow.
- b. There are several sunken storm drains and manholes that create obstacles for bicyclists. The storm drains and manholes need to be made flush with the pavement so that bicyclists don't even notice them.

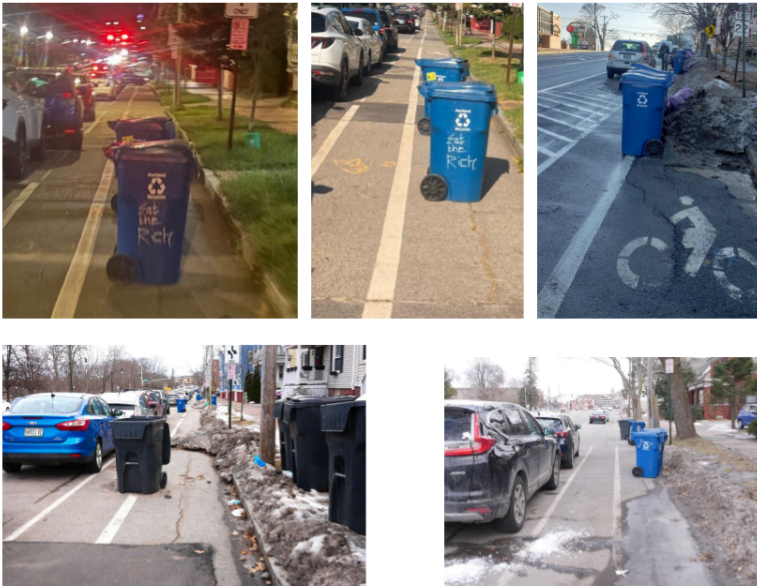
Blue recycle bins block the Bicycle lane, sometimes for over 24 hours

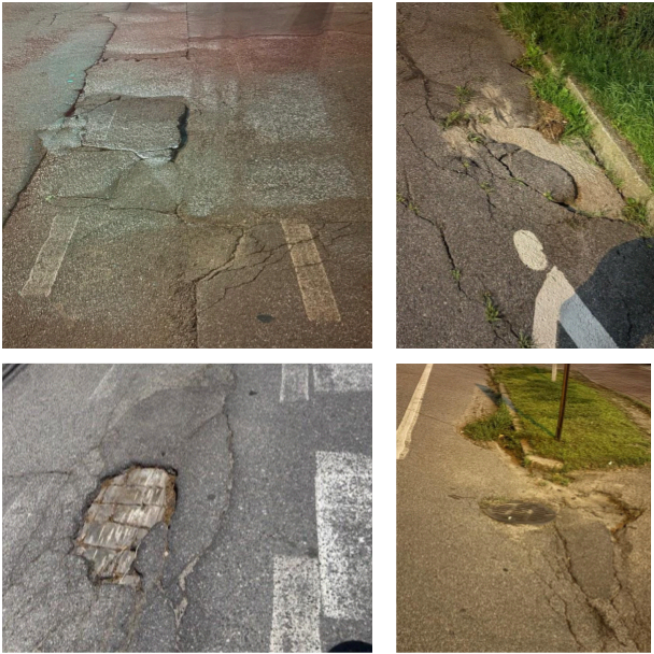
Broken Pavement presents a hazard and distraction

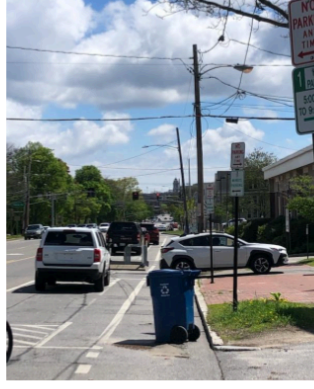
Cars block or infringe throughout, and during game nights, buses and crowds block the bike lane in front of Hadlock Field
