December 13, 2024

**Clerk of the Works Site Visit Report - IAA H.O. Wheeler Elementary School Project**

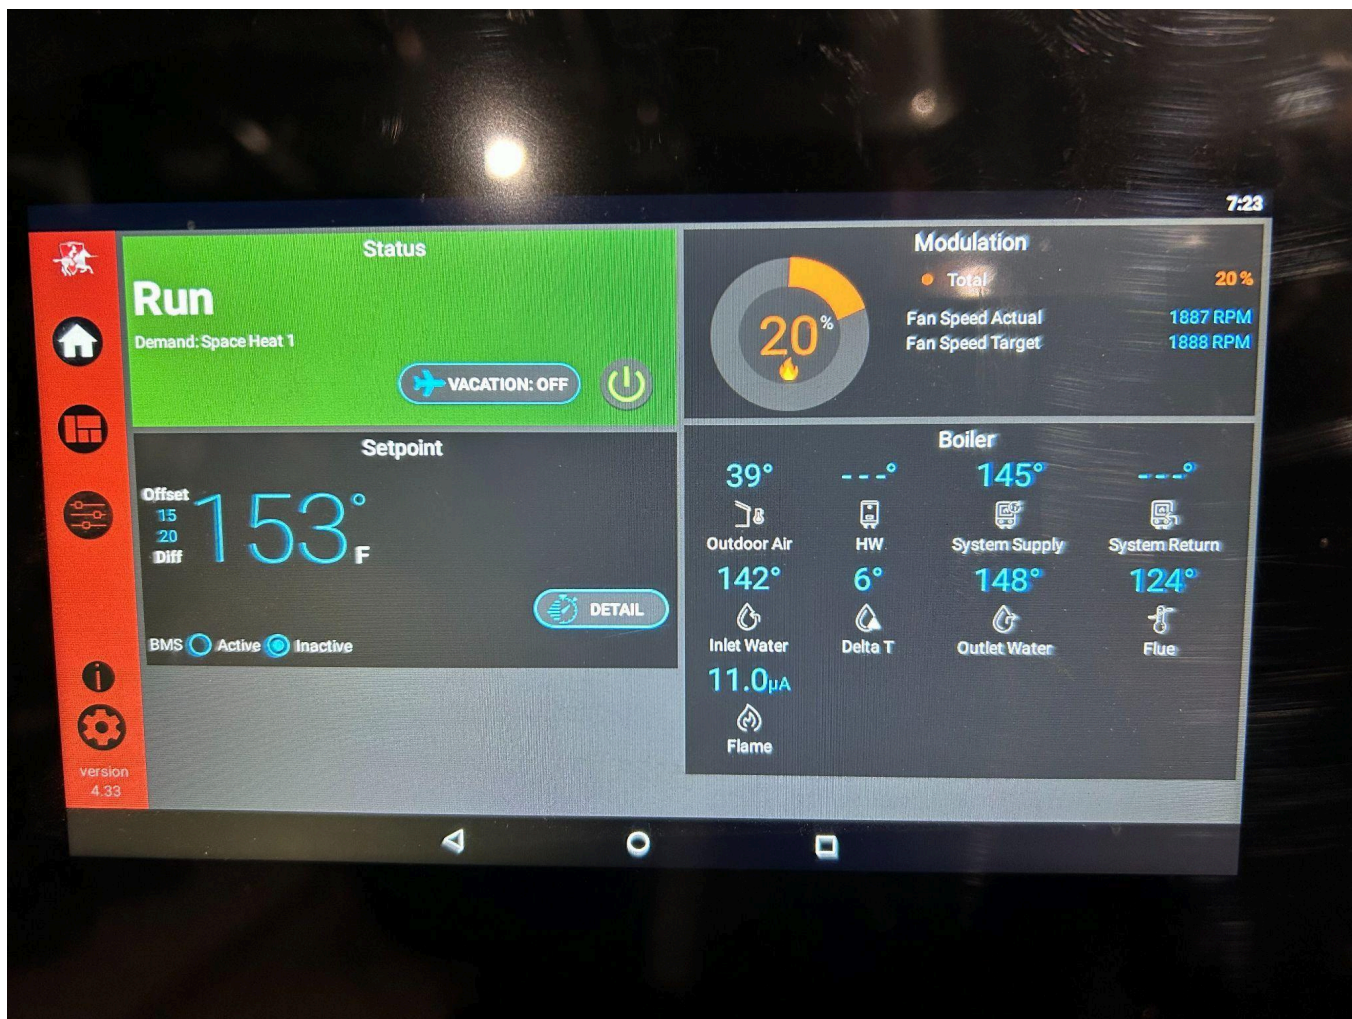
Picture showing the display of the Boiler running. Yes, it was 39 degrees outside, but the Boiler was maintaining the temperature within the building as set by one of the temporary thermostats at only 20 percent of full load. That is a very efficient Boiler.

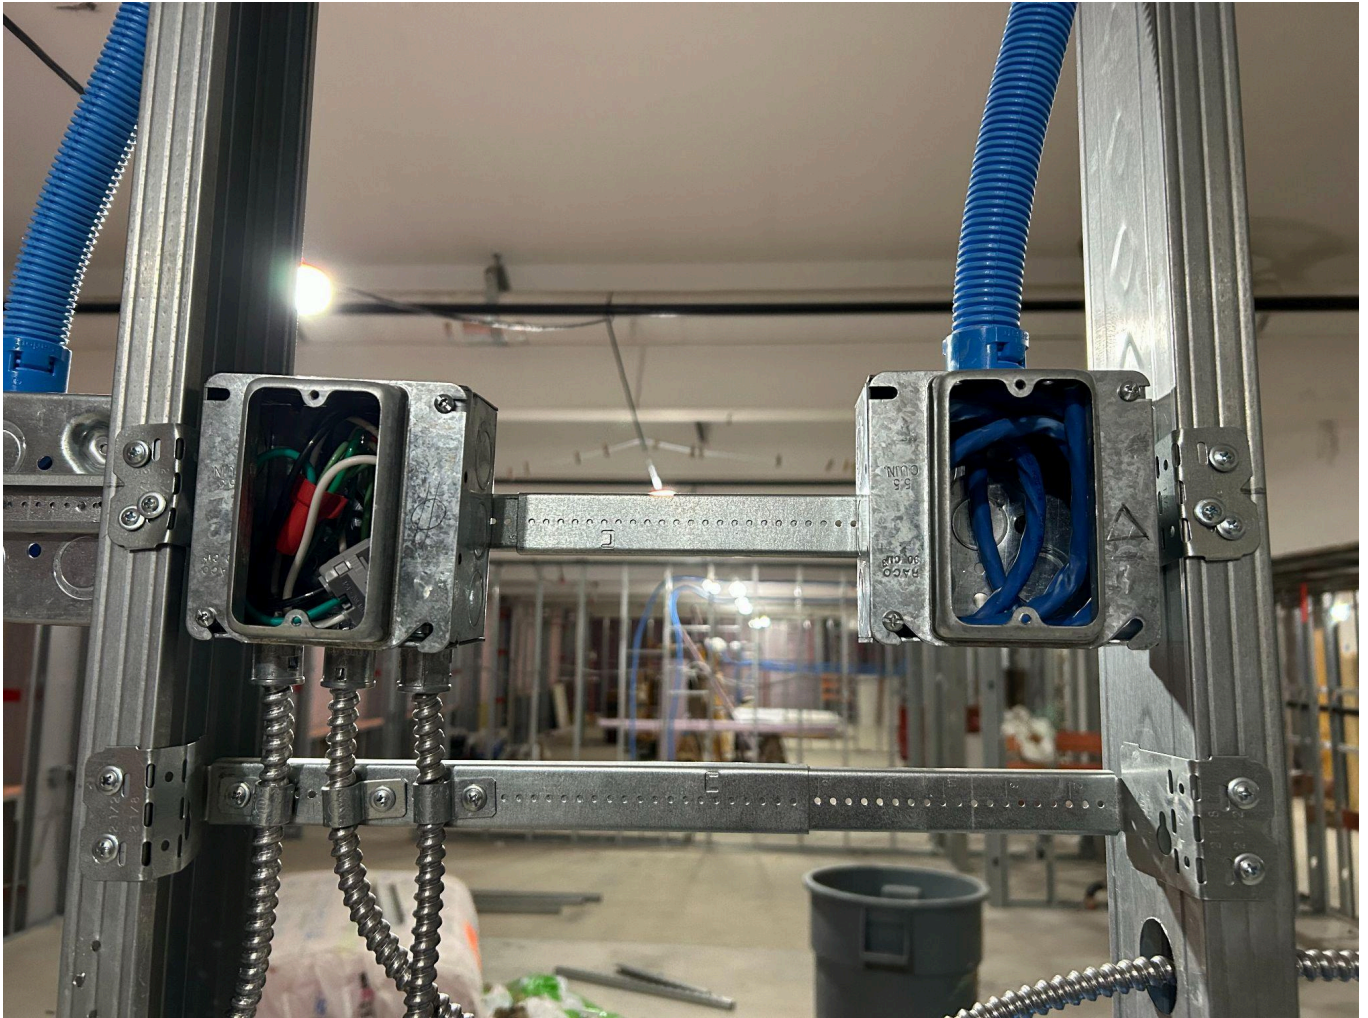
A picture showing the installation of wiring within the metal Jboxes for either the electrical outlet (Jbox on the left) or the data wiring (Jbox on the right) in the classrooms in the 1965 wing of the building.

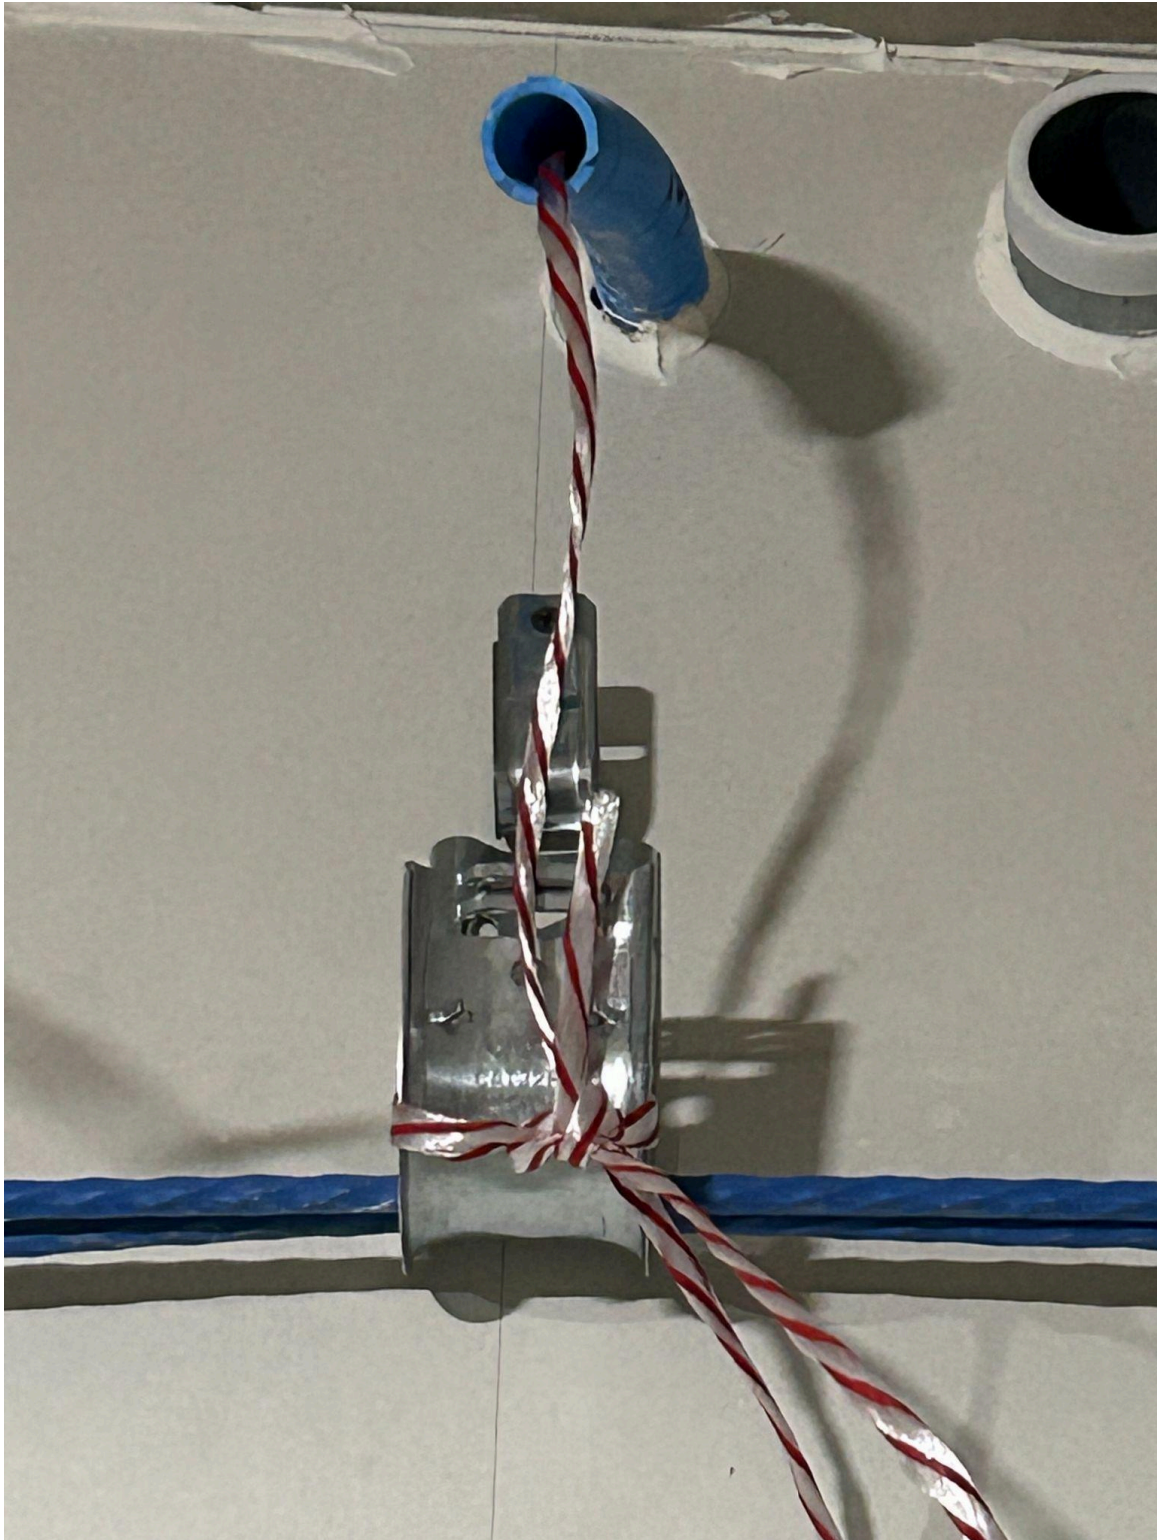
A picture showing the installation of string in the smurf tubing coming from a classroom out to the corridor. The string is there, so that when the wire does start to get installed, you attach the wire to the string, pull the string, and that will then pull the wire into the tubing to the Jbox.

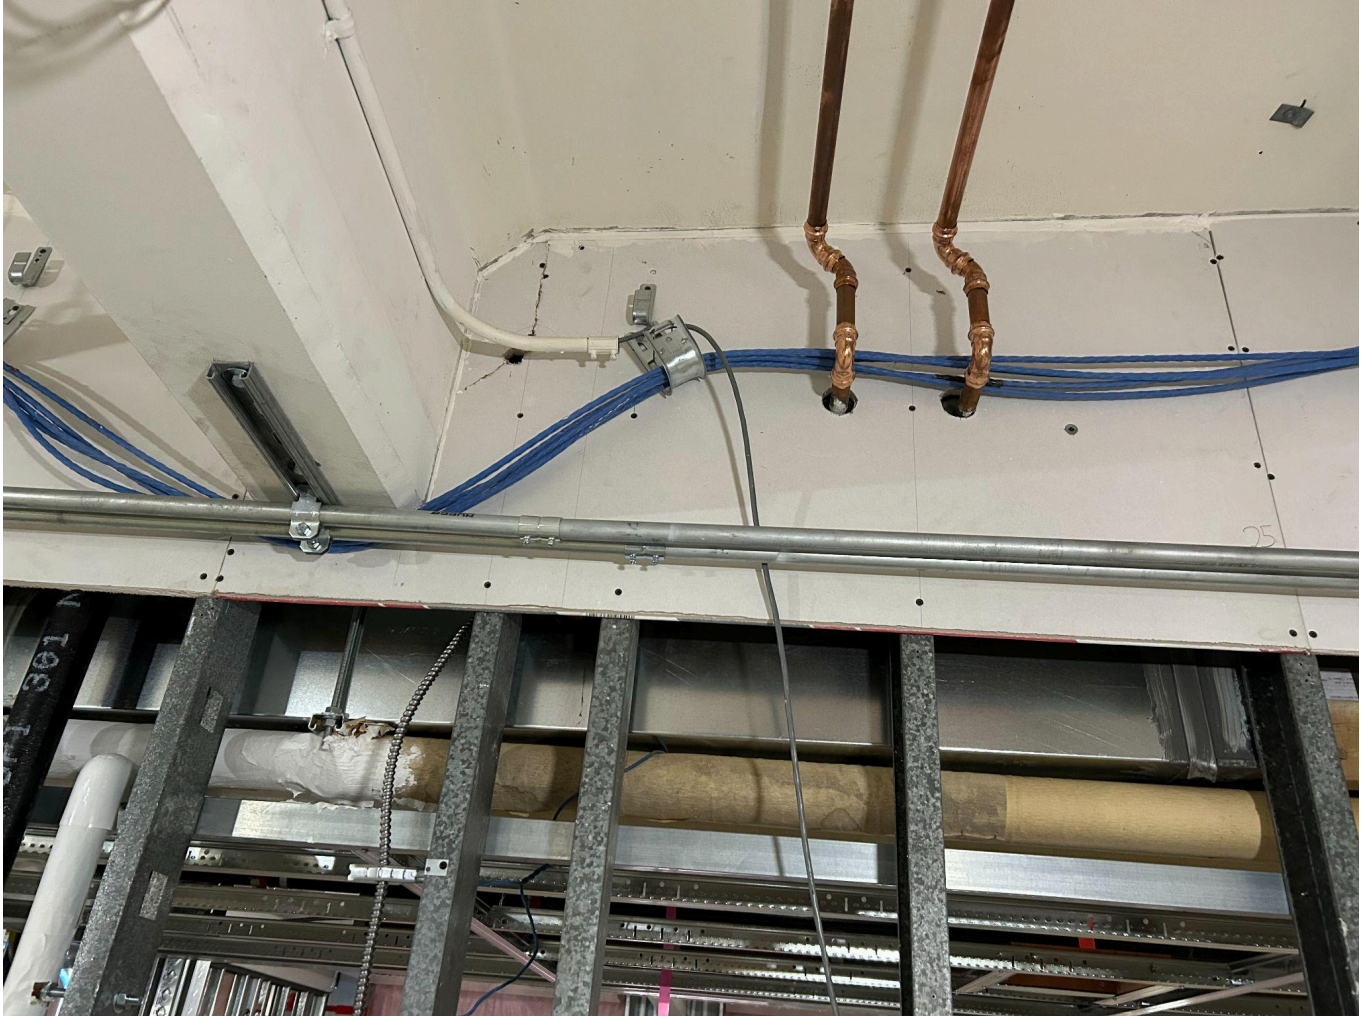
Picture showing the data wiring being hung on the corridor walls that will then be above the new ceilings.

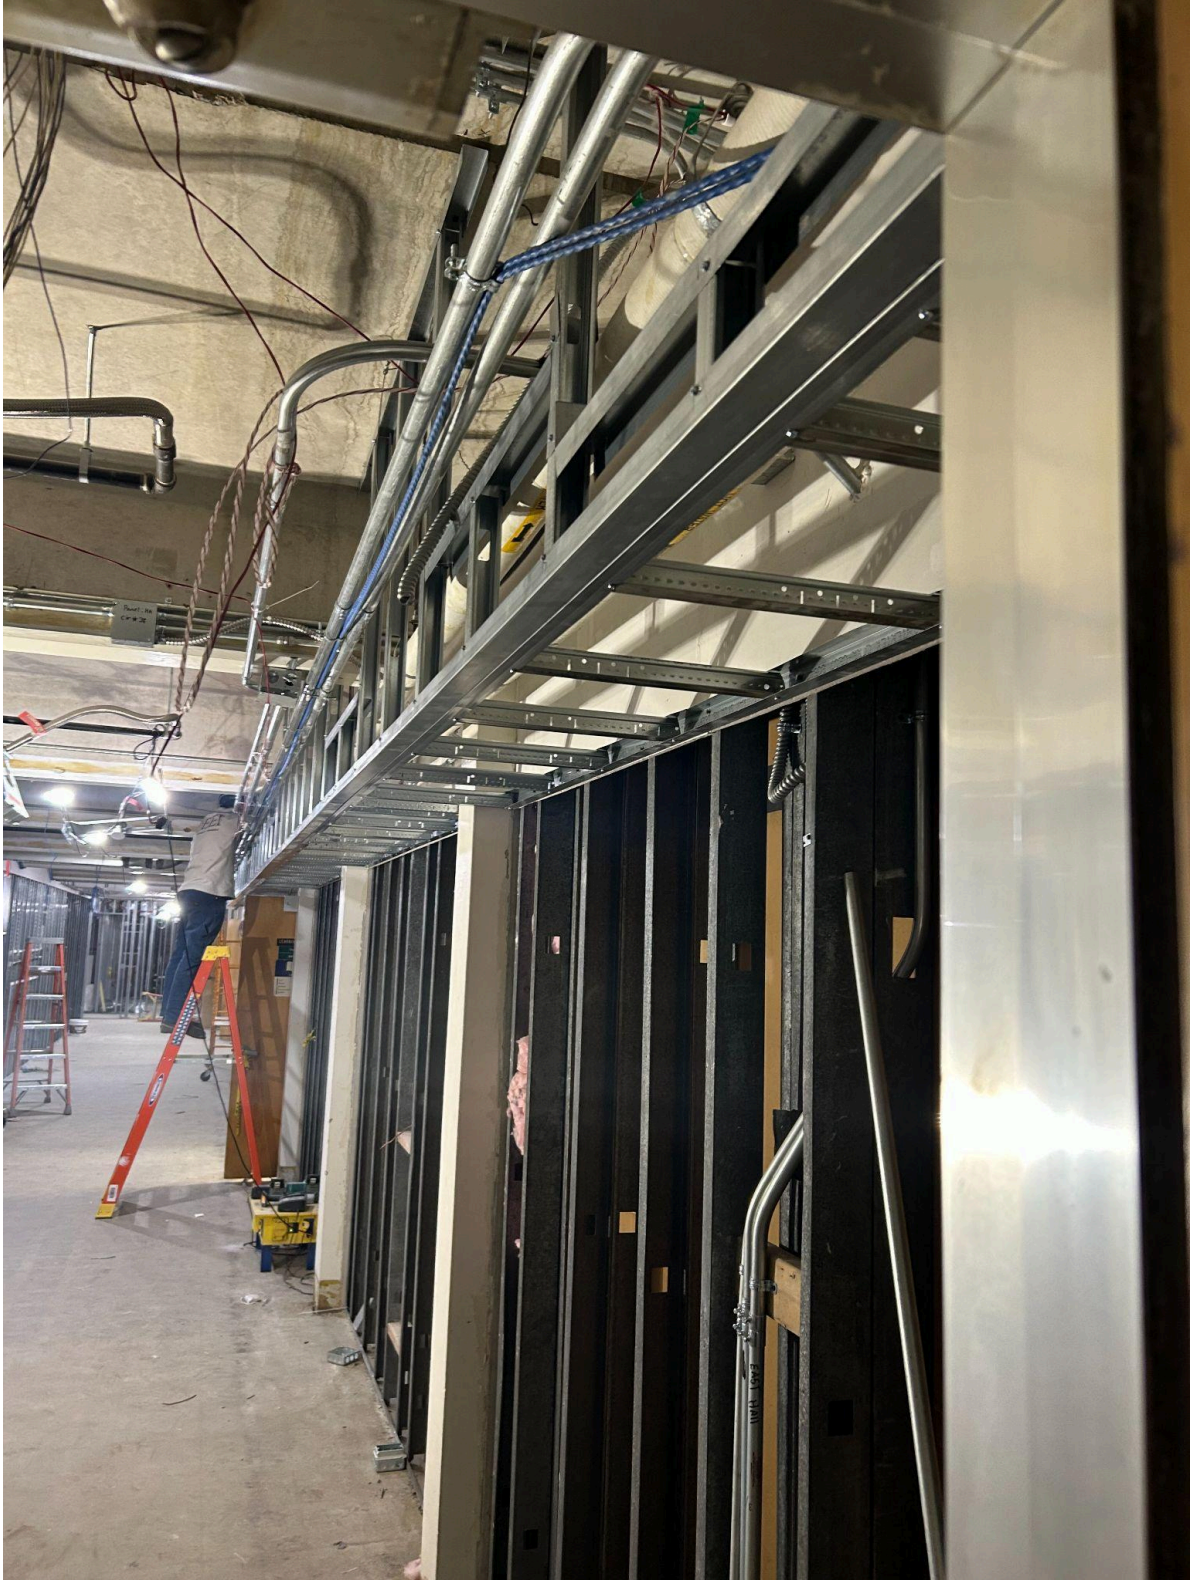
A picture showing the installation of the framing for the soffit in the corridor in the 1965 wing of the building.

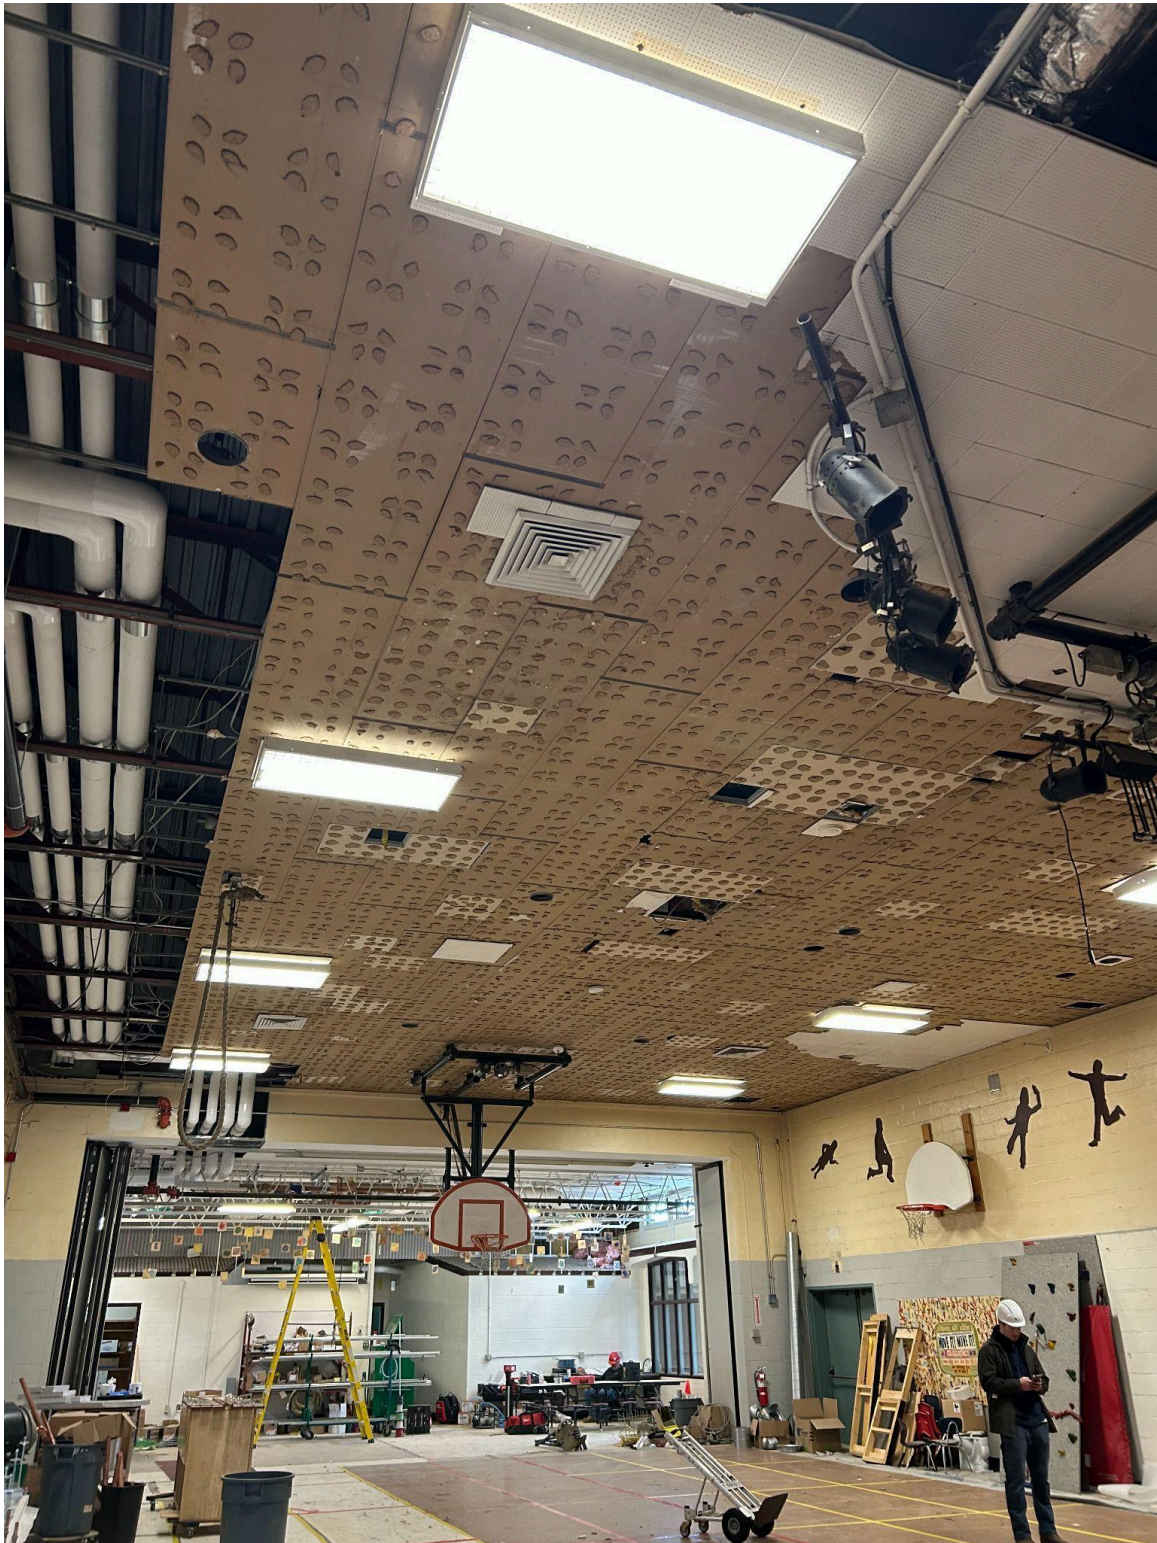
A picture of the GYM ceiling that is starting to be taken down. The GYM will have a new ceiling when construction is complete.

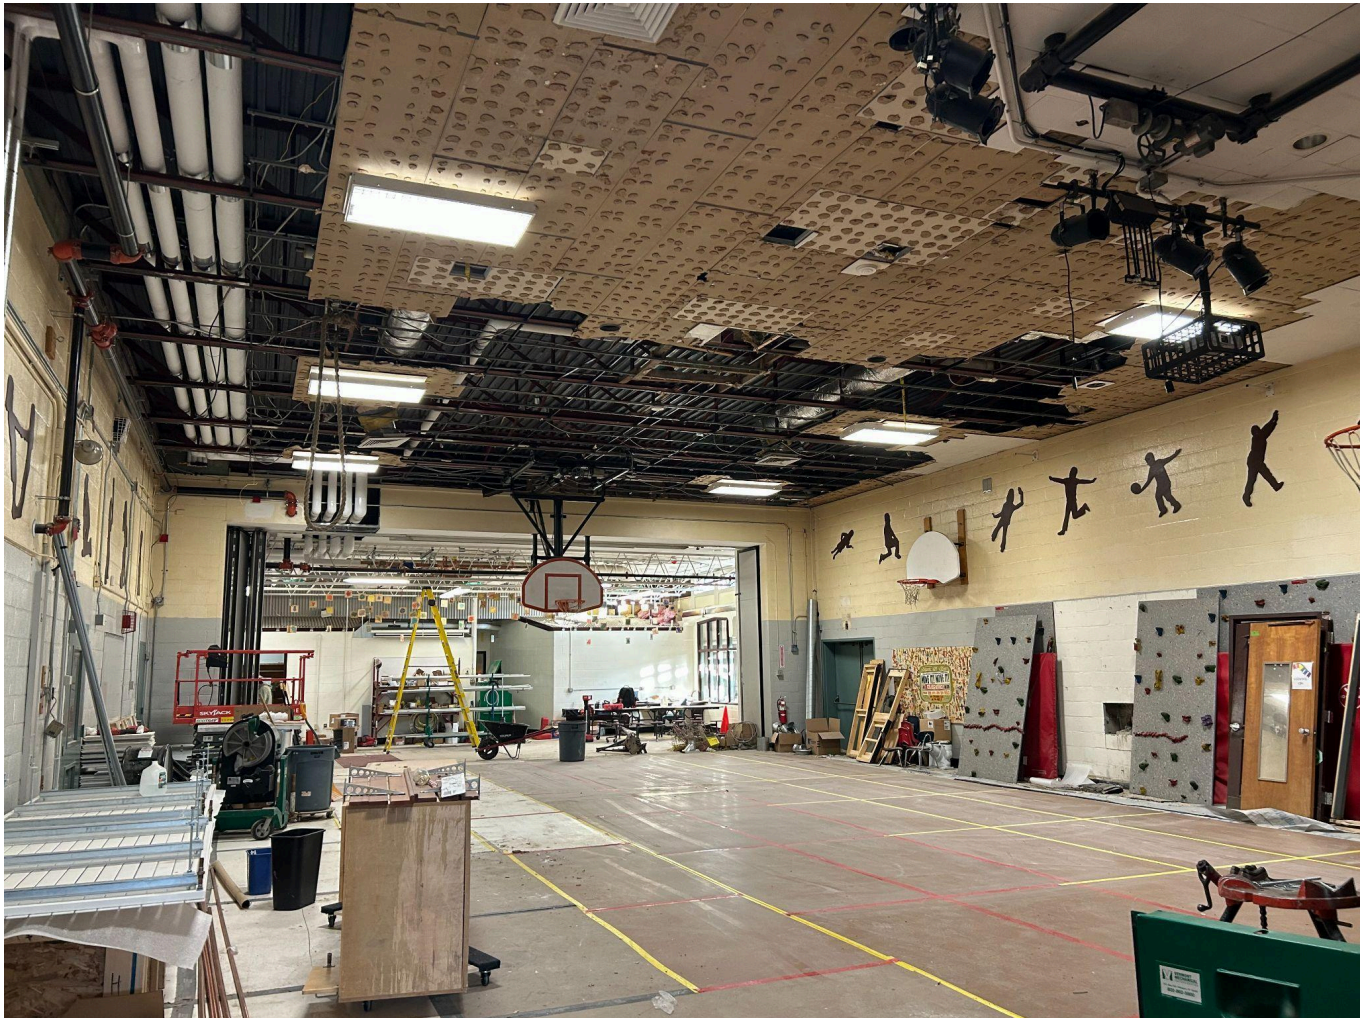
A picture showing the progression of the work going on in removing the old ceiling in the GYM.

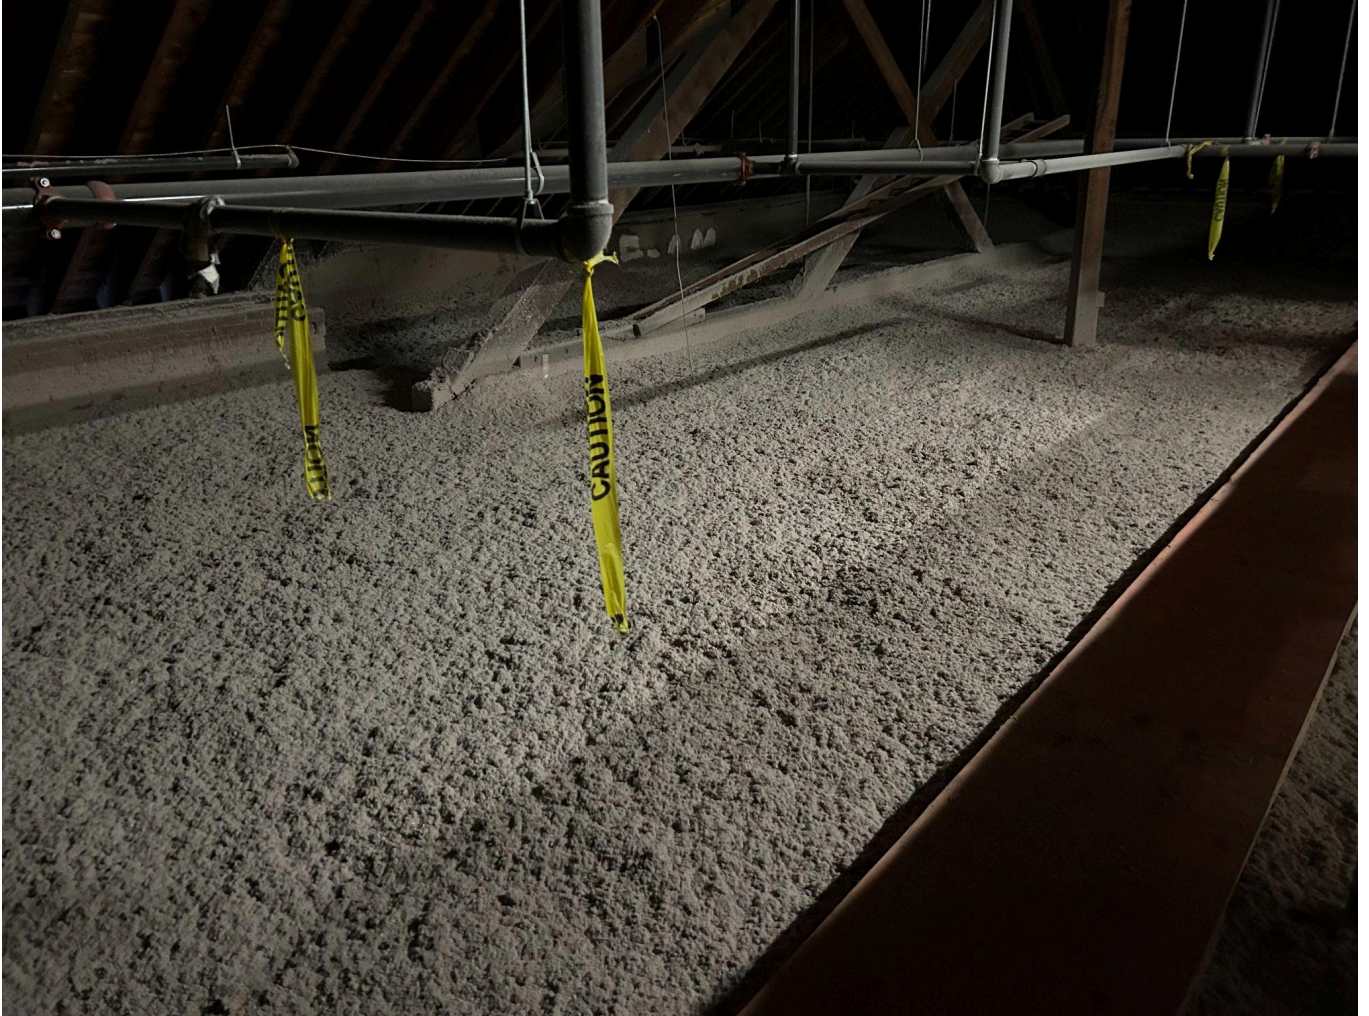
A picture showing the new insulation that has been installed in the Attic. This insulation covers the floor of the Attic.

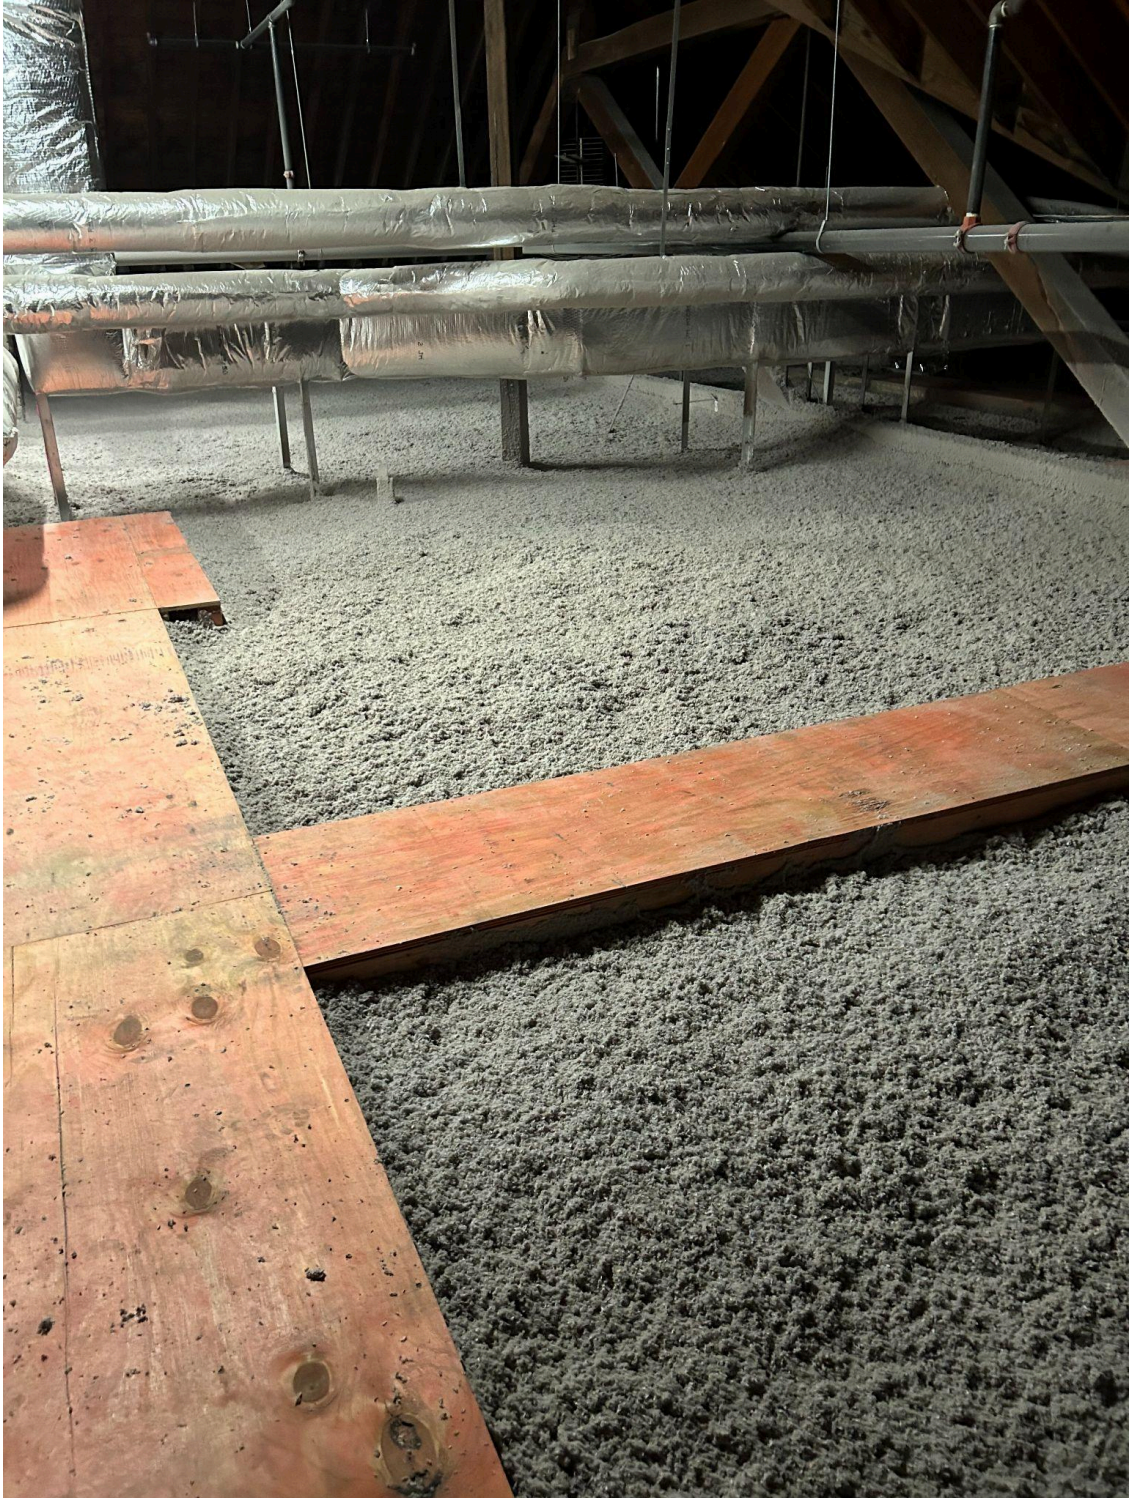
Another picture of the insulation in the Attic. A few weeks ago, we showed pictures of these catwalks being installed. The catwalks are now above the insulation and it is easier to walk around up in the Attic of the 1904 wing in the building.

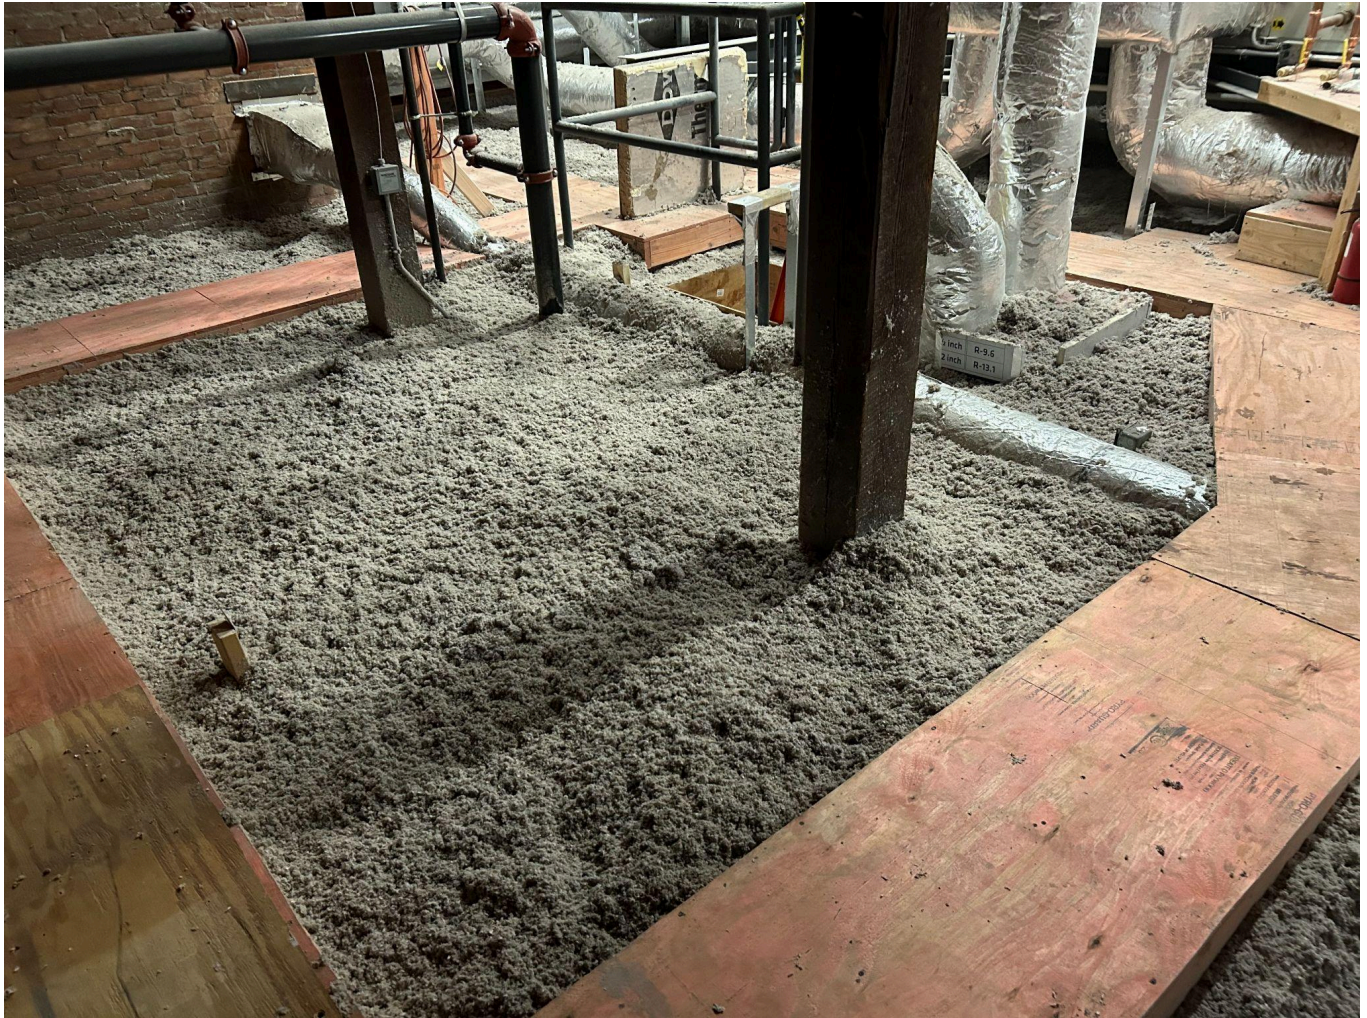
Insulation was installed under the catwalks as well. The amount of insulation on the floor of the Attic is equal to R-60. The insulation on the floor of the Attic is now code compliant. The test will be this winter to see if the big icicles will be hanging off of the building. The amount of this new insulation that is installed should prevent the icicles from forming.

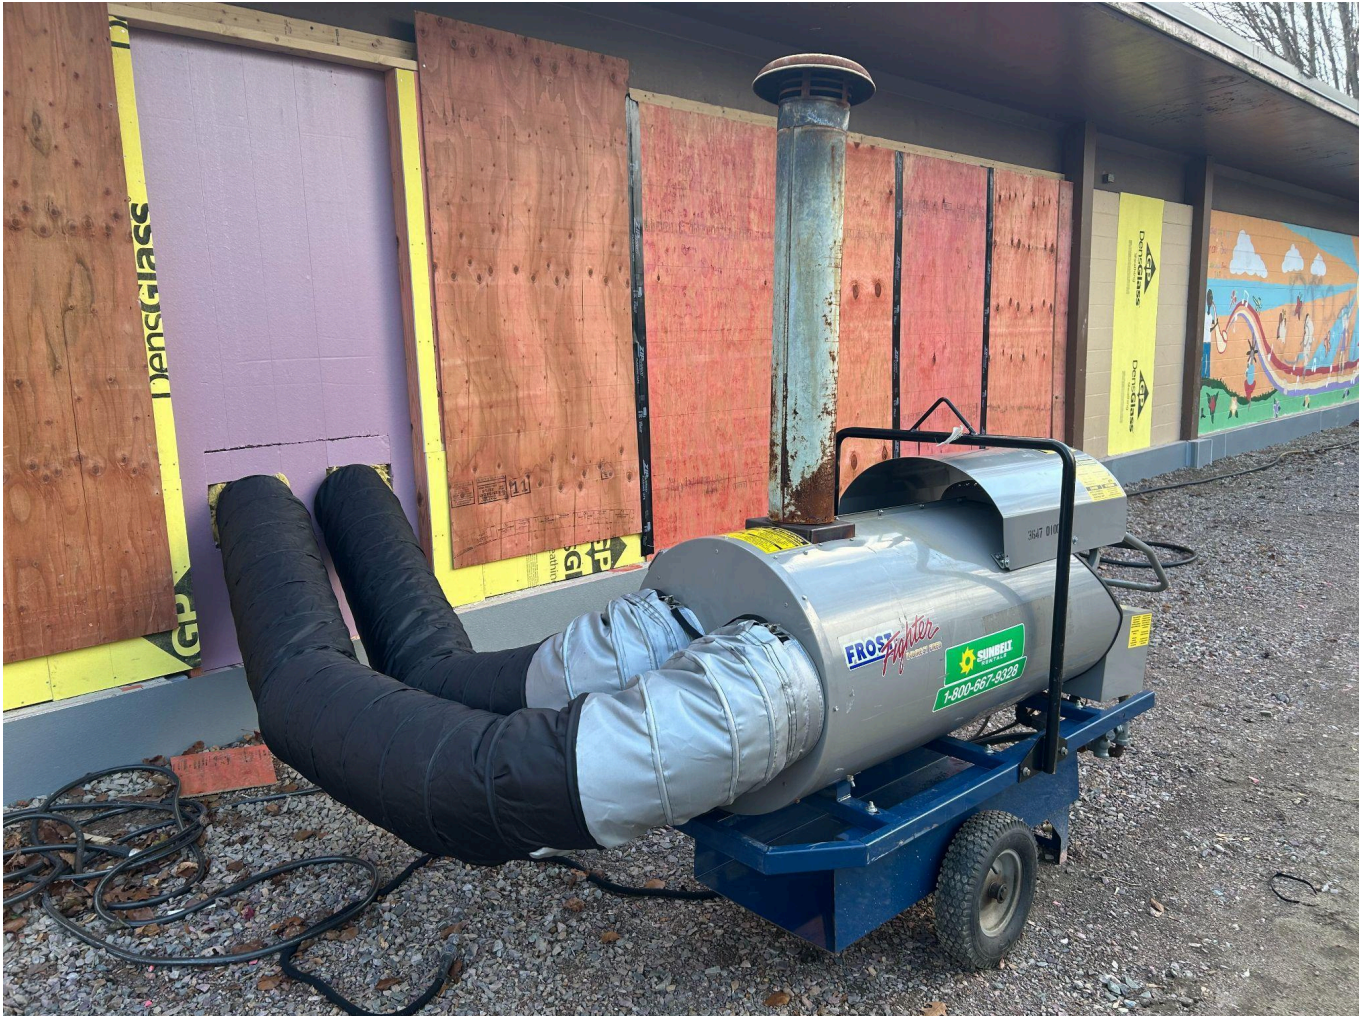
A picture showing a gas fired heater that the contractor has installed as a temporary measure to help with the heating of the building in the 1965 wing.

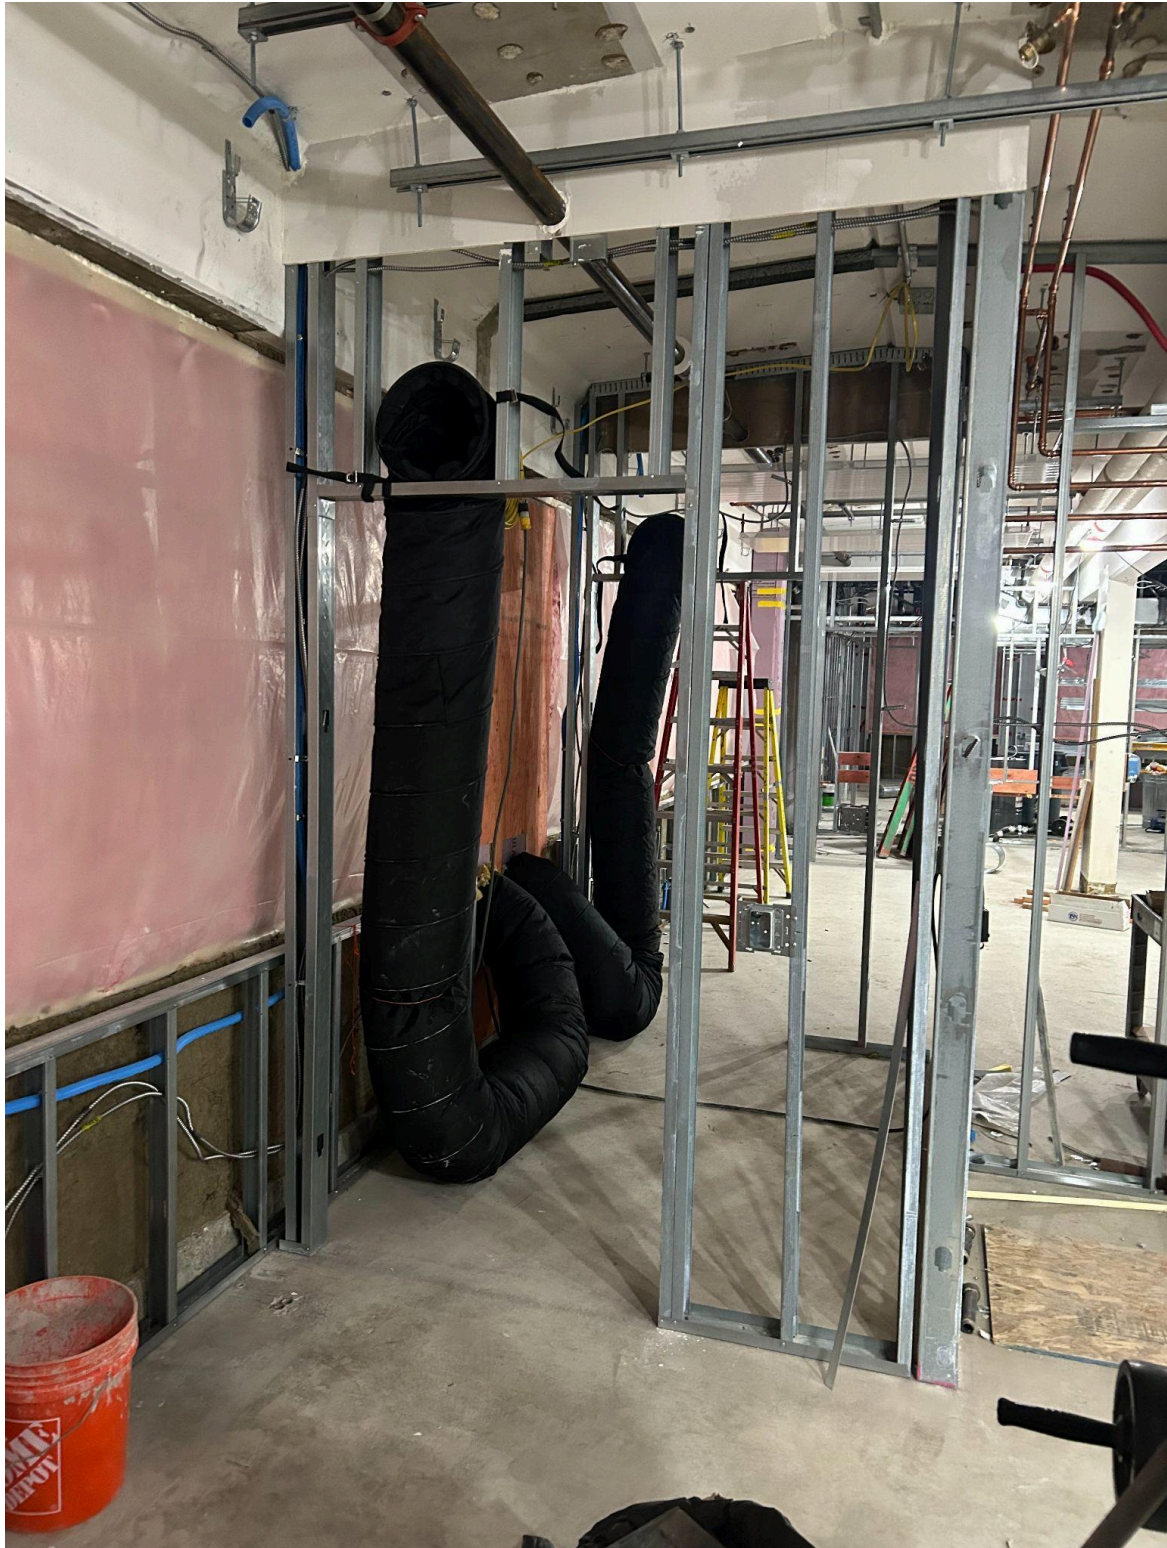
The tubes from the temporary heater come into the building and terminate with these flexible ducts blowing the warm air into the 1965 wing of the building.
