December 13, 2024

## Clerk of the Works Site Visit Report - IAA H.O. Wheeler Elementary School Project

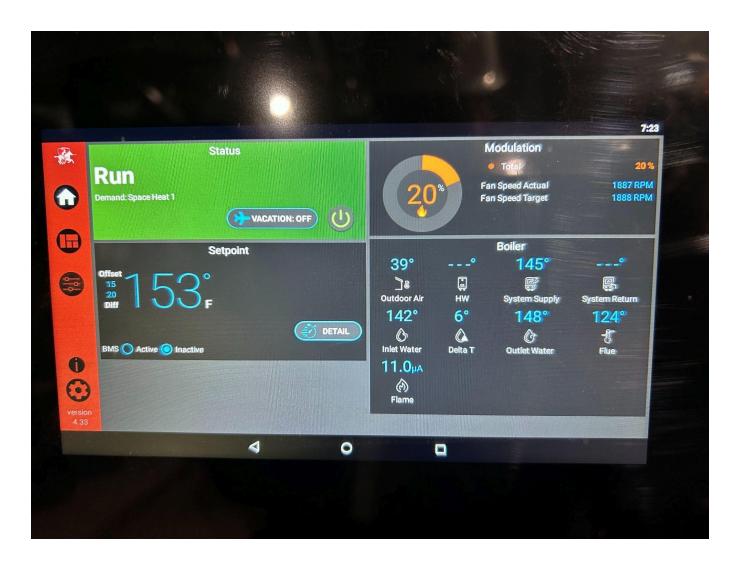
Picture showing the display of the Boiler running. Yes, it was 39 degrees outside, but the Boiler was maintaining the temperature within the building as set by one of the temporary thermostats at only 20 percent of full load. That is a very efficient Boiler.

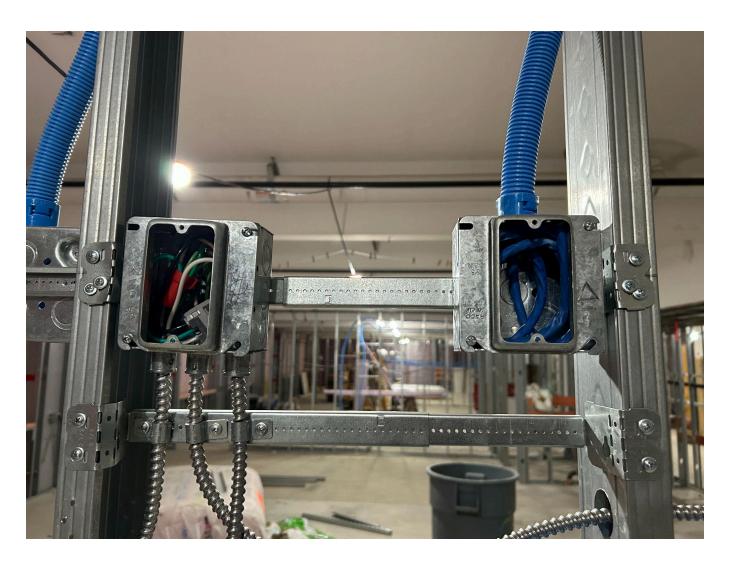
A picture showing the installation of wiring within the metal Jboxes for either the electrical outlet (Jbox on the left) or the data wiring (Jbox on the right) in the classrooms in the 1965 wing of the building.

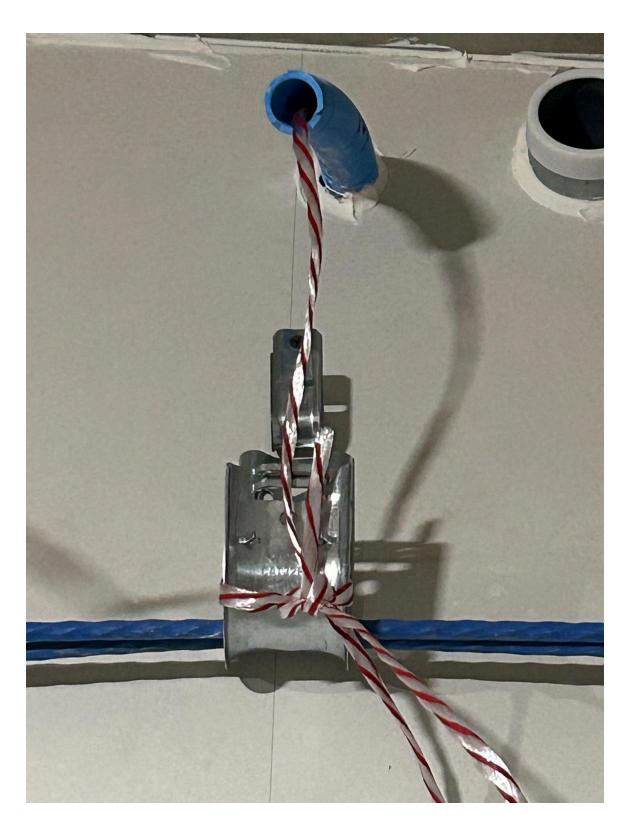
A picture showing the installation of string in the smurf tubing coming from a classroom out to the corridor. The string is there, so that when the wire does start to get installed, you attach the wire to the string, pull the string, and that will then pull the wire into the tubing to the Jbox.

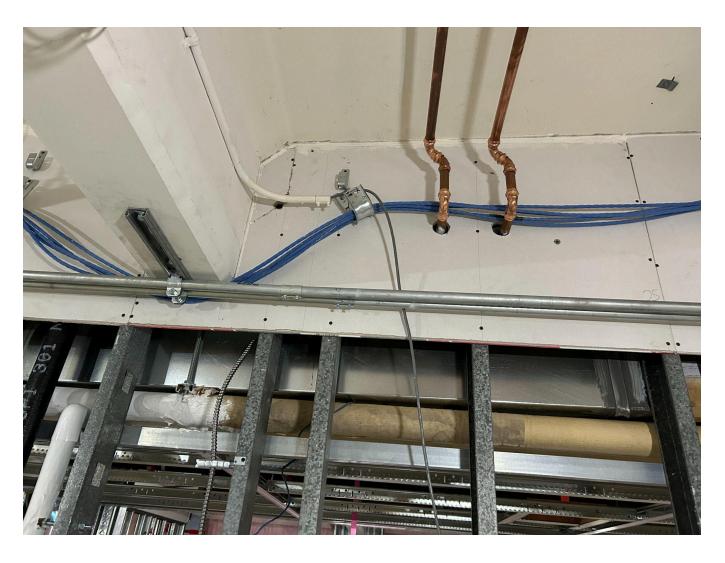
Picture showing the data wiring being hung on the corridor walls that will then be above the new ceilings.

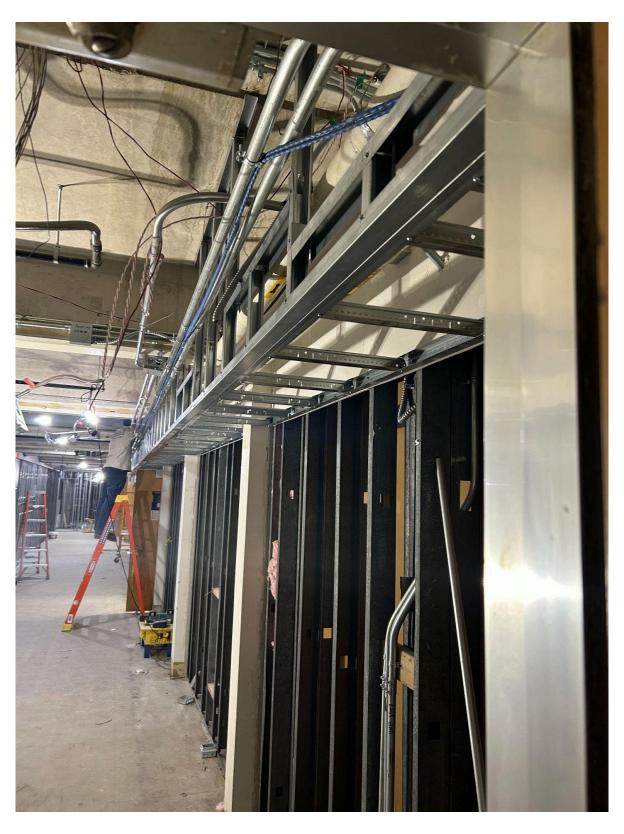
A picture showing the installation of the framing for the soffit in the corridor in the 1965 wing of the building.

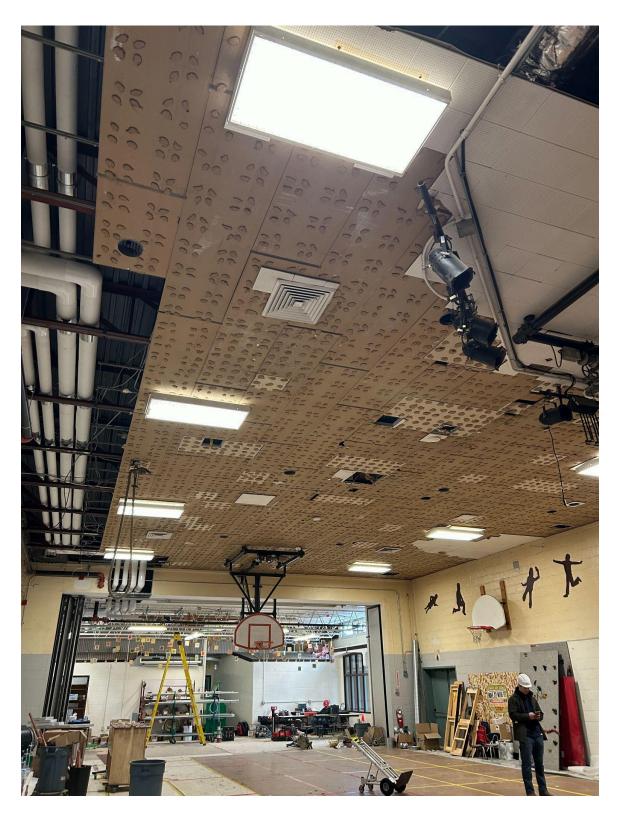
A picture of the GYM ceiling that is starting to be taken down. The GYM will have a new ceiling when construction is complete.

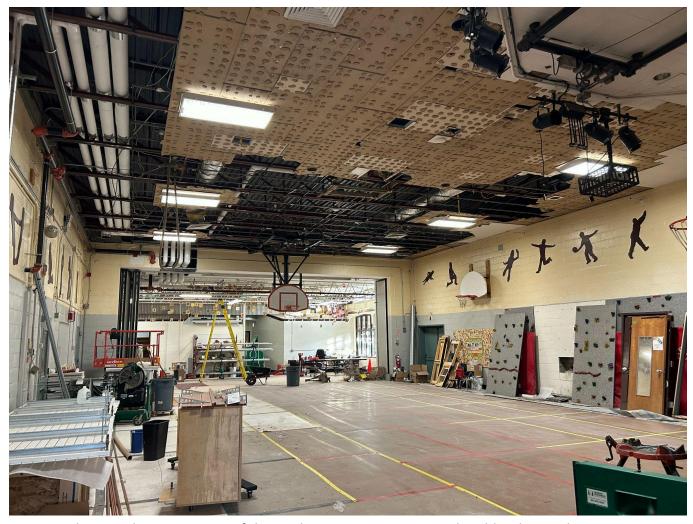
A picture showing the progression of the work going on in removing the old ceiling in the GYM.

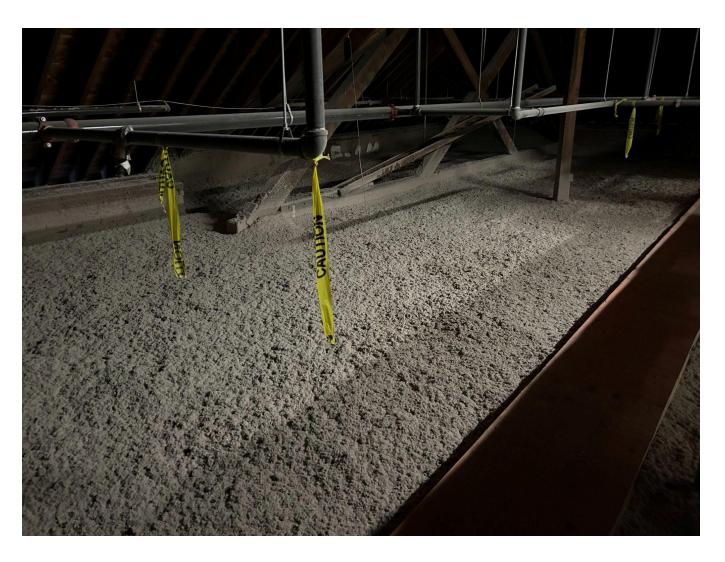
A picture showing the new insulation that has been installed in the Attic. This insulation covers the floor of the Attic.

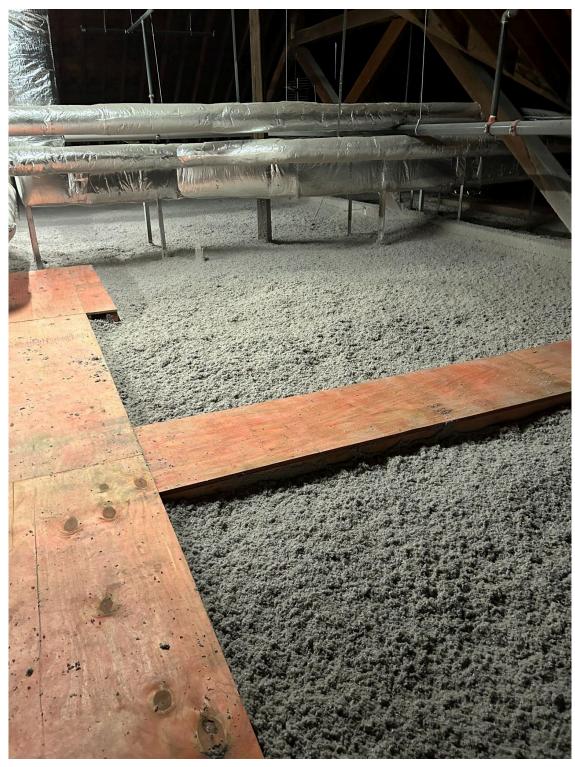
Another picture of the insulation in the Attic. A few weeks ago, we showed pictures of these catwalks being installed. The catwalks are now above the insulation and it is easier to walk around up in the Attic of the 1904 wing in the building.

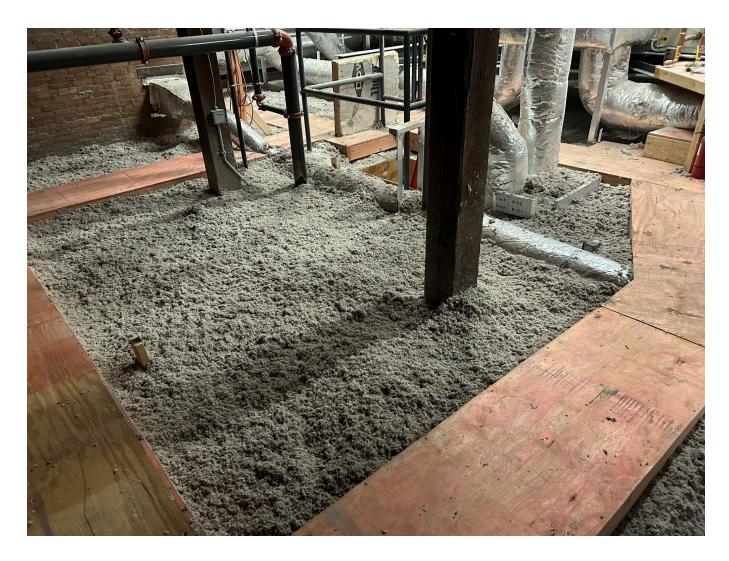
Insulation was installed under the catwalks as well. The amount of insulation on the floor of the Attic is equal to R-60. The insulation on the floor of the Attic is now code compliant. The test will be this winter to see if the big icicles will be hanging off of the building. The amount of this new insulation that is installed should prevent the icicles from forming.

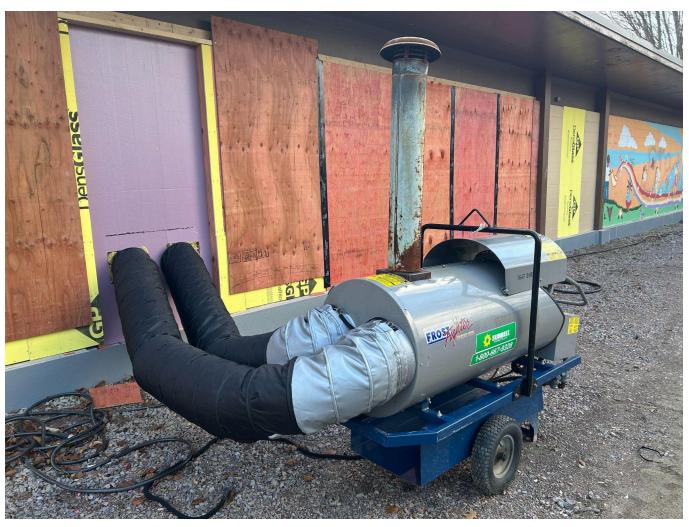
A picture showing a gas fired heater that the contractor has installed as a temporary measure to help with the heating of the building in the 1965 wing.

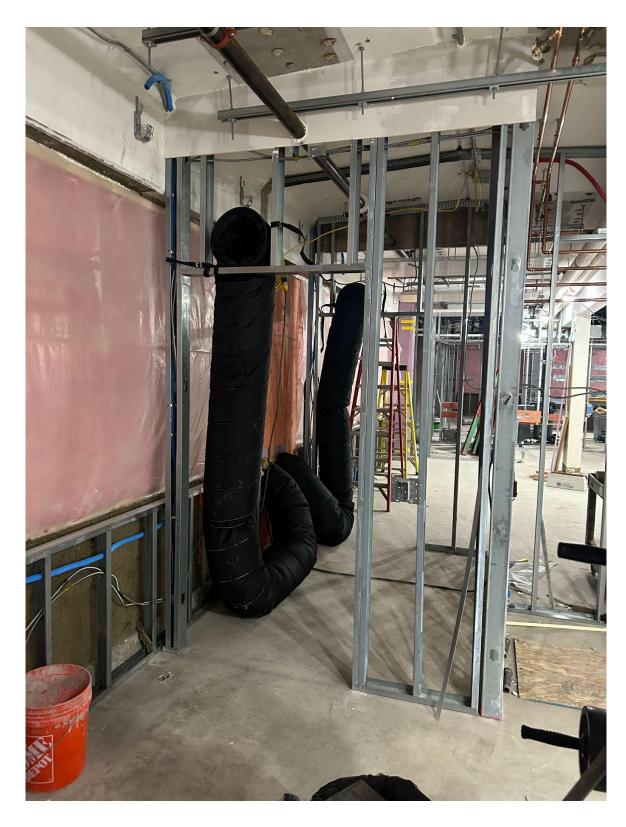
The tubes from the temporary heater come into the building and terminate with these flexible ducts blowing the warm air into the 1965 wing of the building.
