# Results of Infra-Red Surveys

## Summary of Survey

### Church

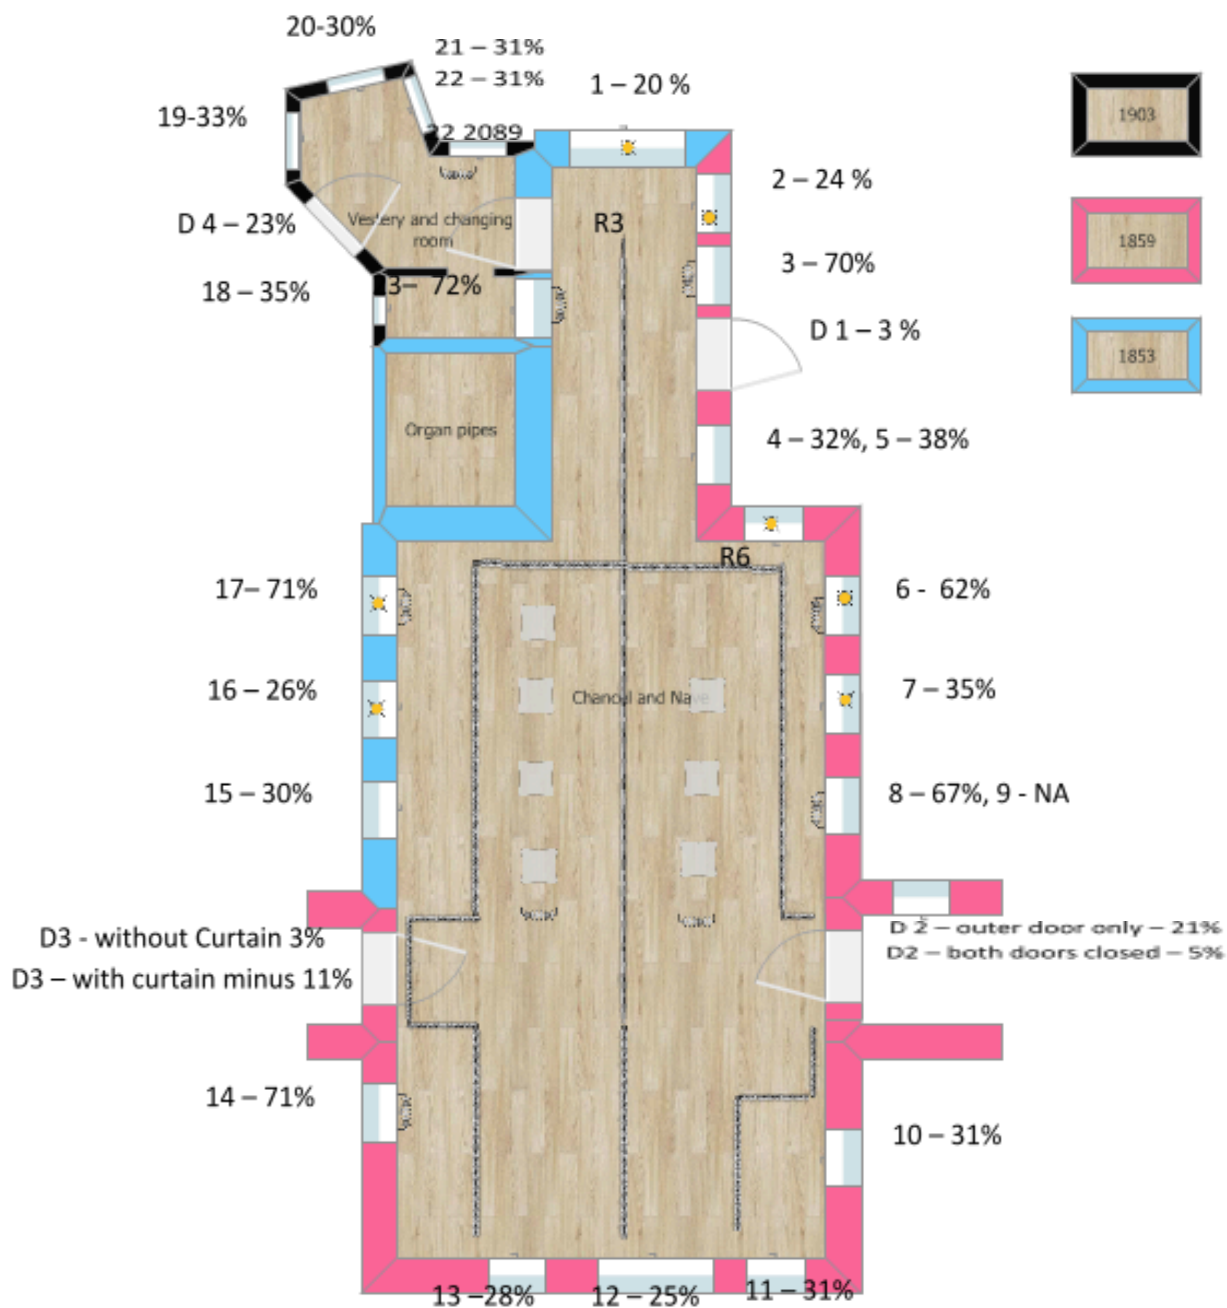
### Church Diagram showing heat loss figures

Surface Area	Temp		Temp Diff from Room	Heat loss
Window 1	12		3	20%
Window 2	11.4		3.6	24%
Window 3	13.7	radiator 55.6 degrees	1.3	70%
Window 4	10.2		4.8	32%
Window 5	9.3		5.7	38%
Window 6	13.2	radiator 35	21.8	62%
Window 7	9.7		5.3	35%
Window 8	9.8	radiator 30	20.2	67%
Window 9	na			
Window 10	10.3		4.7	31%
Window 11	10.3		4.7	31%
Window 12	11.3		3.7	25%
Window 13	10.8		4.2	28%
Window 14	12.5	radiator 42.6	2.5	72%
Window 15	10.5		4.5	30%
Window 16	11.1		3.9	26%
Window 17	12.4	radiator 44.6	2.6	72%
Window 23	11.9	radiator 43	31.1	72%
church wall v1	12.9		2.1	14%
church wall v2	13.1		1.9	13%
church wall v3	12.2		2.8	19%
Door D1	14.5	With Curtain in place	0.5	3%
Door D3 - with curtain	16.7	With Curtain in place + plus floor heater by door	-1.7	-11%
Door D3 - without curtain	14.5		0.5	3%
Door D2 (south)	14.3	Both Doors closed	0.7	5%
Door D2 (south)	11.8	Outer door only	3.2	21%

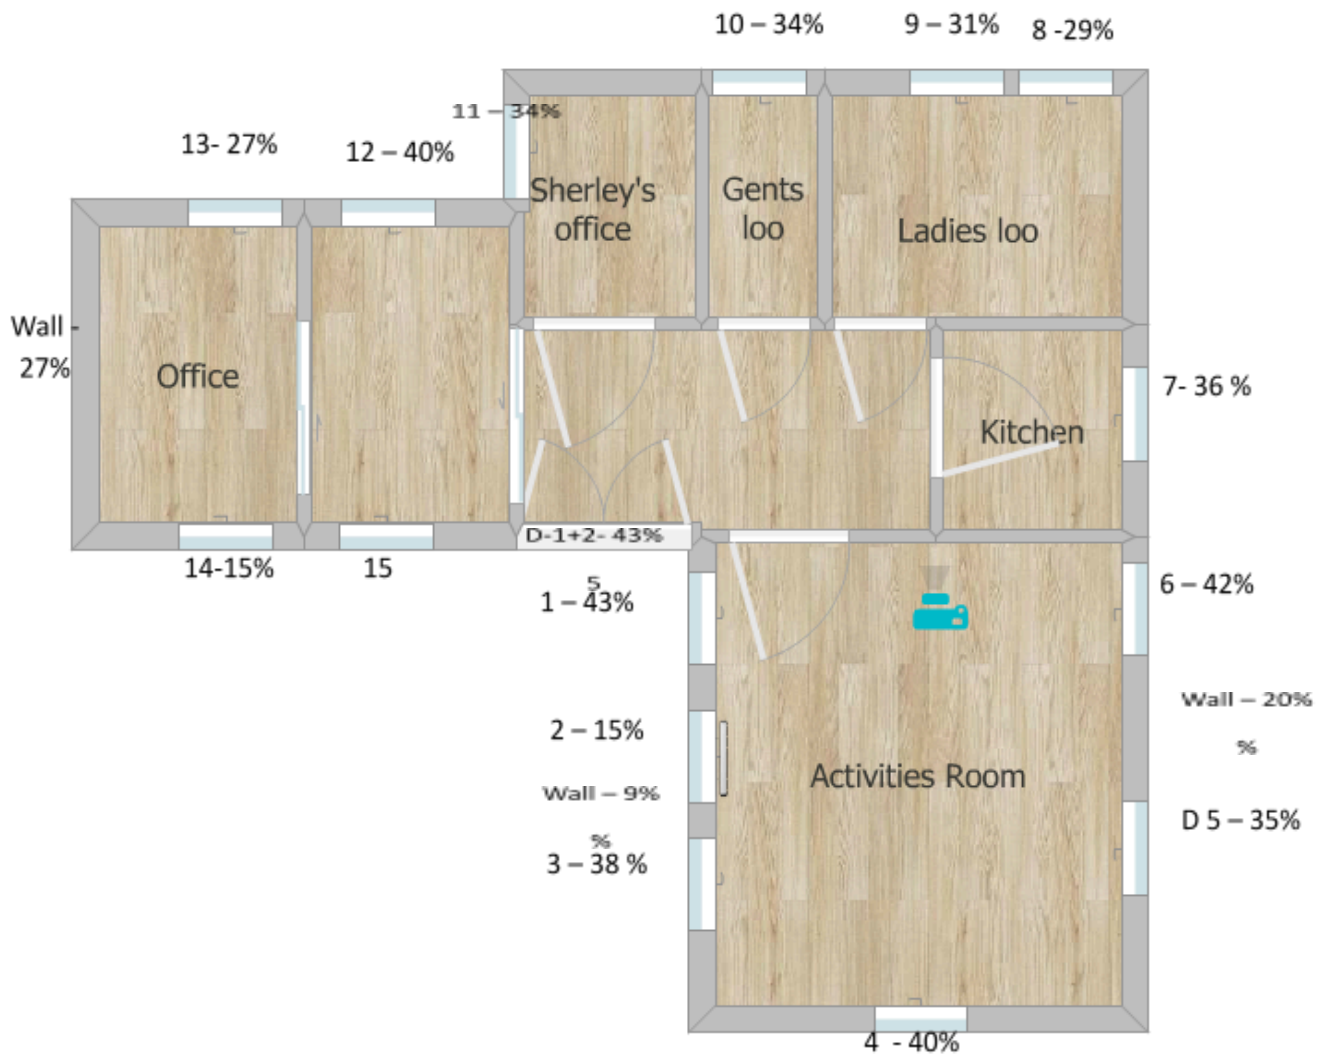
## Church Hall – Diagram of heat loss

Window	Temp	Comments	Temp Diff from Room	Heat loss
	<b>Meeting room</b>			
Window 1	12.5		9.5	43%
Window 2	18.6	radiator below window	3.4	15%
Window 3	13.7		8.3	38%
Window 4	13.2		8.8	40%
Window 5	14.3	Door?	7.7	35%
Window 6	12.8		9.2	42%
wall	17.5	wall by no 6 window	4.5	20%
wall	20	Wall between no 2 -3 window	2	9%
Ceiling	15.2		6.8	31%
Ceiling	15.7		6.3	29%
Ceiling	16		6	27%
Ceiling	16.2		5.8	26%
Floor	14.5		15.5	70%
	<b>Communal Areas</b>			
Window 7 (Kitchen)	9.6	( not heated as much 15 degree air temp during test)	5.4	36%
Window 8 (Ladies Loo)	10.6	( not heated as much 15 degree air temp during test)	4.4	29%
Window 9 (Ladies Loo)	10.3	( not heated as much 15 degree air temp during test)	4.7	31%
Window 10 (Gents Loo)	9.9	( not heated as much 15 degree air temp during test)	5.1	34%
11 (Sherley's office)	9.9	( not heated as much 15 degree air temp during test)	5.1	34%
12 (food bank)	9	( not heated as much 15 degree air temp during test)	6	40%

<b>Marie's office</b>			
13	16		6	27%
14	18.8		3.2	15%
Marie's office wall	16		6	27%

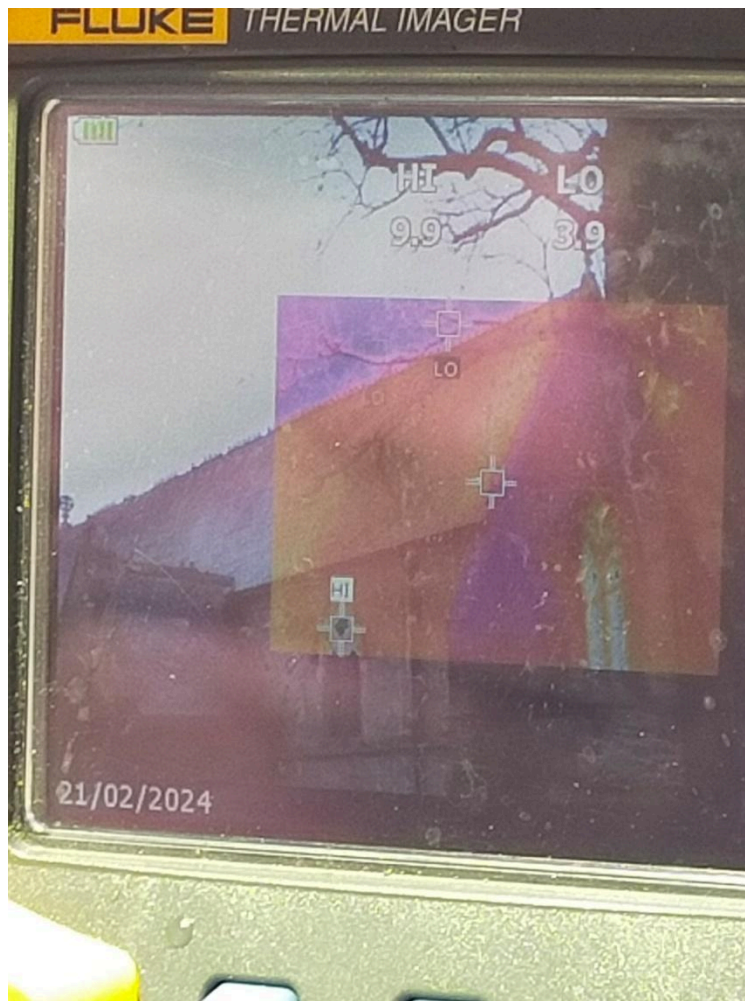
Roof on first cold day.

Average summary for Church	
Average heat loss were radiator not under window	35%
Average heat loss were radiator was under window	70%
Average heat loss walls	15%
Average heat loss for door with curtains (curtains stored and radiated heat) was	-8%
Average heat loss for door where no curtains used) was	22%
South porch double doors when both shut	5%
1853 old roof on very cold day showed heat loss between rafters.	See photo

Average temp of 1853 (west end) was 6.6% - Could clearly see the heat being lost between joists.

This was did not show on the new roofs.

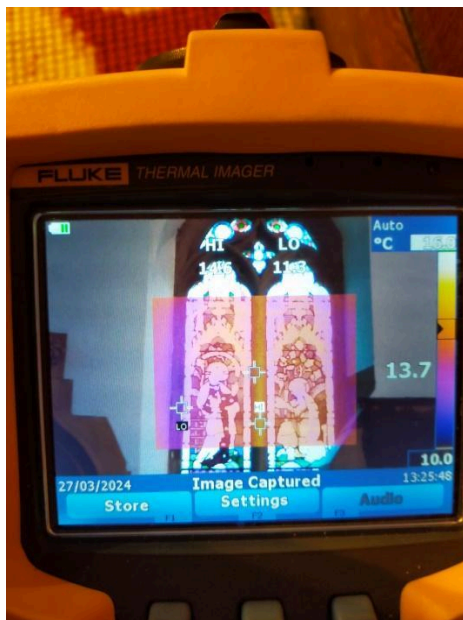
Window 3 (note there is a radiator under this one)

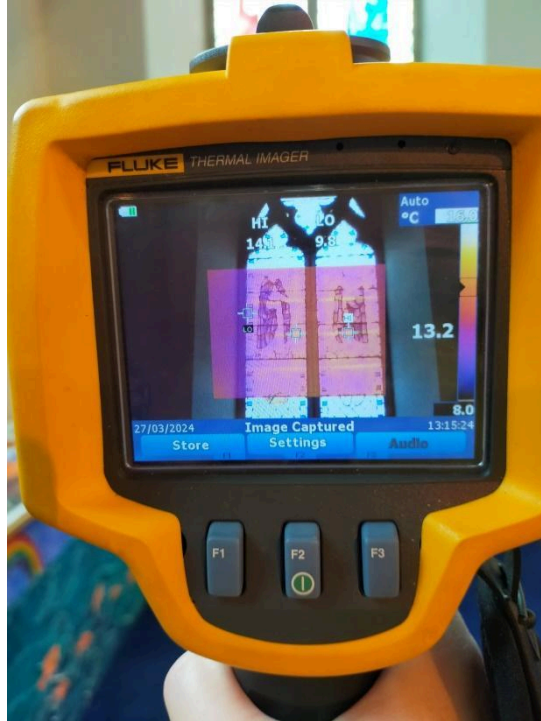
Note 4 – The south wall radiators in the chancel are not working as well. In particular the one under the window nearest the south porch entrance, number 6.

Window 6 (radiator below window)

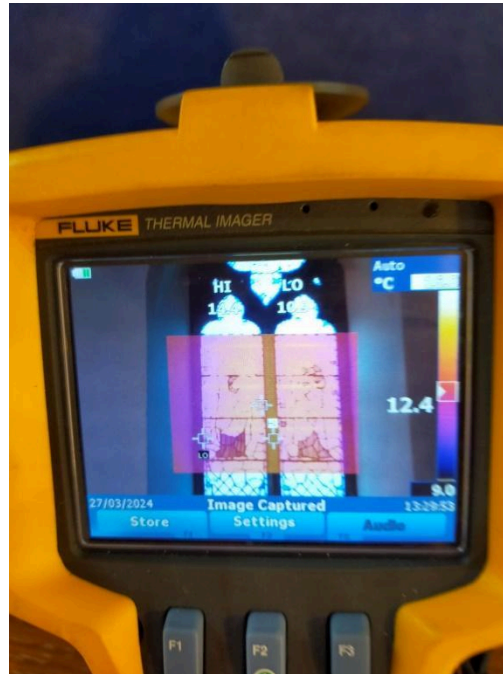
Window 17 (radiator under the window)

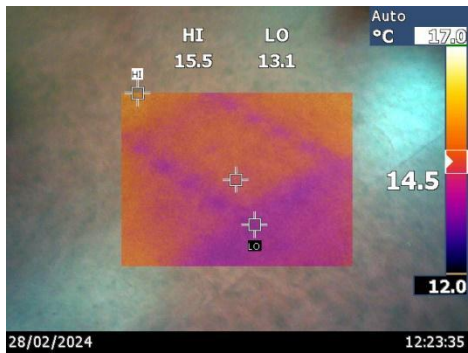
## Floor

Events - Meeting room	
Average heat loss were radiator not under window	33%
Average heat loss were radiator under window	15%
Average heat loss for ceiling	27%
Average heat loss for walls	15%
Floor (when room was well heated)	70%

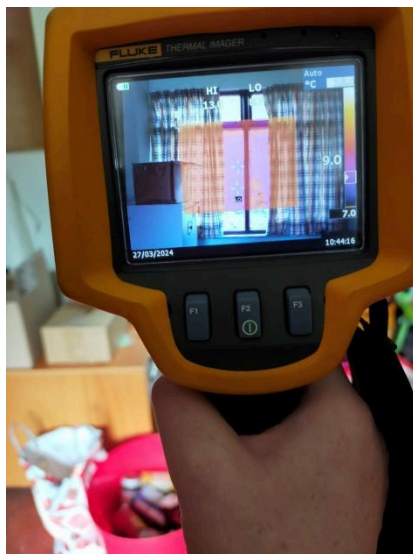
Window 12 (Very little heat in the room)
