CENTER FOR ECOLOGY & NATURAL
RESOURCE SUSTAINABILITY

SITE 4

Ravenna Housing

Franklin Township
Portage County, OH

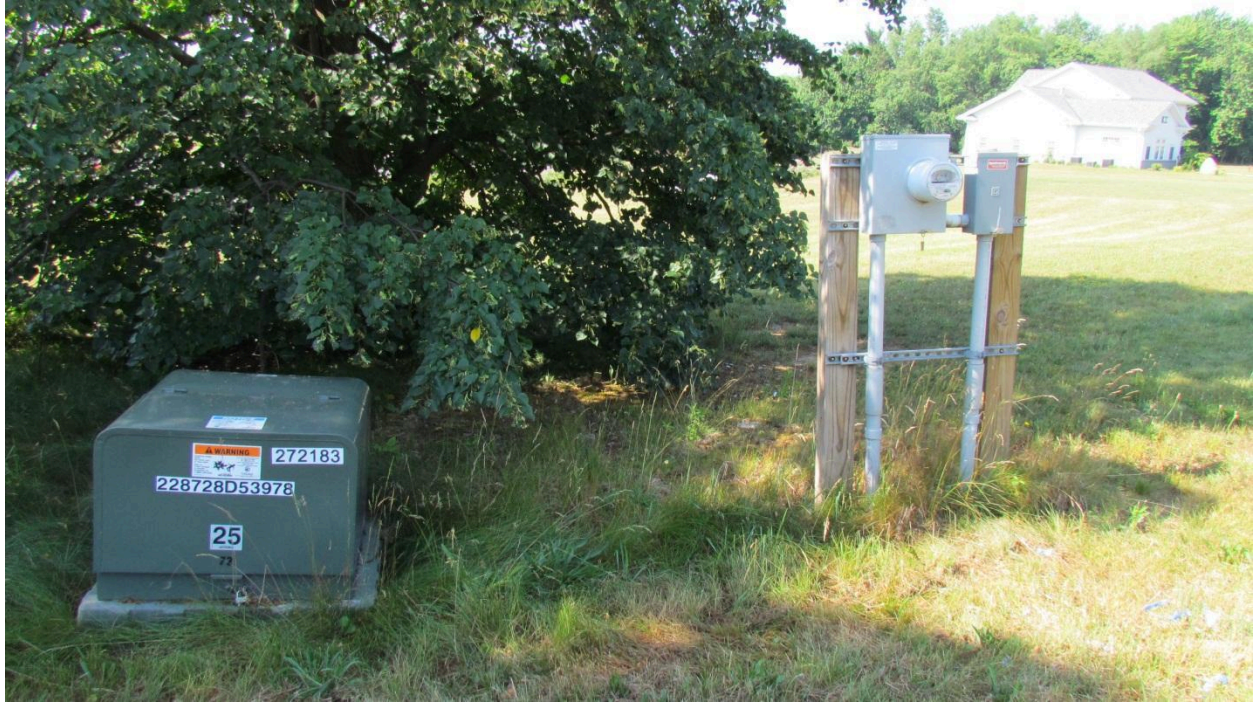
S4-01: *Electric Meter*

- An electric meter and box – Photo Point S4-01
- Sewer and Water Pipes – Photo Point S4-02 – a concrete drainpipe with a rocked waterway is located near the sewer and water pipes.

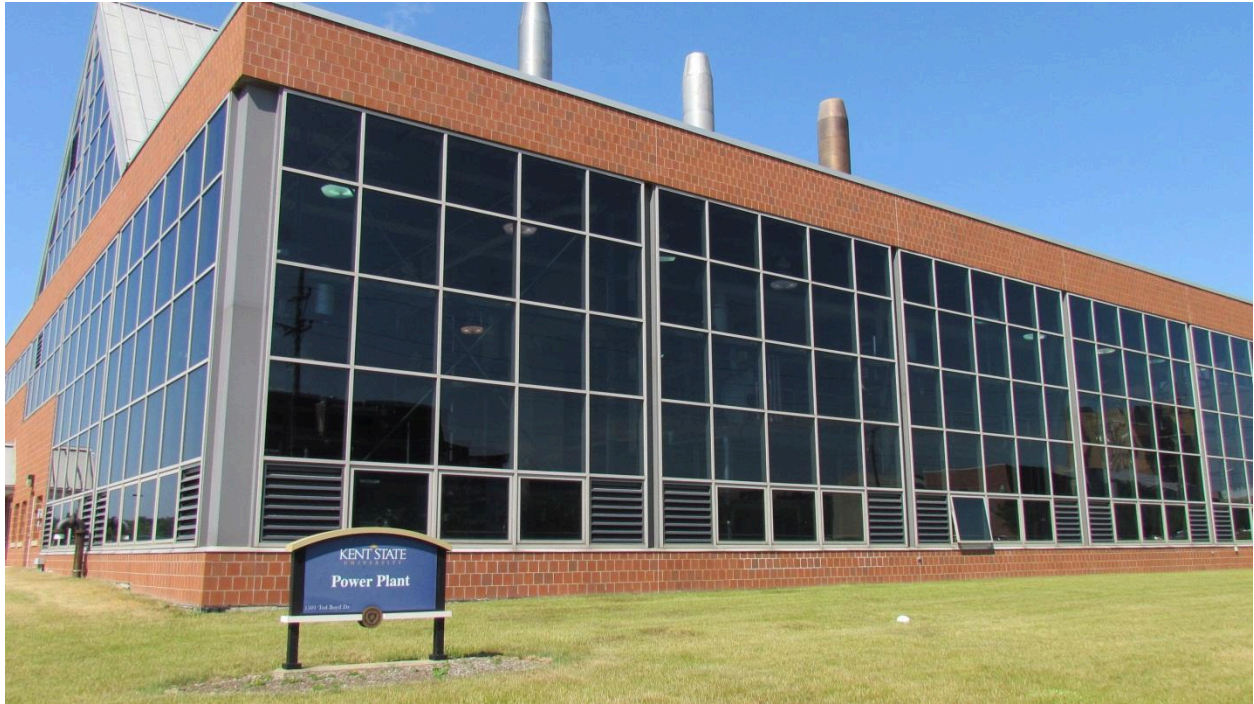
S4-03: *Power Plant*

- Power Plant – Photo Point S4-03
- Stream – Photo Point S4-04 – is located near the northeast corner of the property. A pooled area has developed in front of a drainpipe outlet. The water in this area is clear and the bottom is visible, boulder substrate. Riparian growth is heavy with shrubs and trees, shading the water. Feeds the pond located southeast of REC Center.

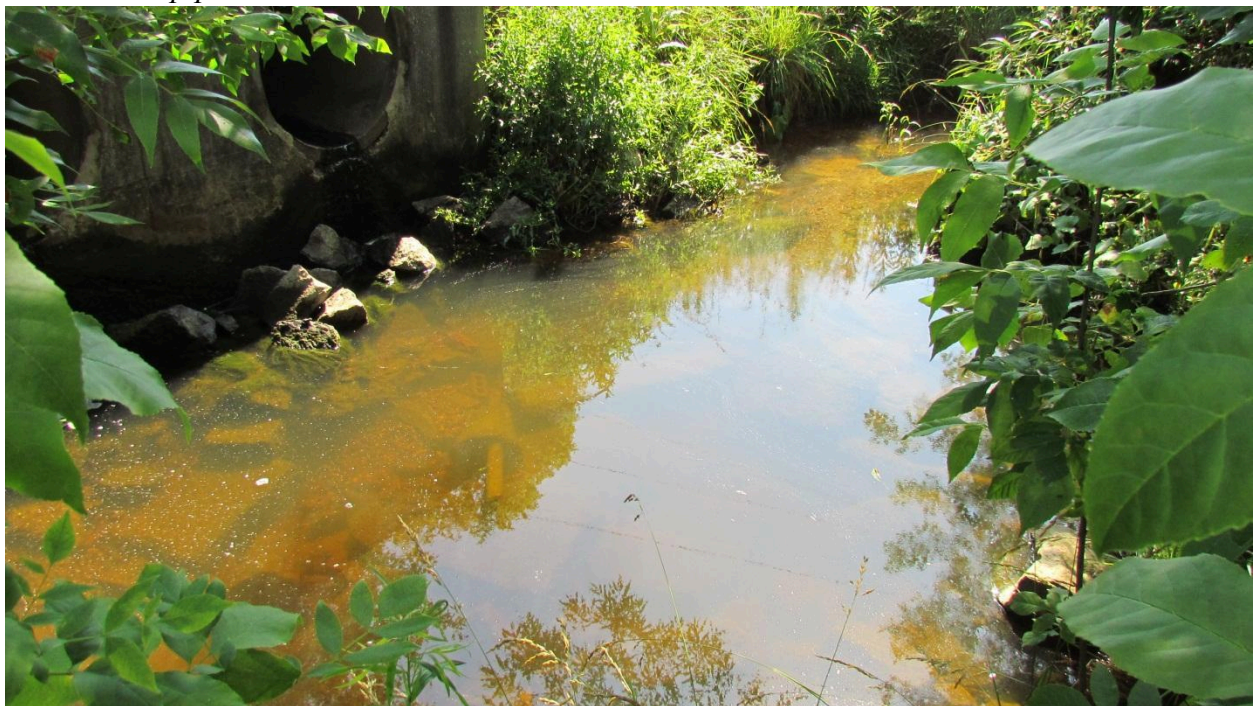
S4-05: *Drainpipe*

- Drainpipe – Photo Point S4-05 – outlets into the pond.
- Pond - Photo Point S4-06
- REC Center – Photo Point S4-07
- Drainpipe – Photo Point S4-08 – cattail growth present with large substrate bottom.

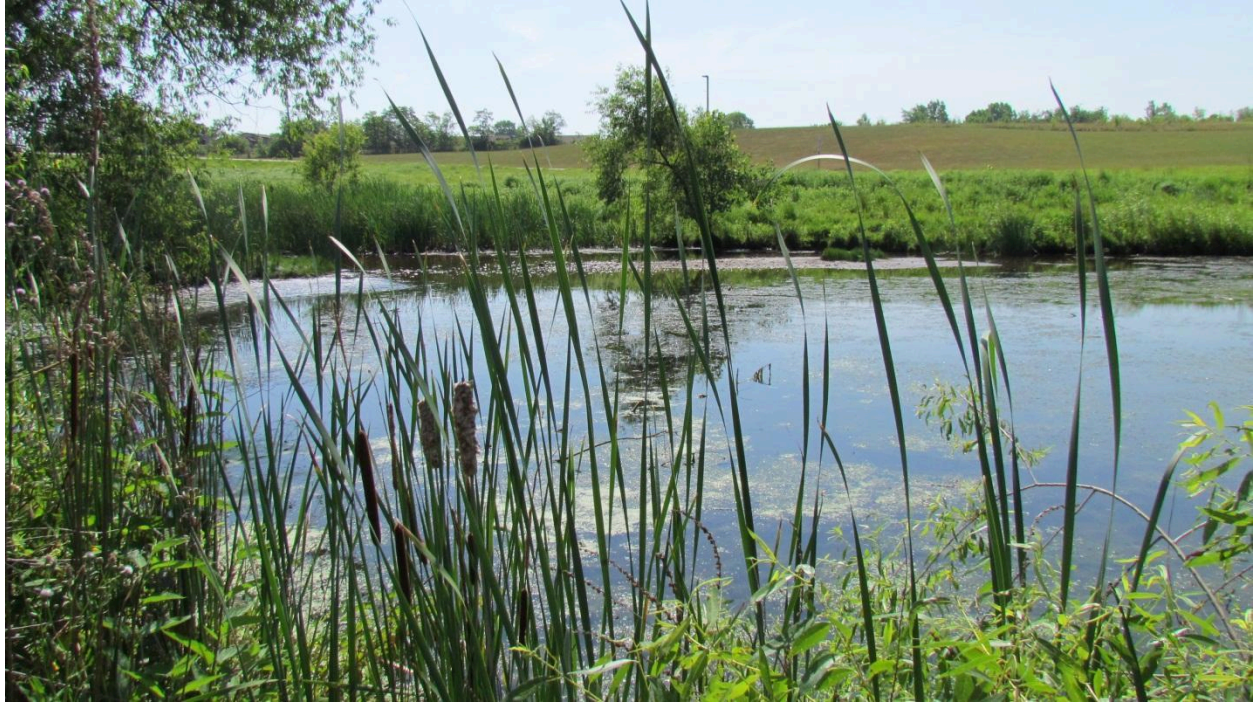
S4-06: *Pond*

A pond is located southeast of the REC Center. A stream that runs near the northeast of the property empties here. Cattail growth is dominant along the edges of the pond. The depth appears shallow which could be the result of little rainfall this summer. Heavy aquatic plant growth lines the bottom of the pond. Frogs and turtles were observed.

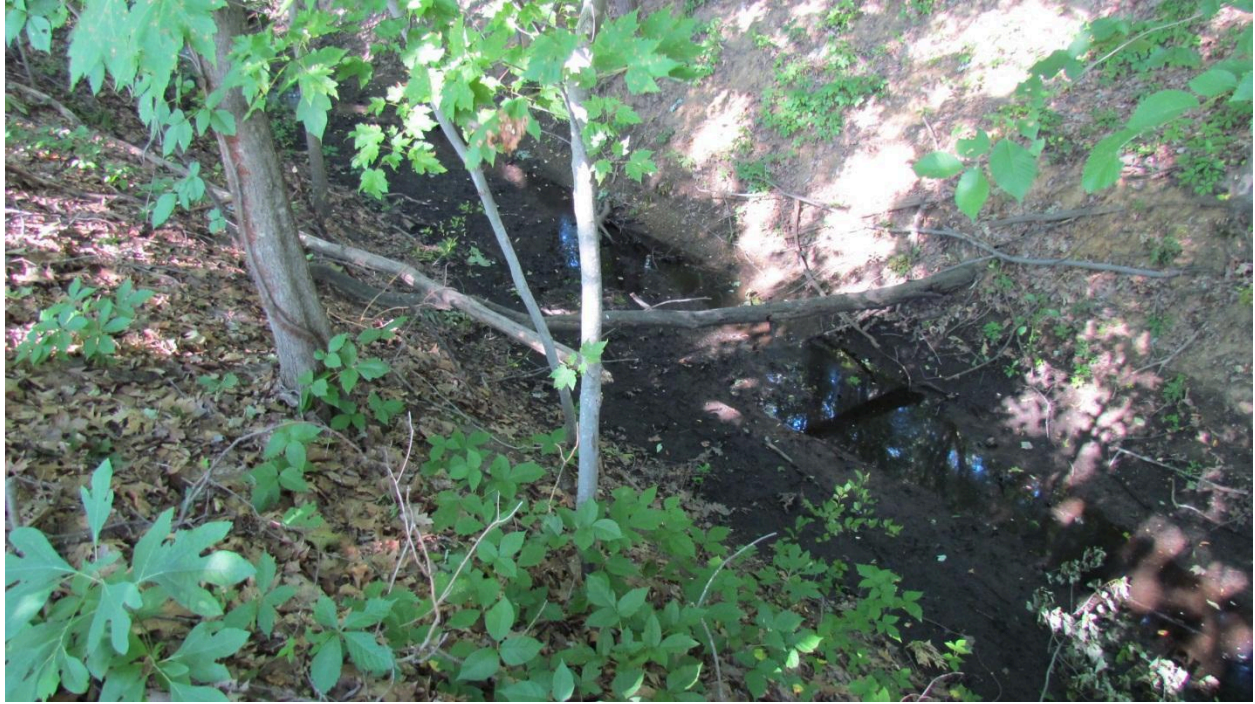
S4-15: *Trailhead*

- Allerton Apartments – Photo Point S4-09 through S4-14
- Trailhead – Photo Point S4-15 – marks the beginning of a gravel trail just off of the baseball field road. Poison ivy is present on the right of the trail in the forested area. A small creek runs adjacent with the path. The creek has a silt bottom with few small boulder and large cobble size substrate. The water was low and appeared to have no flow at time of visit. The banks are bare soil with tree and shrub growth.

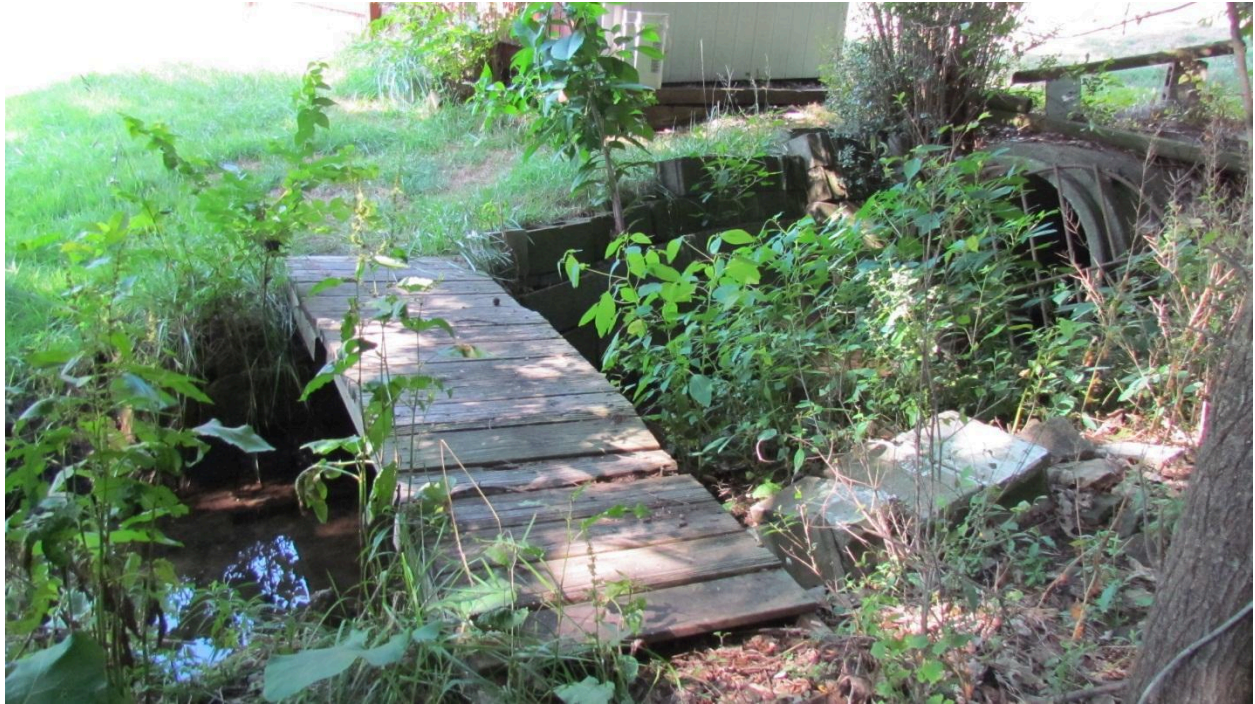
S4-20: *Bridge and Drainpipe*

- A Wooden Bridge – Photo Point S4-20 – sits over a small creek. A drainpipe towards the west property line is missing its drain cover. Gravel and sand substrate dominate with few boulders. Riffles and what seems to be natural sinuosity are visible along with eroded banks and root-wads.

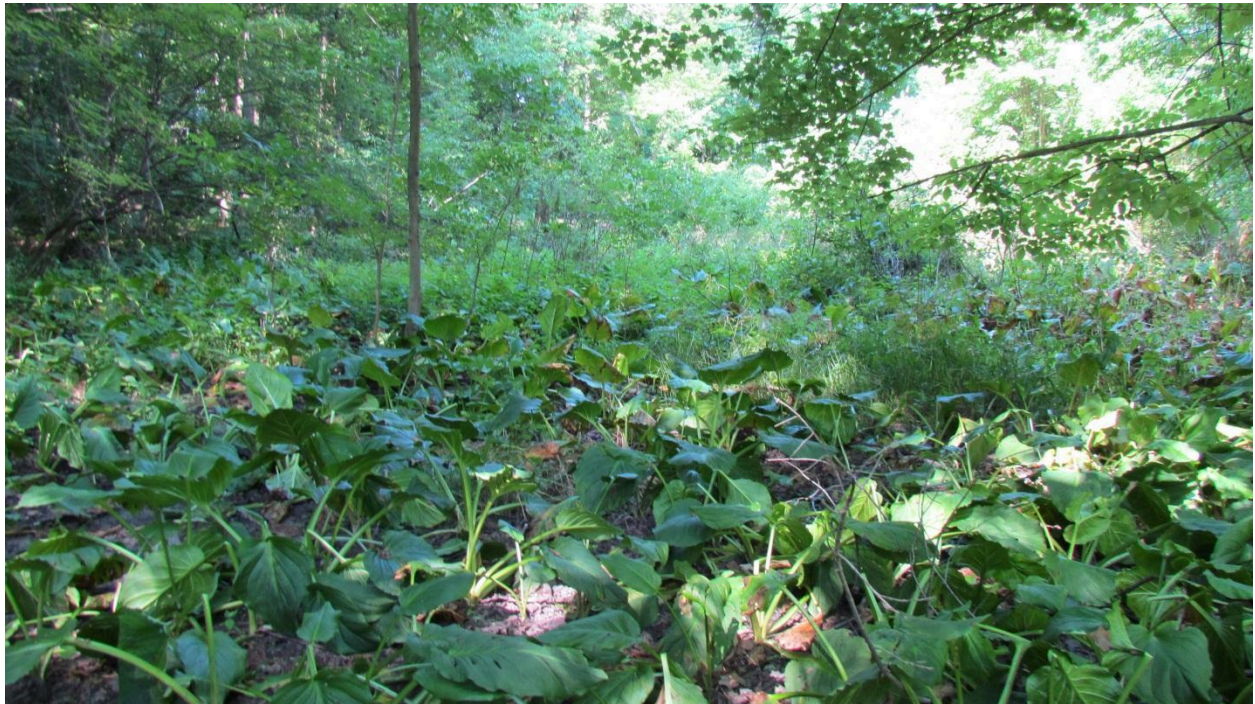
S4-21: *Low Laying Area*

- A Low Laying Area – Photo Point S4-21 – is a monoculture of a large, leaved plant. Seems this area is seasonally flooded, very moist and dark soil visible.

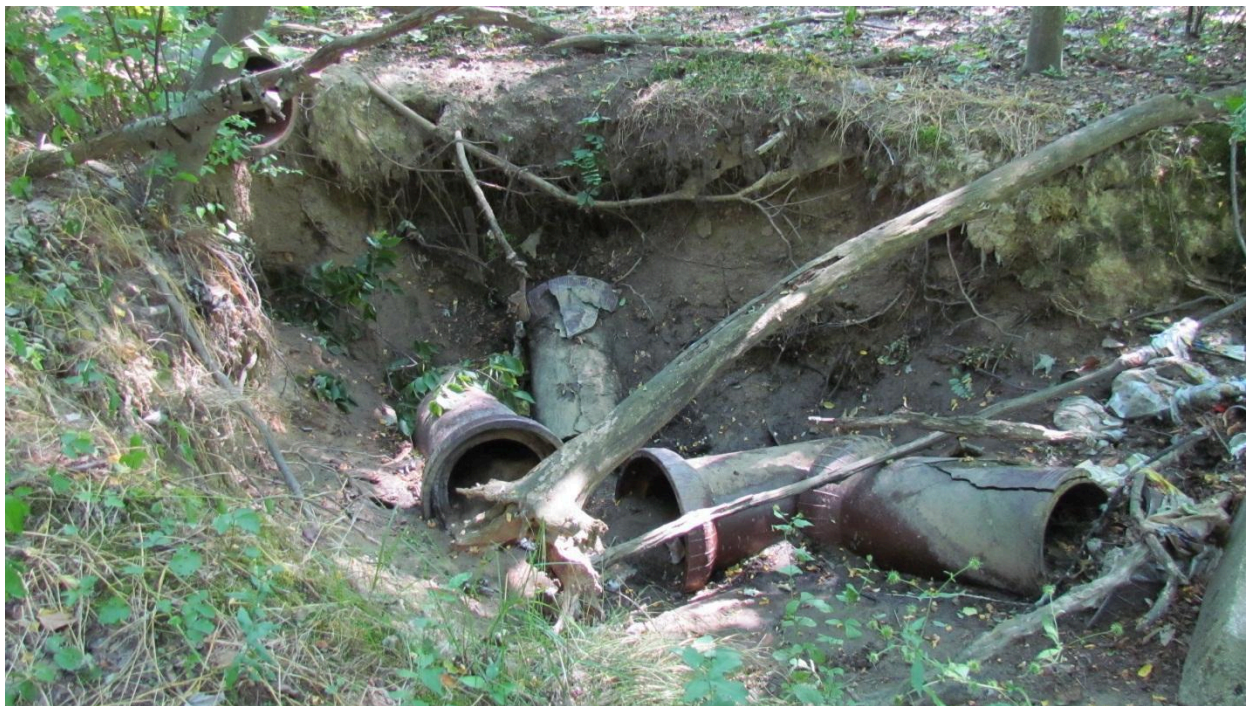
S4-22: *Broken Drainpipe*

- Broken Drain Pipes – Photo Point S4-22, S4-23 – could be the water source that fills the low laying area mentioned above and possibly a dried creek – Photo Point 24.

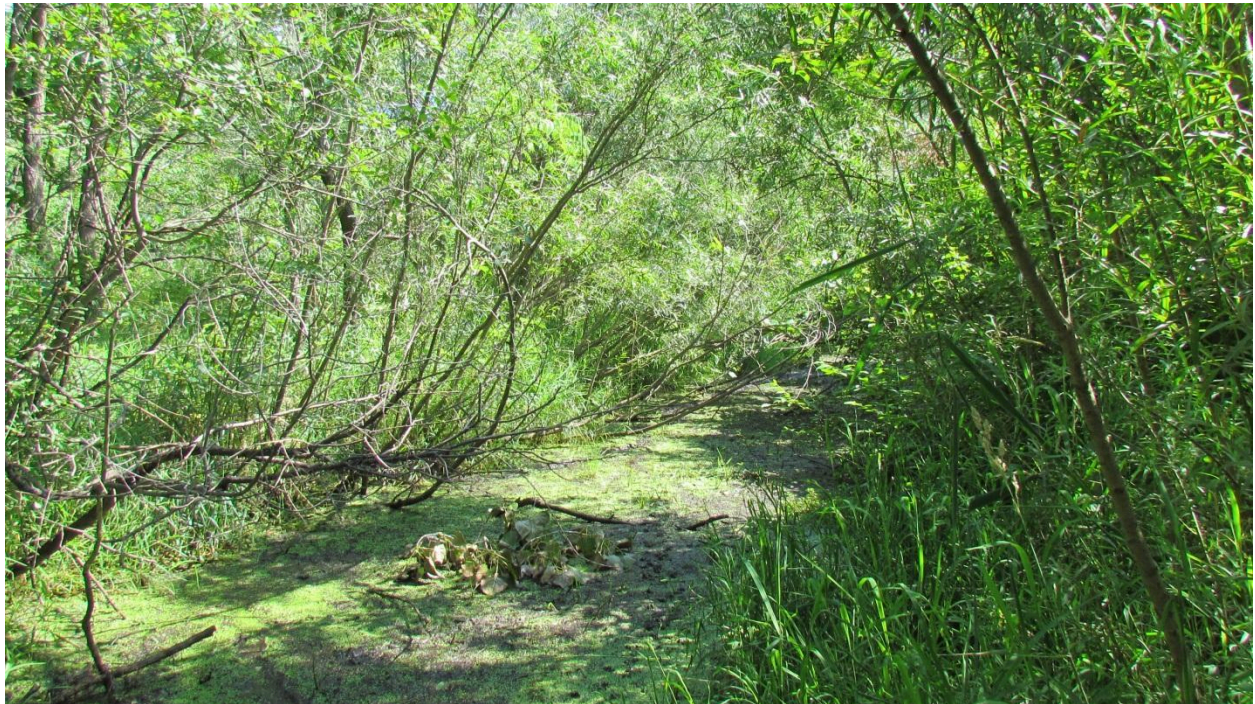
S4-25: *Drainpipe with Pooling Area*

- A Drainpipe – Photo Point S4-25 – is located off of Campus Center Dr. and feeds the wetland area to the NE. The area is muddy and both damselflies and dragonflies were seen during visit.

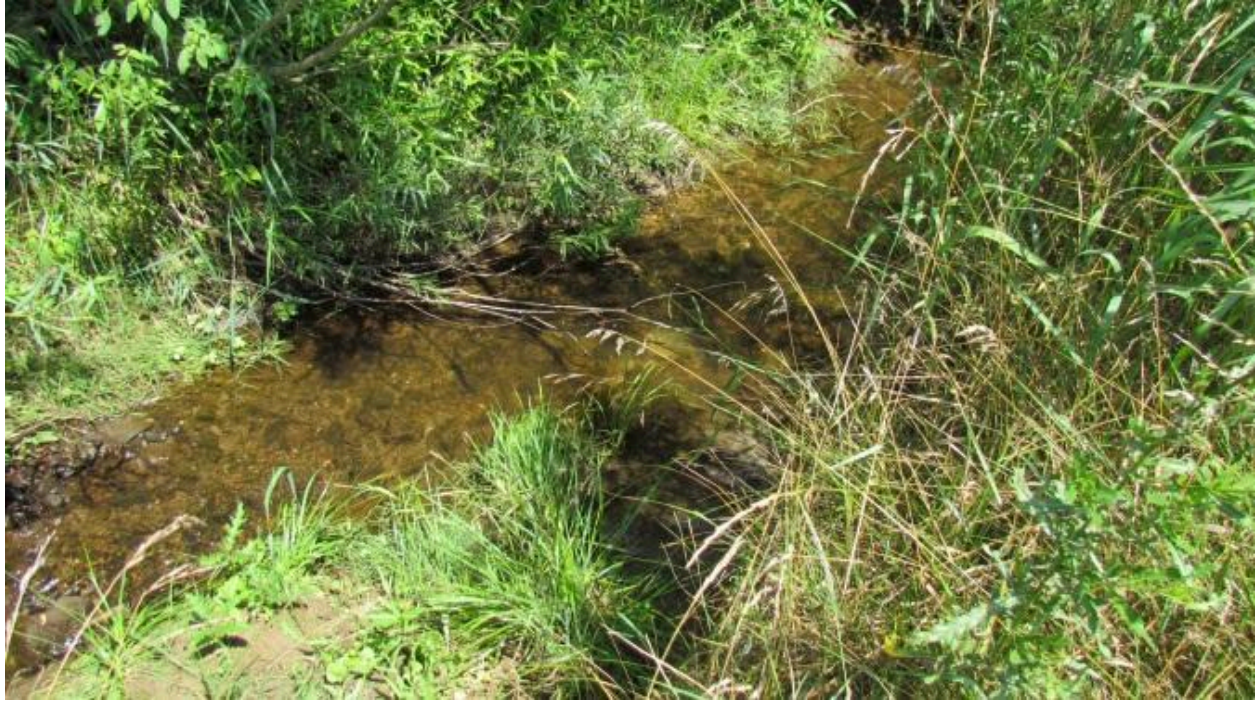
S4-27: *A Creek*

- A Small Wetland – Photo Point S4-26 – is located near a wooded area. Cattail growth present with some shrub and few large trees.
- A Creek – Photo Point S4-27 – is part of a creek found on the Ensigner Site. The bottom is sand with some gravel throughout. The riparian area has lots of vegetation growth.

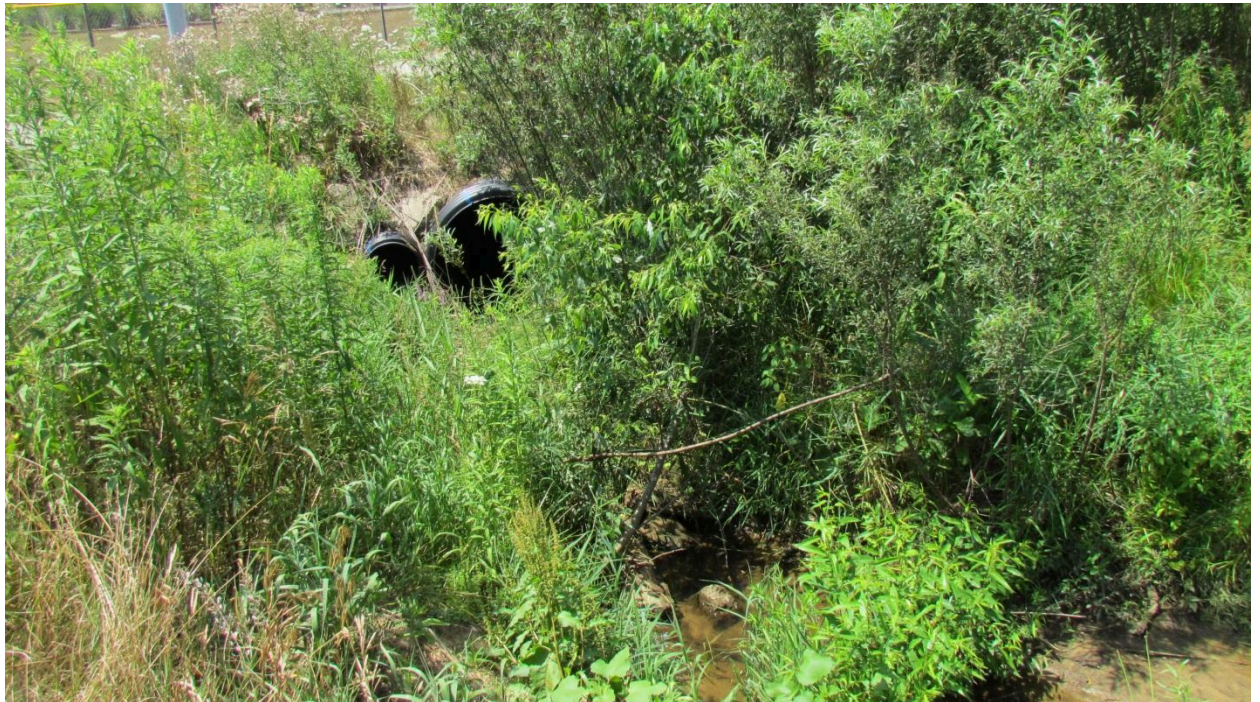
S4-28: *Drainpipe*

- A Drainpipe – Photo Point S4-28 – feeds the small creek mentioned above. Damselflies were observed at time of visit.
