Burlington School District Attn. Lyall Smith, Director of Facilities 150 Colchester Road, Burlington, VT, 05401

September 20, 2024

Clerk of the Works Site Visit Report - IAA H.O. Wheeler Elementary School Project

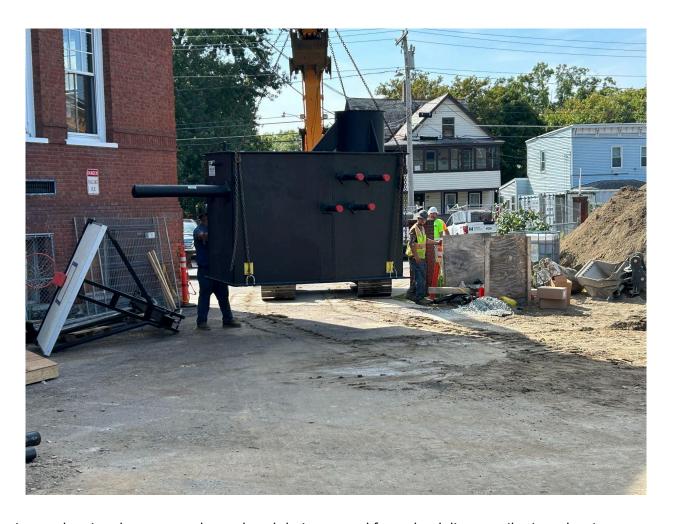
The main vault for the geothermal piping arrived at the site this week. This vault is where the main heating and / or cooling water from the building comes into, and then gets dispersed out to the 30 different wells that are located in the playground. Manosh rigged the unit off from the trailer and installed the unit. See the pictures at the end of this report.

A picture showing the new geothermal vault being moved from the delivery trailer into the site.

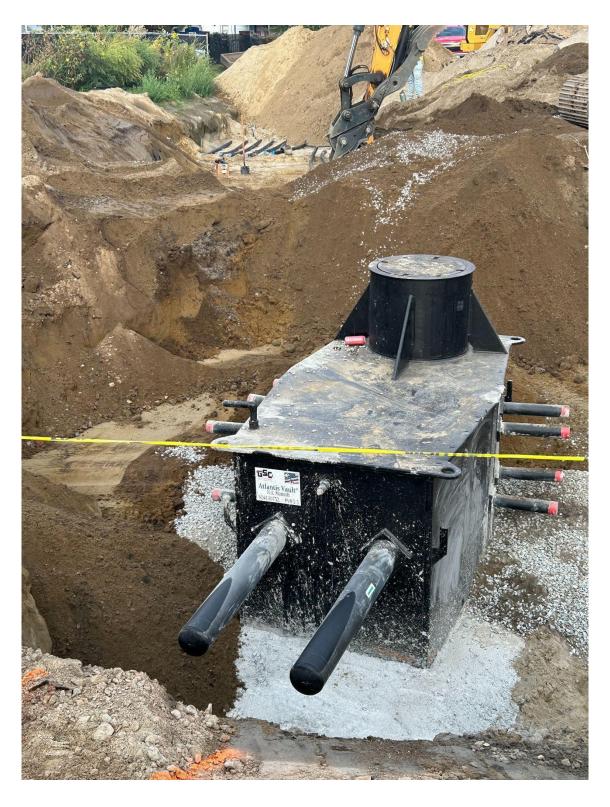
A picture showing the final resting place for the geothermal vault. In the foreground, you can see the geothermal piping heading in the direction of the vault. Manosh is in the process of extending and attaching the piping to the new vault.

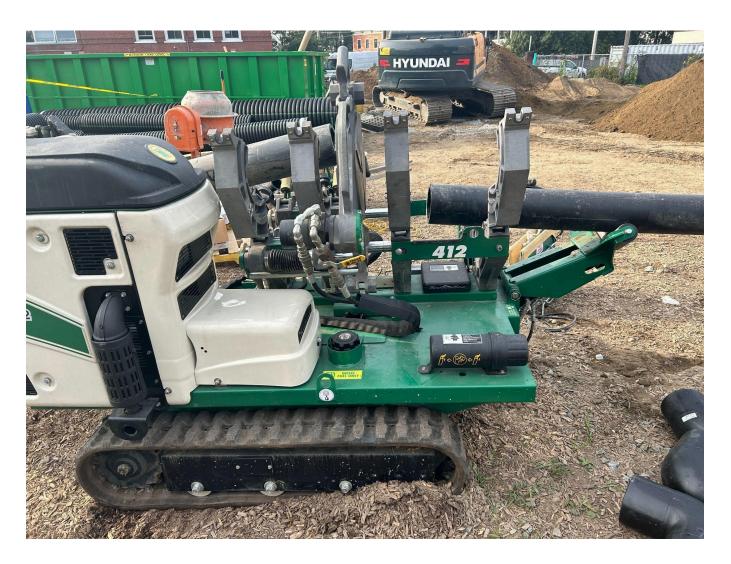
Just like in the TV Show, "Gold Rush", this is the same machine that will cut, and melt the plastic piping together to make one continuous piece of piping. Underground, you need the piping to be continuous with no joints, especially when the piping is delivered to the site in only 20 foot sections.

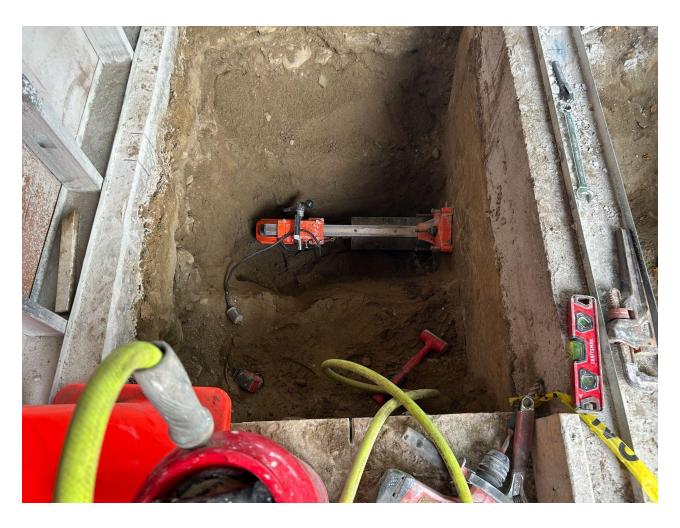
In the 1965 wing of the building, more underground plumbing work is happening for rerouting the existing stormwater piping out of the building into the stormwater holding system that Manosh has installed. See the picture at the end of this report.

The concrete cutting contractor is coring a hole through the existing concrete foundation wall for the plumbing contractor to install new underground plumbing piping to be directed to the storm water storage system.

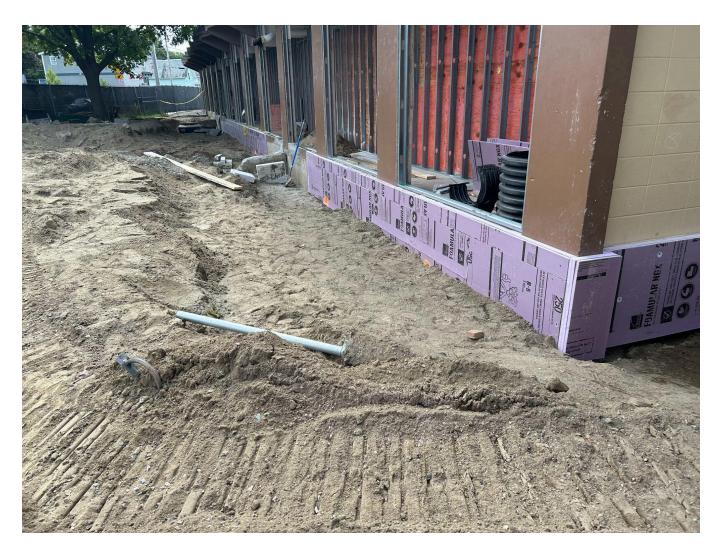
In the 1965 wing of the building, insulation is being installed up against the foundation. This will help with the energy efficiency envelope for the building. See pictures at the end of this report.

This picture is showing the installation of insulation on the Walnut Street side of the building against the foundation.

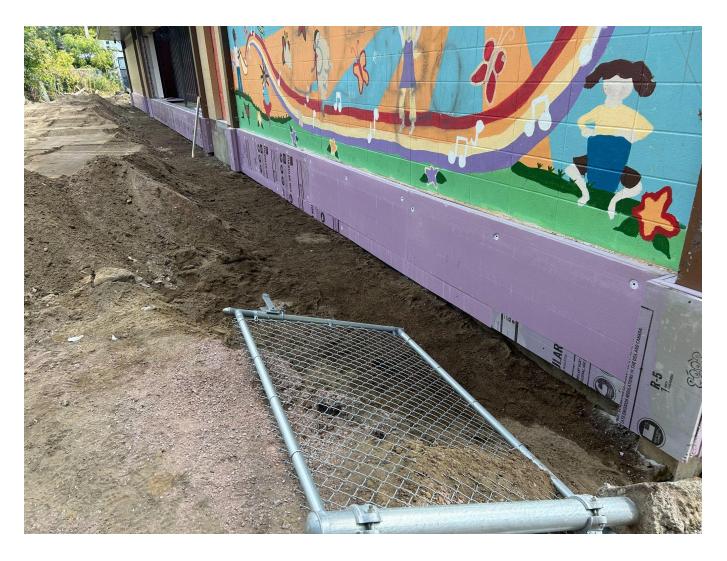
This picture shows the installation of insulation on the back side of the building against the foundation.

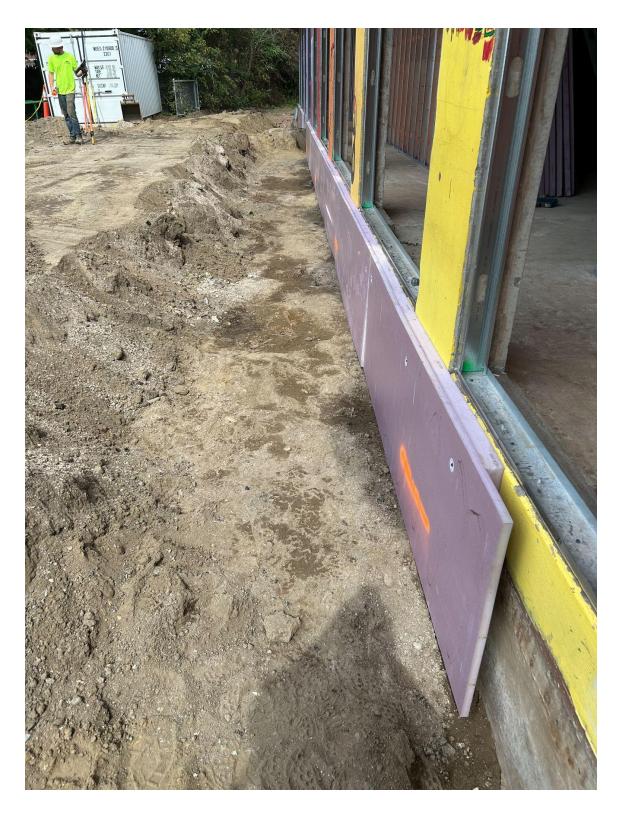
This picture shows the installation of insulation on the Manhattan Street side of the building against the foundation.

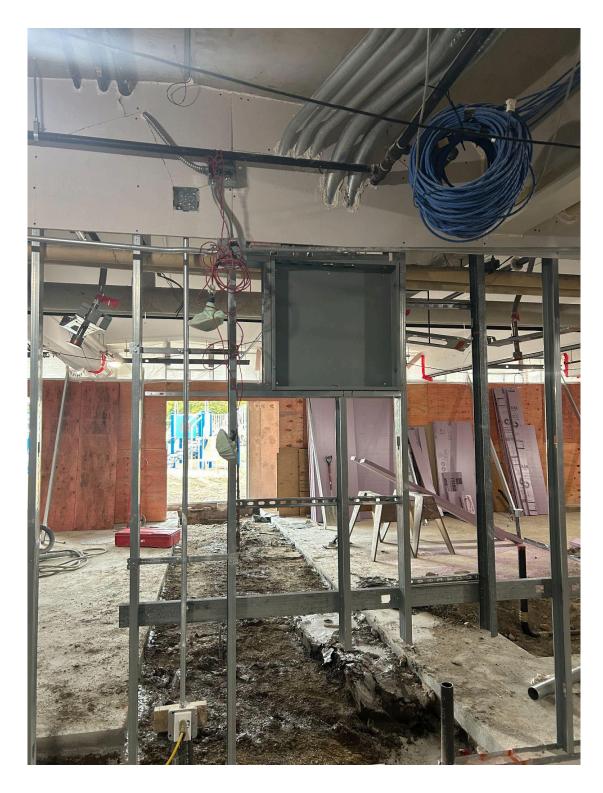
The Electrical contractor is installing new conduits for the new mechanical equipment. They need to get power from the electrical room of the 1965 wing of the building to the Boiler room located in the 1904 wing of the building. See the pictures at the end of this report.

The new conduits in the ceiling are installed to a new junction box located in the corridor wall of the 1965 wing of the building. The concrete floor has been cut, and will be dug up for the installation of underground conduits that will go from this junction box out and to the existing Boiler Room. This is being done, because there is not space in the corridor ceilings to do this work.

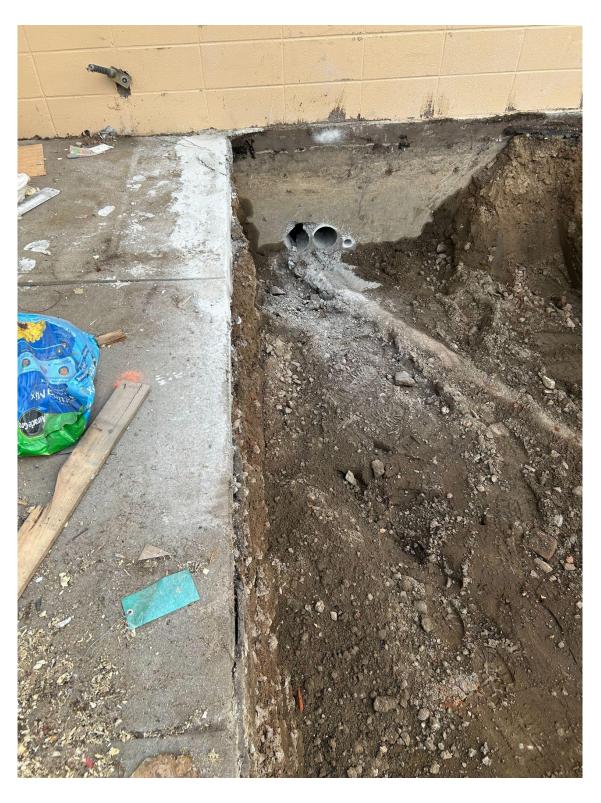
Picture showing the existing concrete foundation wall being cut, so that new electrical conduits can be installed from the new transformer into the building and to the existing Electrical Room in the 1965 wing of the building.

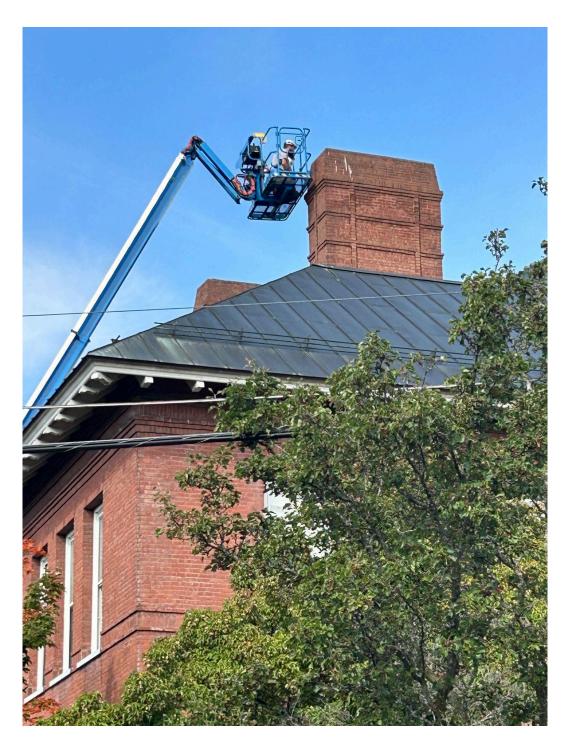
Lastly, the contractors have started their inspection of the existing chimneys in the 1904 wing of the building. See the picture at the end of this report.

This picture is showing the contractors up on a lift starting to inspect the existing chimneys in the 1904 wing of the building.
