# ***Draft MLK Corridor Rail Crossing Safety Review Technical Memorandum***

**October 2021**

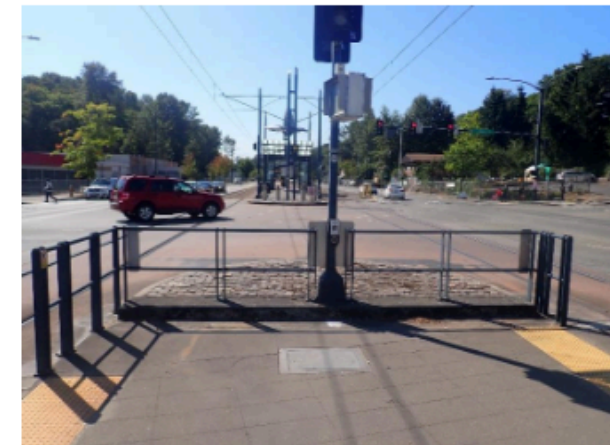
View of both crossings from the north crossing, facing south  
(Field Image taken September 2, 2021)

- Implementation of ped swinging gates
- Increased pedestrian signage and pavement markings
- Crossing arm installation
- Installation of Z-crossing
- Dynamic Train Envelop Pavement Markings
- Rail safety ambassadors
  - In pavement lighting
