January 24, 2025

**Clerk of the Works Site Visit Report - IAA H.O. Wheeler Elementary School Project**

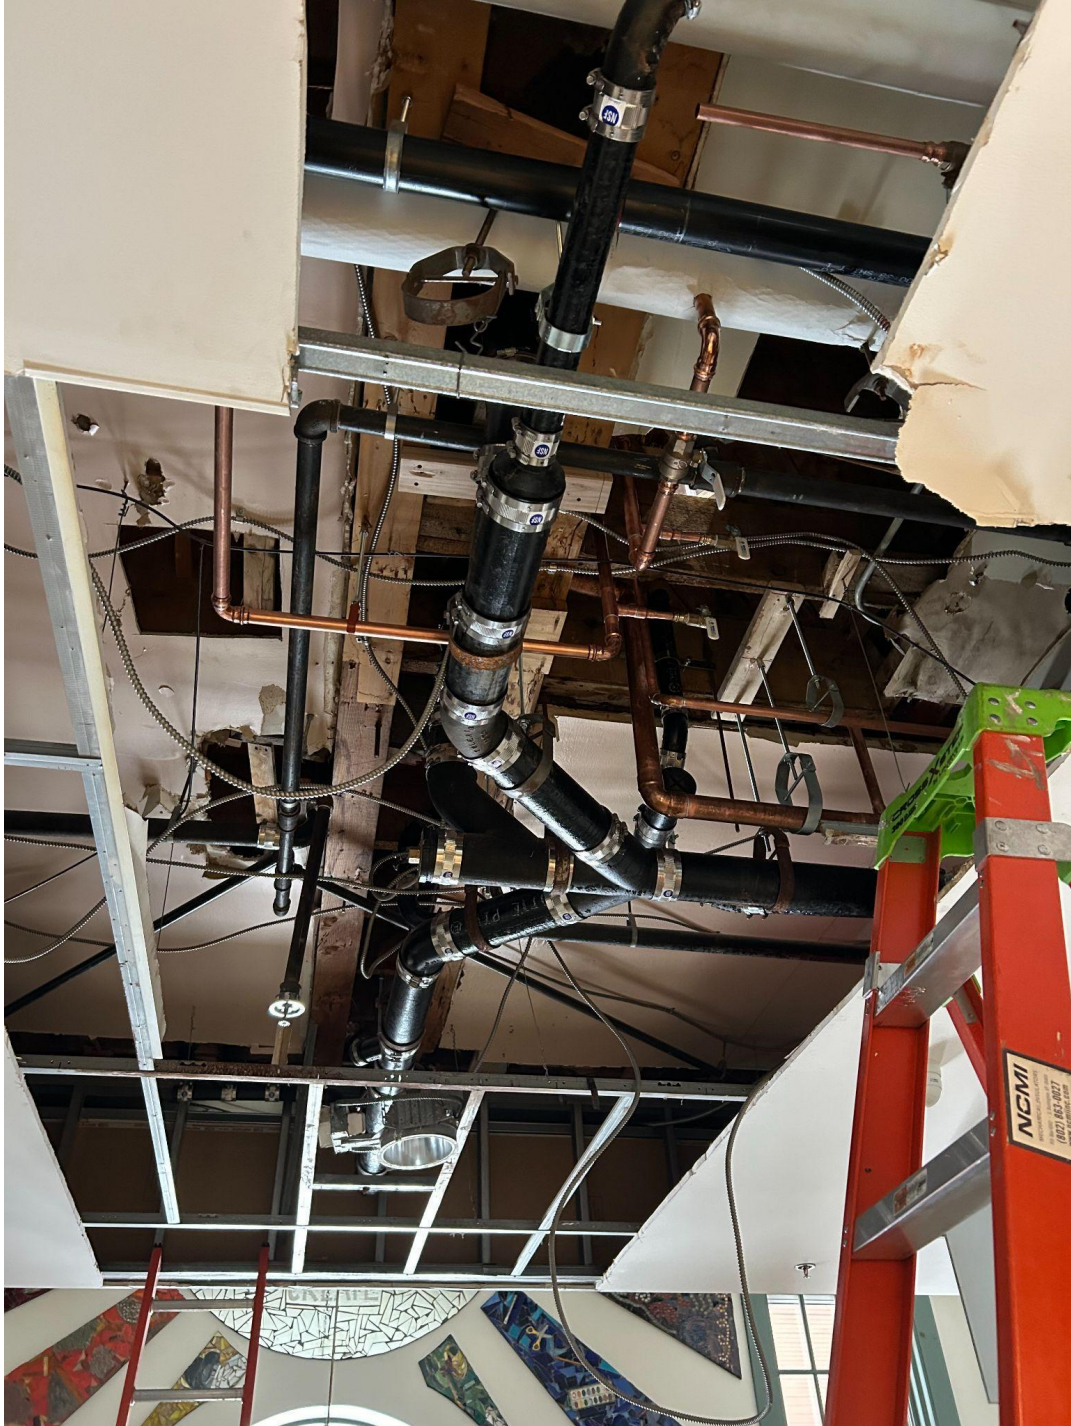
The plumbing piping serving the new gang bathroom on the second floor in the 1904 wing of the building. This piping is installed in the ceiling of the lobby on the first floor. Sheetrock will go back to cover all of this piping up, with access panels to the valves and the clean out of the sanitary piping. Interesting, how all of these services that serve such a big part of the building will be covered up, and nobody but us will know what is really above the ceilings.

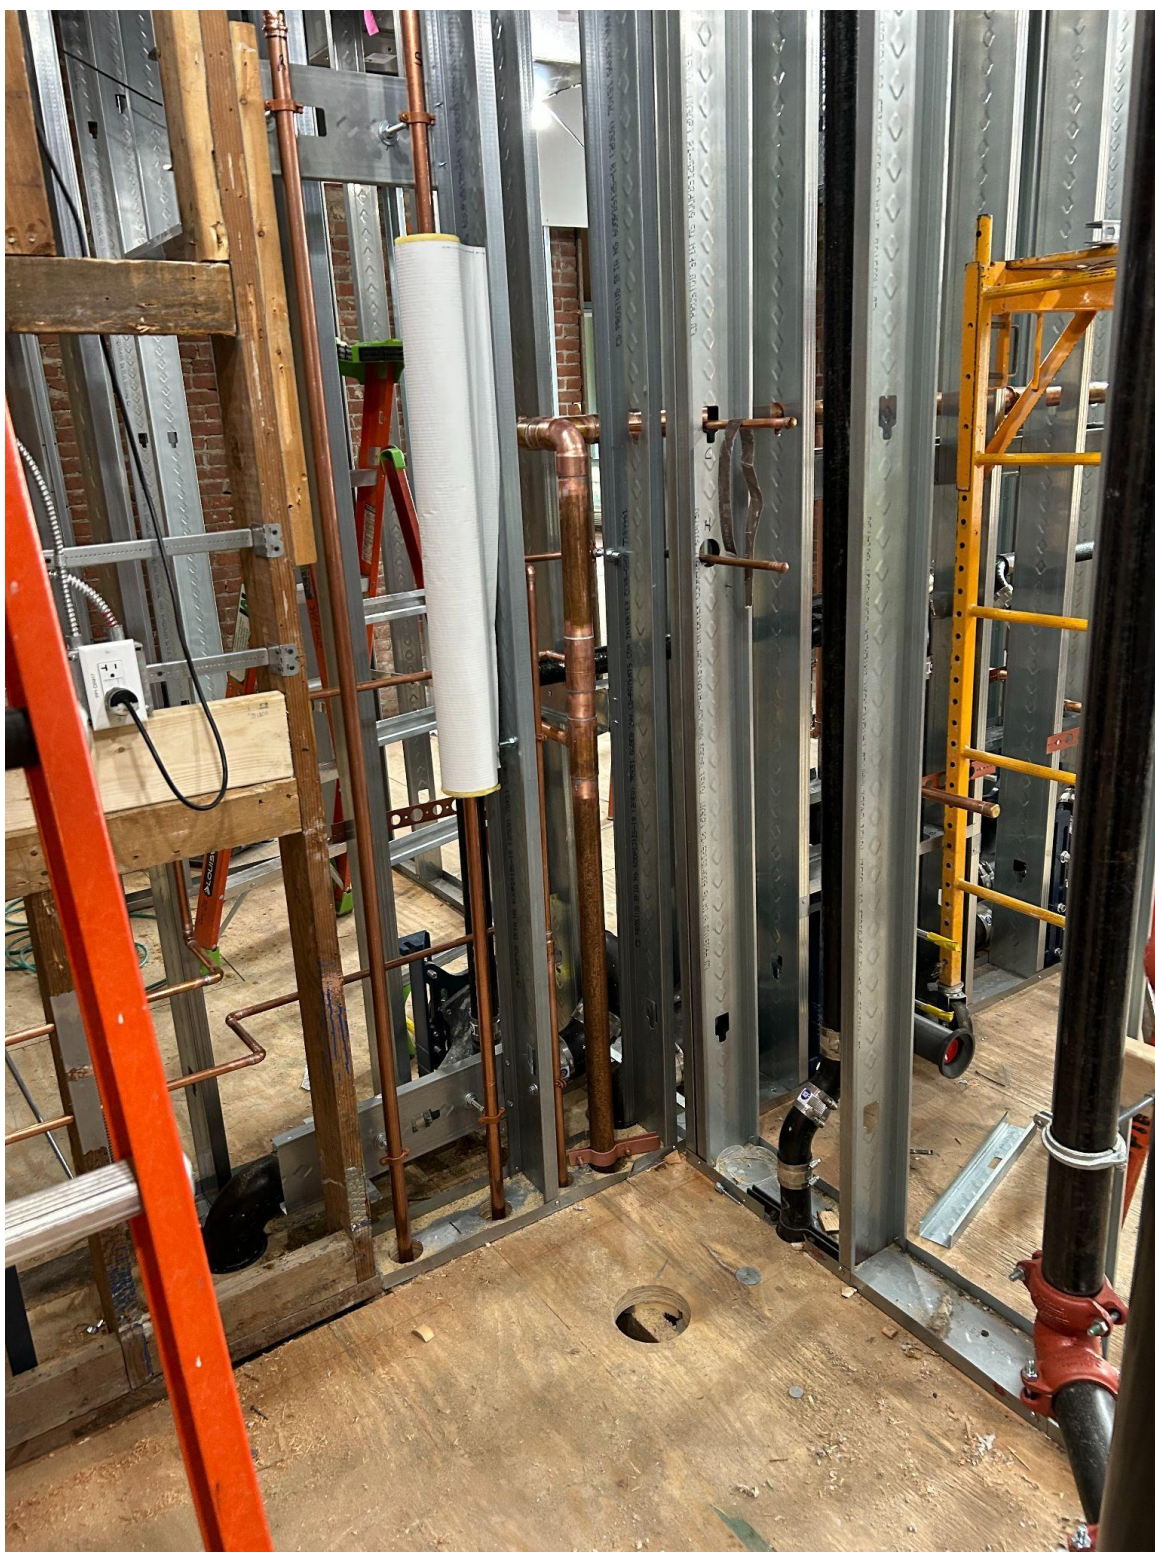
The installation of the copper piping for the gang bathrooms on the second floor in the 1904 wing of the building. The copper piping is for the domestic cold and hot water piping to the fixtures.

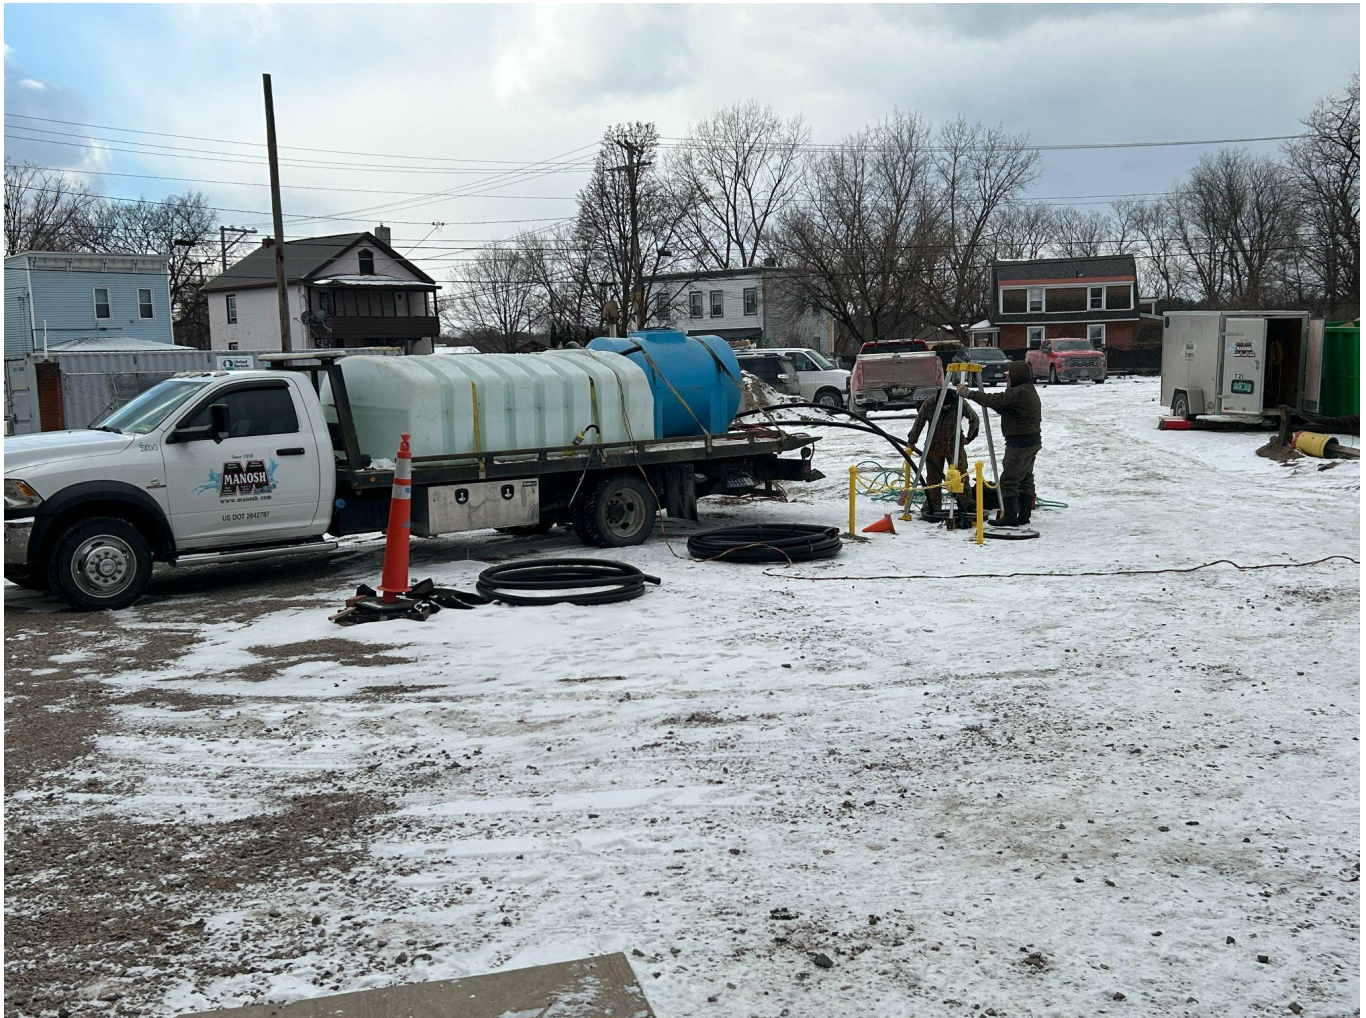
Manosh, the geothermal well contractor, was on site this week to fill the piping in the 30 wells that were drilled earlier this year. They did not use just water, they used a mixture of water and glycol. The additive of glycol helps the water not to freeze in the wintertime.

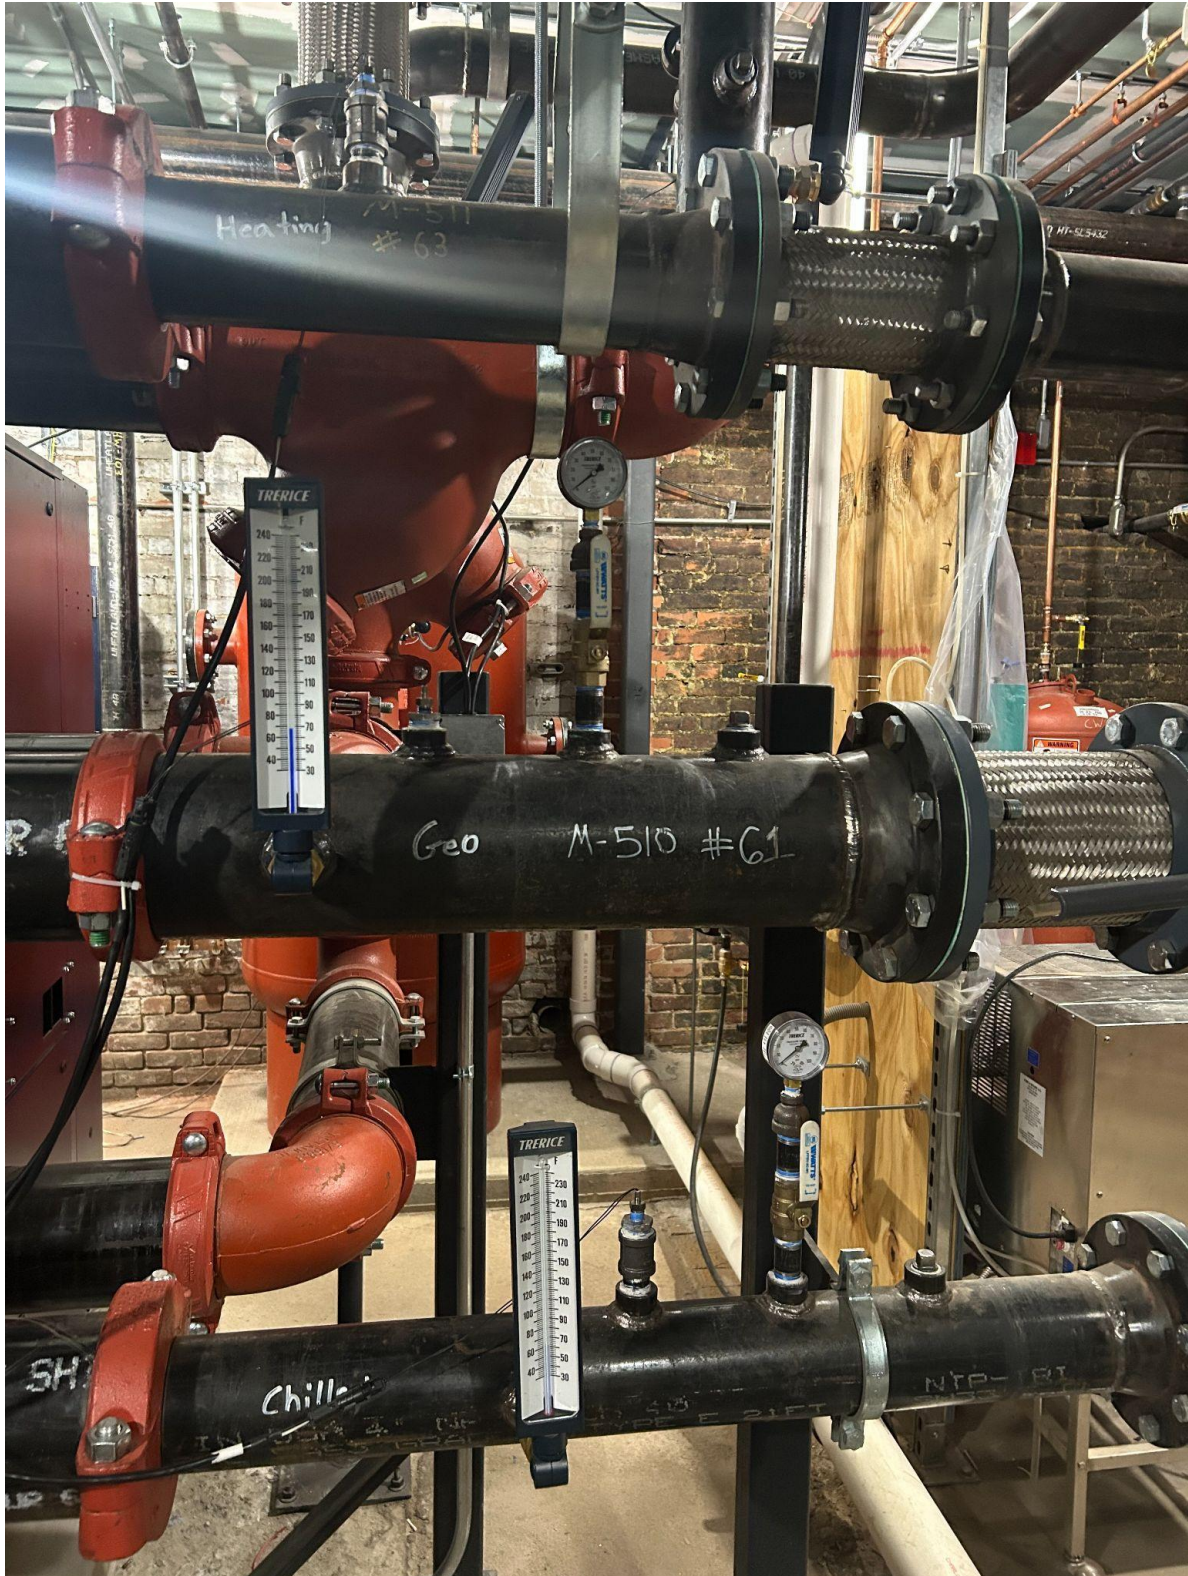
This picture shows the control sensors, for not only the new temperature controls, but the thermometers and pressure gauges used on the piping to the mechanical equipment. These devices will be used by the maintenance personnel to be able to see (sense) what is going on within the piping.

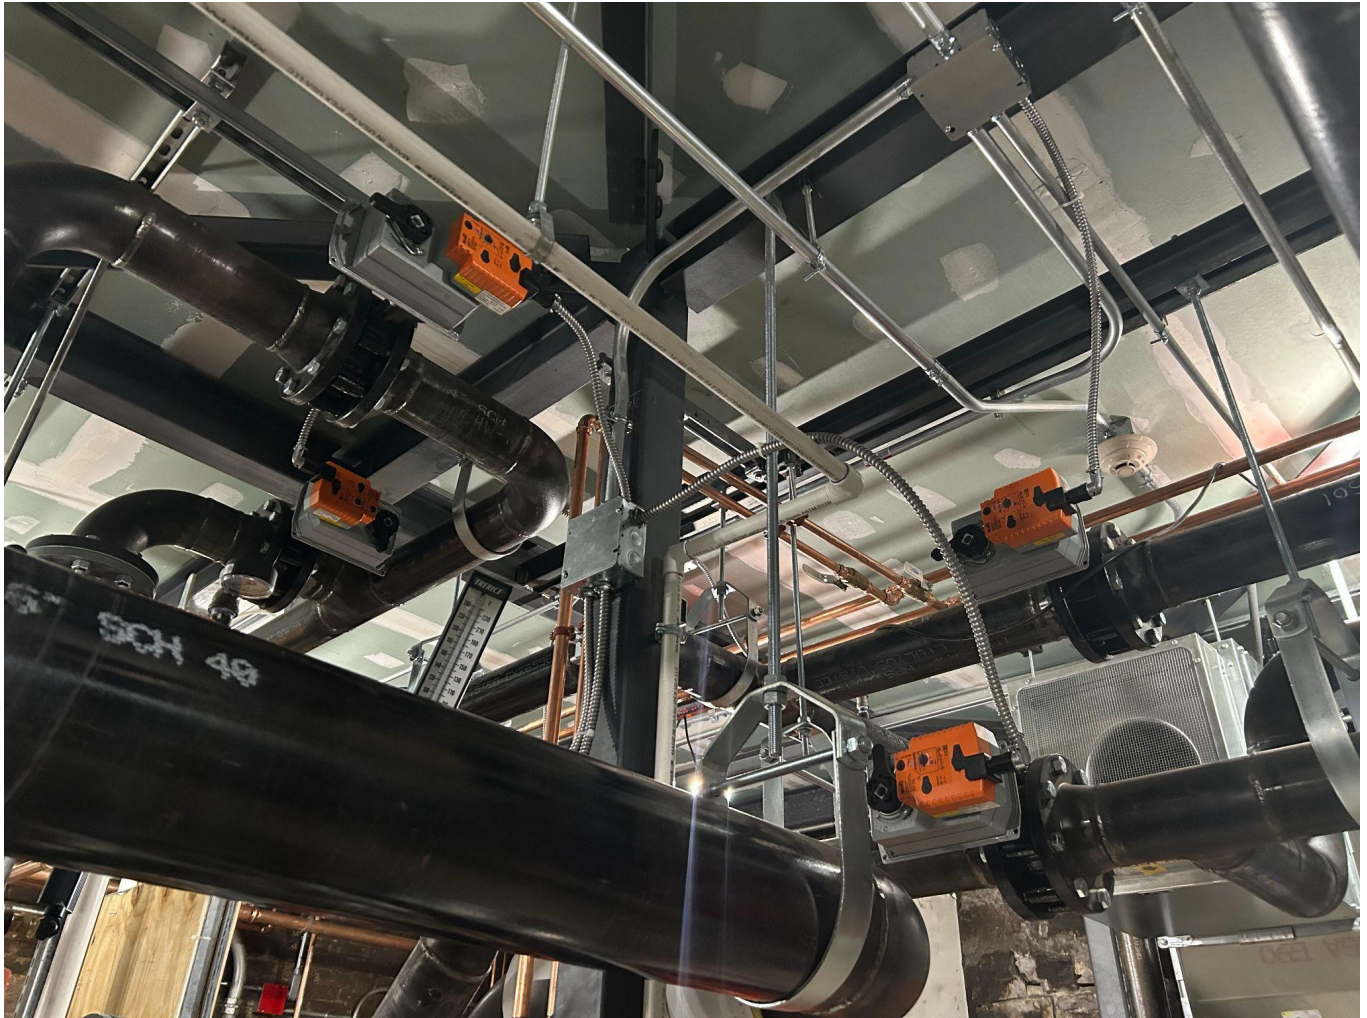
The control valves are being wired up to the new temperature control system. These valves will modulate to be able to deliver the right temperature to the system for optimum temperature comfort for each room of the building.

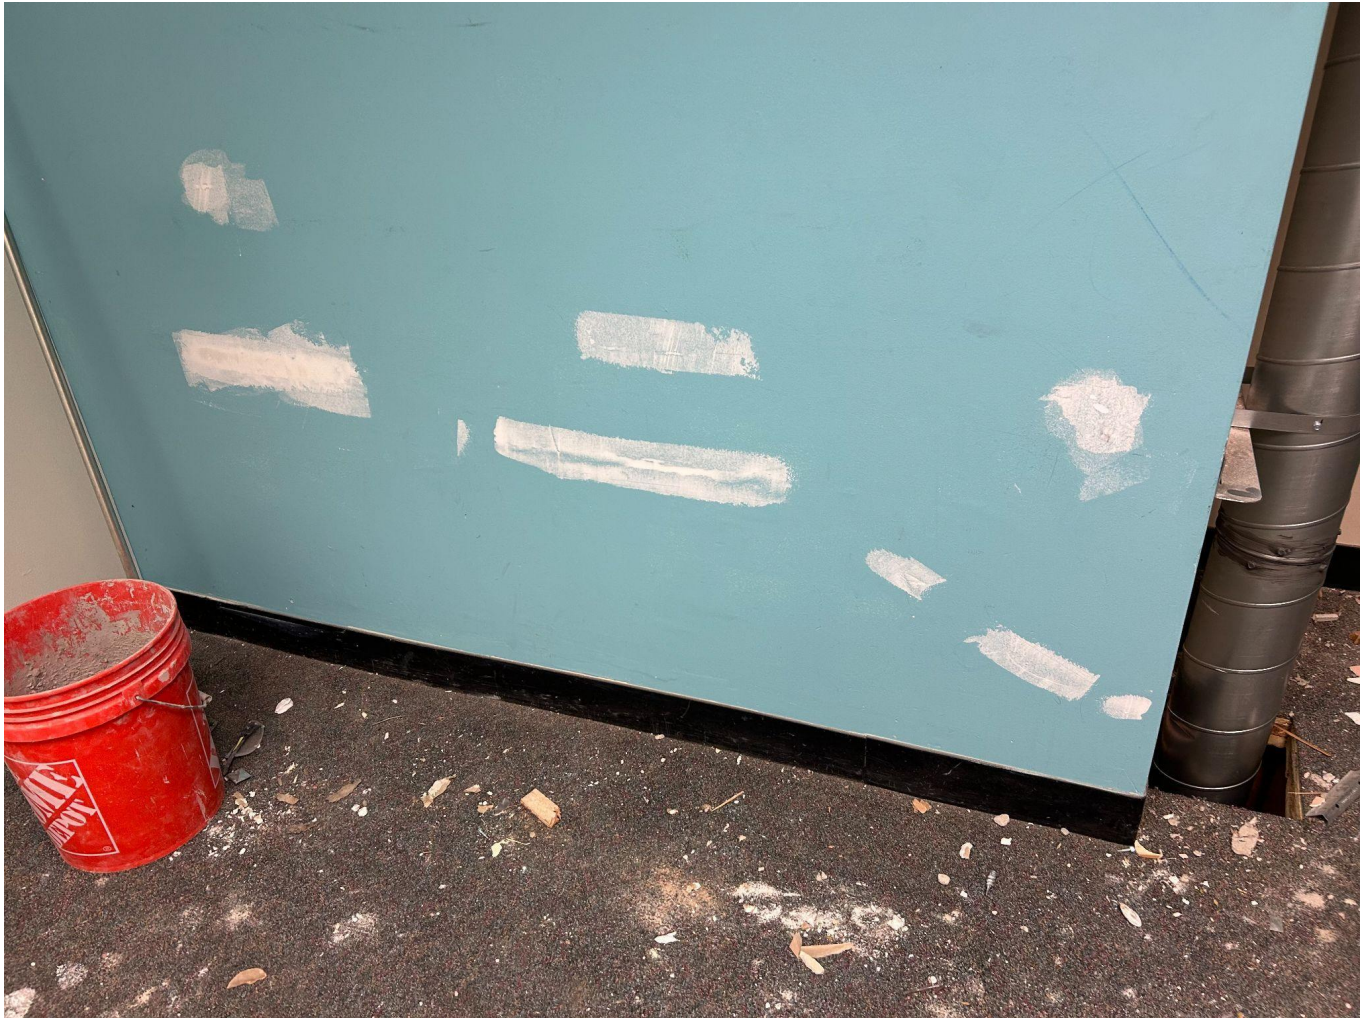
Sheetrock mud is being placed on the walls to cover up holes that were made during construction.

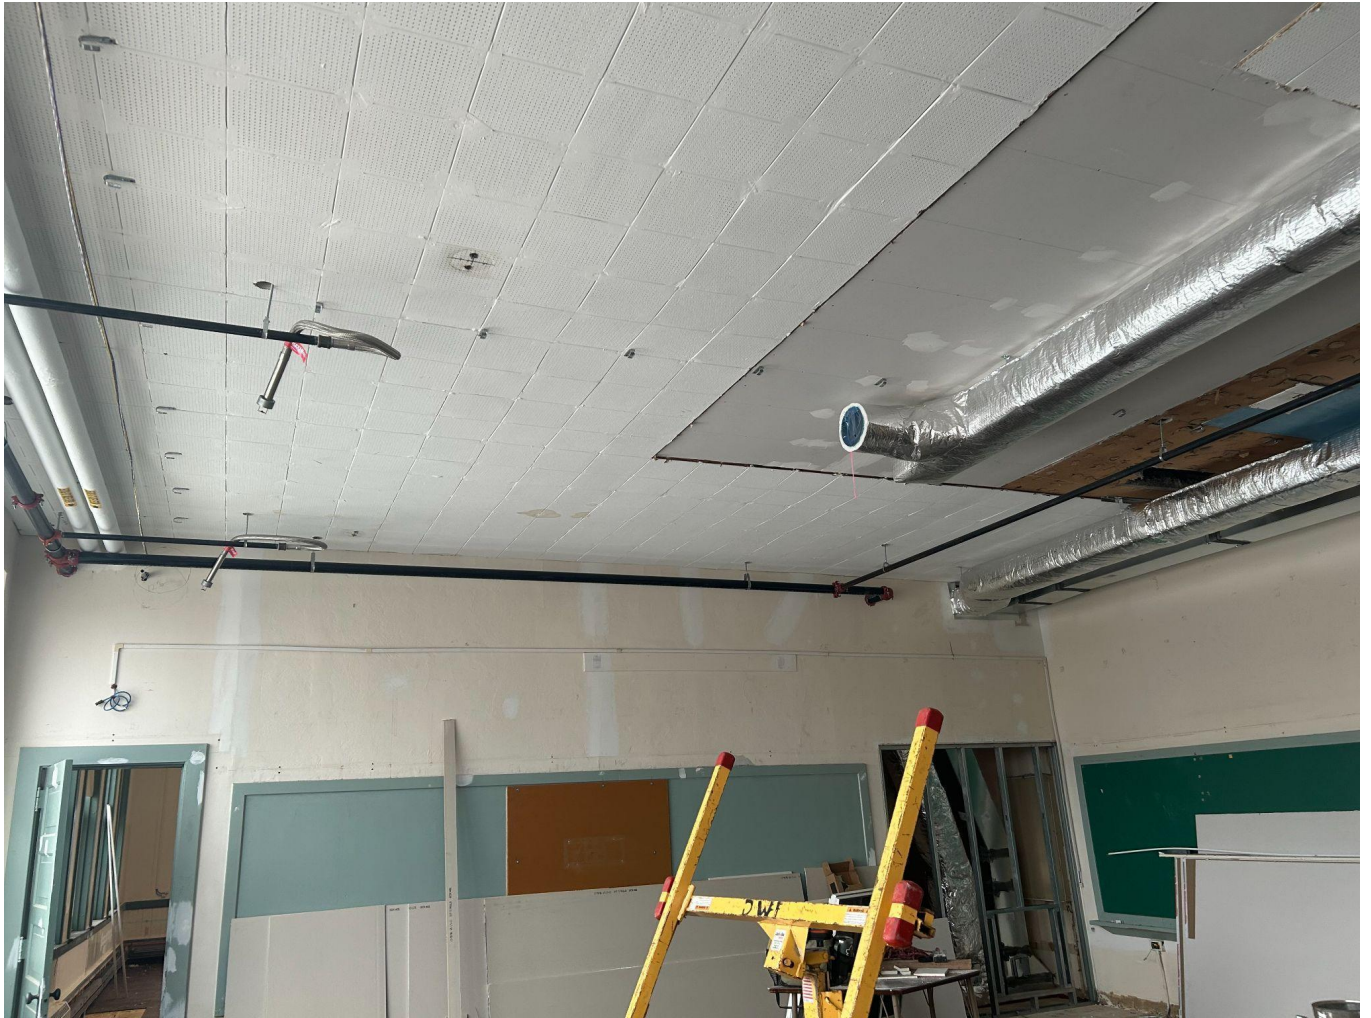
The old lights in the classrooms in the 1904 wing of the building have been taken down. New LED lights will be placed in the new ceiling grid that will illuminate the classrooms.

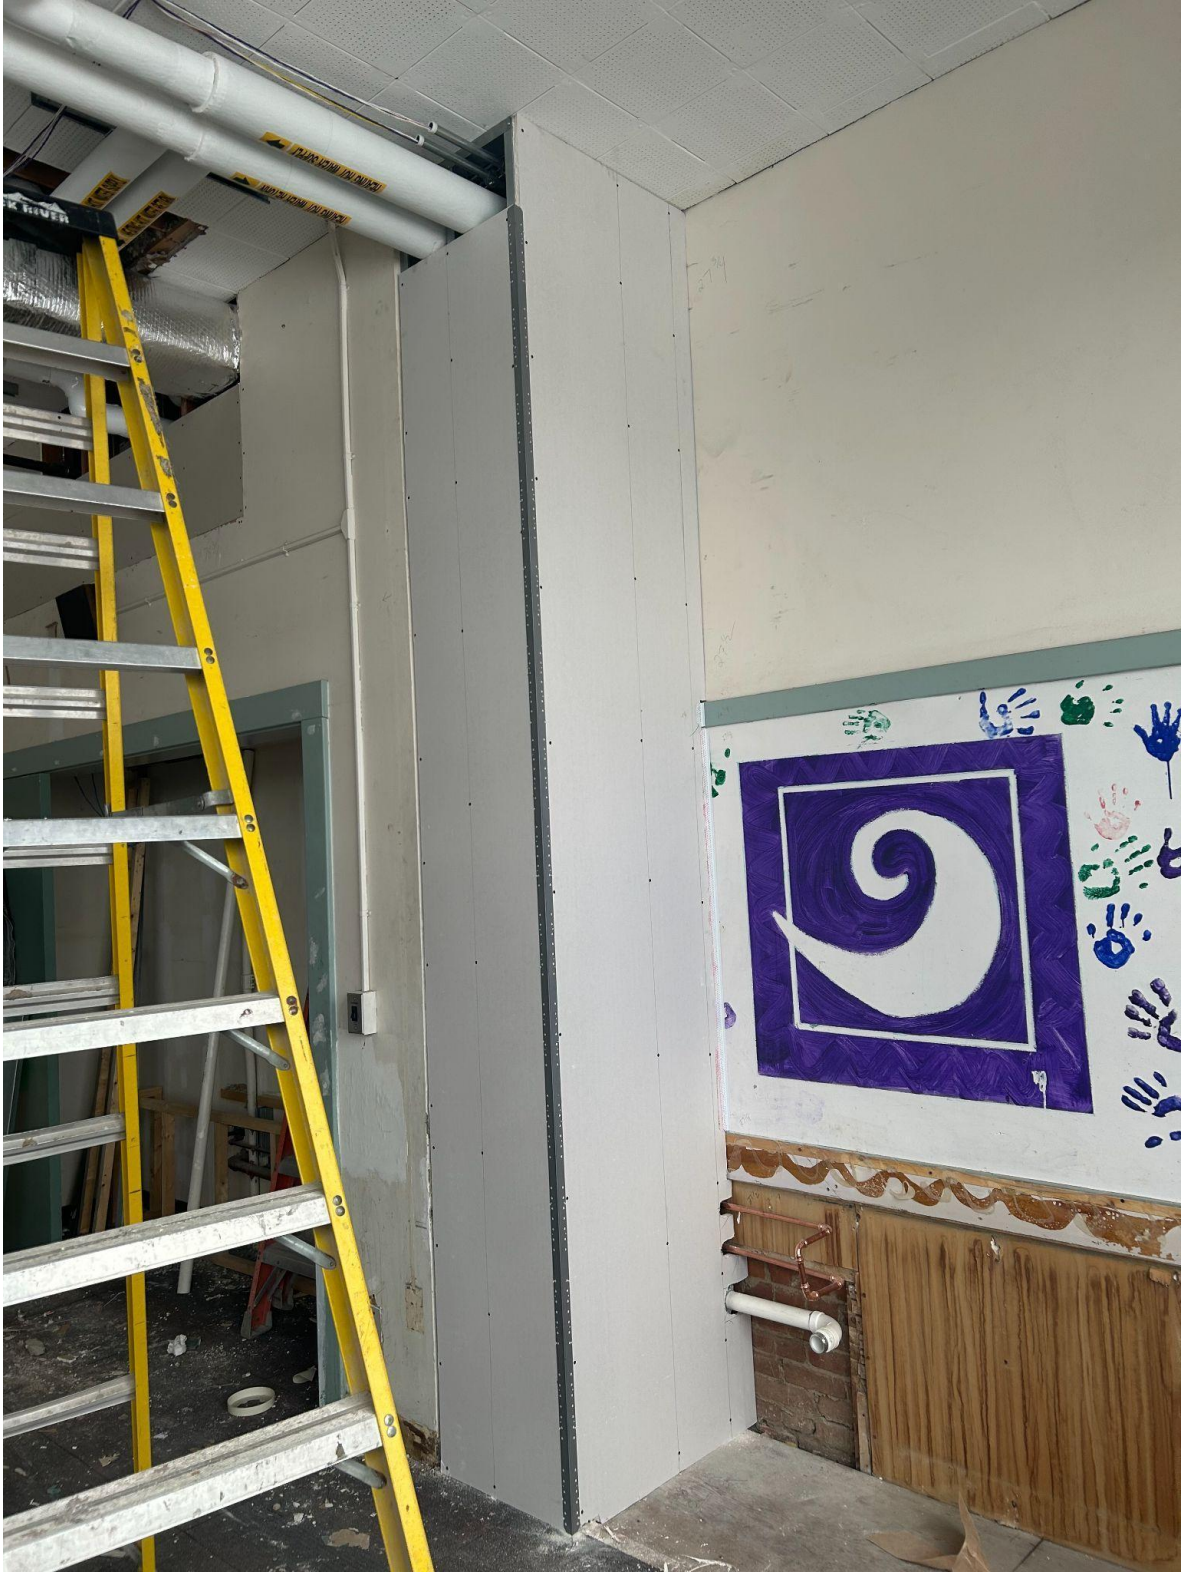
The piping and electrical conduits are being covered up by new chases being installed by the framing contractor.

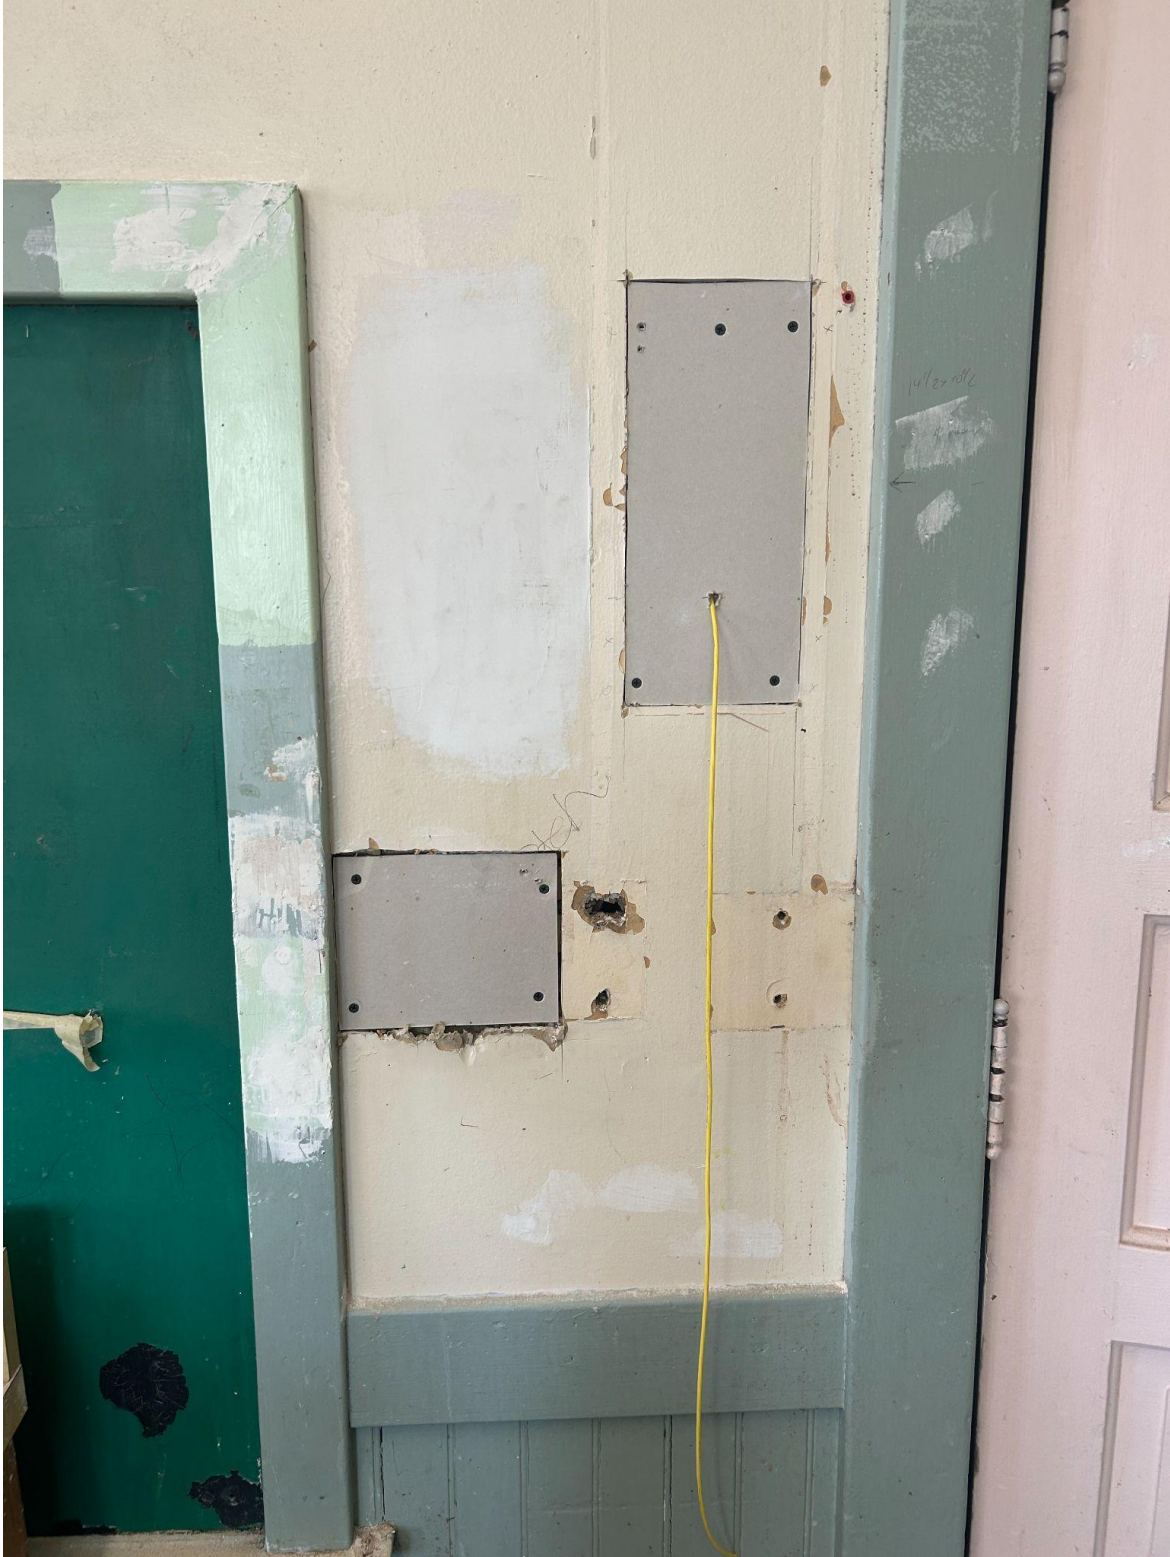
The framing contractor is going around and sealing up holes that were made in the existing walls or where electrical devices were removed.

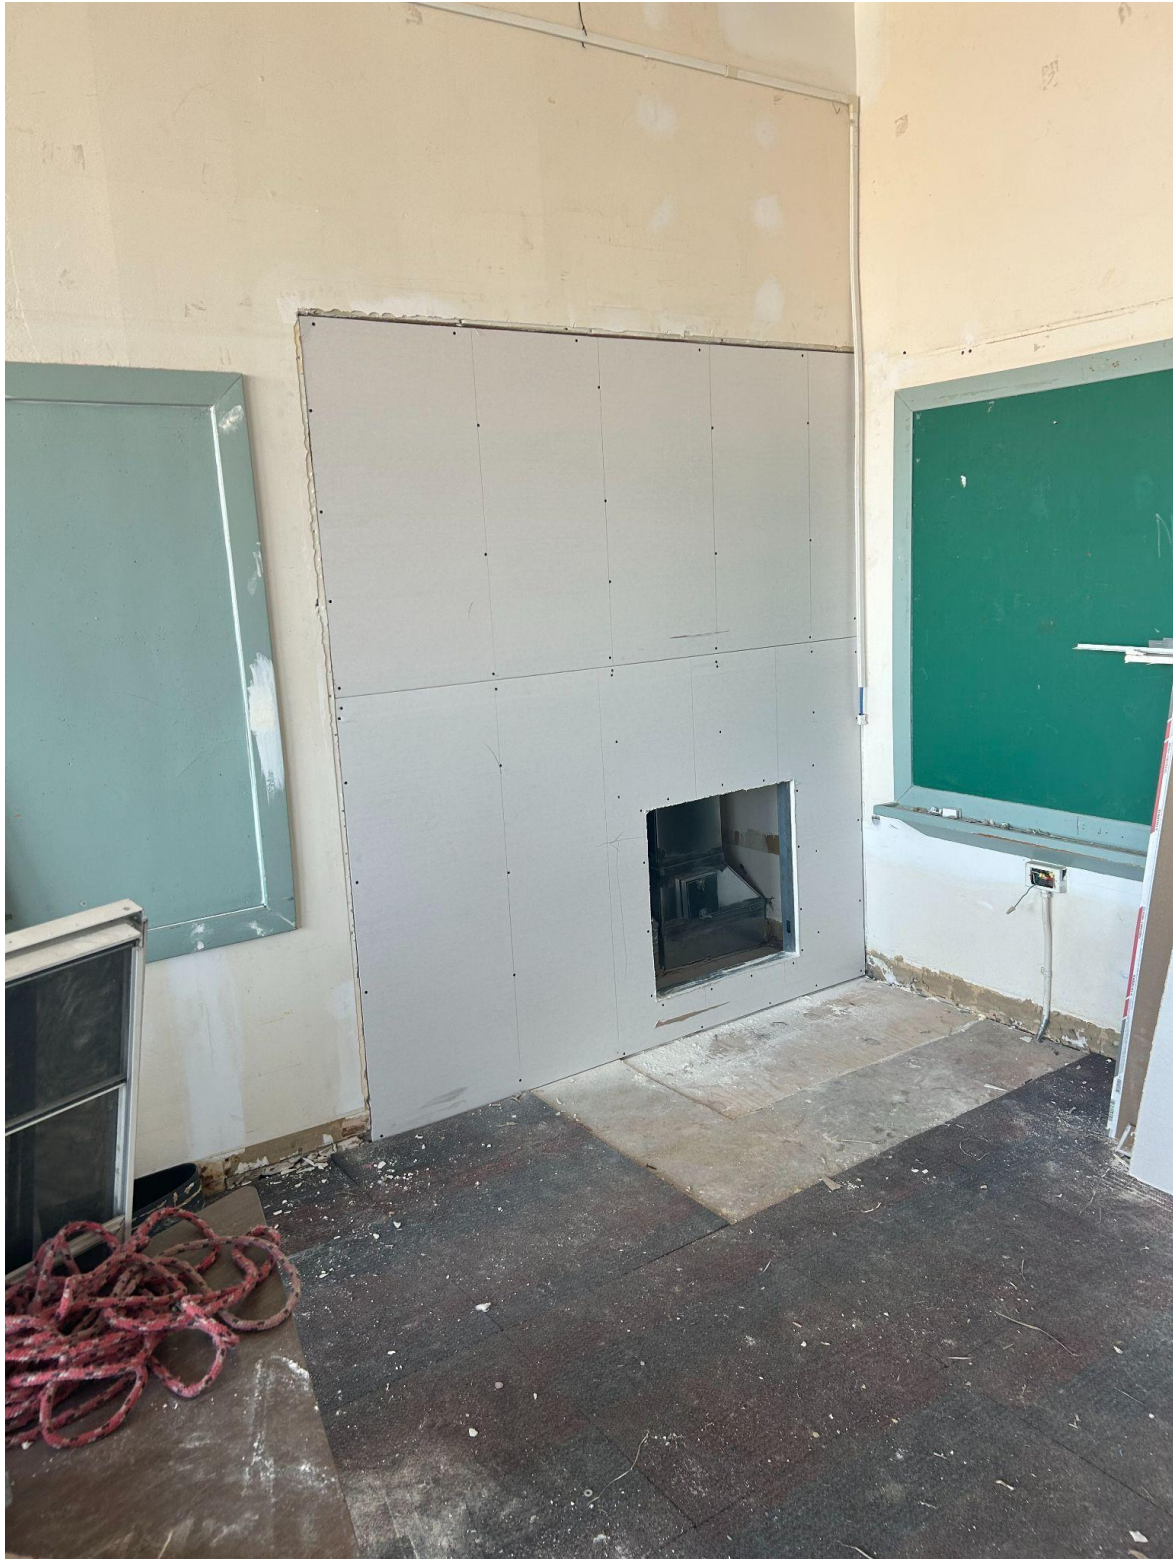
Another area where the framing contractor is covering up where ductwork, sprinkler piping, electrical conduits from one floor to another are getting covered up.

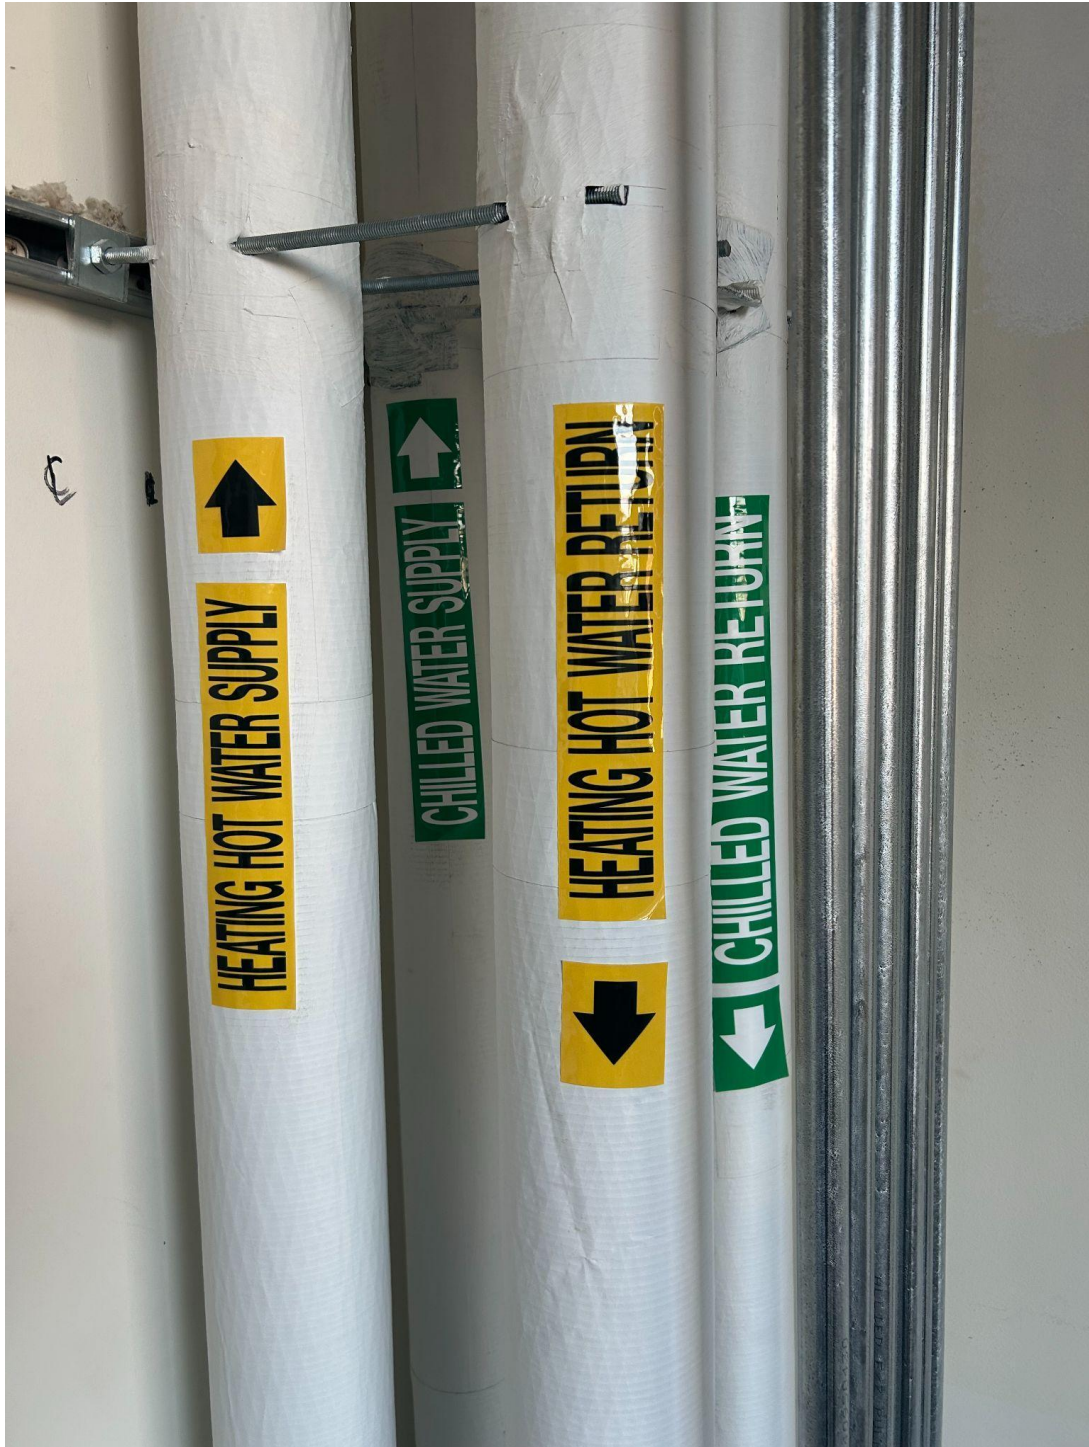
The mechanical contractor continues to finalize the installation of the mechanical equipment in the building. Now that the piping is installed, insulated, and before the piping gets covered up, the mechanical contractor is going through the building labeling the piping. This way in the future, when anyone needs to do maintenance, they will know what system they are dealing with. And the arrows placed on the piping shows which direction the water is flowing.
