**Report for Reconnaissance Archaeological Survey of the 17-19 Pinckney Street Well,
Boston (Beacon Hill), Massachusetts**

Joseph Bagley

2019

City of Boston Archaeology Program
201 Rivermoor St.
Boston, MA 02132

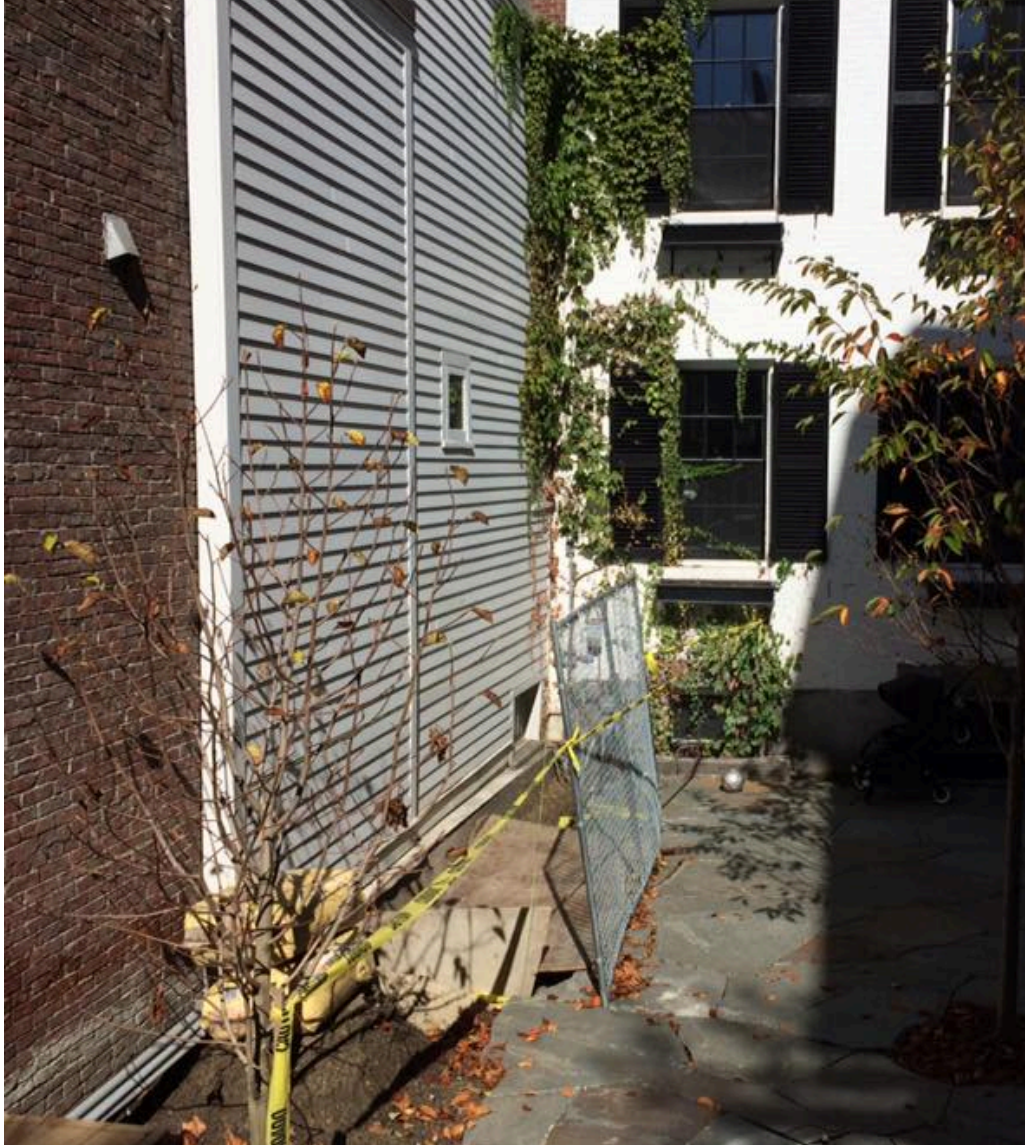
Figure 18, site of well discovery under plywood at western edge of property. View to the north. Fence segment is five feet tall.

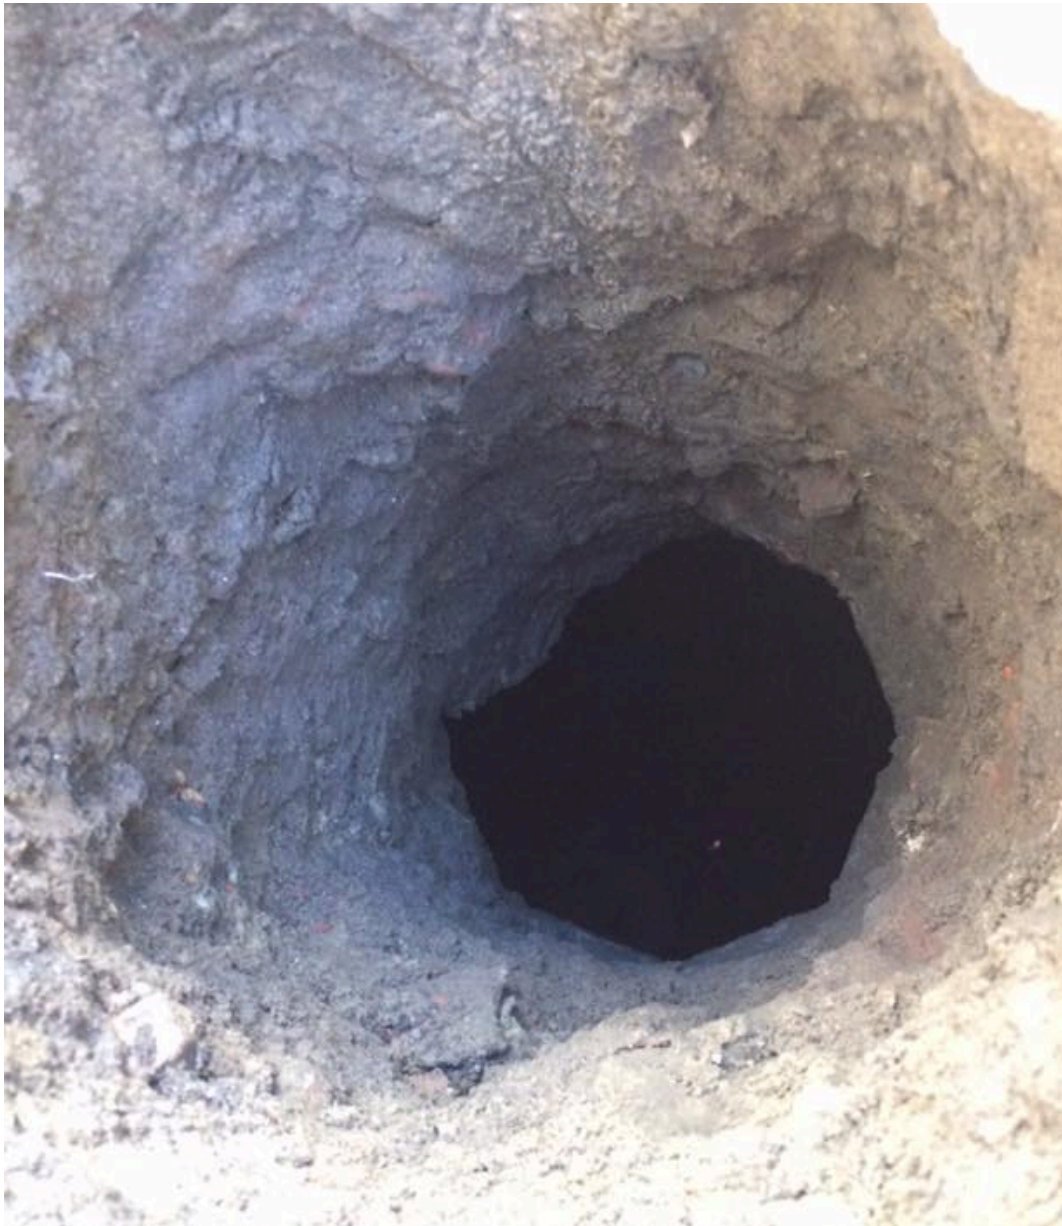
The distance from the current surface to the well cover/opening is approximately 1 meter, all appearing to be sandy fill.

Figure 20- View pointing straight down from the surface of the opening of well. Octagonal opening is 12" wide (30 cm). Note consistent sandy fill above the opening. White dot in black void is the sun-lit octagonal opening reflected in water at the bottom of the well.

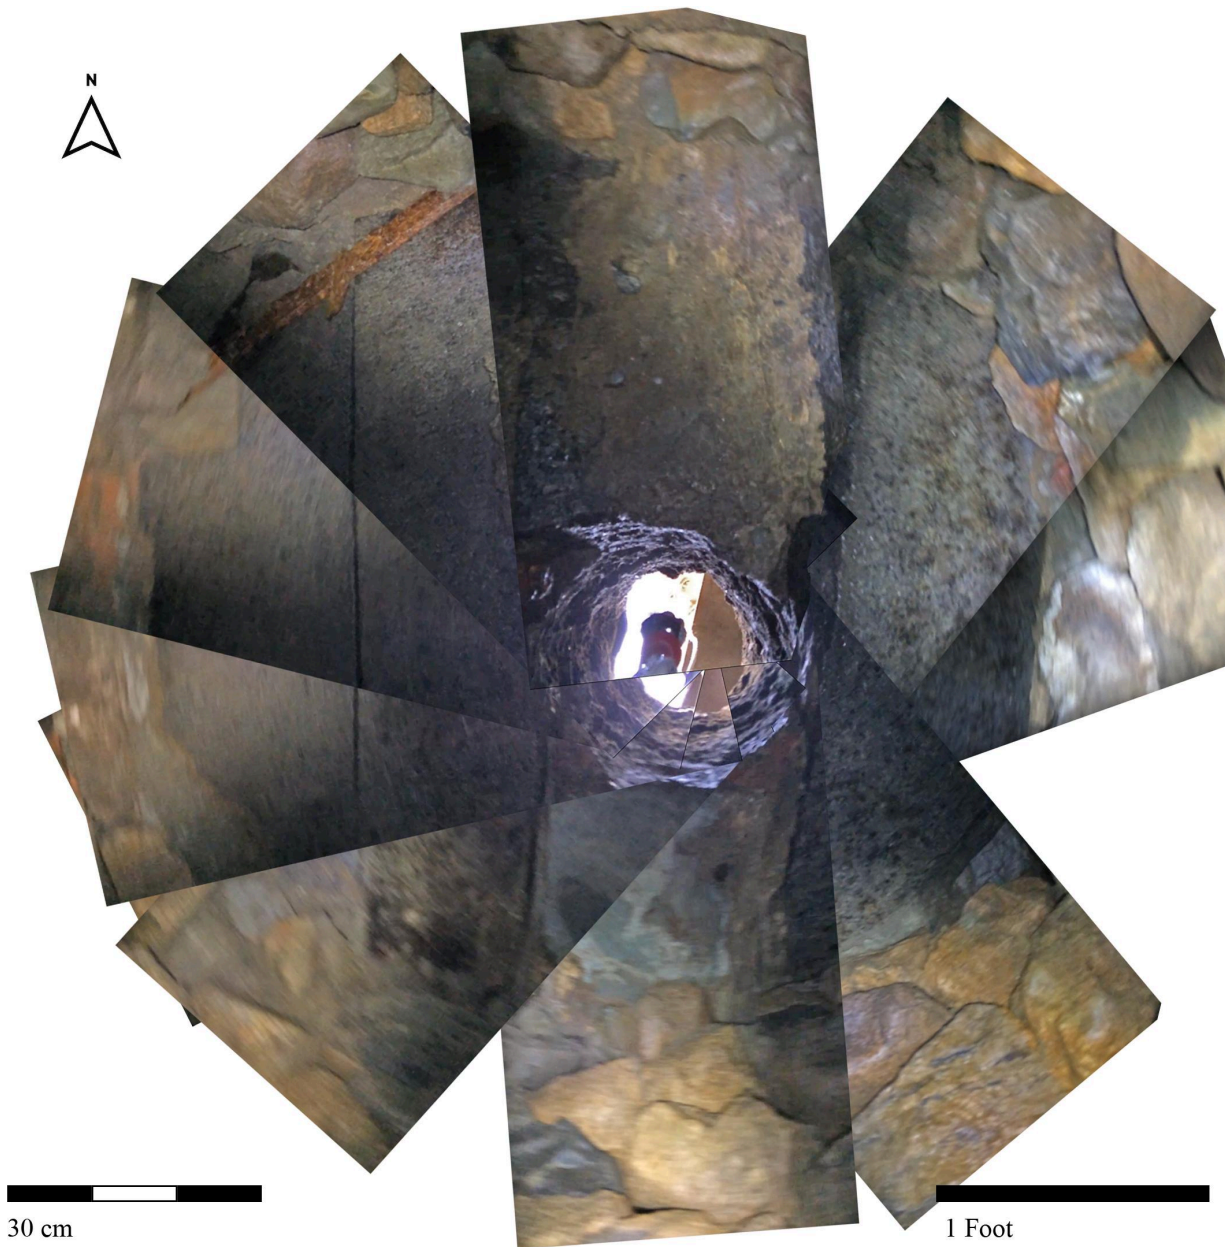
An approximately 2" wide iron strip about .25" thick is visible in the northwest portion of the well cover. It is not known if this is for structural support or if it aided in the construction of the well.

Figure 25- Composite mosaic view of the underside of the well cover from video footage

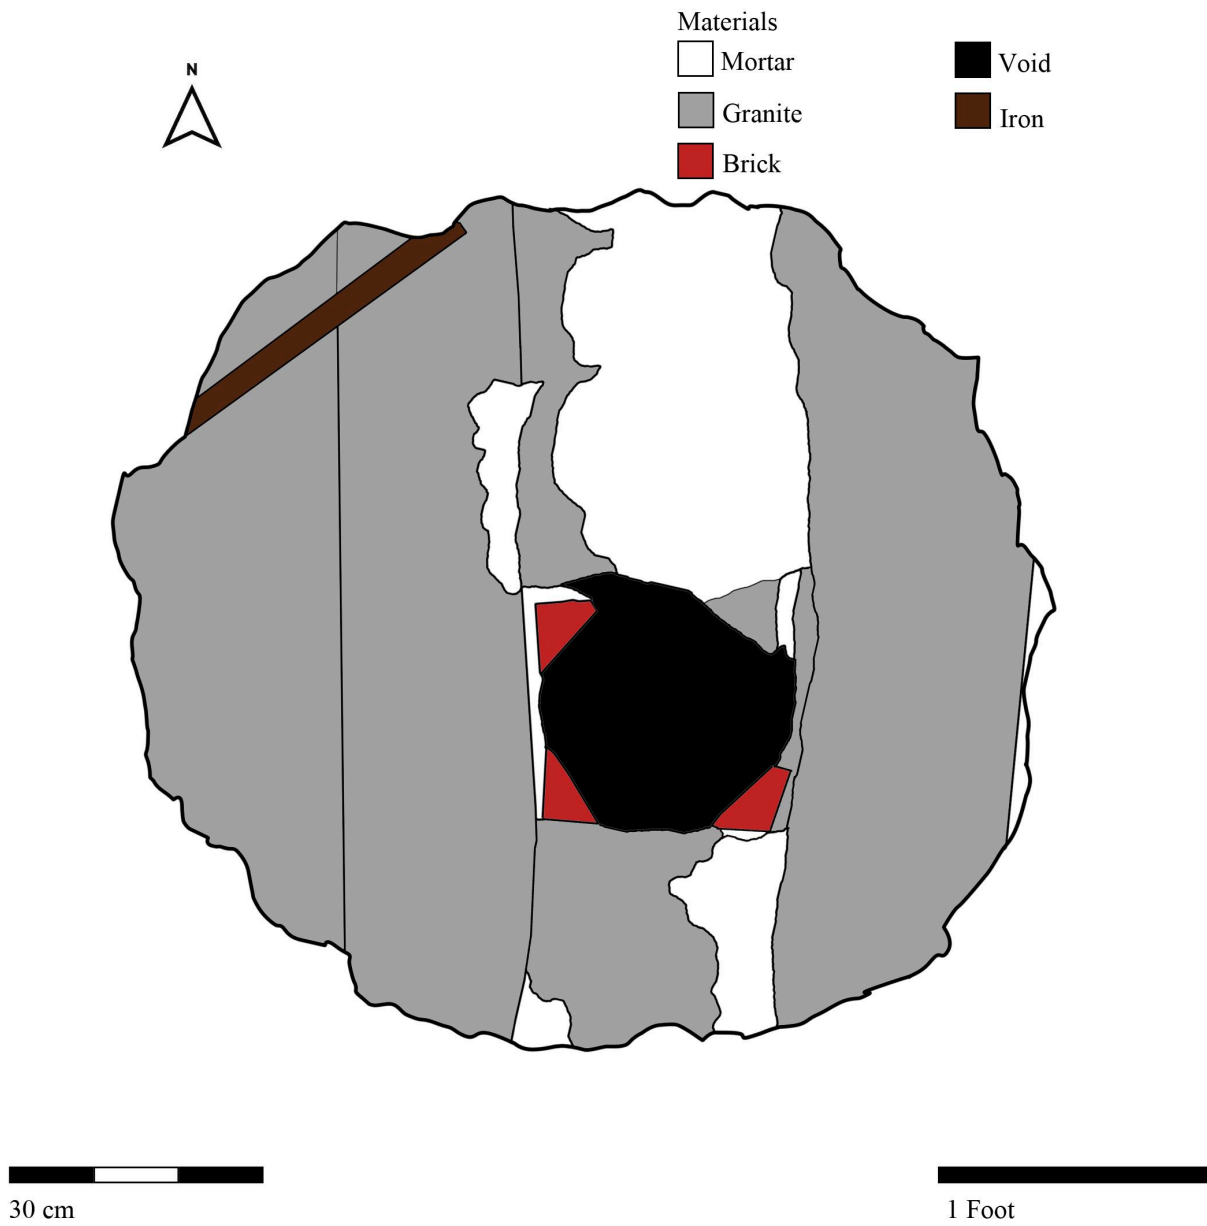
Figure 26- Materials drawing of the underside of the well cover from composite image

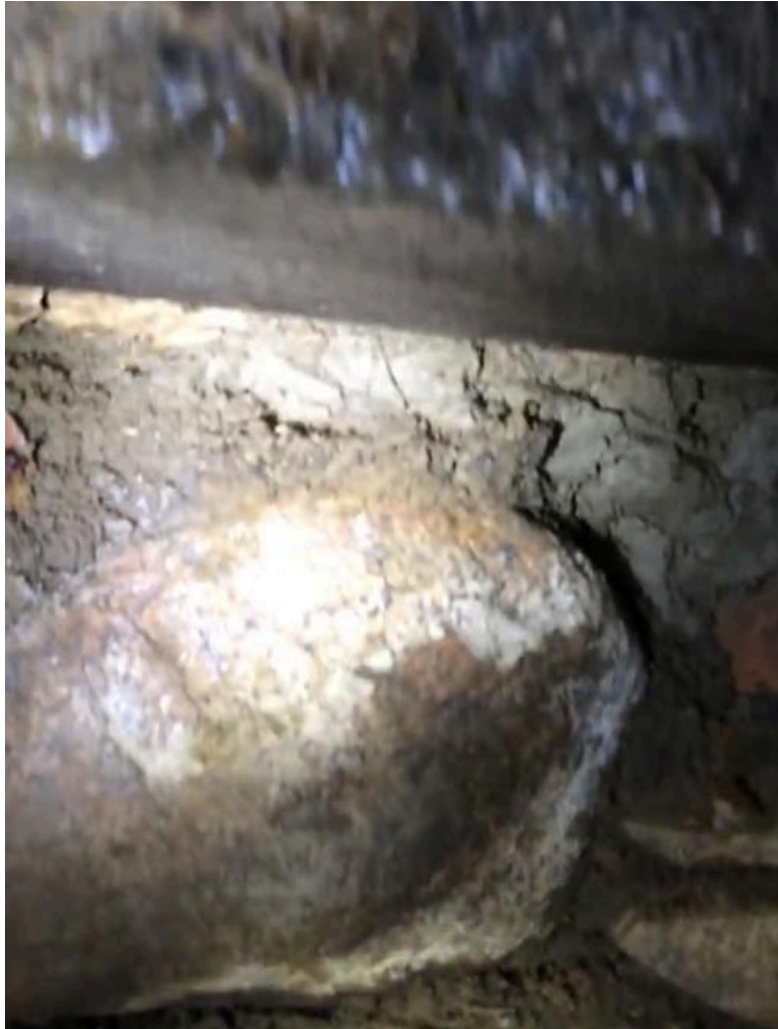
Figure 27- Well cap (top) and stones of well showing only areas where mortar is used near the surface of the well. Width of view is approximately 1 foot.

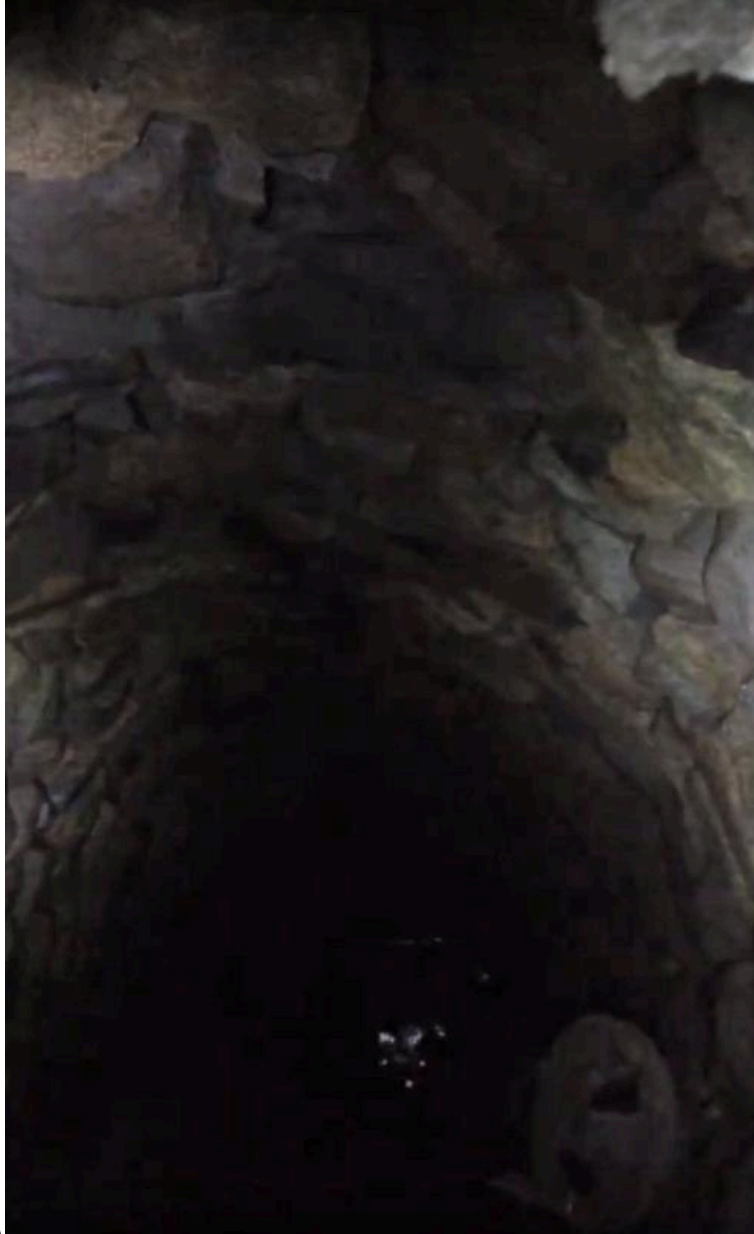
Figure 28- Video still of the well shaft just below the well cap. View shows pump pipe in the lower right. Width of view is approximately 4 feet.

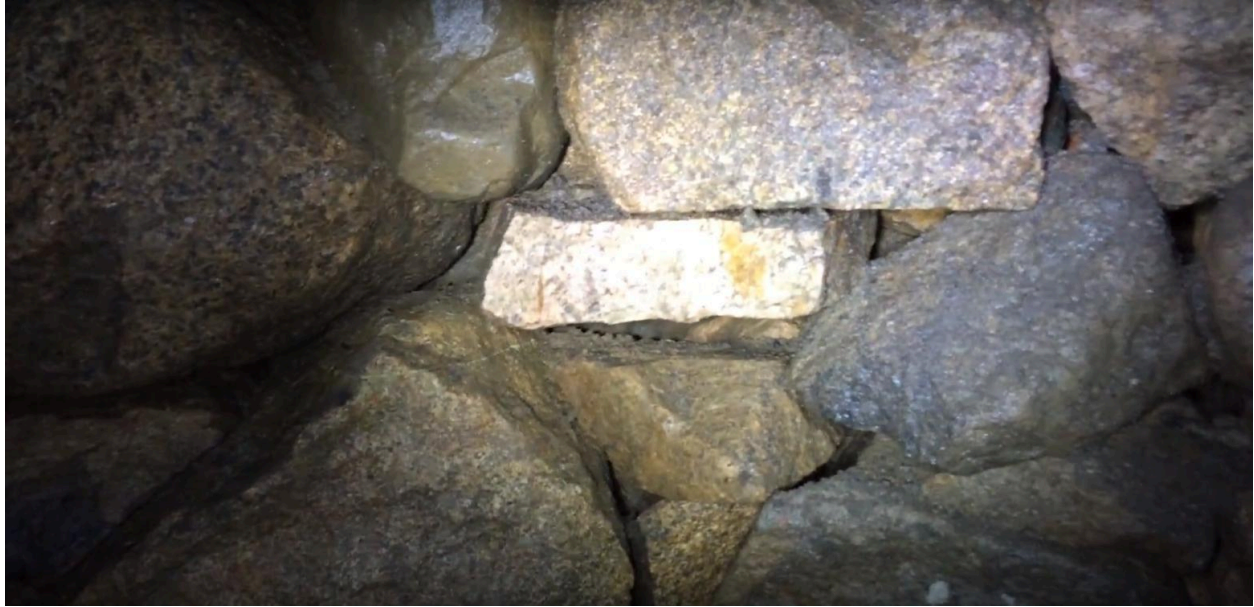
Figure 29- Video still showing stones in well structure. Note lack of mortar. View is approximately 2 feet wide.

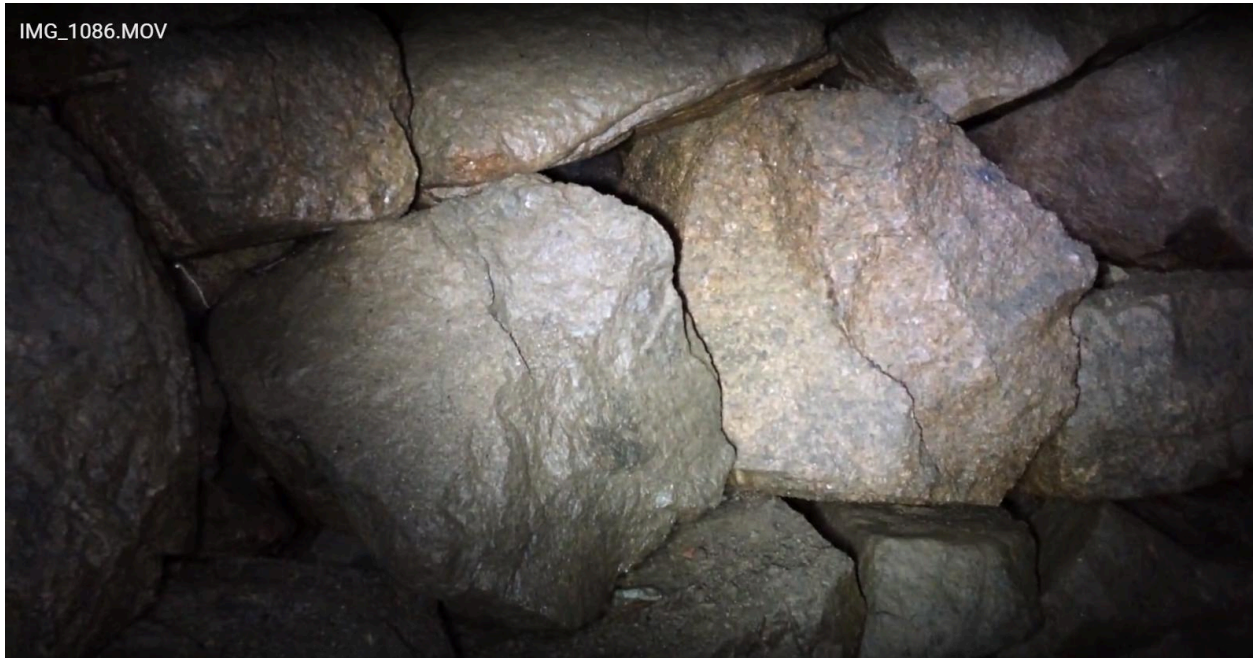
Figure 30- Video still of interior wall of well showing materials used in its construction. View is approximately 2 feet wide.

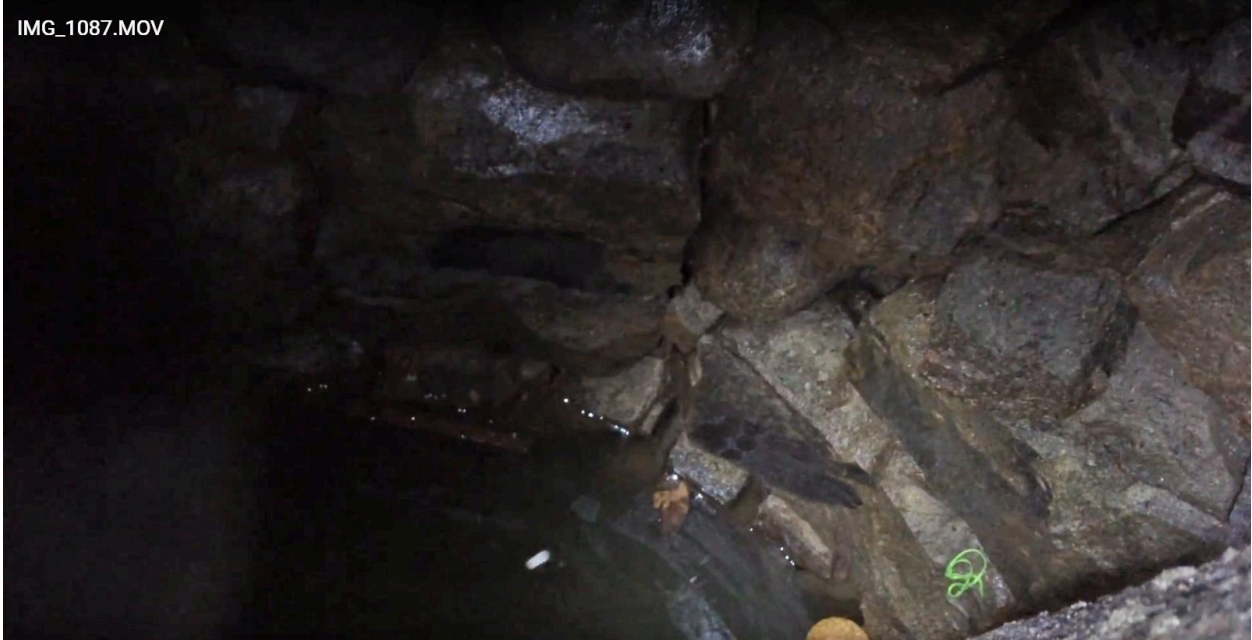
Figure 31- View near bottom of well showing water pooling at the bottom. Green string fell in from recent landscape work, as did the fall leaves (Photo taken in October). Pipe is visible in extreme lower right of image. View is approximately 3 feet wide.

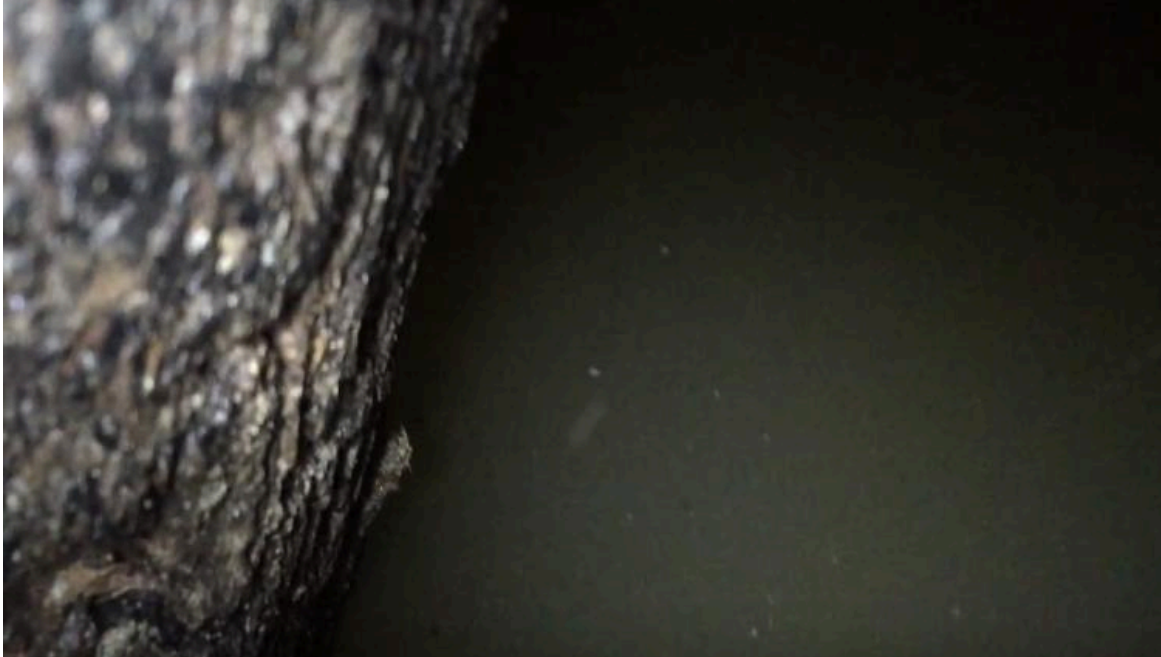
The well does not appear to differ in width from top to bottom measuring approximately 4 feet wide. The distance from the well cap to the surface of the water was measured at 34 feet in depth, though that is just to the surface of the water, which is cloudy (Figure 32), and is therefore possibly deeper.

Figure 32- Video still of the water at the bottom of the well showing its lack of transparency. Pipe to the left.

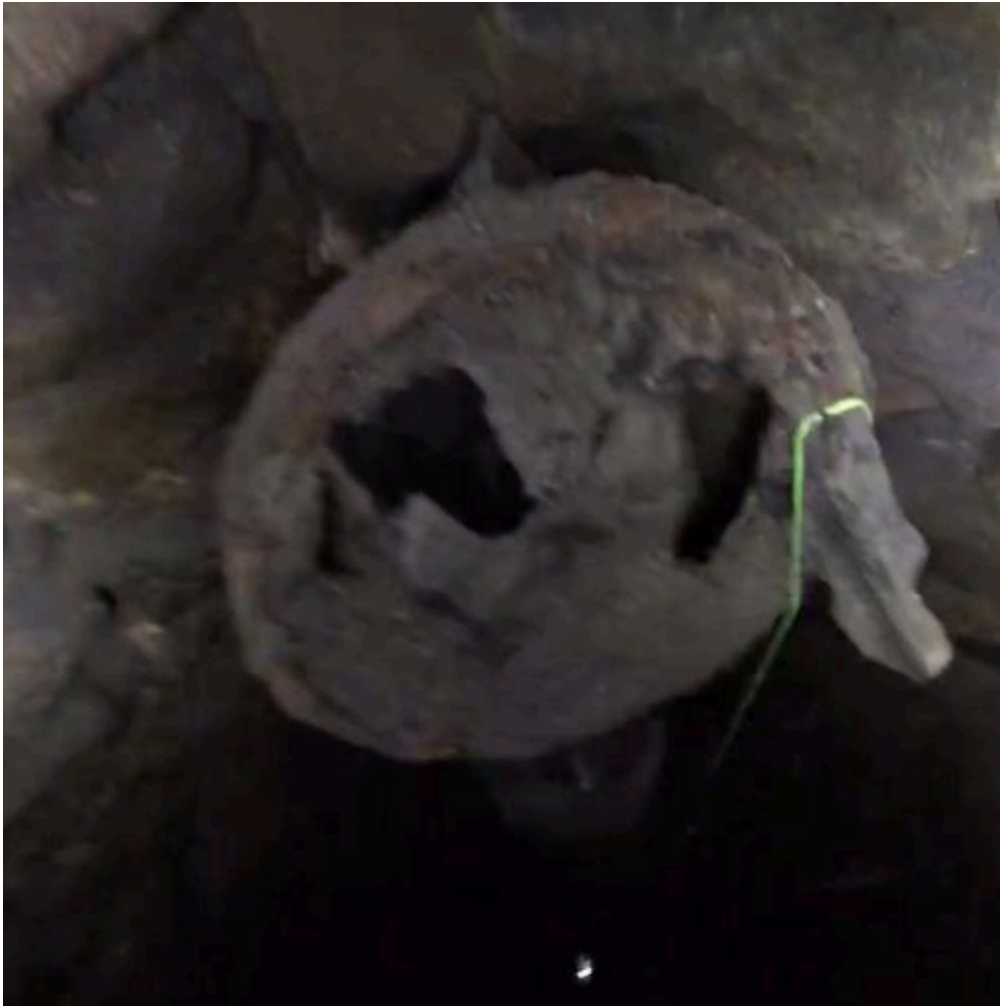
The original wooden pump pipe was still present within the well. It appeared approximately 10 feet below the well cap, and continued into the pool at the bottom of the well. The upper-most portion of the pipe that was visible appears to have broken, perhaps at a coupling place given the metal ring present at the break. It is likely that each pipe segment consisted of a flat, open end, with a bored hole, and an end that was tapered to fit into the subsequent bore hole of the next pipe.

Figure 33- Full view of upper coupling. View facing slightly downward in well. Pipe is approximately 10 inches wide.

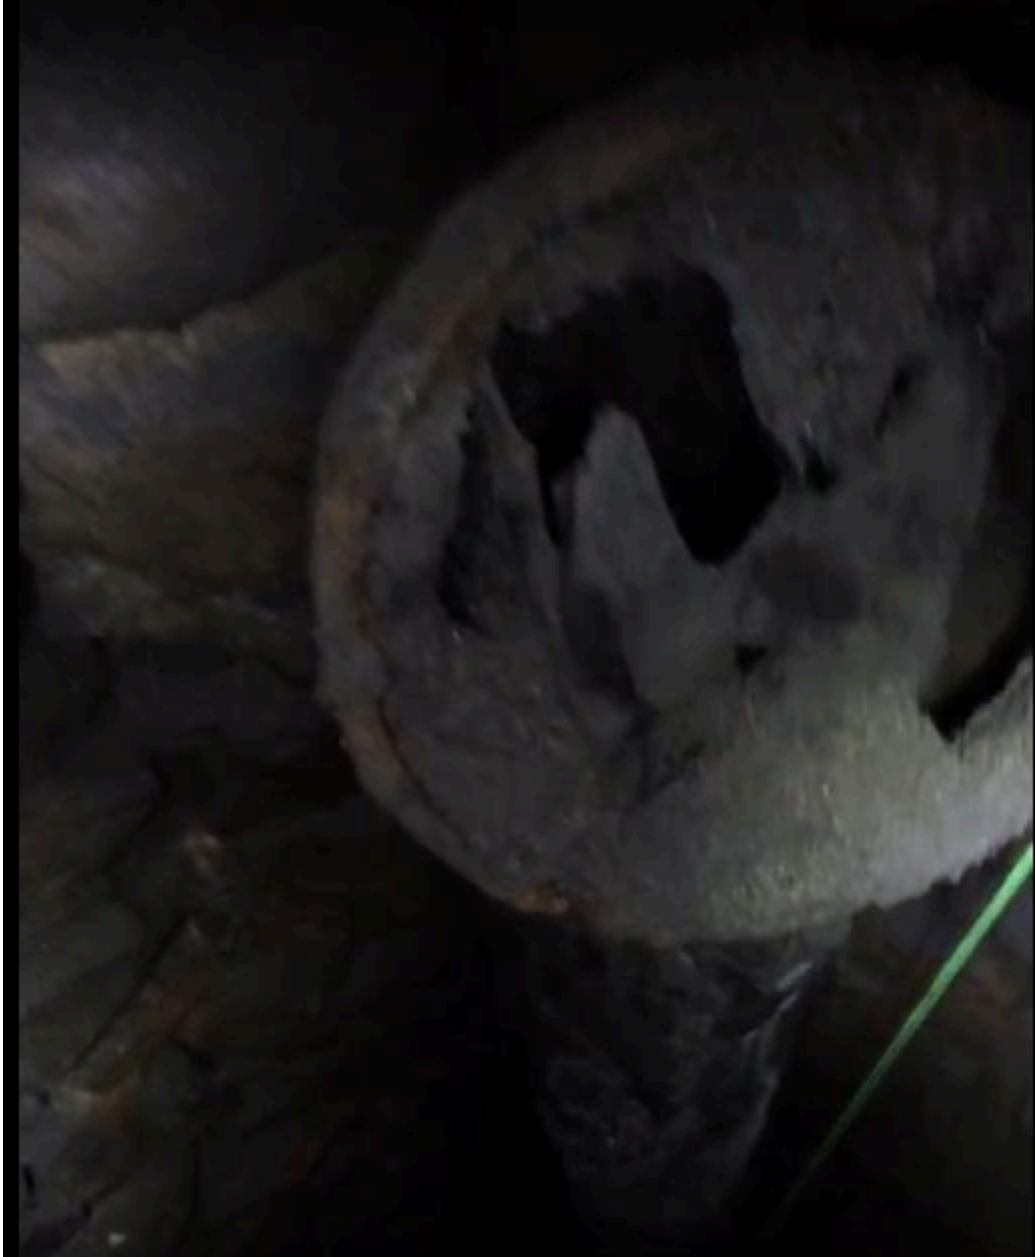
Figure 34- Detailed view jagged upper/top end of pipe segment with iron band remaining, but hanging off of the broken element. Green string from landscapers. Pipe is approximately 10 inches wide. View facing approximately horizontal in well.

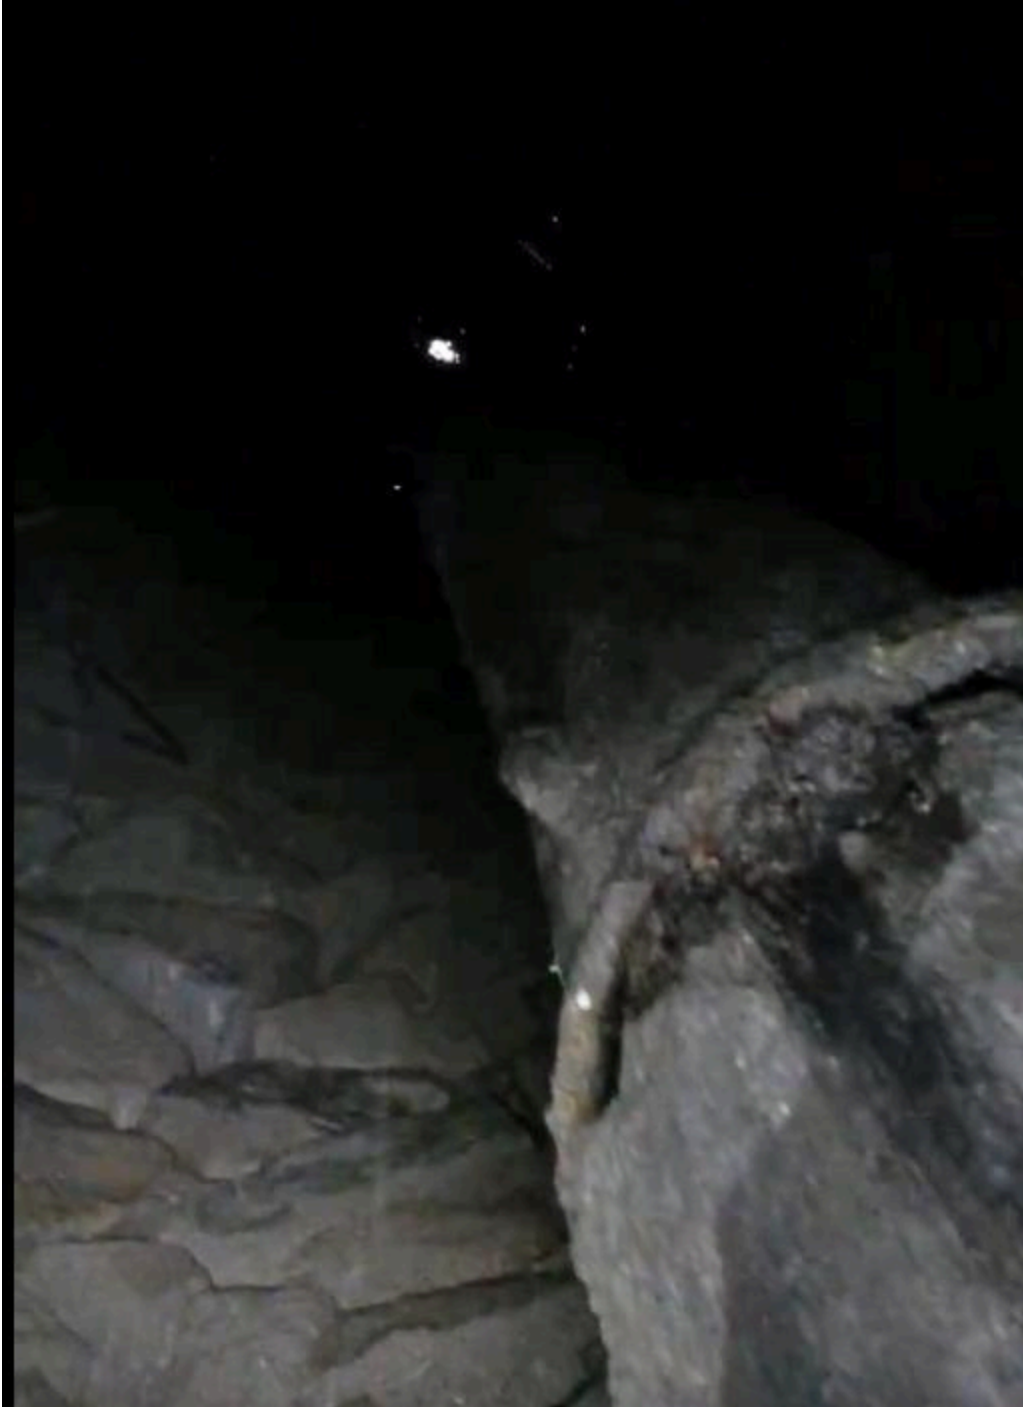
Figure 35- Banded coupling between the lower and upper pipe segment. Pipe is approximately 10 inches wide. View facing downward.

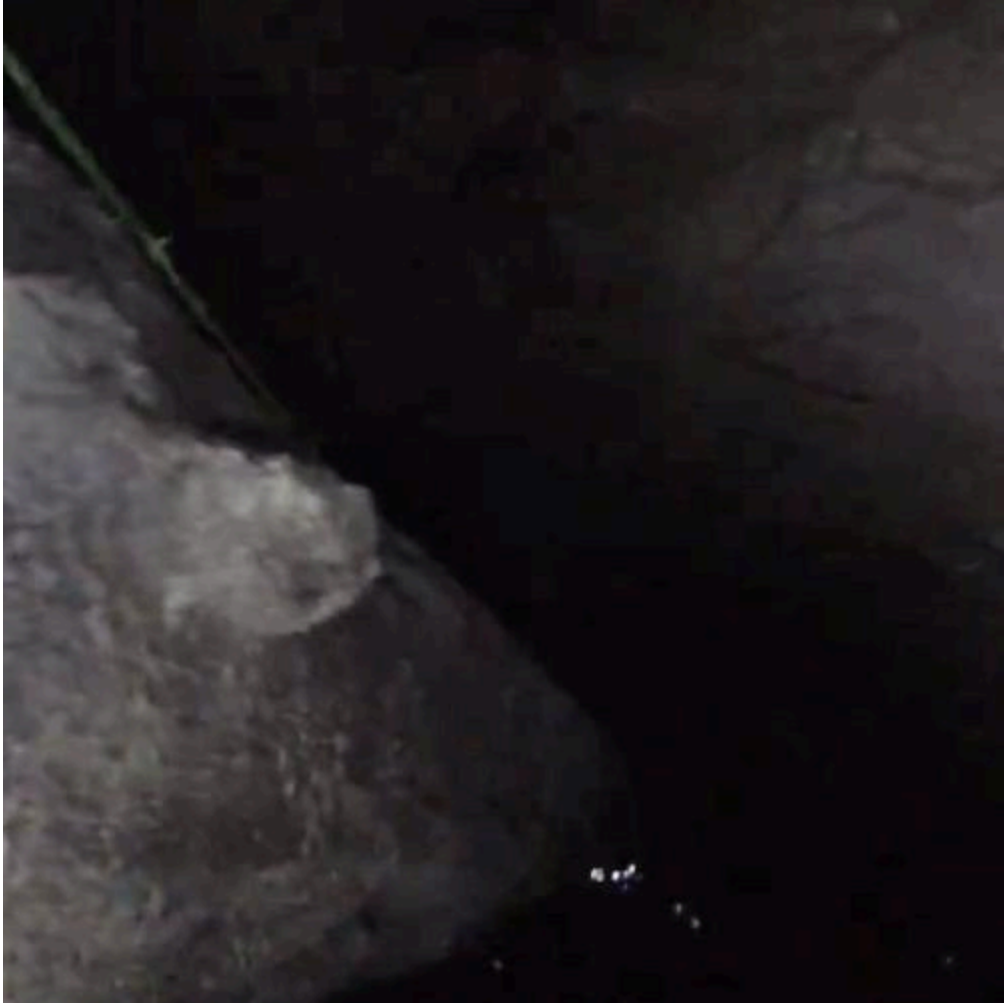
The exterior of the pipe is dark brown with white elements suggesting mold, salt, sediment, or other accumulation of material on the surface of the wood. The pipe appears to be round, but may have been faceted at one point, if elements of the exterior of the pipe have fallen off.

Figure 36- Possible remnant of a branch on exterior of pipe. Pipe is approximately 10 inches wide. View facing downward.

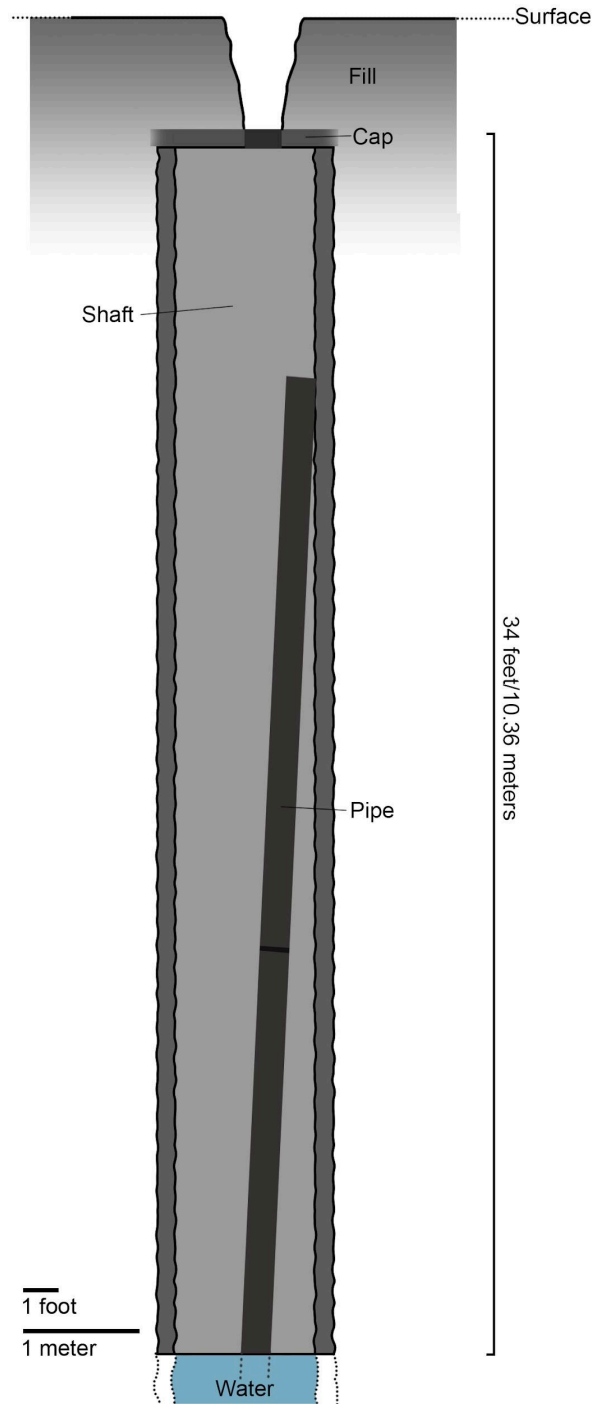
Figure 37- A profile of the c. 1800 well at 17-16 Pinckney Street, Beacon Hill.

The water was transported from the bottom of the well to the surface through a series of interconnected hollowed logs, likely of pitch pine, each around 10 inches across with an approximately 3 inch bore. These pipes traversed the bottom of the well to a cap where it met a hand pump on the surface of the yard. The uppermost segment of this pipe was not found and may have decomposed, was removed, or fell into the well and sunk to the bottom. If this is the case, the well extends at least 6 feet further in depth.

It is not known what the current conditions of the well are, but it is believed to be capped. The owners of the property were last exploring costs to fill the well with gravel. The owners had no intention of attempting to modify or remove the well, only re-seal the opening at the top and
