Safety & News
RV-10 Door Open in Flight
and
AAL Flight 5342

RV-10 Fatal Accident

AAL FI 5342 and US Army Black Hawk Helicopter Collision

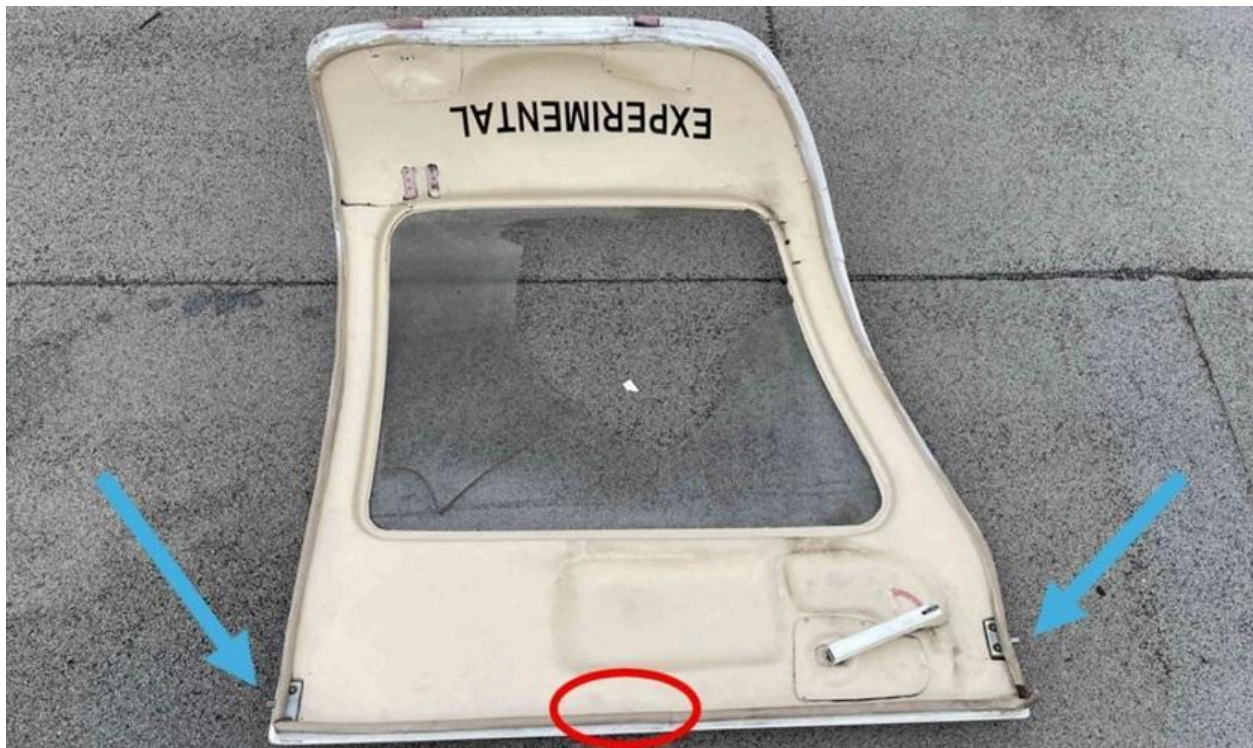
Investigators found the left cabin door of the Van's Aircraft RV-10 that crashed January 2 on the roof of the same warehouse that the airplane struck while attempting an emergency landing at Fullerton Municipal Airport. Blue arrows point to the primary door latches, and the area where a secondary latch should have been installed is circled in red. NTSB image.

The witnesses also saw a white, panel-like piece fall from the airplane just before impact. Investigators found the door on the roof of the damaged building, and determined that a secondary safety latch shipped by the manufacturer to Reid in 2010 was never installed.

The gull-wing doors on both sides of an RV-10 are secured by top hinges and locking pins at the bottom of the frame, forward and aft. The secondary latch, mounted on the bottom of the door frame, was added to the original design and made standard on all kits shipped on or after January 4, 2010. Reid, who received his first kit components in 2007 and completed the build in 2011, was shipped a safety latch kit on January 25, 2010, the NTSB report notes.

The NTSB report notes that Reid made some modifications to the door design, including replacement of aluminum locking pins with steel pins—and, more significantly, the absence of two of the four magnetic switches included in the kit that trigger LED indication lights that confirm that the door is locked.

"As such, the modified system would not have warned the pilot if the forward latch pins had failed to fully engage," the report states. Investigators found the left door handle short of the locked position. When they moved the handle forward, the pins extended nearly half an inch further, and the locking button engaged.

A Van's Aircraft Service Bulletin issued in January 2010 directs owners to install the safety latch assembly, which includes an aluminum hook that engages as the door's edge comes within range, prior to full closure. Installation was directed "before further flight."
