# Failure Analyses and Metallurgical Studies

## **A Damascus Failure Analysis**

“A Blow-Up Post-Mortem”, published in *The Double Gun & Single Shot Journal*, Vol. 27, Issue 3, p. 17, 2016

## **“The Southern” Chamber Burst**

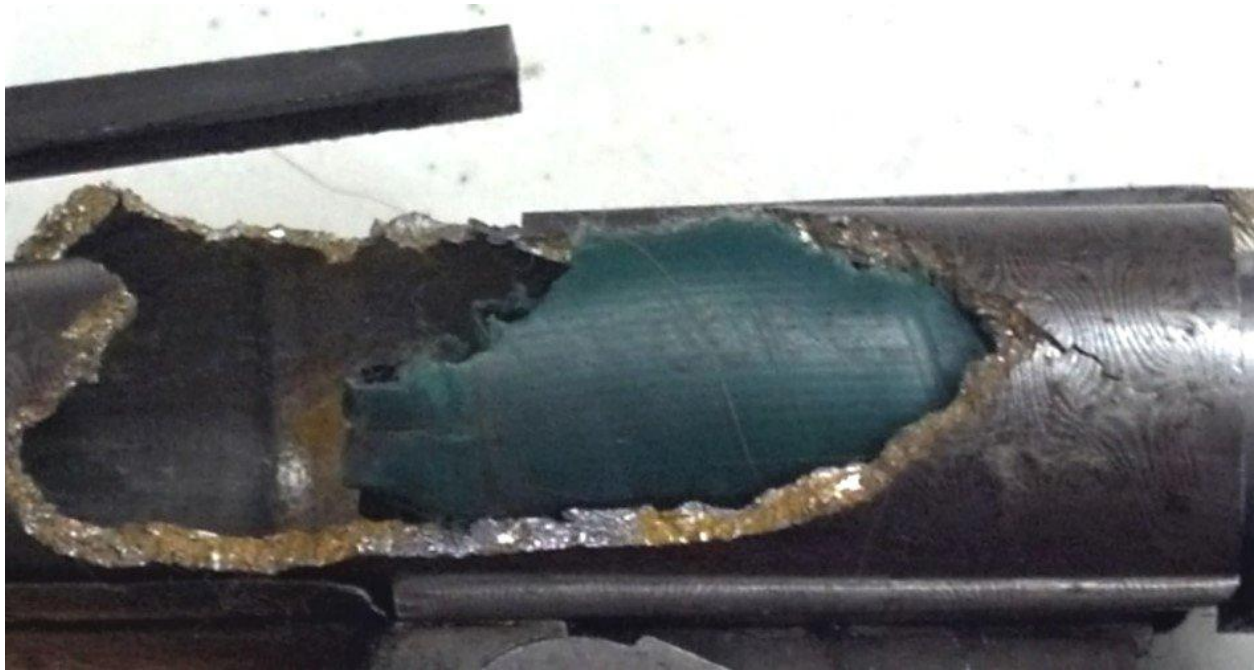
**As received**

The barrels were received with both empty shells in the chambers, along with 19 empty shells that had been used during the round of Skeet, and 4 unused reloads; a total of 25 shells. On careful examination of the empties, there were **no** missing pieces of plastic, inside or out, nor evidence of case head separation.

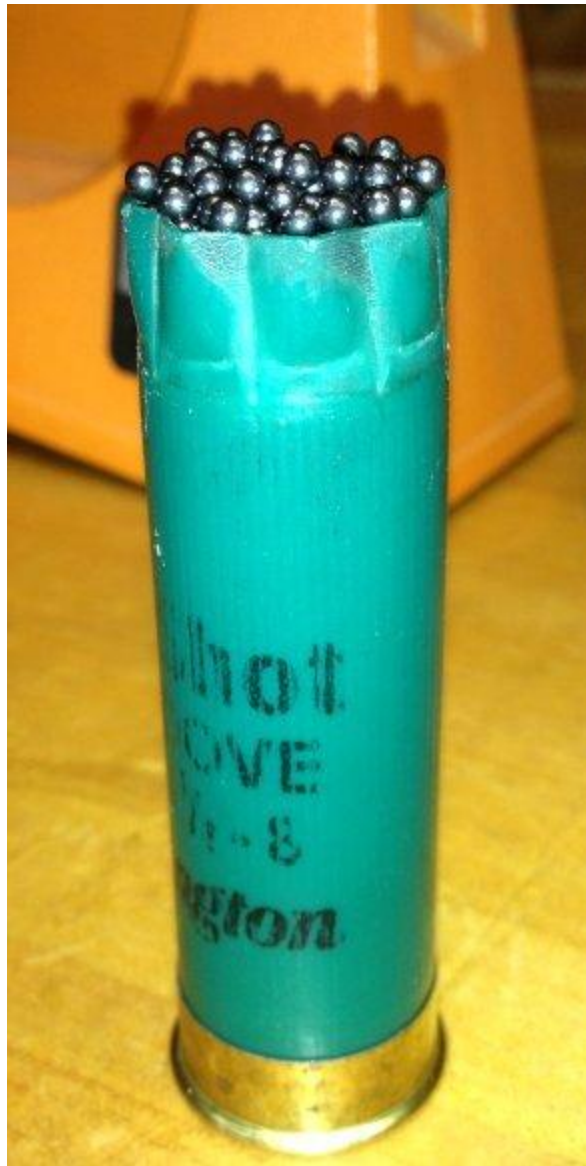
An experienced reloader attempted to duplicate a **double** powder charge with a Gun Club hull and **35 grains** of Clays, Downrange clone of Winchester WAA12L wad, and 1 ounce of shot. With wad pressure on a MEC 9000 of 40 pounds, the hull would not hold the entire shot charge; about 1/16 ounce spilled over the mouth of the hull. (Courtesy of Joe Wood)

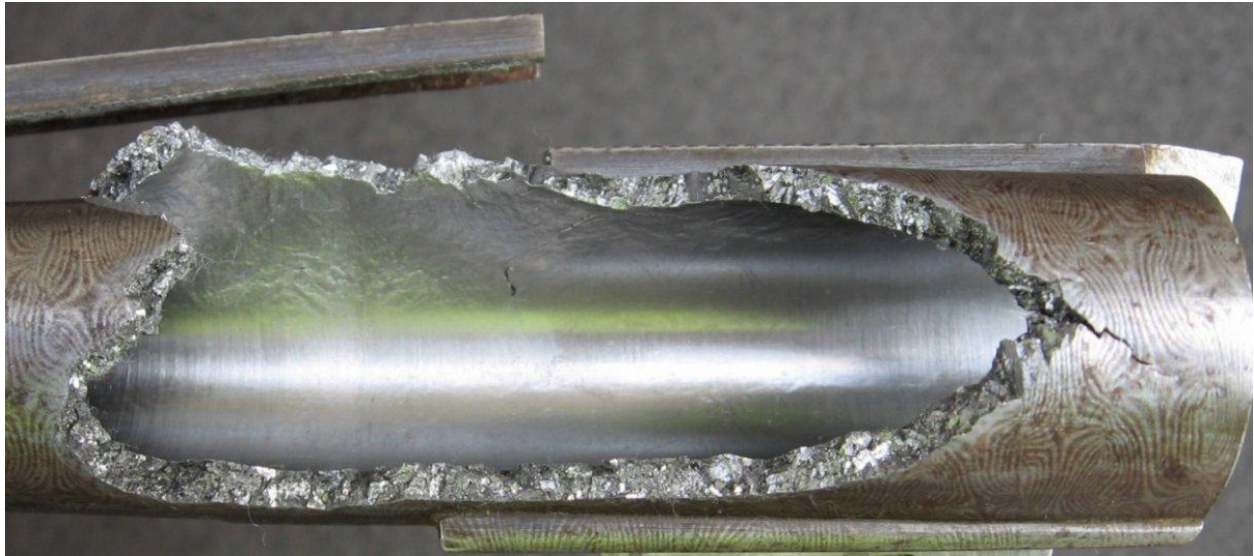
**Wall thickness around the edges of the burst:**

Starting to the right, 5/8" from the breech WT was .150".

At the bottom 1 1/8" from the breech .130".

Moving along the bottom to the front was uniformly .121" to .123".

At the top, 1 1/8" from the breech was .126", 1 1/4" from the breech .122", and 2 5/8" from the breech .119".

The thinnest section was at what I believe to represent the apex of the ring bulge from 2 1/4" to 2 1/2" from the breech and WT was .110".

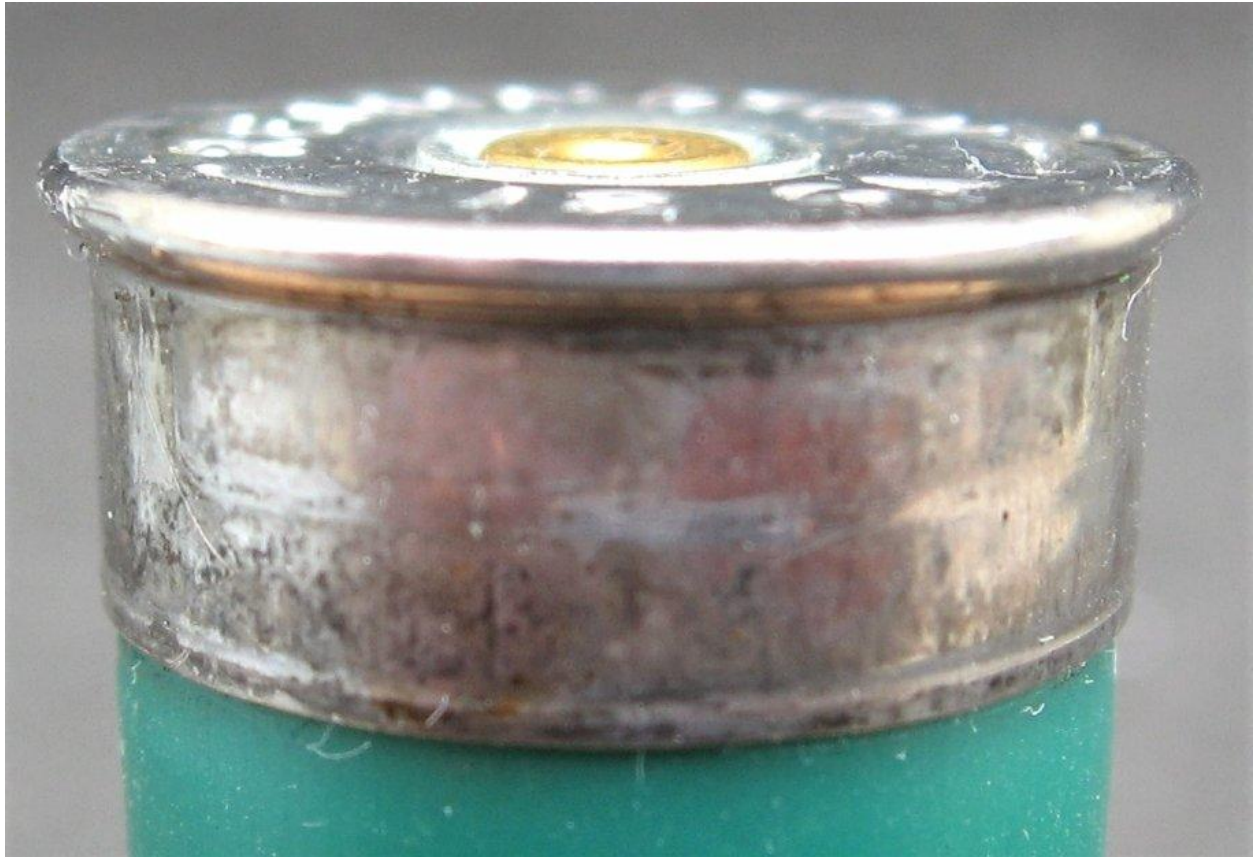
Extractor imprint on the shell in the burst barrel

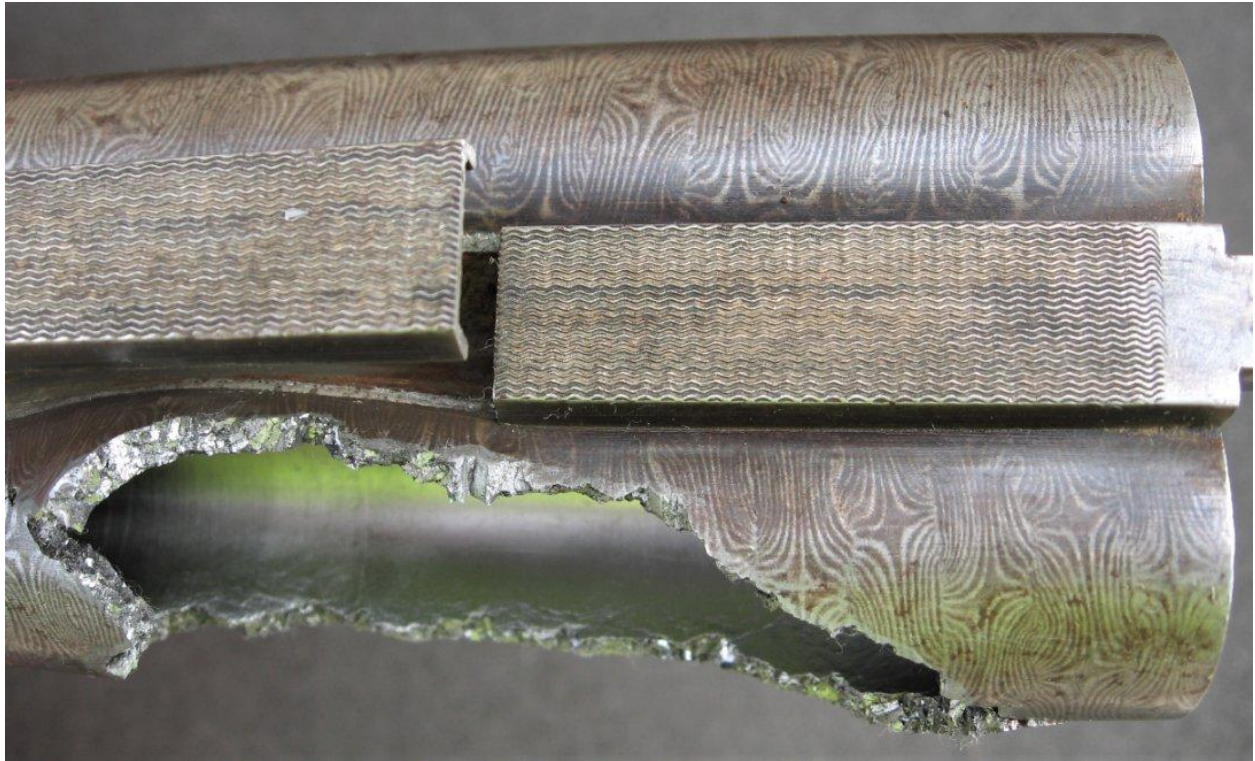
**Ring bulge with rib separation and burst**

The ring bulge establishes that the burst was caused by an obstruction.

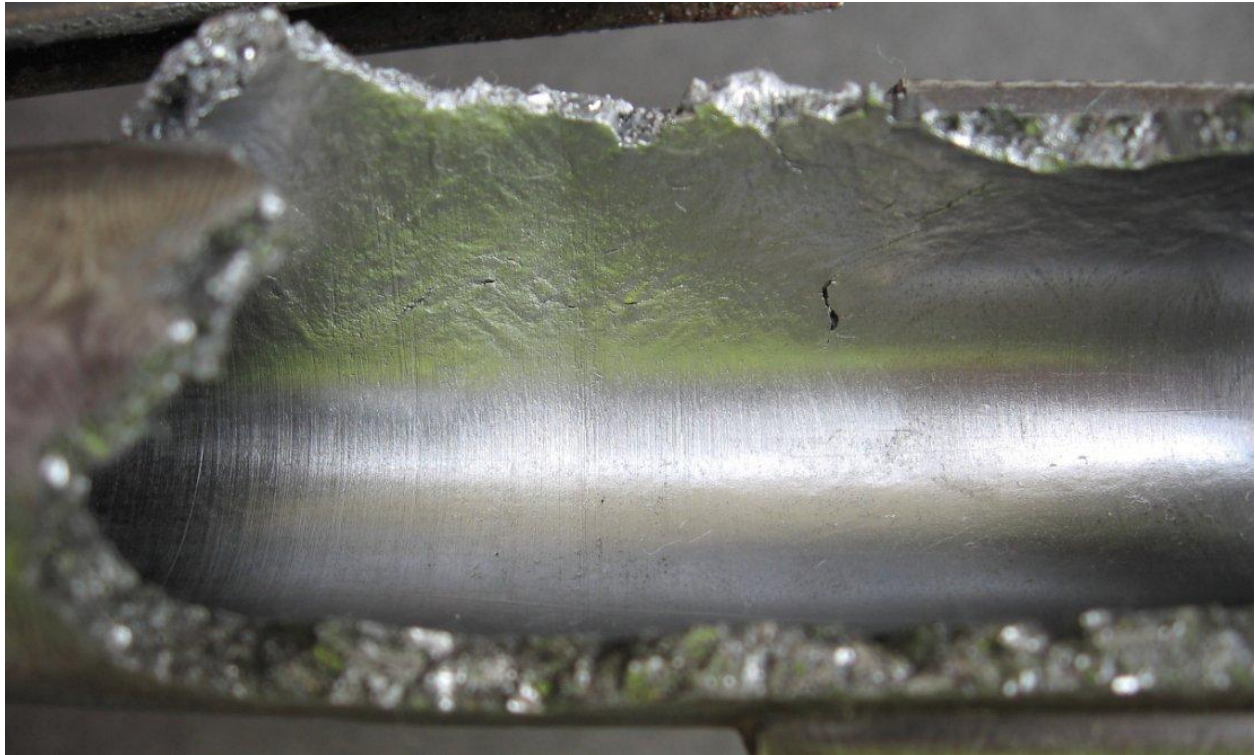
Plastic deformation (wrinkles) and small cracks. On 10X magnification, some cracks followed the crolle pattern; others were across the crolle pattern.

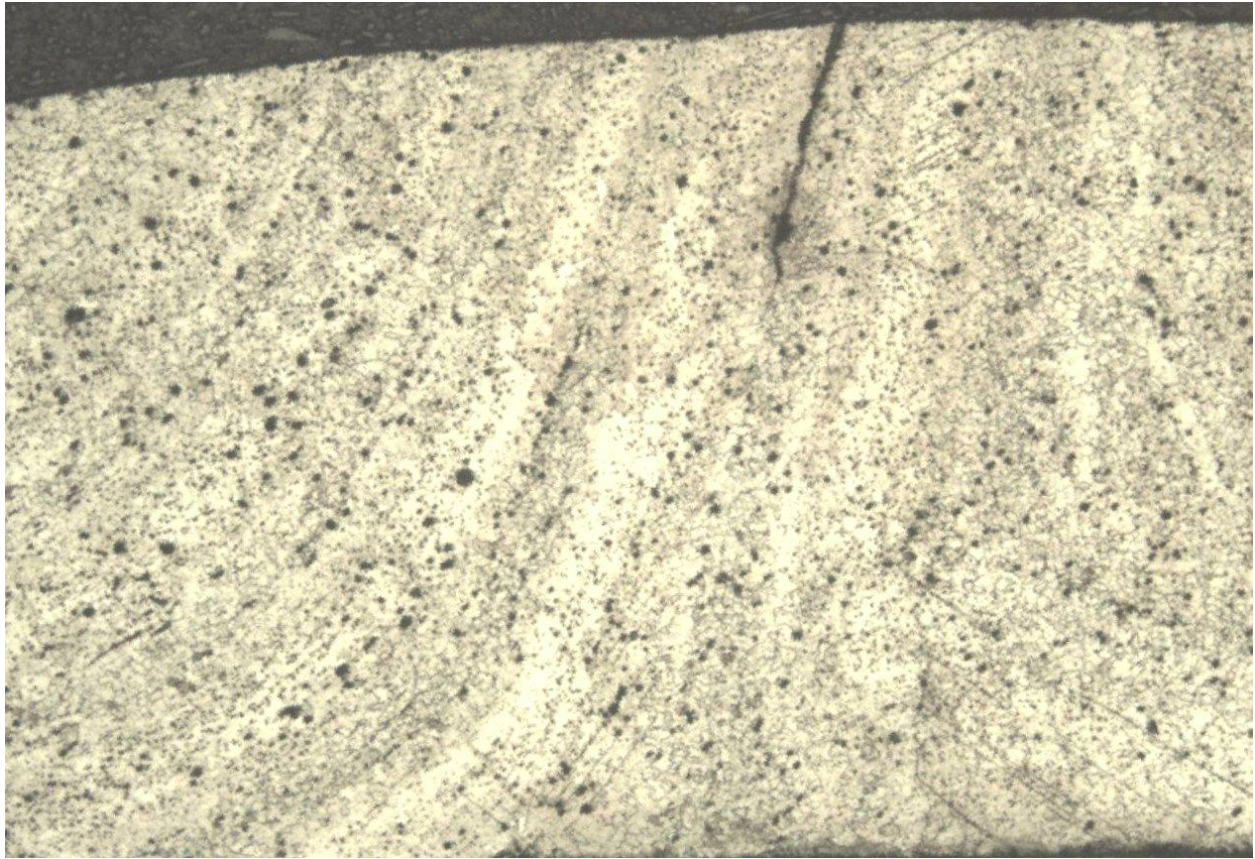
20X photomicrograph after etching with 3% Nital solution showing the bands (*alternees*) and a crack probably within a steel *alternee*, but possibly at an iron-steel interface.

The parallel lines inferiorly may be related to shear forces during the rolling and hammer welding manufacturing process.

The globular inclusions are predominantly within the grey etched steel *alternees*.

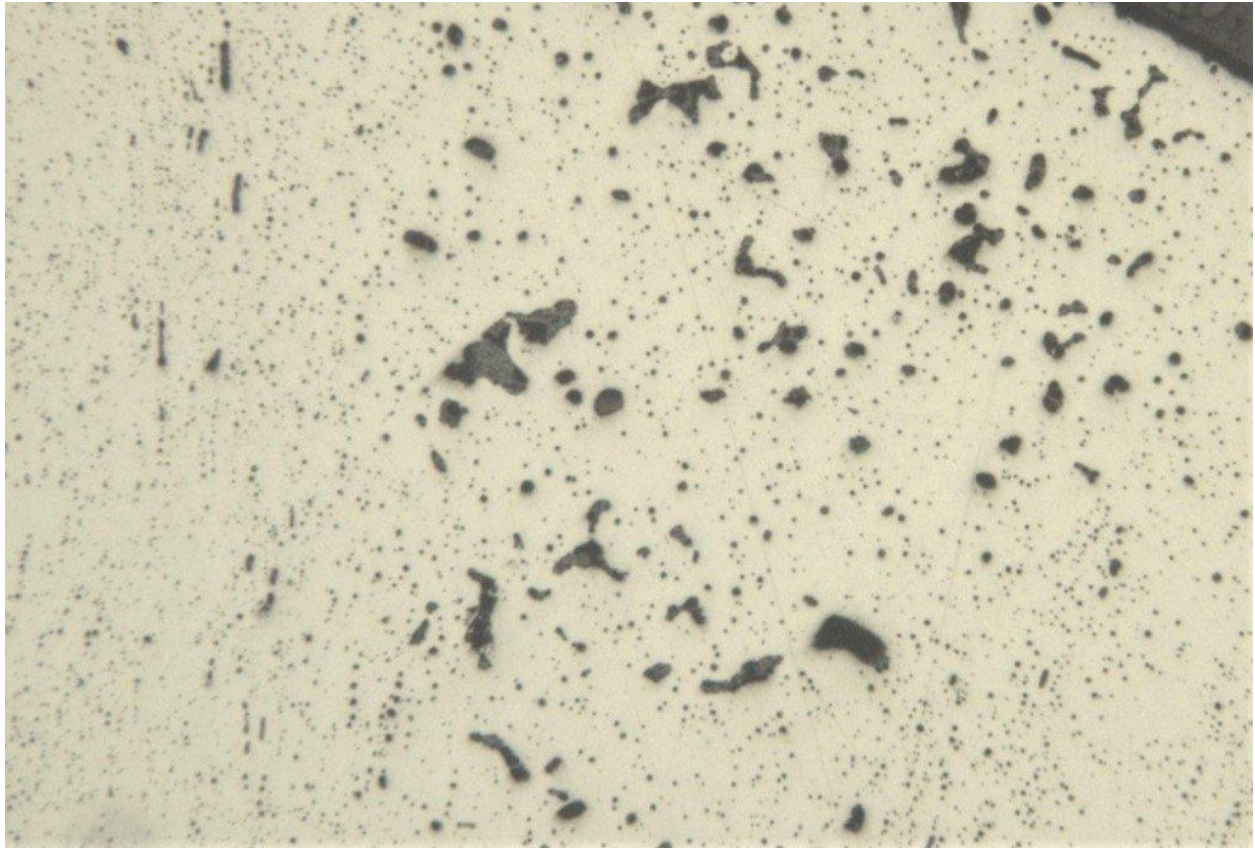
3. Did the barrel burst related to rust, inclusions, voids, or embrittlement? **NO**  
No voids, evidence of embrittlement, nor interlaminar rust were observed. There were a large number of non-metallic inclusions, especially within the steel *alternees*, but micro-fractures extending from one inclusion to another were **not** seen. The inclusions are composed predominantly of silicon, phosphorus, and sulfur.

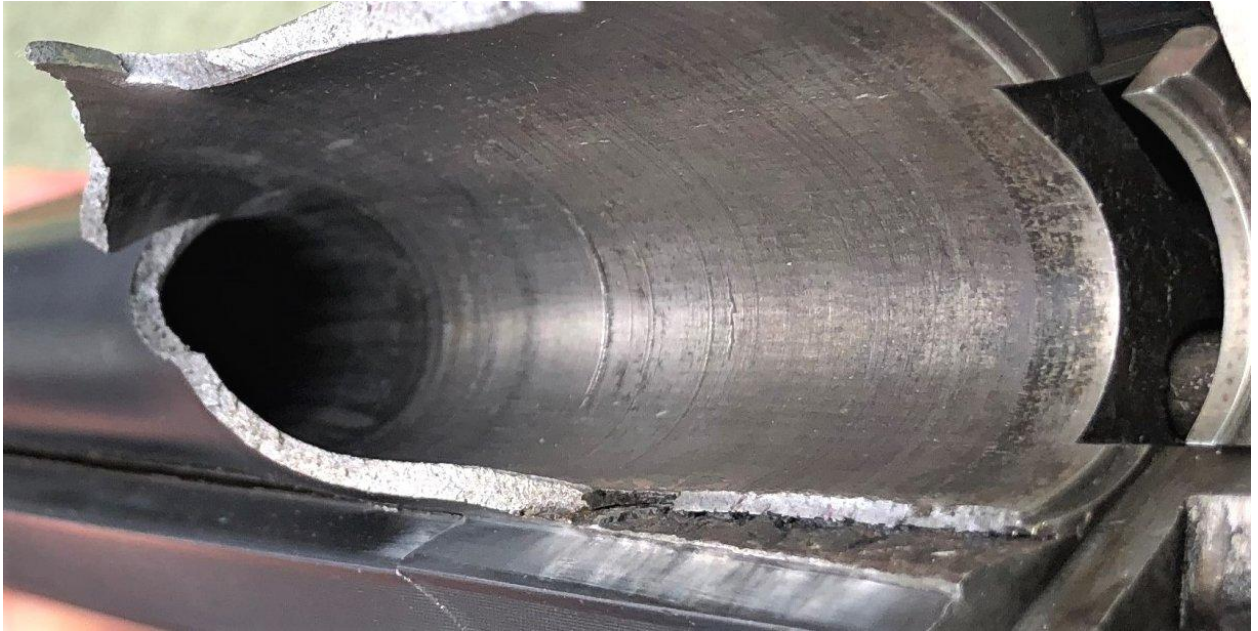
Note that the rib has been lifted

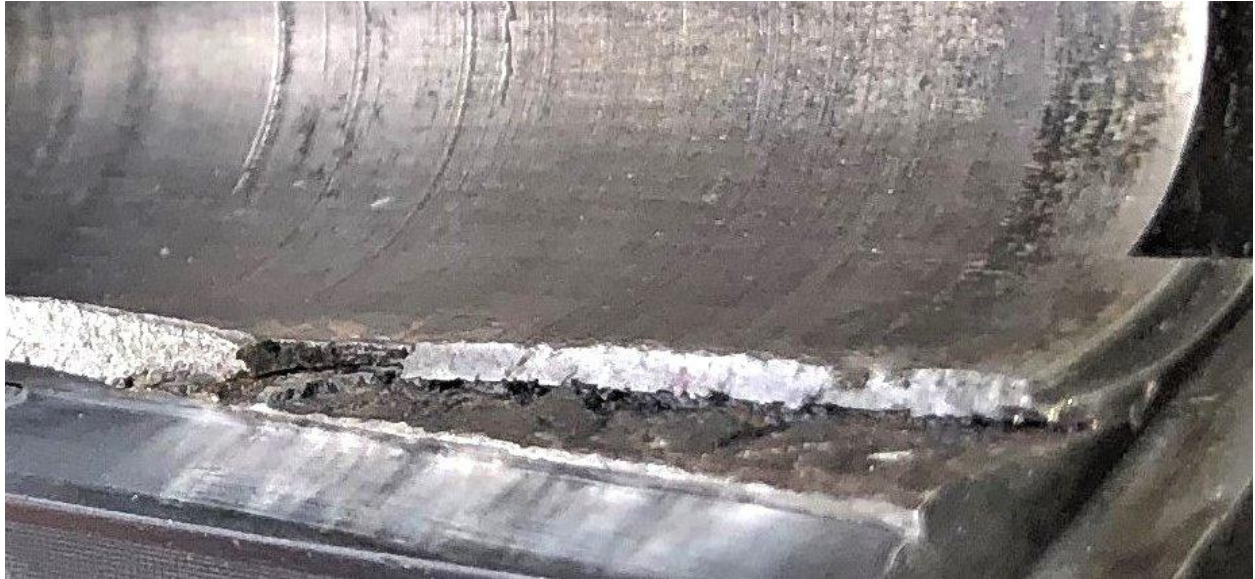
It was initially proposed that the failure initiation point was the dark divot shown here, with failure of or defect in the braze joint + the now unsupported thin wall +/- a flaw (?inclusion) at that point; with the gasses being vented superiorly

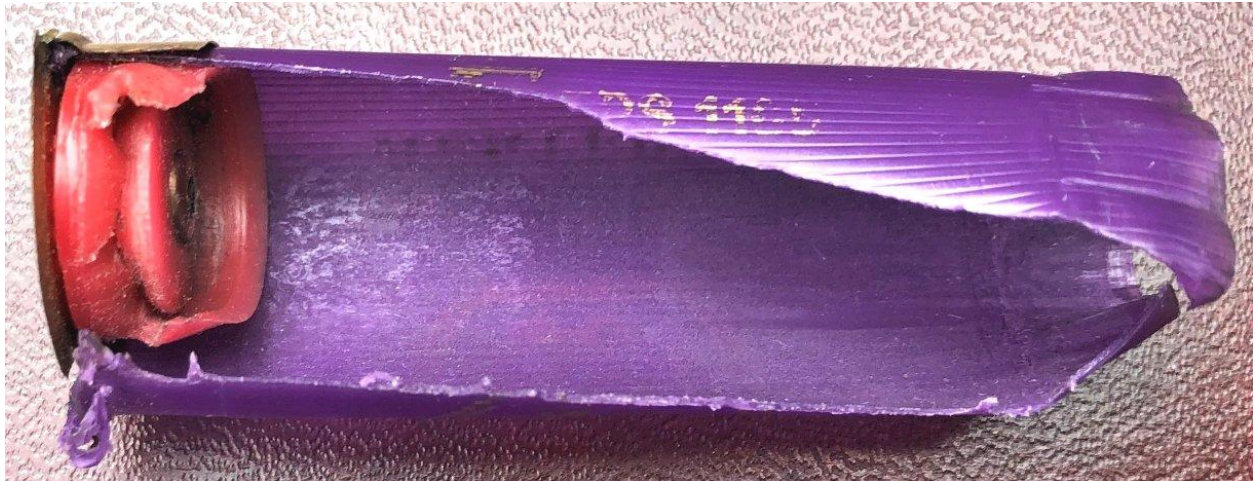
The shell used in the burst chamber. Clearly the Cheddite hulls have a separate plastic base wad, part of which is missing. The brass base has fractured and a section of the base and hull are missing.

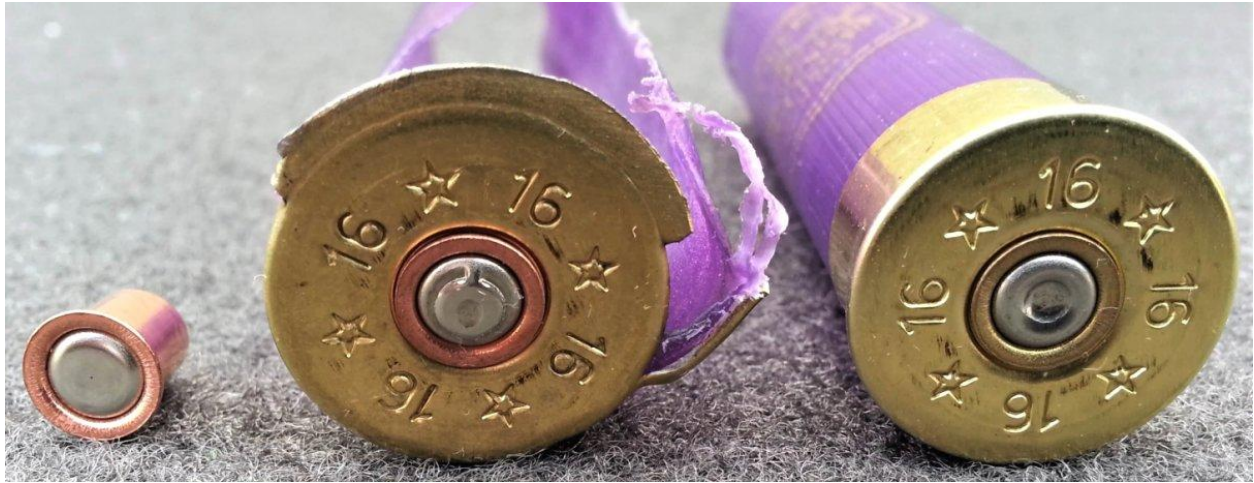
**The burst shell IS A RELOAD** with a Cheddite Clerinox 209 primer. The primer has been displaced out of the pocket, is bulging outward, and the (partial) base of the shell has a distinct extractor indentation.

Clerinox primer on left, burst shell, factory Cheddite/Herters on right

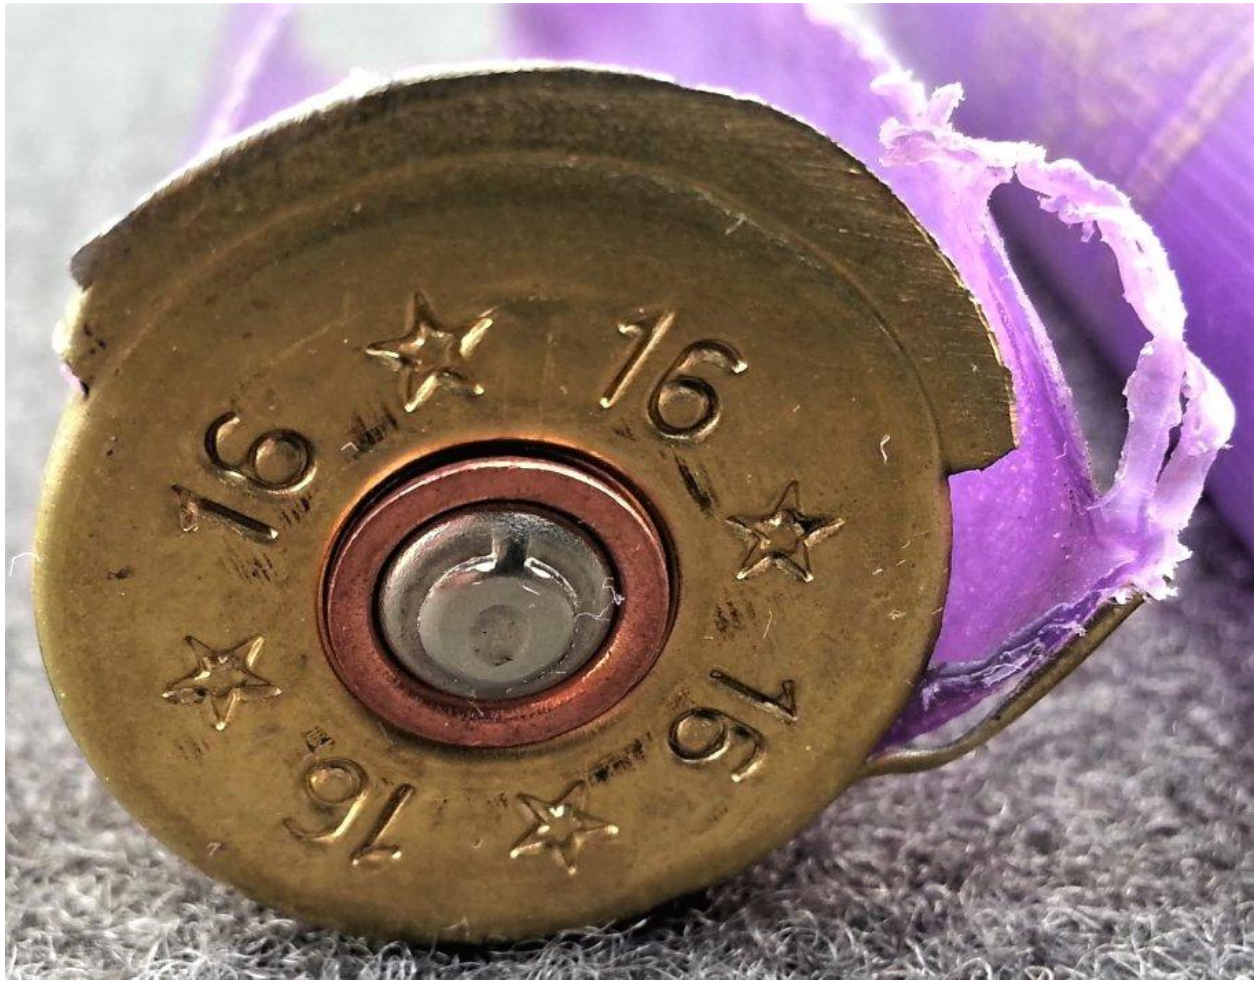
Fractured and flattened rim

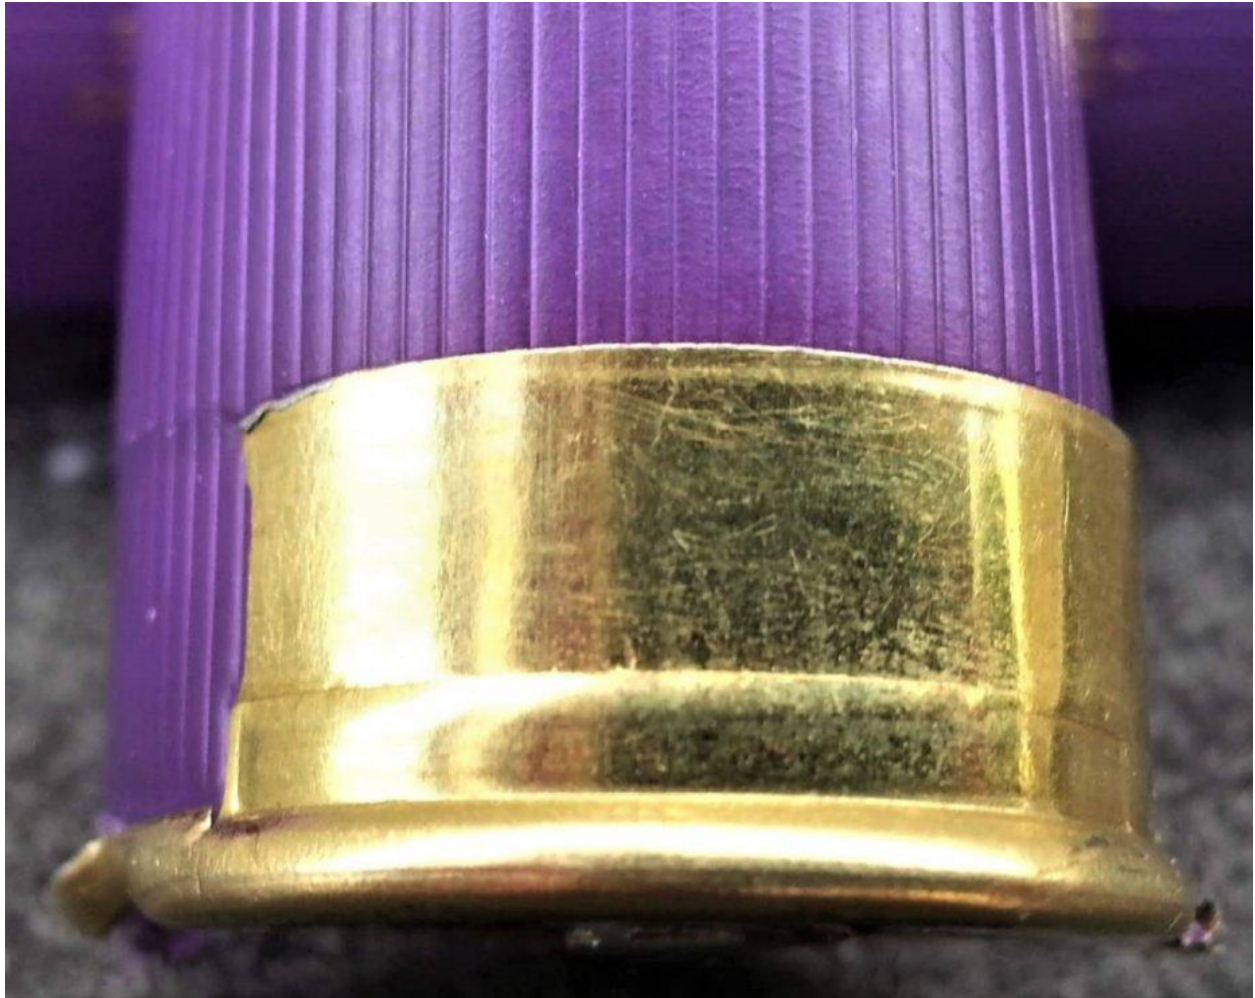
Extractor imprint

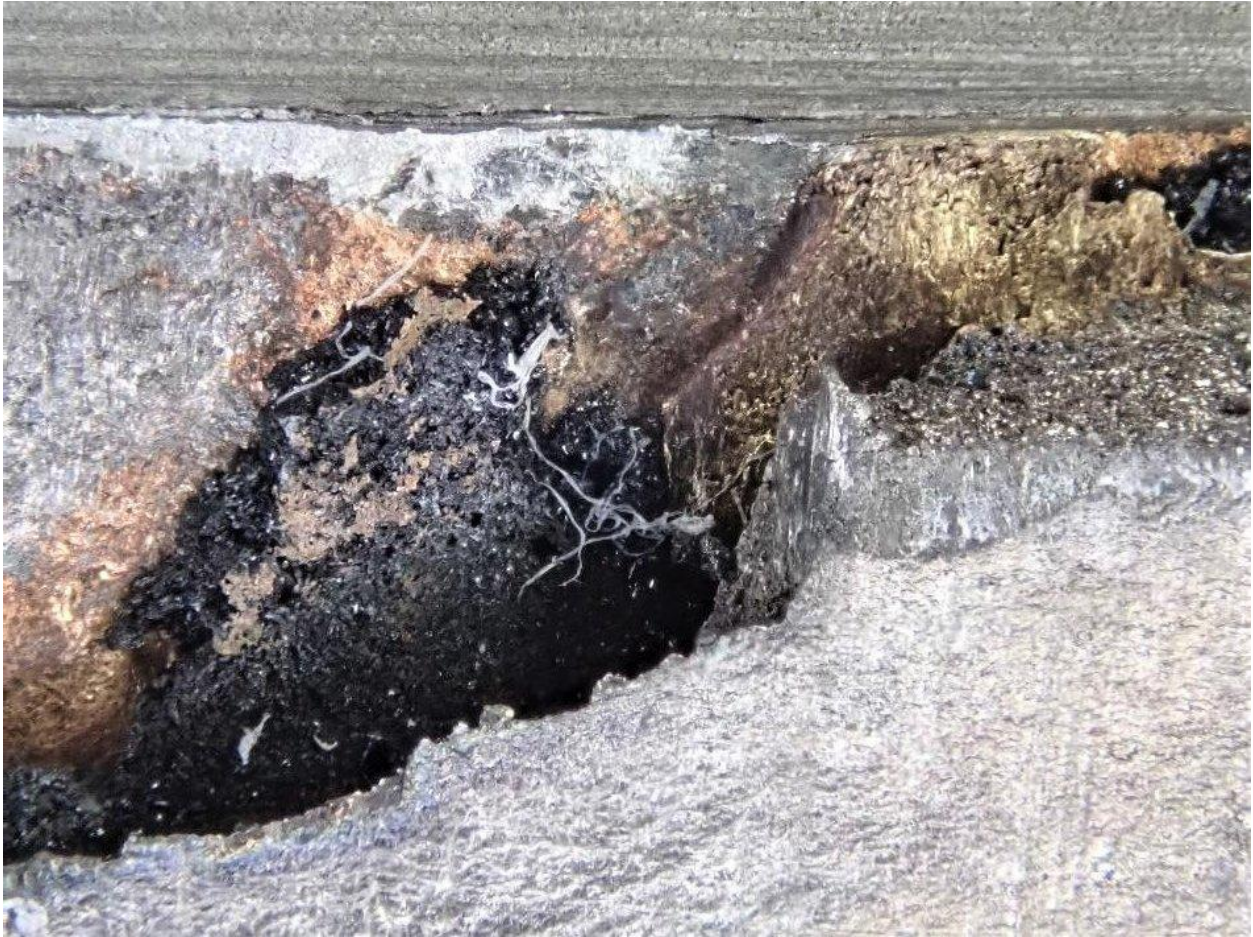
**The initiation point**

Rib extension wedge above

Below left to right: porous steel - black contamination/corrosion (metal oxides - iron and filler material) - gold braze - porous steel

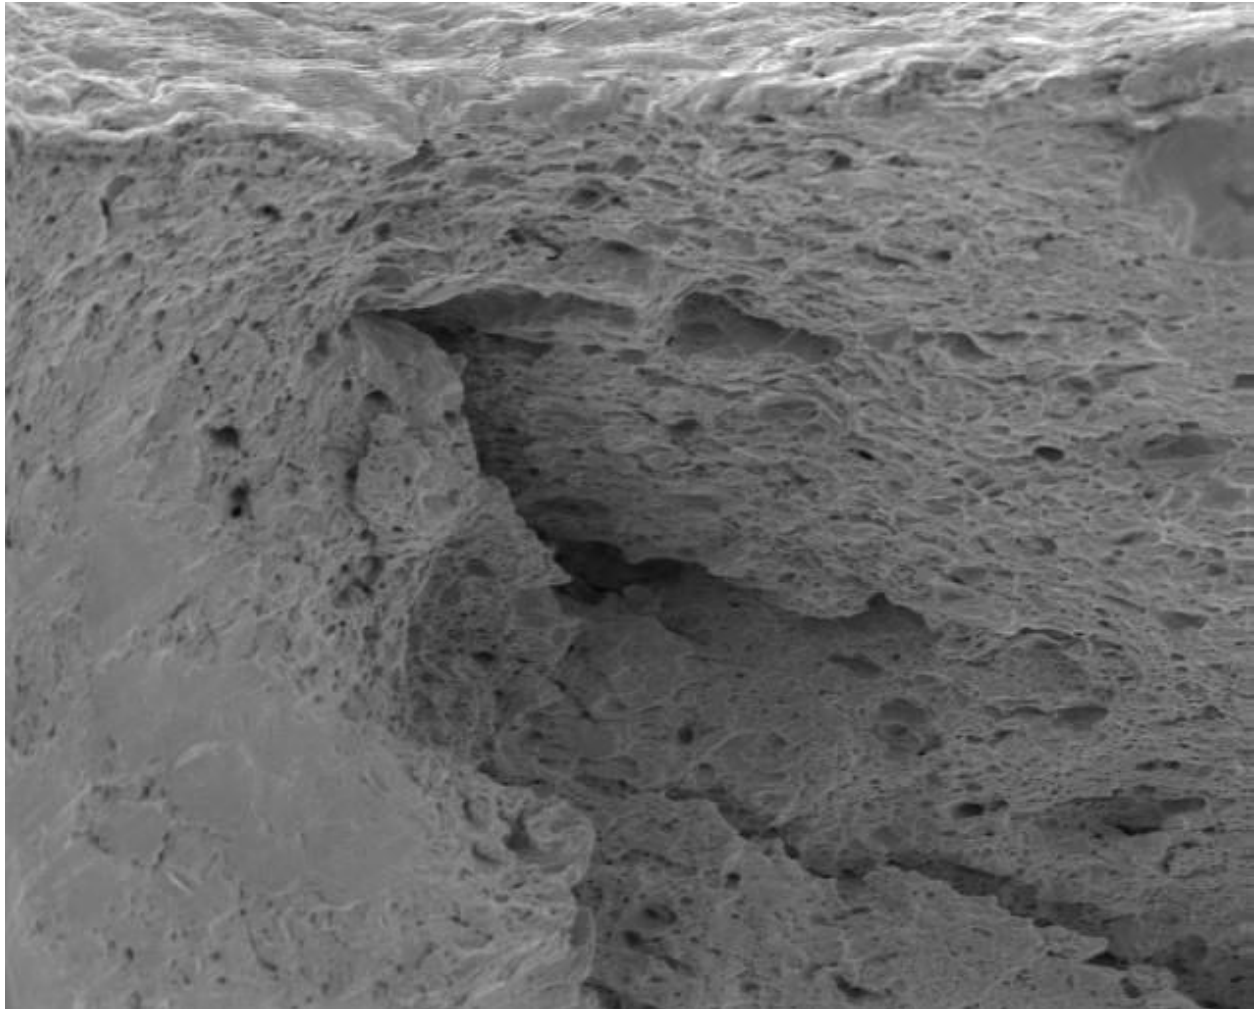
Initiation point cavity with cleavage and voids.  
**No low cycle fatigue “beach marks” (striations).**

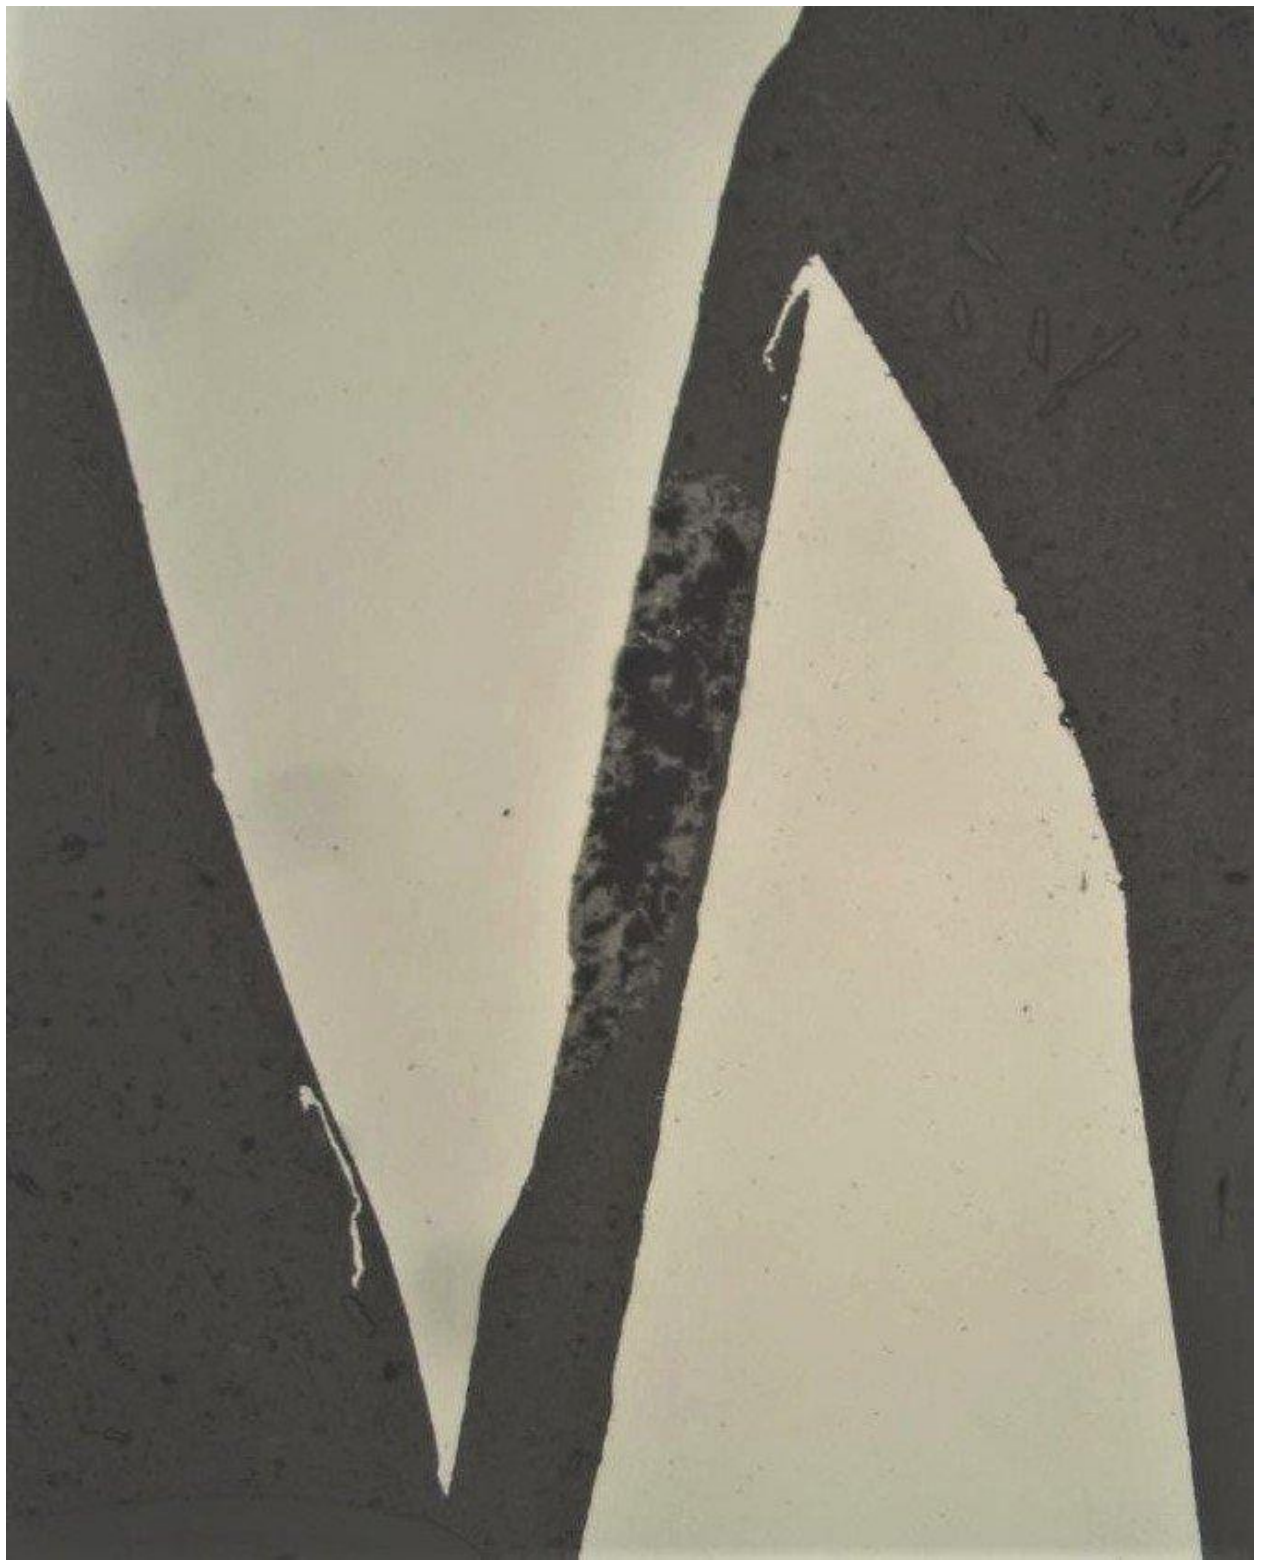
Bad braze with oxidized ferrous debris

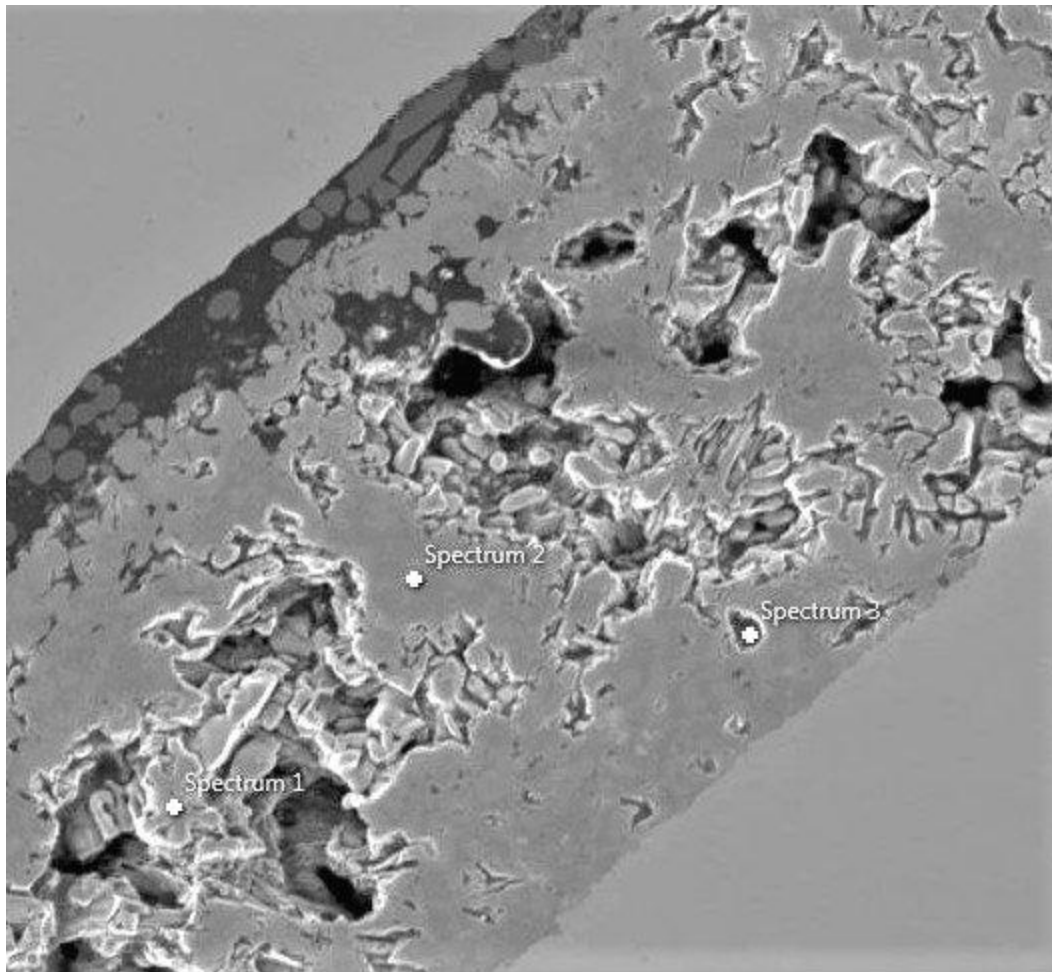
“Contamination” region at 150X with inclusions; primarily ferrous oxidized debris

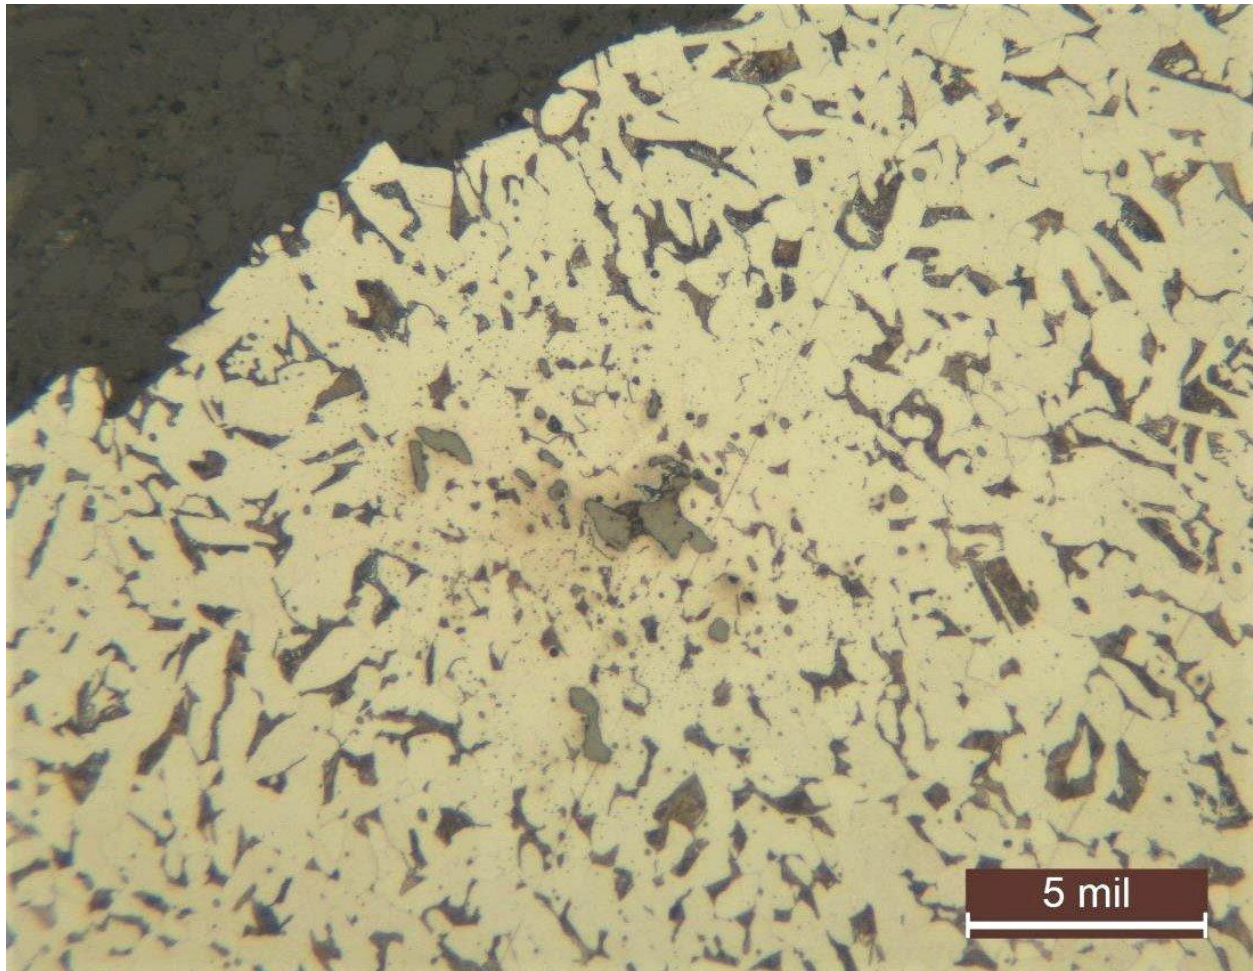
200X of the contamination region (upper left) - oxidized steel (likely over-heated)  
with extensive manganese sulfide inclusions

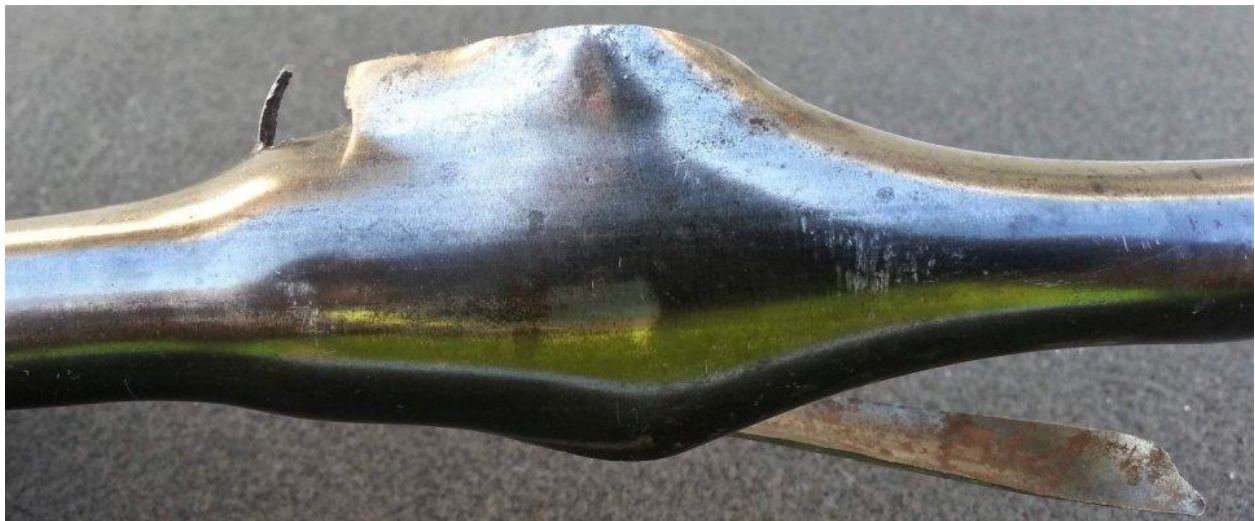
Ring bulge
