Burlington School District Attn. Lyall Smith, Director of Facilities
150 Colchester Road, Burlington, VT, 05401

March 28, 2025

Clerk of the Works Site Visit Report - IAA H.O. Wheeler Elementary School Project

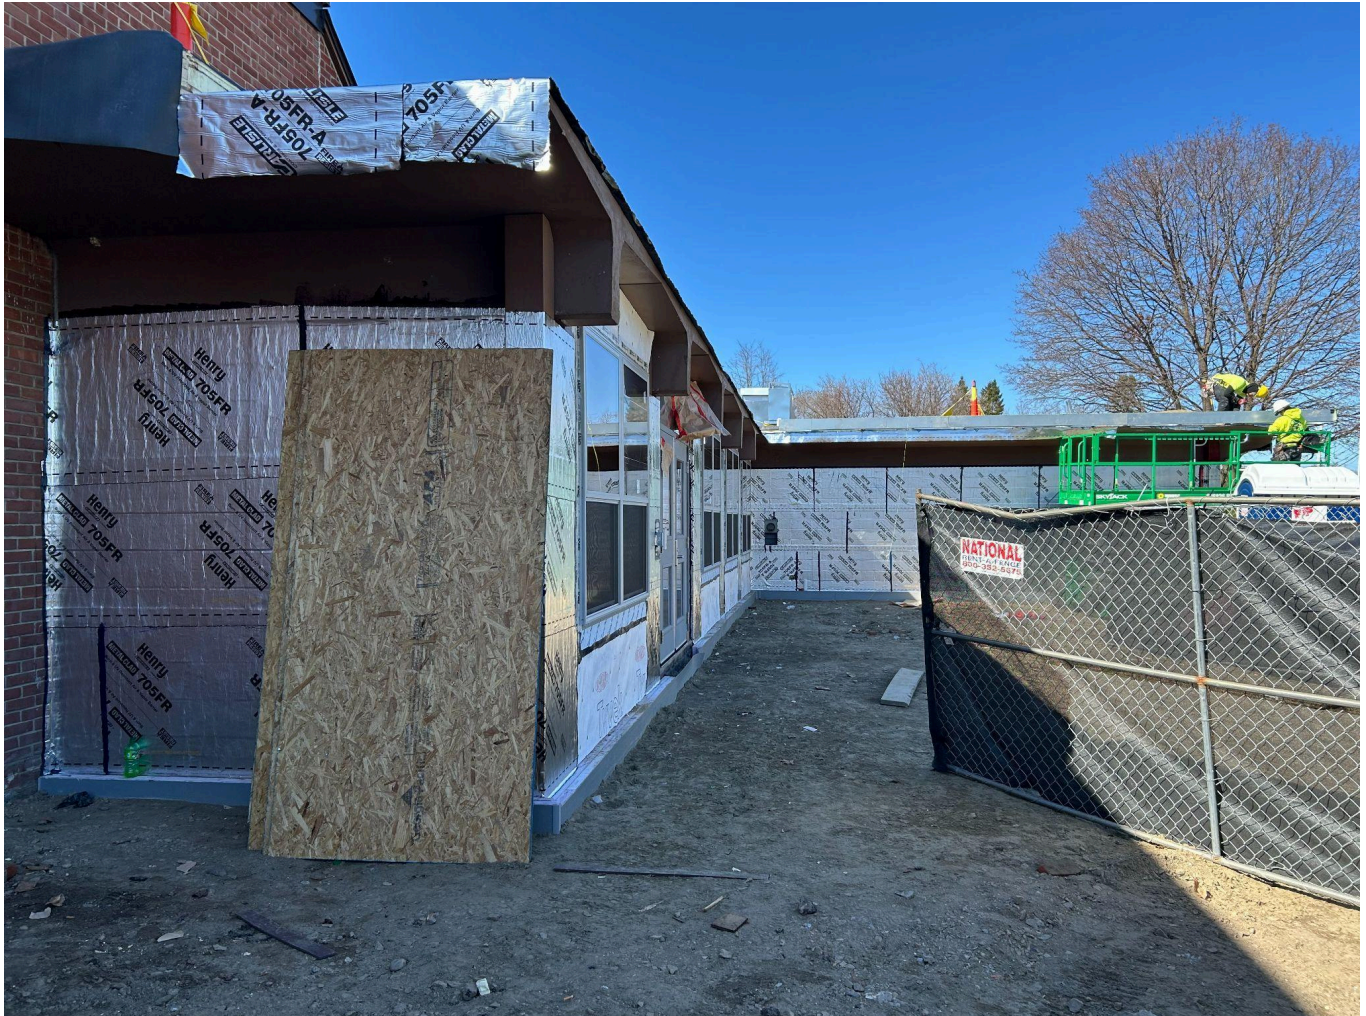
The exterior of the building getting the vapor barrier installed along with working on updating the roof edge on the Walnut Street side of the 1965 wing of the building.

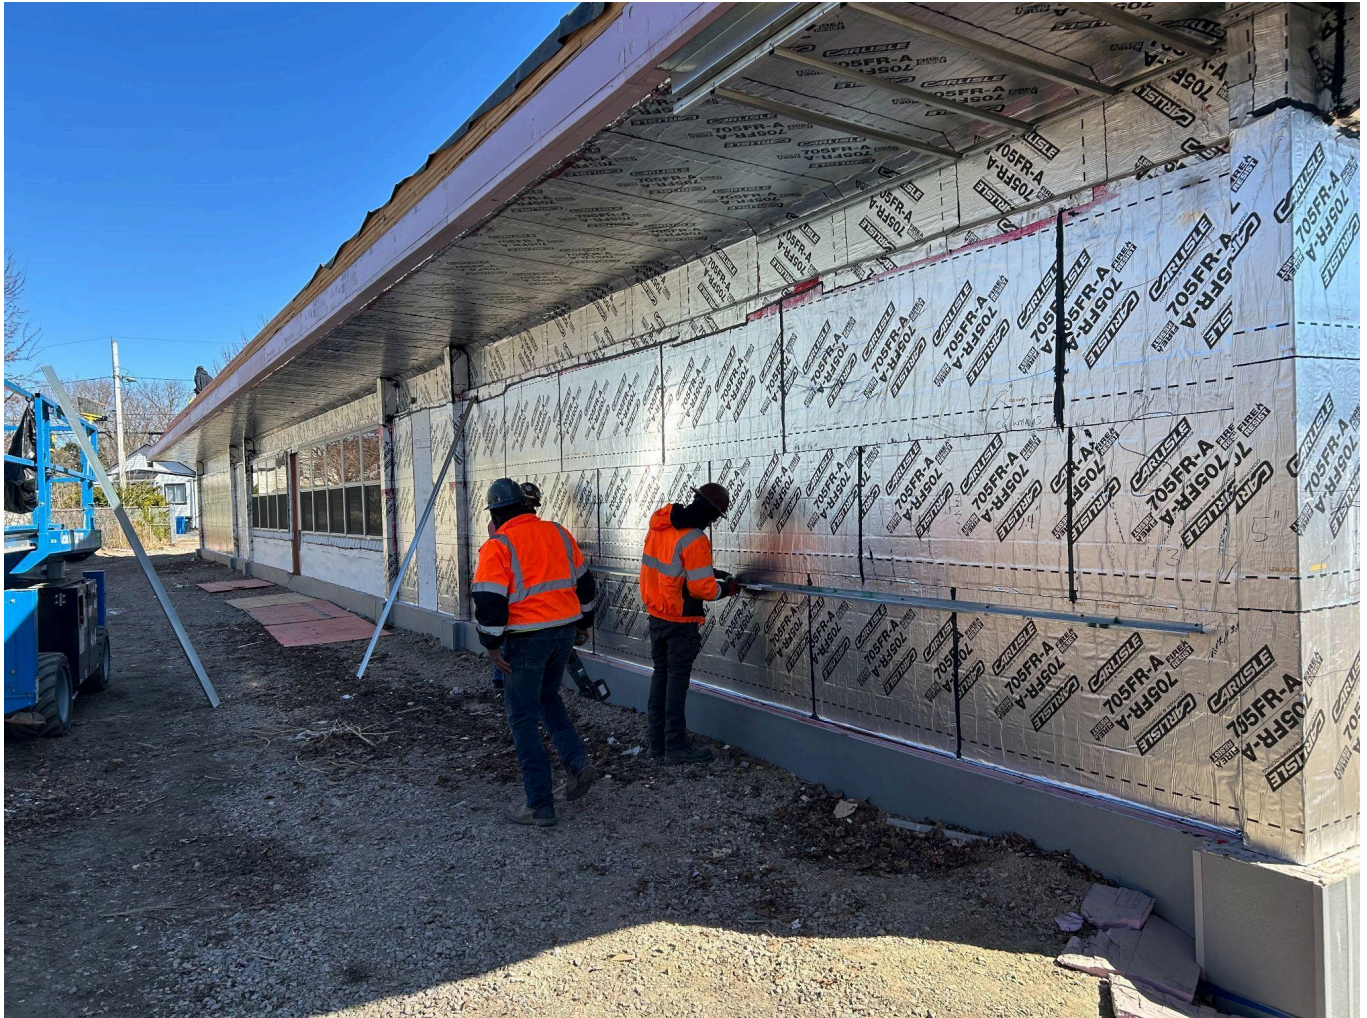
The North side of the 1965 wing of the building has received the vapor barrier and the new roof edge.

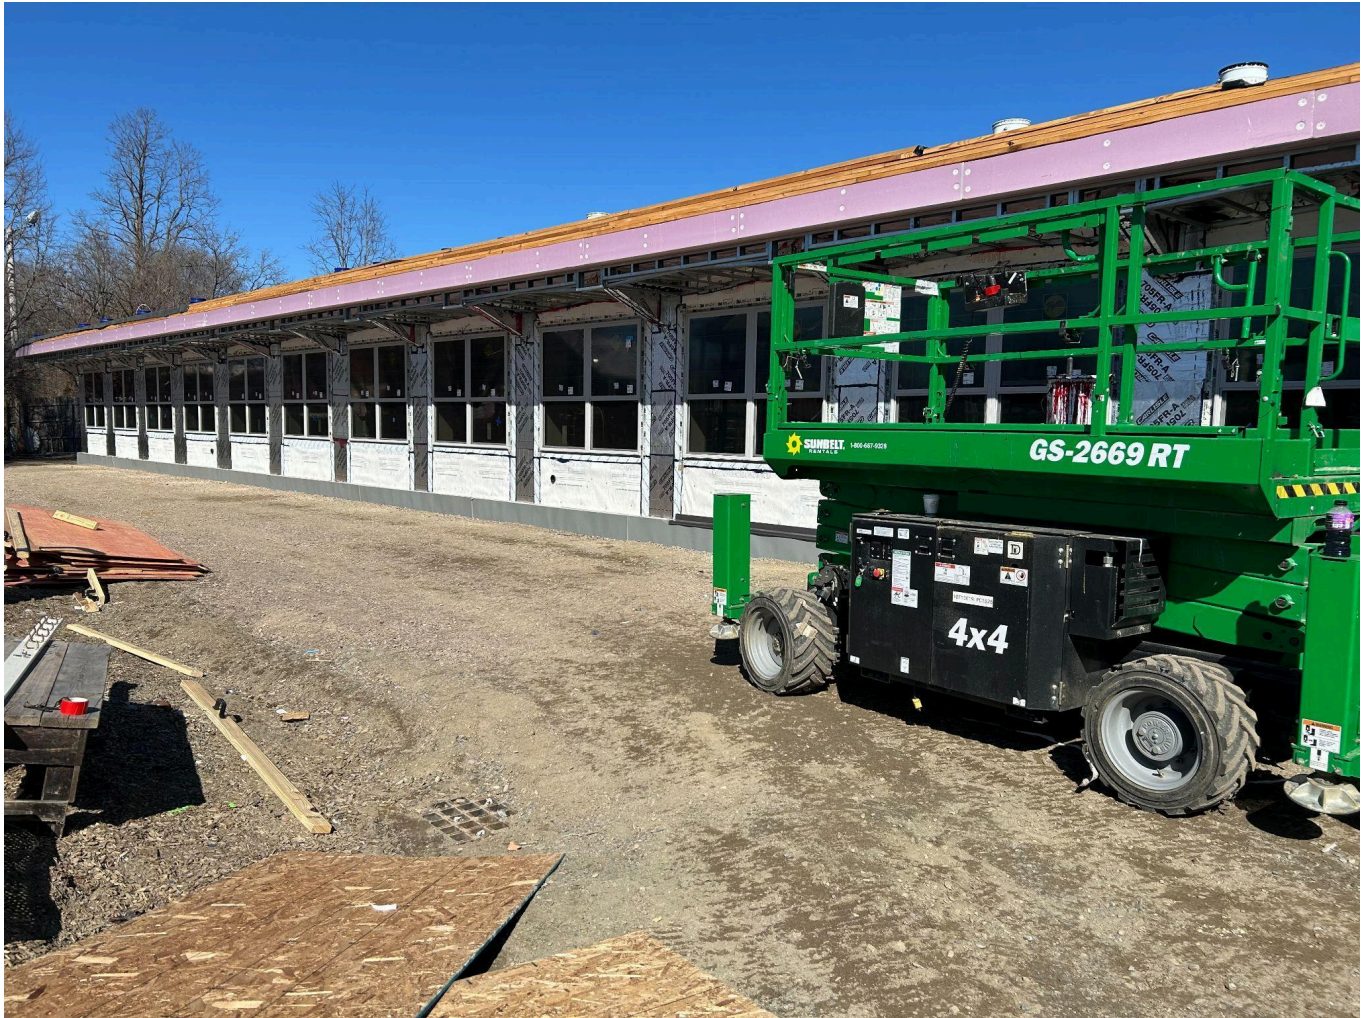
Installation is complete with not only the new windows, but the vapor barrier, roof edge update and the support structure of the soffits. This is on the Spring Street side of the building.

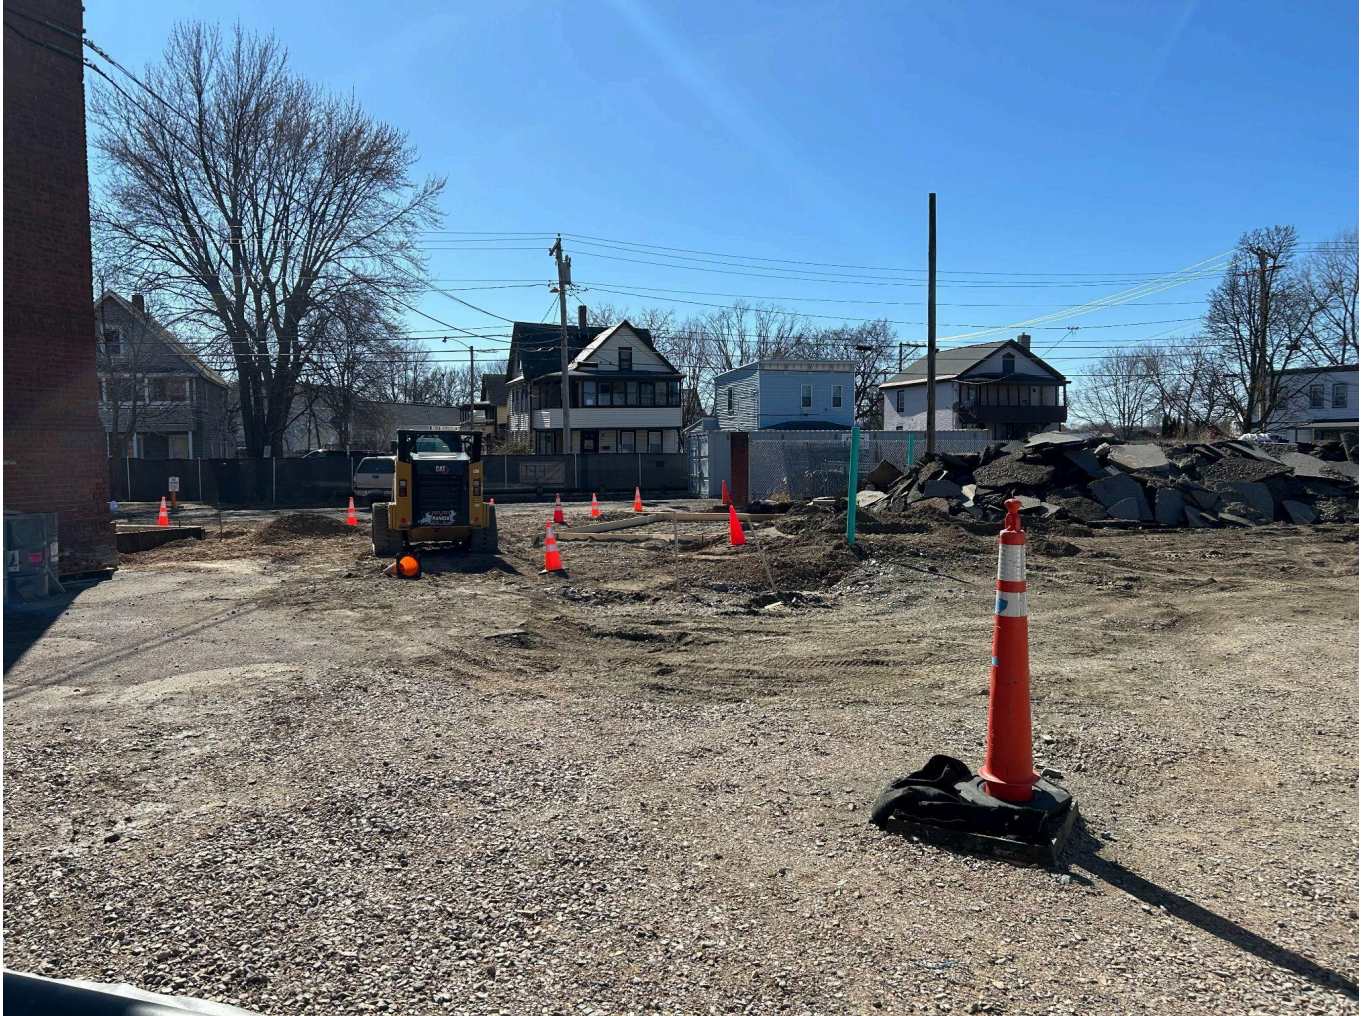
Manosh, the site contractor is back and has removed the old asphalt parking lot. They are getting ready for the new concrete dumpster pad.

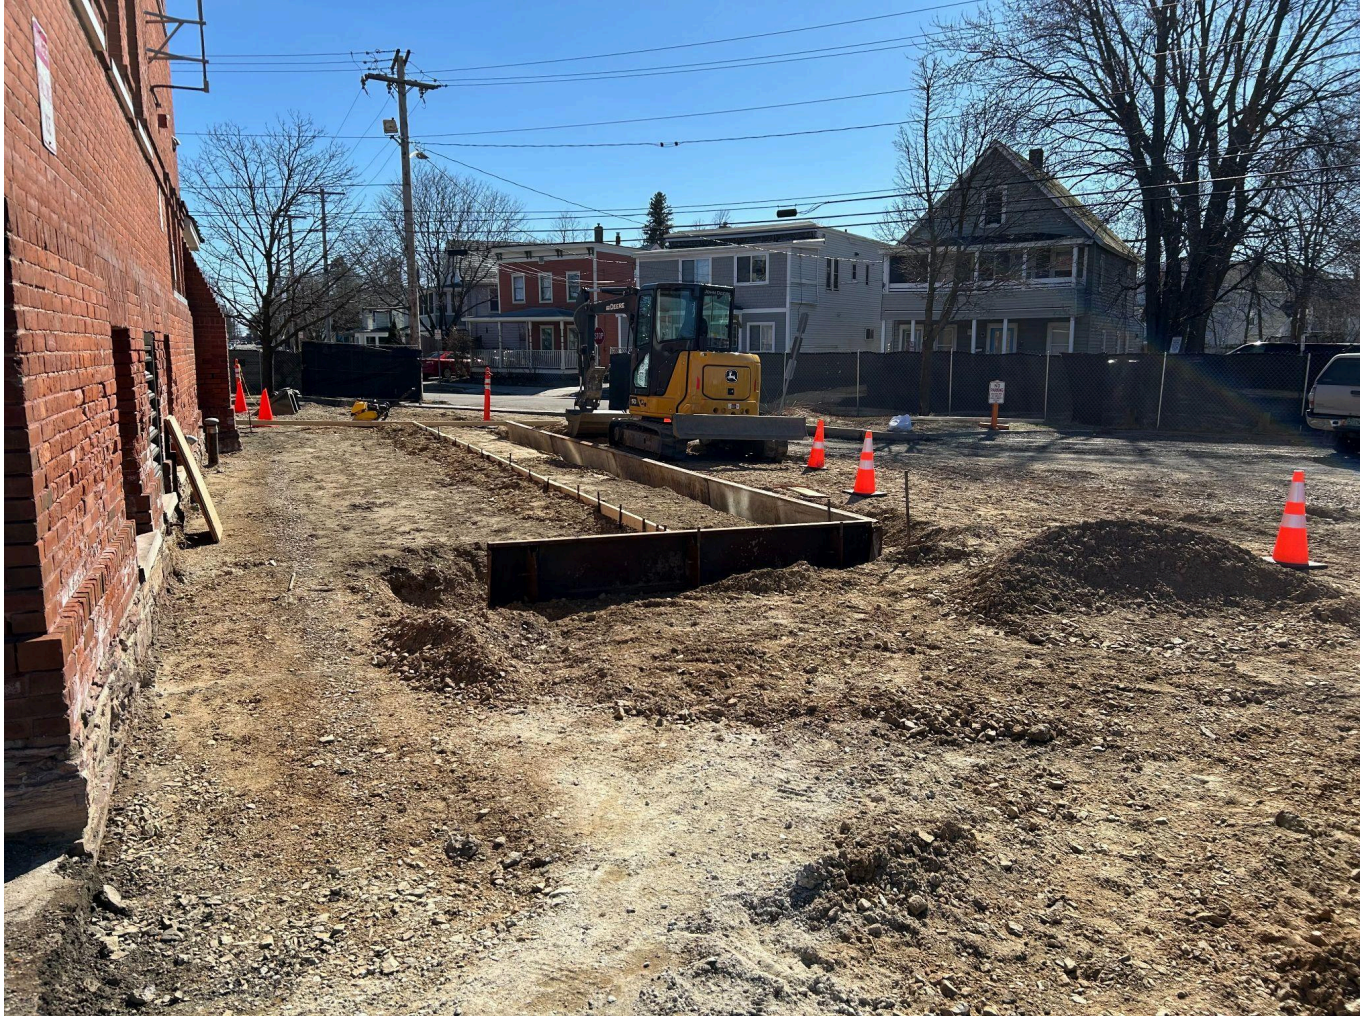
Manosh, the site contractor is back and has removed the old asphalt parking lot. They are getting ready for the installation of the new sidewalk, on the Spring Street side of the building.

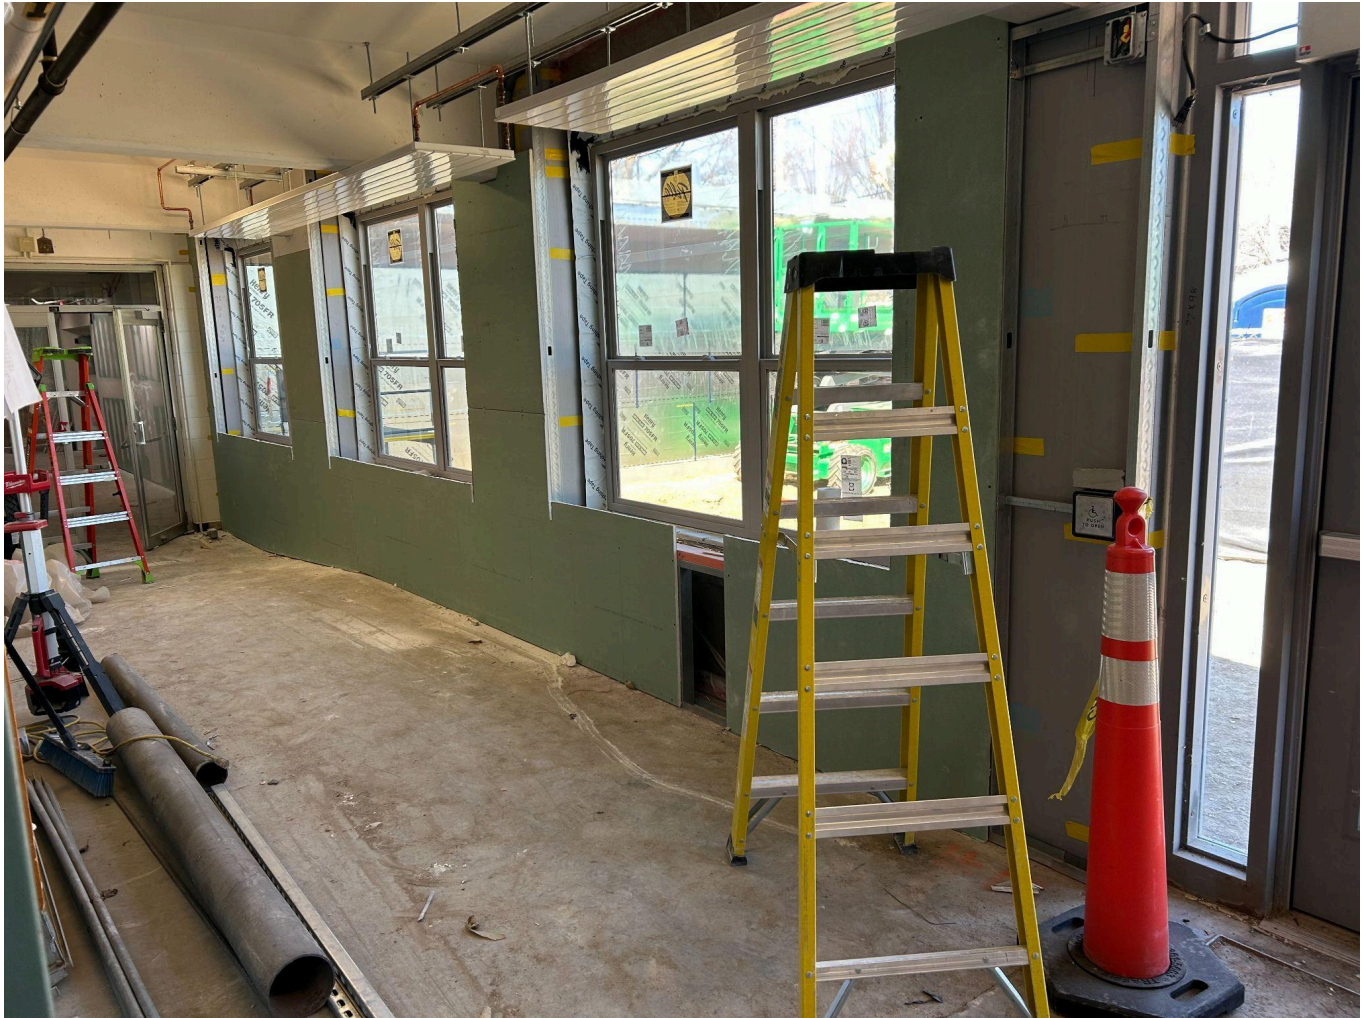
The Window Installer, Burlington Glass has installed the windows in the corridor that goes from the GYM to the 1965 wing of the building on the Walnut Street side of the building.

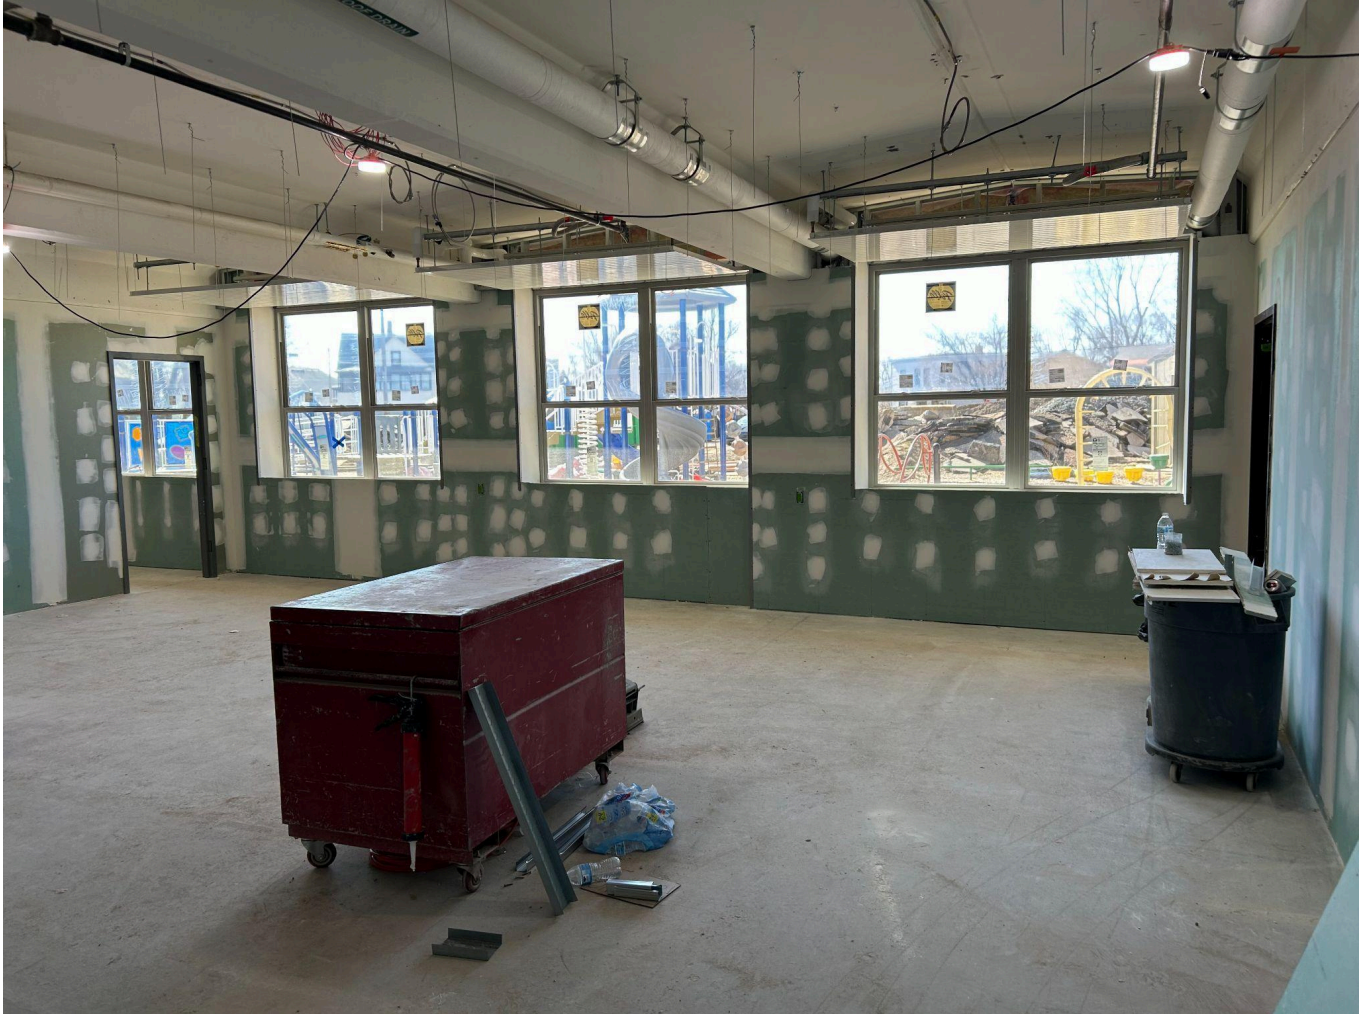
Windows are complete, along with mudding the sheetrock seams in the classrooms on the Spring Street side of the building.

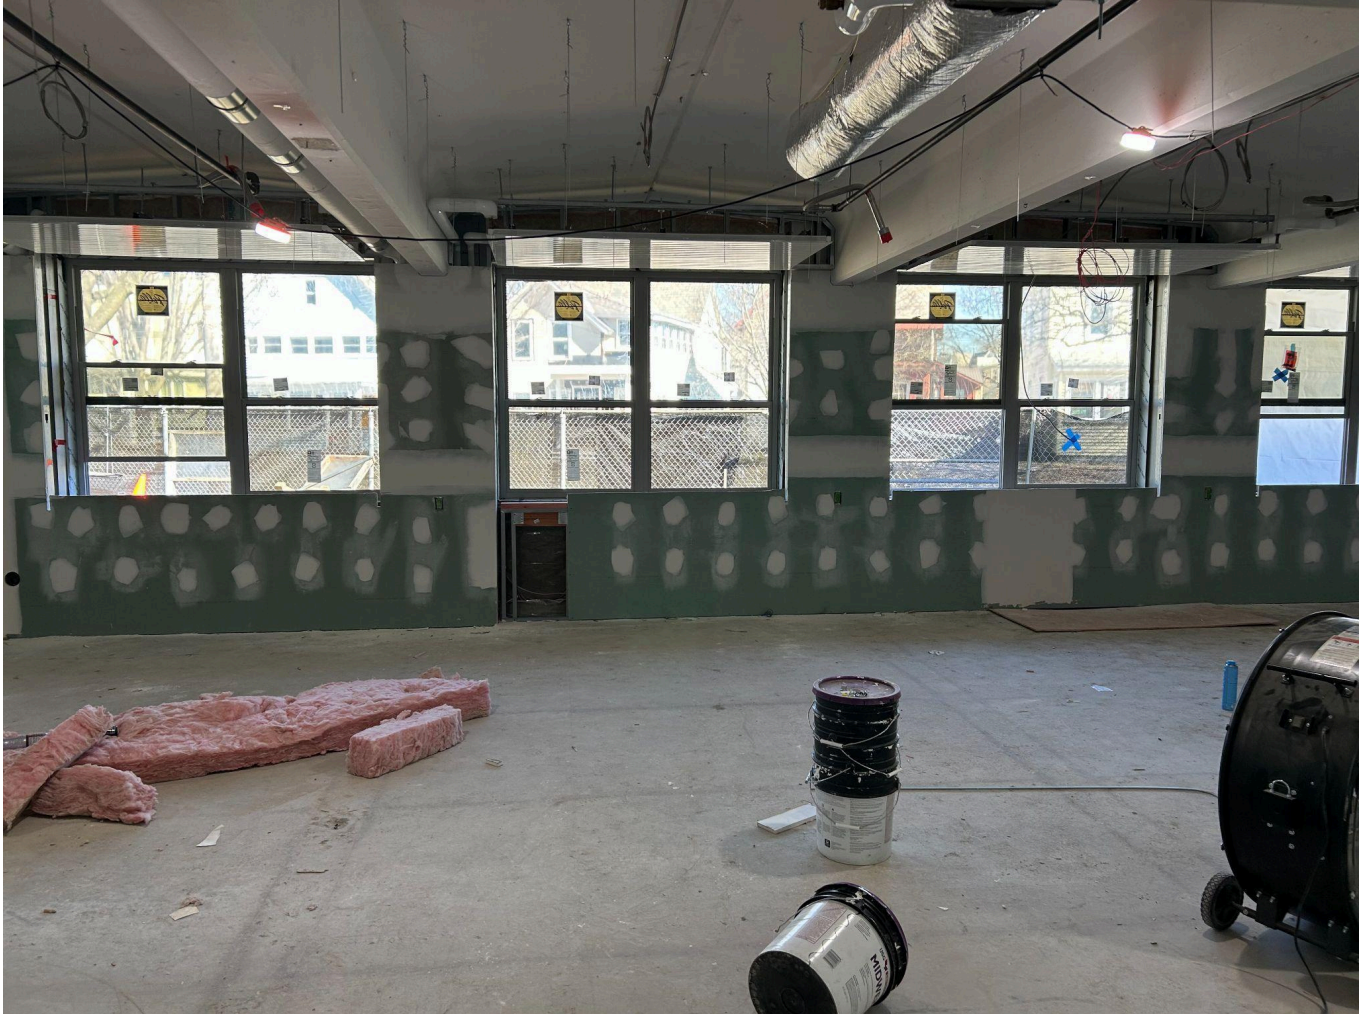
Windows are complete, along with mudding the sheetrock seams in the classrooms on the Walnut Street side of the building.

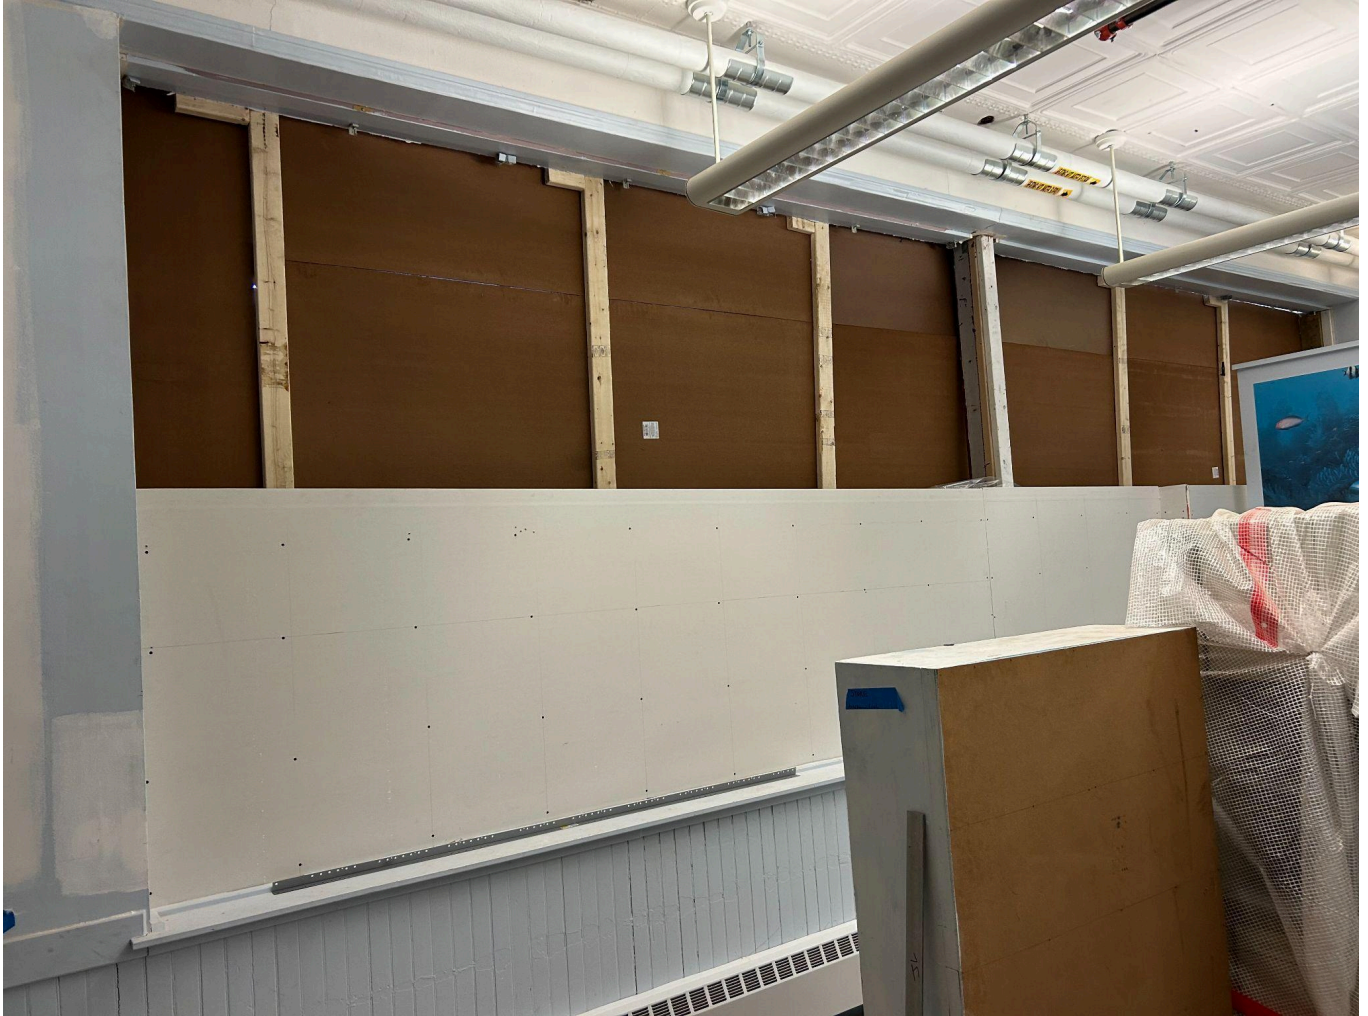
The Windows in the Dental Suite and Nurses Office will be changed out as well. This is showing the removal of the old windows, along with the new framing that is associated for the new windows.

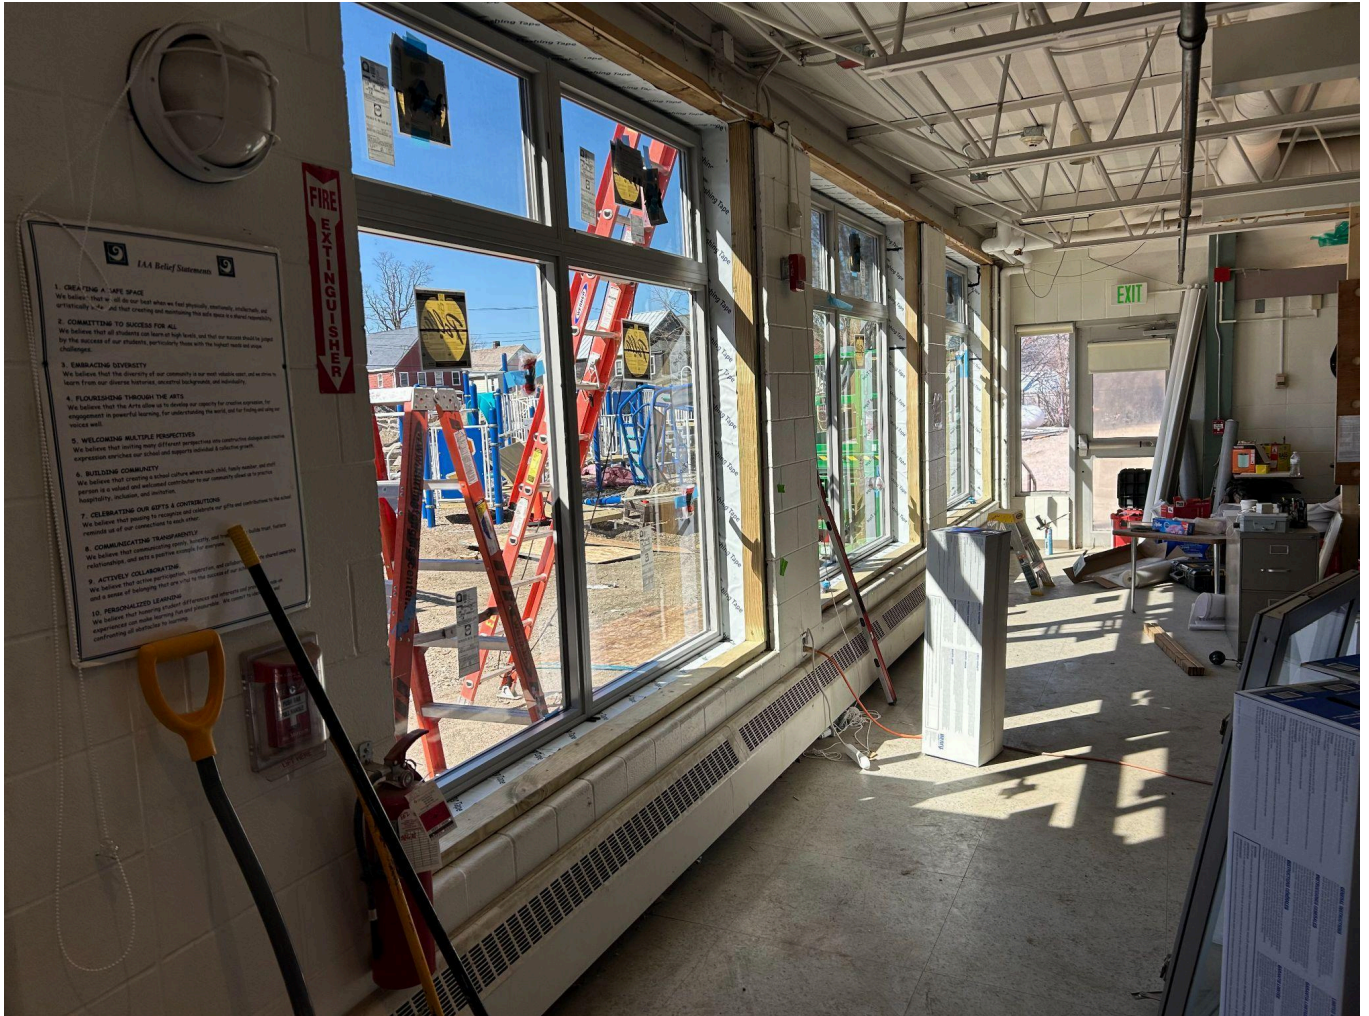
Even the windows in the cafeteria are being changed to the updated, more energy efficient windows.

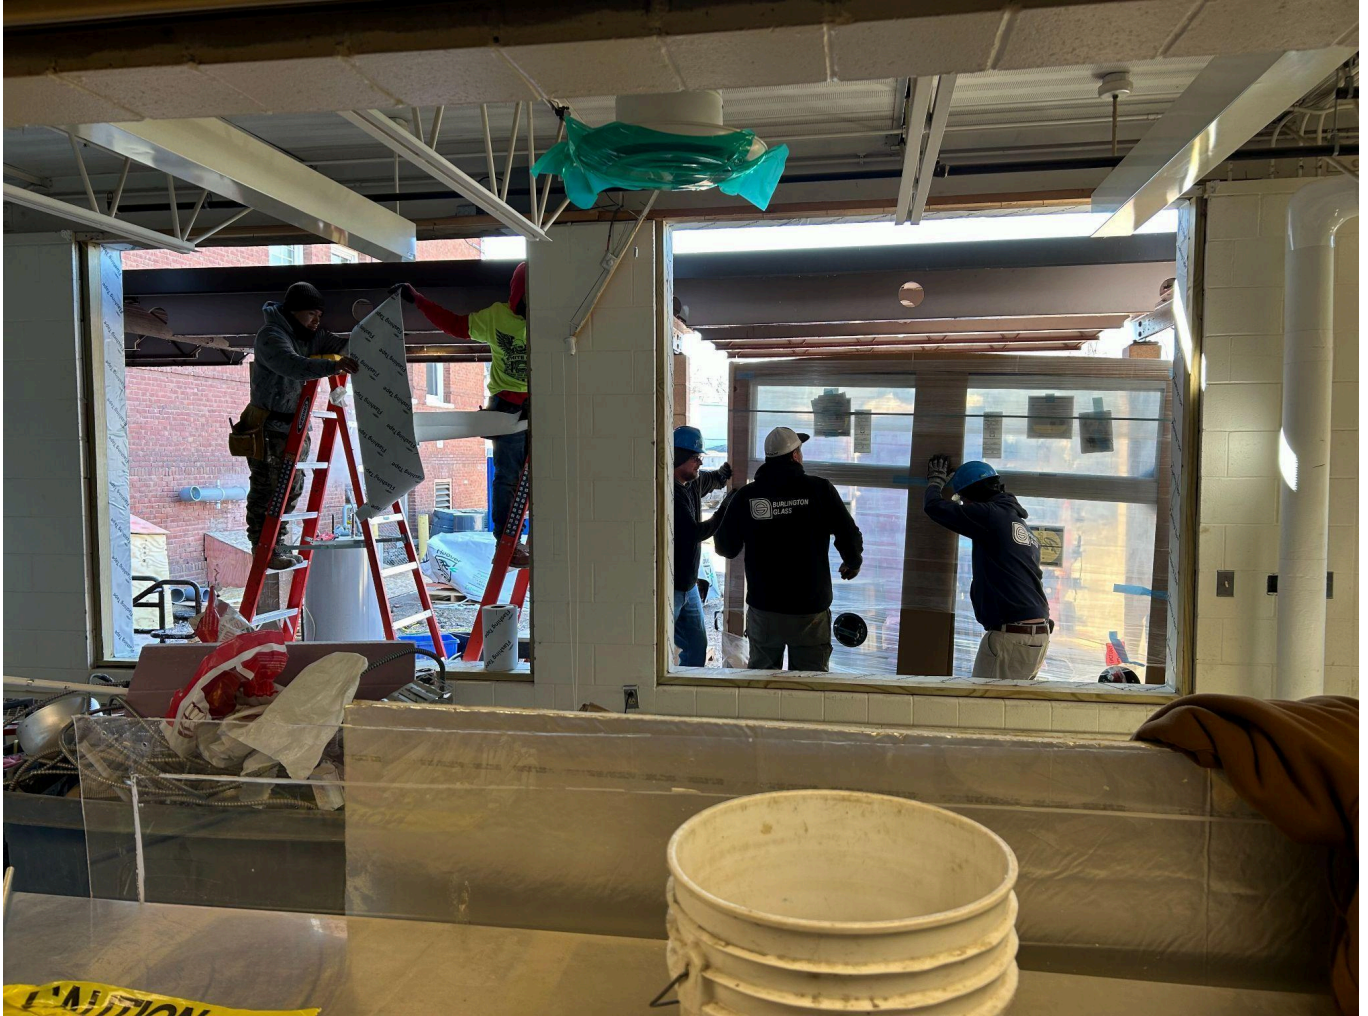
Out with the old and in with the new. Burlington Glass workers are shown installing the new energy efficient windows, while workers prep the existing window (on the left side) opening for the new windows in the cafeteria.

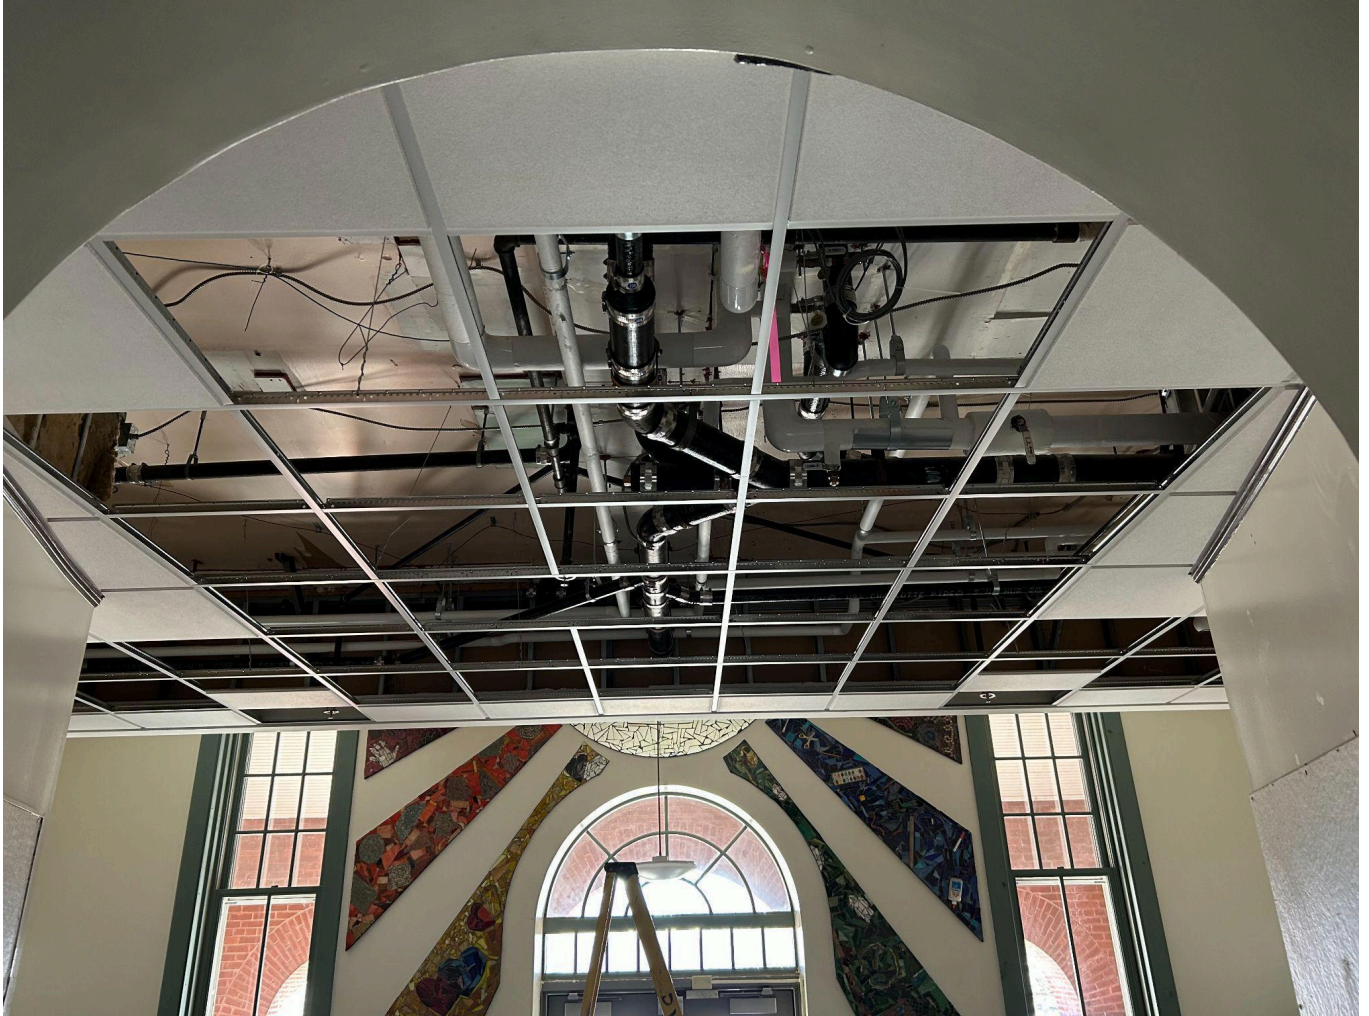
The Framing Contractor has framed up the new ceiling grid in the front Lobby in the 1904 wing of the building.

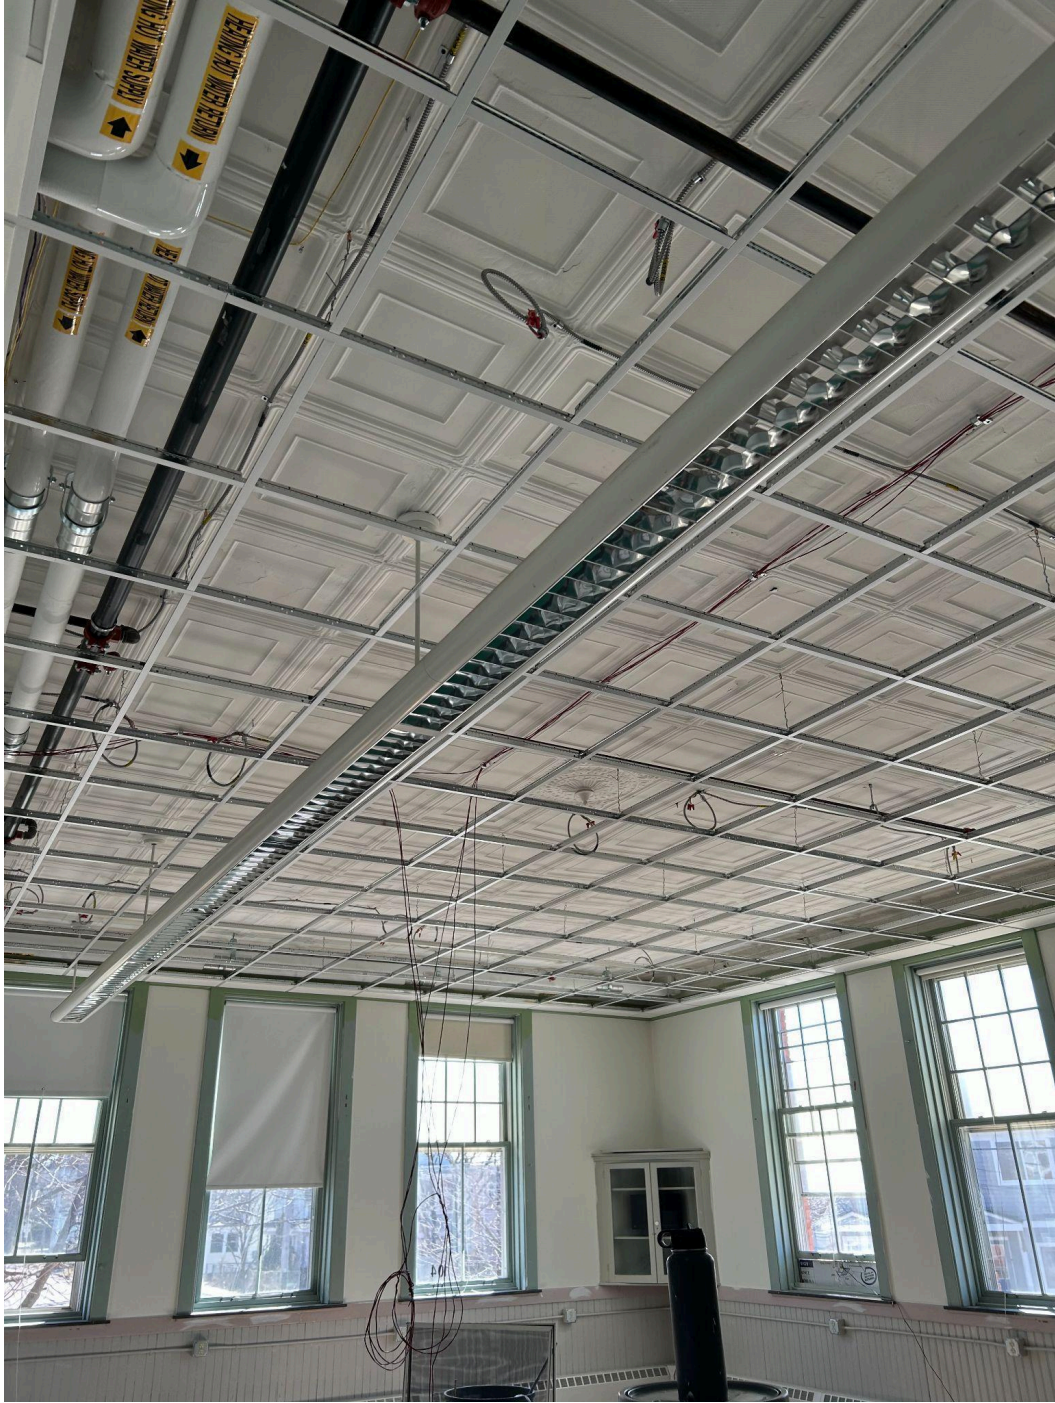
The Framing Contractor has finished the installation of the ceiling grid on the first floor in the 1904 wing of the building.

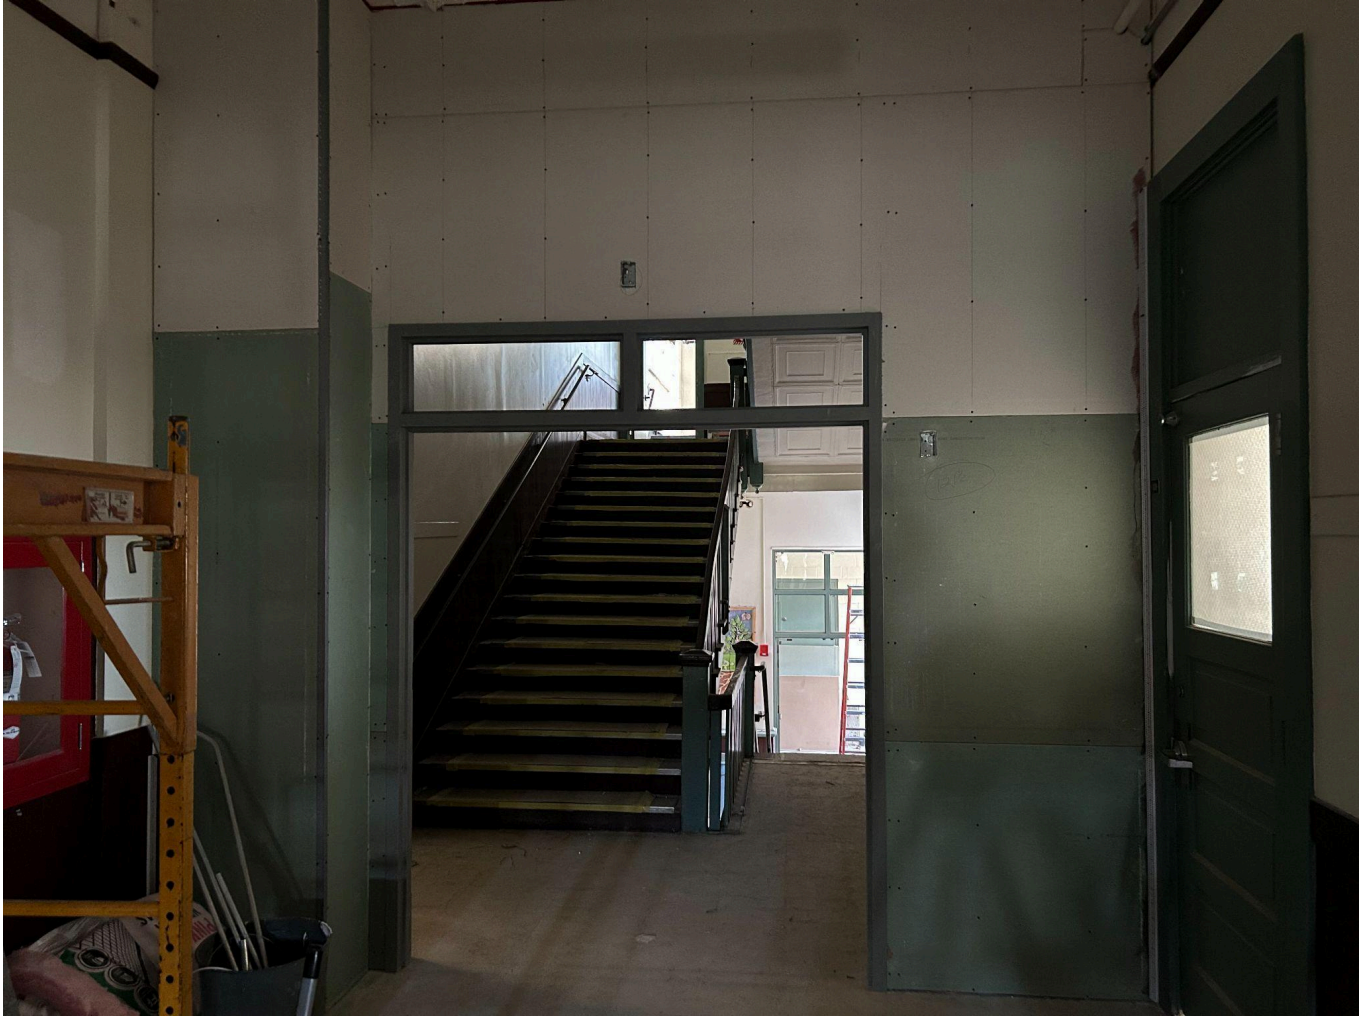
The Framing Contractor has installed the sheetrock on the wall framing the new doorway on the First Floor in the 1904 wing of the building.

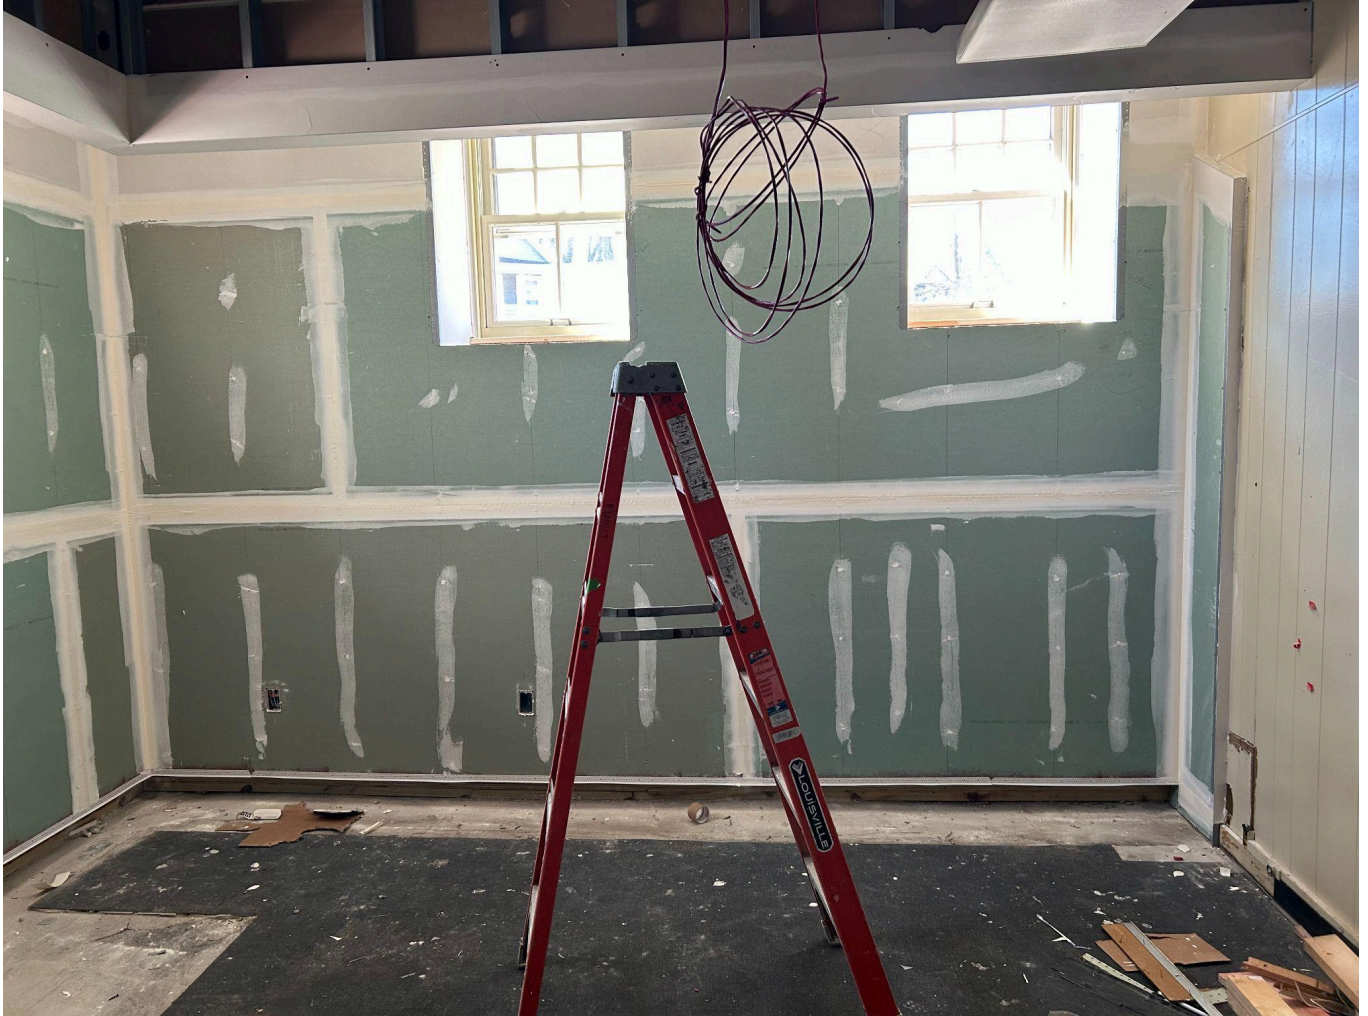
The Framing Contractor has finished the sheetrock and the tapers are starting the mudding process on the walls in the Basement in the 1904 wing of the building.

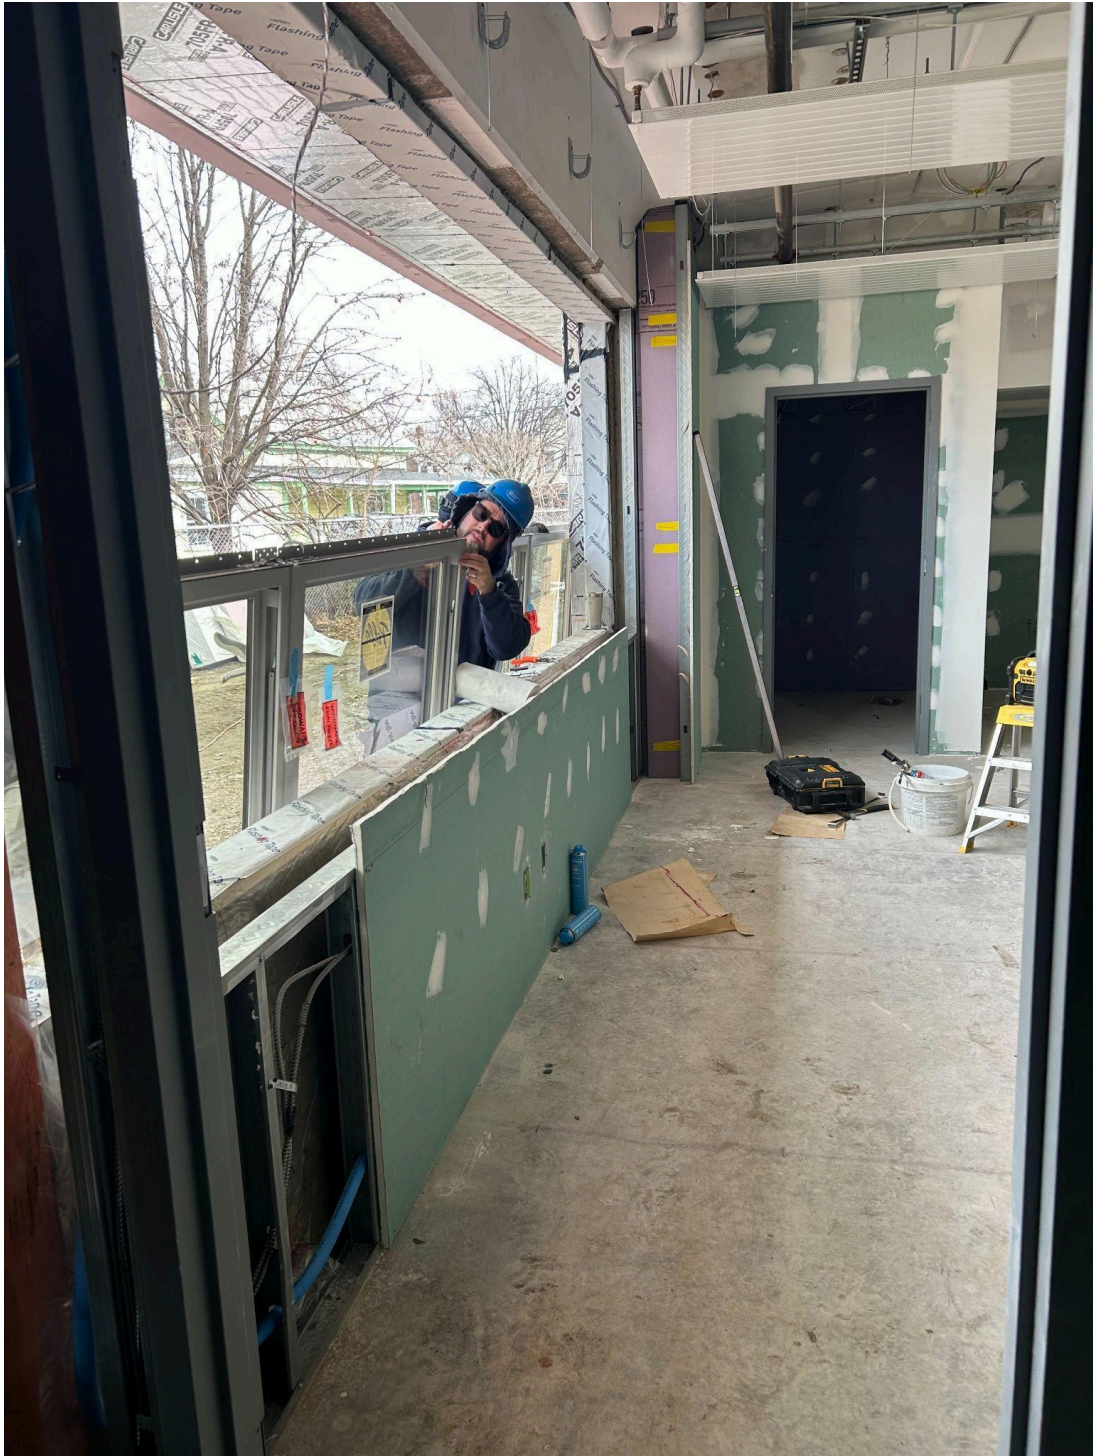
A Burlington Glass working prepping the window for installation in the classroom on the North Side of the building in the 1965 wing of the building.
