Burlington School District Attn. Lyall Smith, Director of Facilities
150 Colchester Road, Burlington, VT, 05401

March 28, 2025

Clerk of the Works Site Visit Report - IAA H.O. Wheeler Elementary School Project

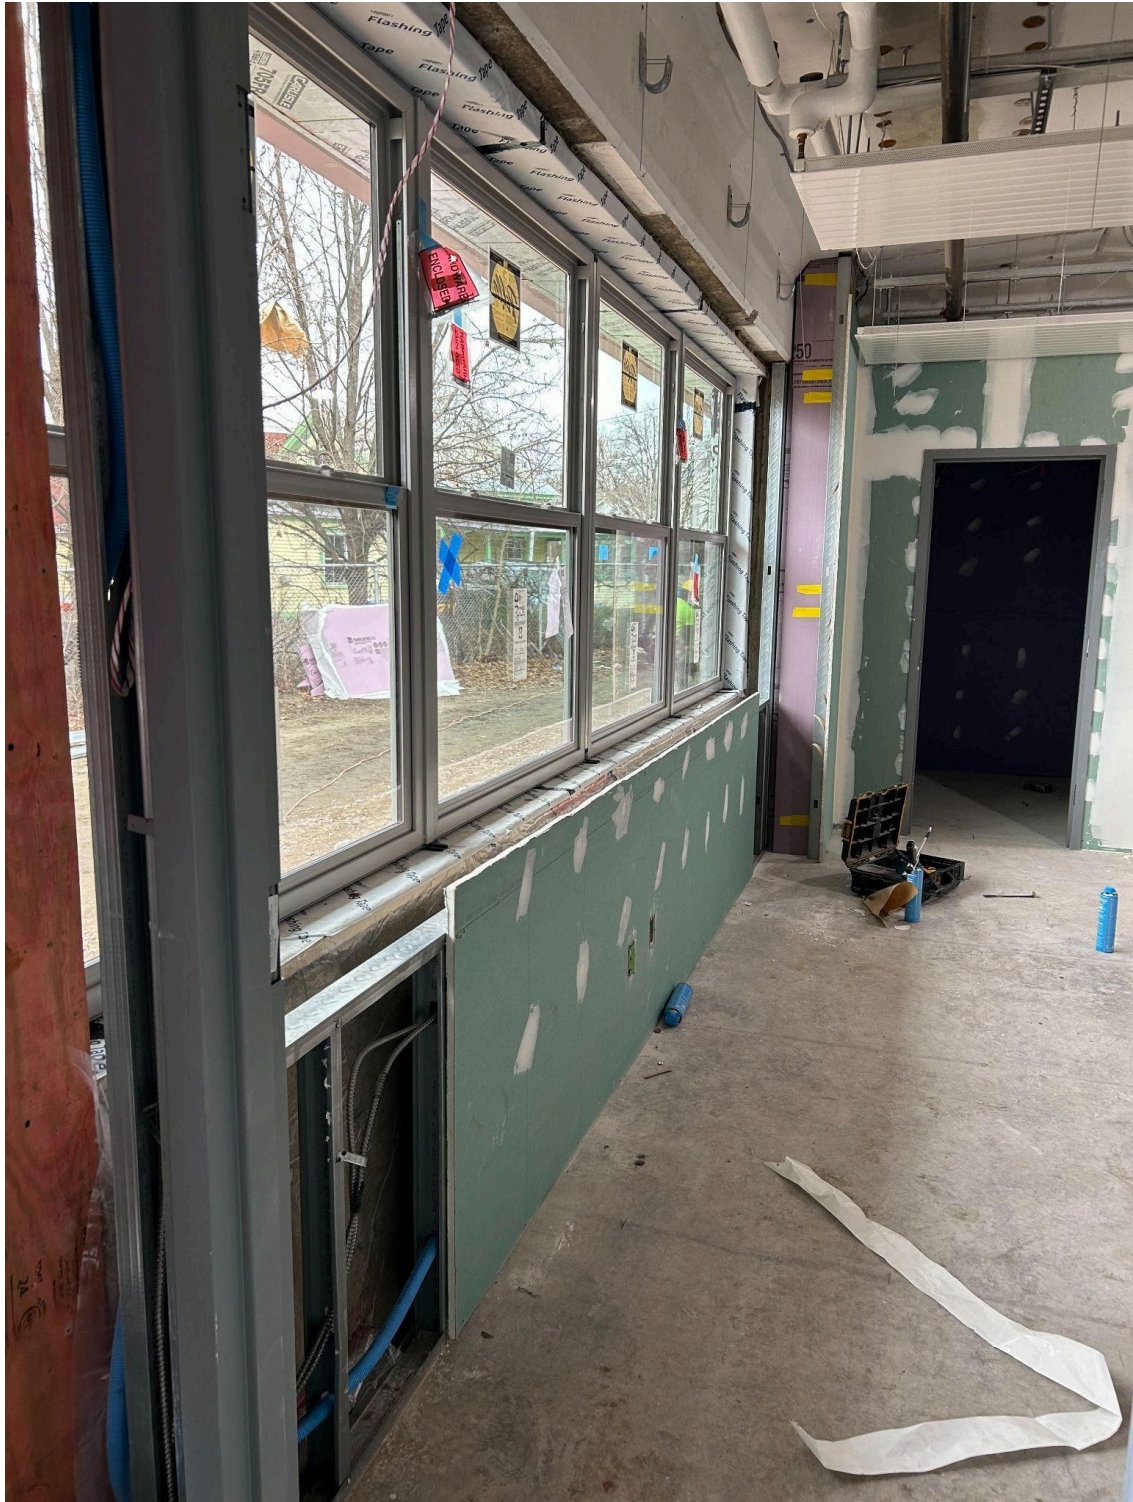
The finished look of the window installation in the classroom on the North Side of the building in the 1965 wing of the building.
