## N013: Happy send to Liverpool

## N014: Error problem

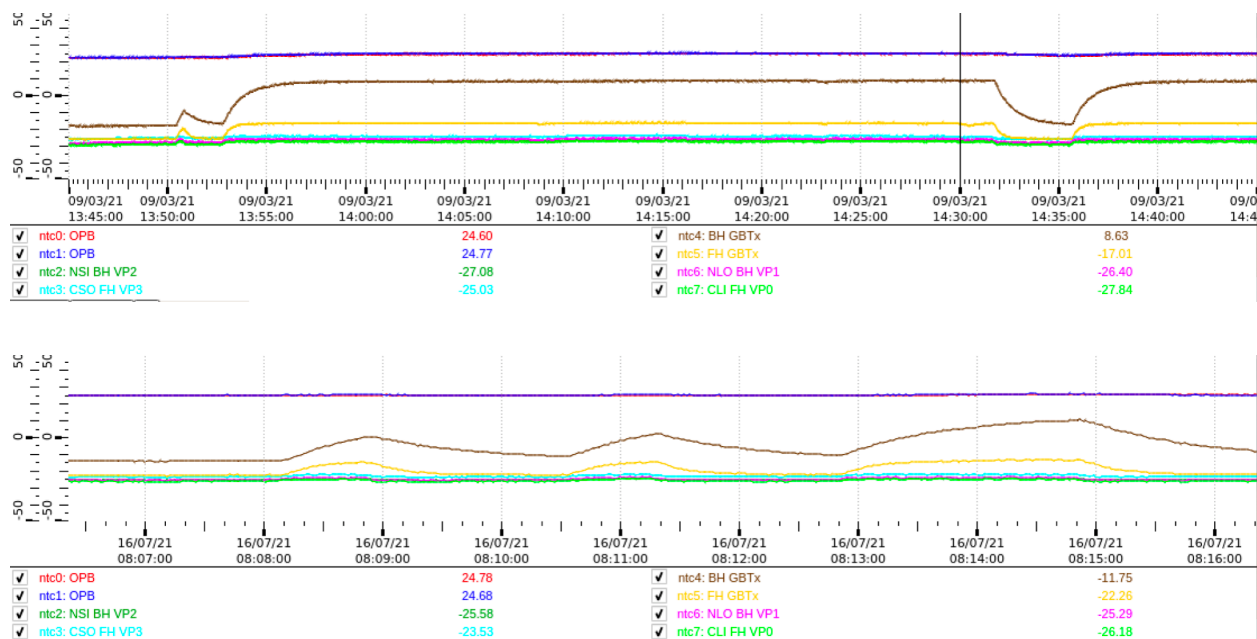
1. Cooling of BH/N-side GBTx: For the situation warm, i.e. 15C, when GBTx is powered, its NTC reaches 40C. This reduces the long-term life expectancy of the GBTx.
2. All FH/C-side VeloPix reset automatically. The time between resets varies with an average around 10 minutes, but in low power mode also saw only a few seconds.
3. Bad PRBS for NSI/VP2 cold (-30C), while PRBS had 0 errors when warm (15C). Upon retesting, links 10-16 now all give problems even when warm.

1. Still present, needs reworking of the module (n-side GBTx hybrid)  
16/07: Module was cooled at -25C. When unpowered the BH GBTx was at -14C and the FH GBTx -22C. When powered the BH GBTx reached +10C before stopping the test, without reaching equilibrium. The FH GBTx reached -14C, but stable.  
Rework options: There is space on the bottom of the N-side GBTx to add glue, the other option is to completely remove the GBTx and glue again  
C-side GBTx is not inspected yet
2. Most likely solved by using the new OPB v3
3. Solved by replacing the long flex tapes and improving the clamps.
