### Home Inspector 4

#### Crawl Space - Structural Defects, Insulation Defects and other fraudulent Omissions

## **Crawl Space Structural and Insulation Defects - \$4,358 for structural and \$2,000 for insulation**

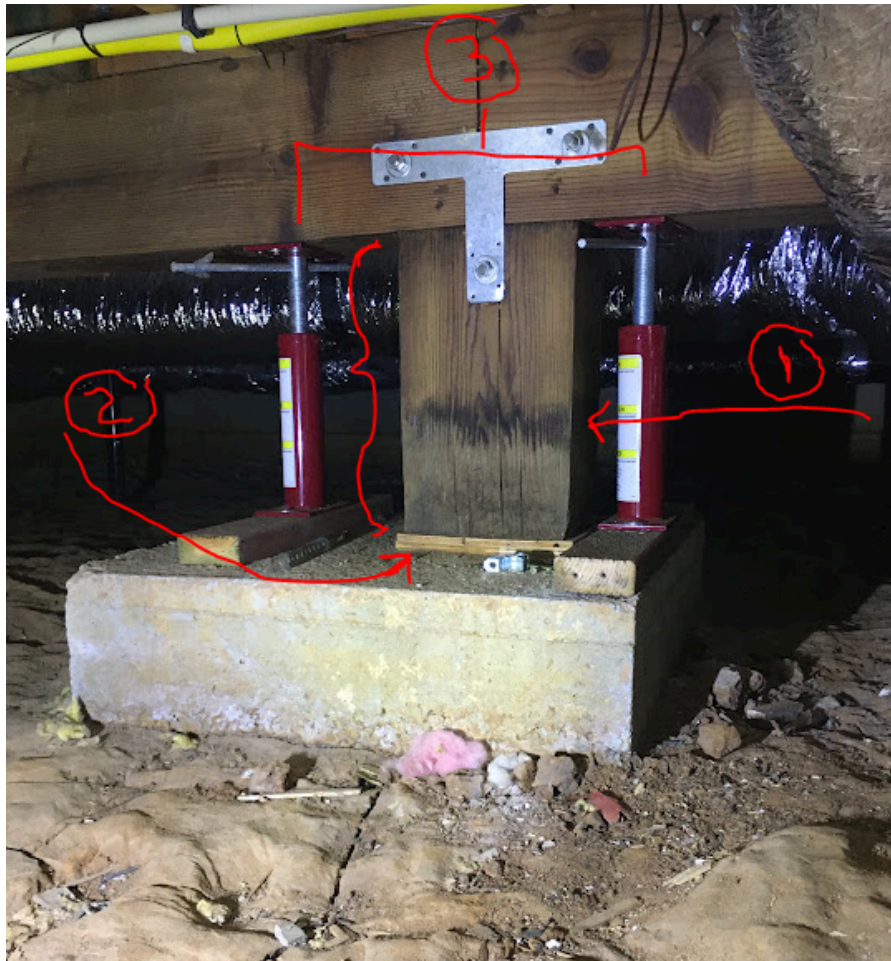
This image shows the center pier and post in the crawl space. The “high water line” (1), was/is from long term flooding many years or decades prior to this transaction. The Plywood lift (2) and support jacks (3) were installed after close of escrow to properly support the home.

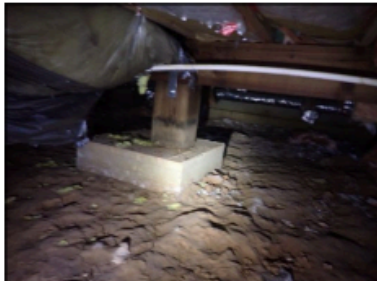
The buyer's inspector included photos of the defective columns with a note of "satisfactory condition" because nobody wants to write "structural defects" in a report for fear of getting sued.

Observations:

- Appeared to be in satisfactory condition.

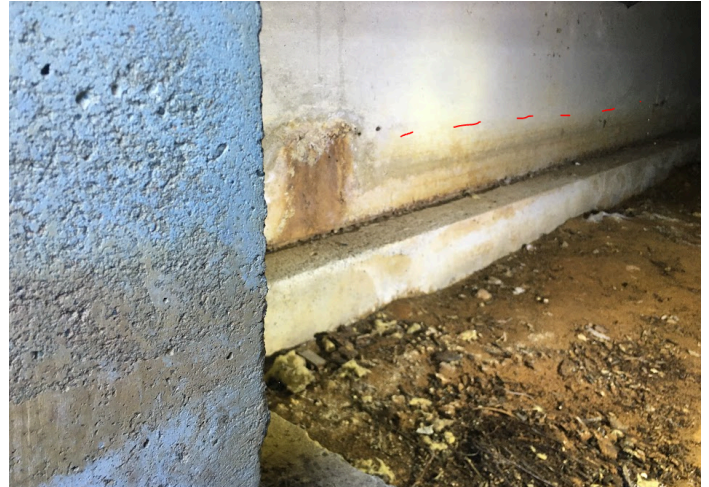
High water flood marks are visible on the side wall from opening.

Flood mark visible around foundation from crawl opening. Anyone looking in at all would have seen this and could have expected other problems

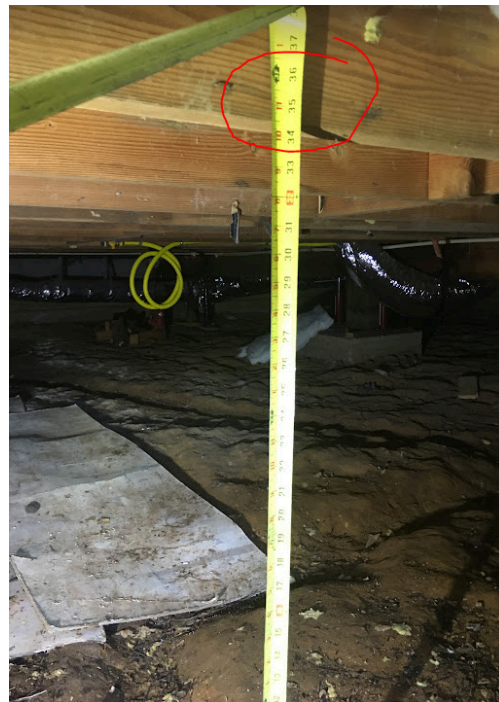
The crawl is 34" tall at opening and gets taller.

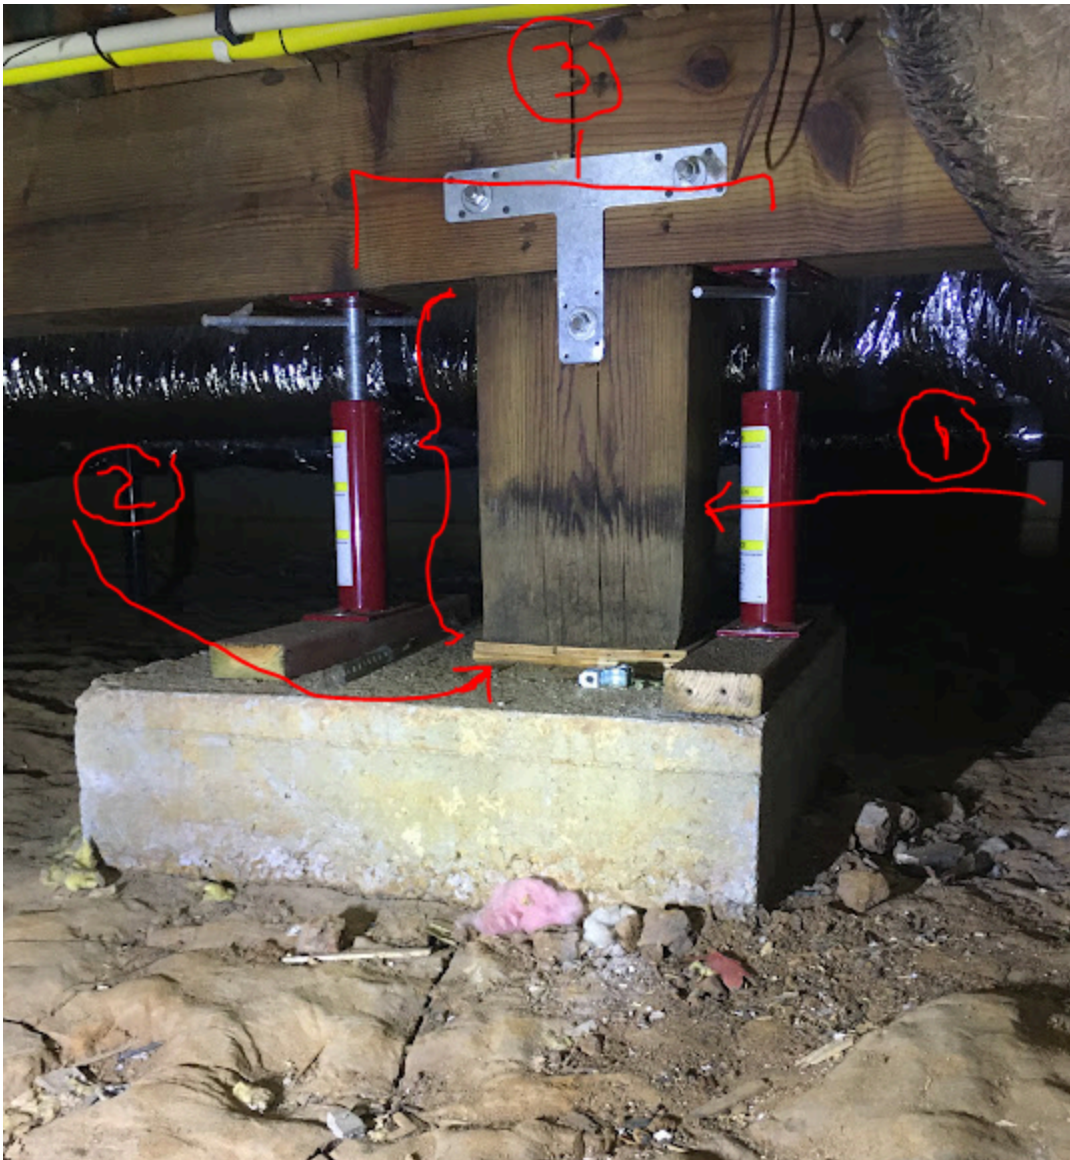
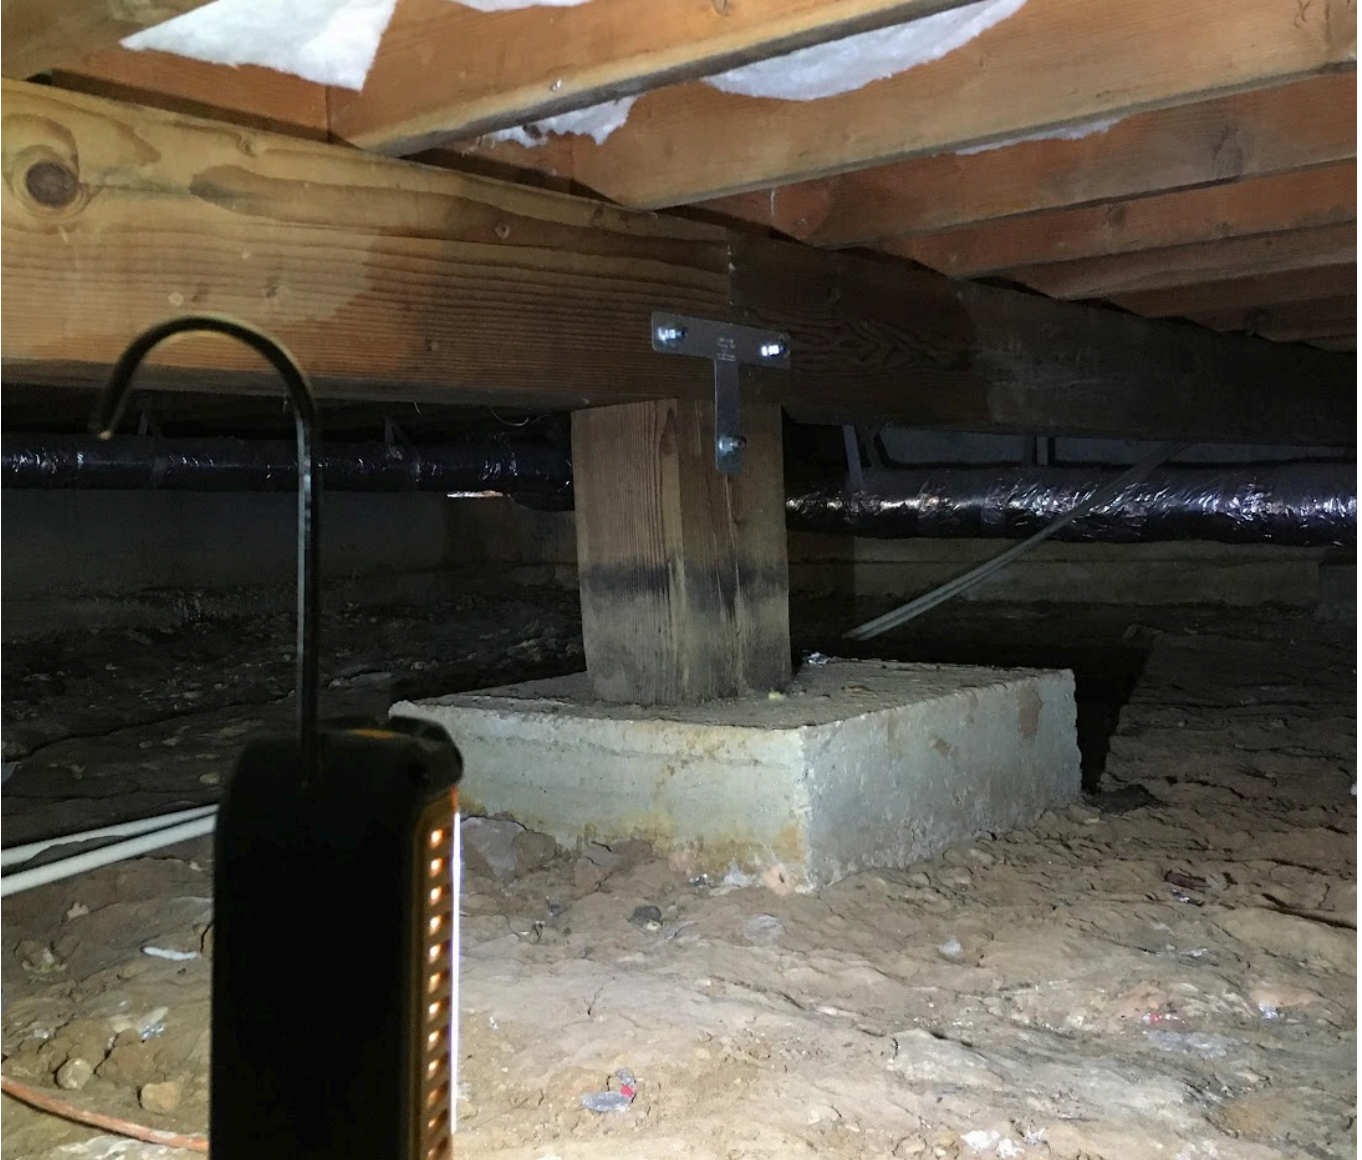
### Center Post Dryrot and Structural Defect Details

The post had clear signs of dry rot visible from 15' away

- 1) The flood line that corresponded with the line on the walls
- 2) After close of escrow, the home was jacked up by 3/4" to correct the fall from dry rot
- 3) After close of escrow jacks were installed to support the home in the event of further main post deterioration

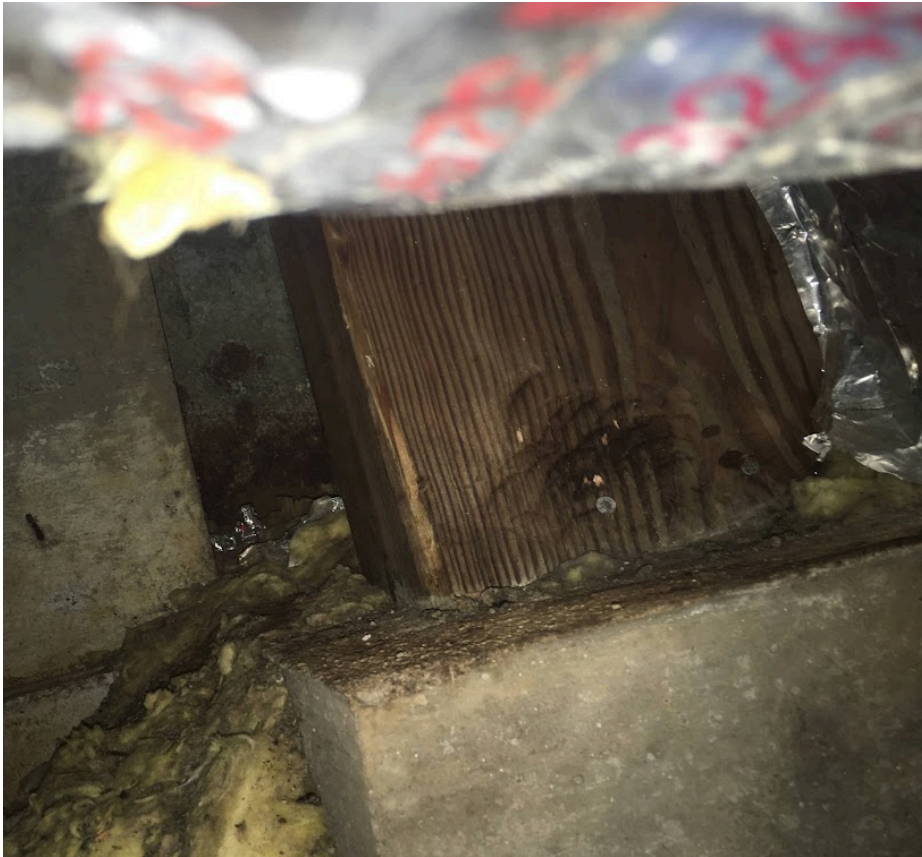
4/9/2021 - Only photo found showing the rear post and pier prior to wood removal. Can identify via the separate concrete block in front of foundation

| Description of Work | Price 1 | Price 2 |
|---|---|---|
| <u>End Support Post for main Beam - Far end of crawl</u><br>Jack up home by 1/2"<br>Install temporary supports<br>Remove original column and secondary column that had been installed years ago as a repair.<br>Install Columns for support | \$1,935 <sup>00</sup> | |

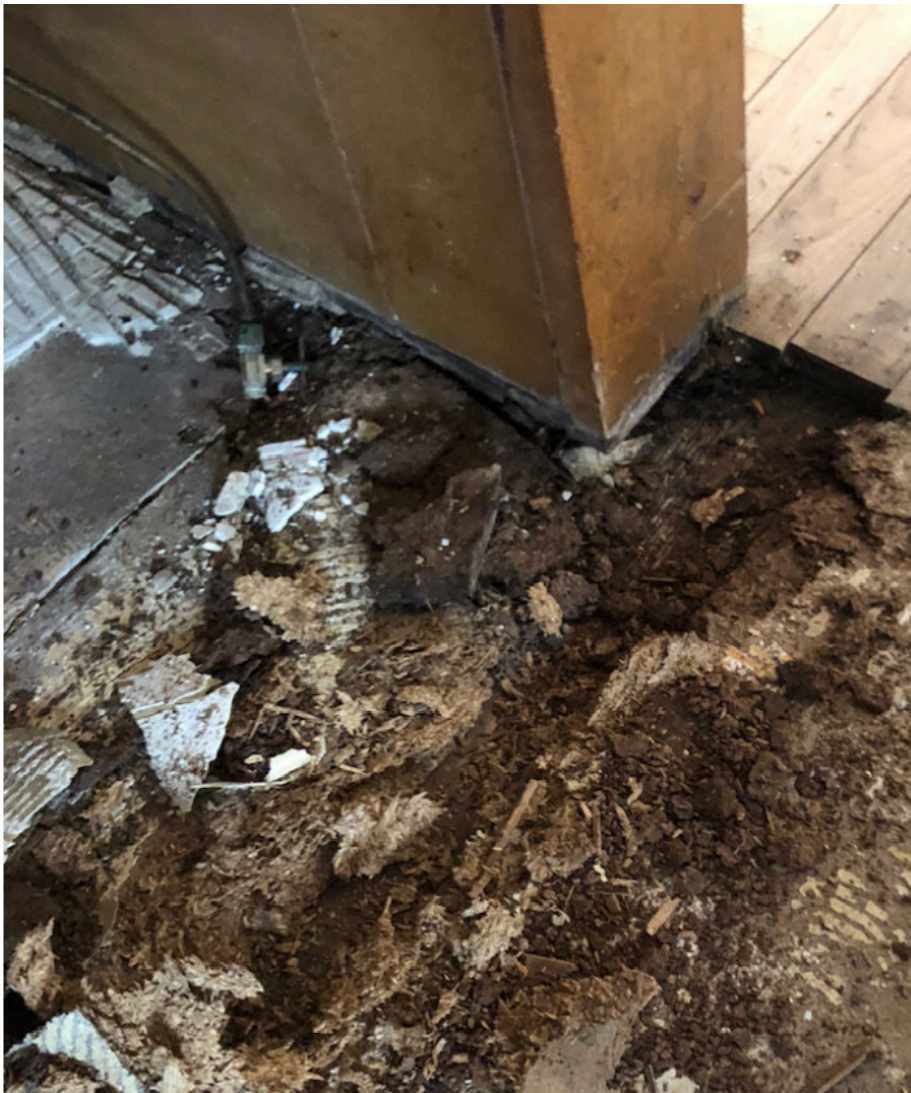
**MAF001115 / MAF 001115 - email with photo only of damaged subfloor**

In Discovery, Forstein produced an email from his General Contractor and a photo. It was an image of subflooring defects that the GC wanted to cover up with new tile. This is within 24" of the low spot of the sunken floor and the subfloor he covered up was a contributor to the sunken floor, along with a dry rotted post and pier in the crawl. The condition of the subfloor defects was not visible to buyers as this was covered over with new tile and a transition from tile to hardwood.

Micah, I thought I better send you this information sooner instead of later so we can keep going forward. The underlayment in the kitchen is in really bad shape which explains why the tile was breaking- it's not the appropriate underlayment for tile, and take into account, some moisture issues over the years has caused it to deteriorate badly. The correct underlayment is a half- inch cement board which I have and I'm ready to install but I'd like your approval first. The additional cost for labor and materials is \$900. That includes removal of the old underlayment too. Normally it would be about \$1200 but since this is a surprise Ill do it as close to cost as I can to help out. Please advise, as to approval, and we will get the new underlayment installed ASAP.  
Sincerely, John Chatters.

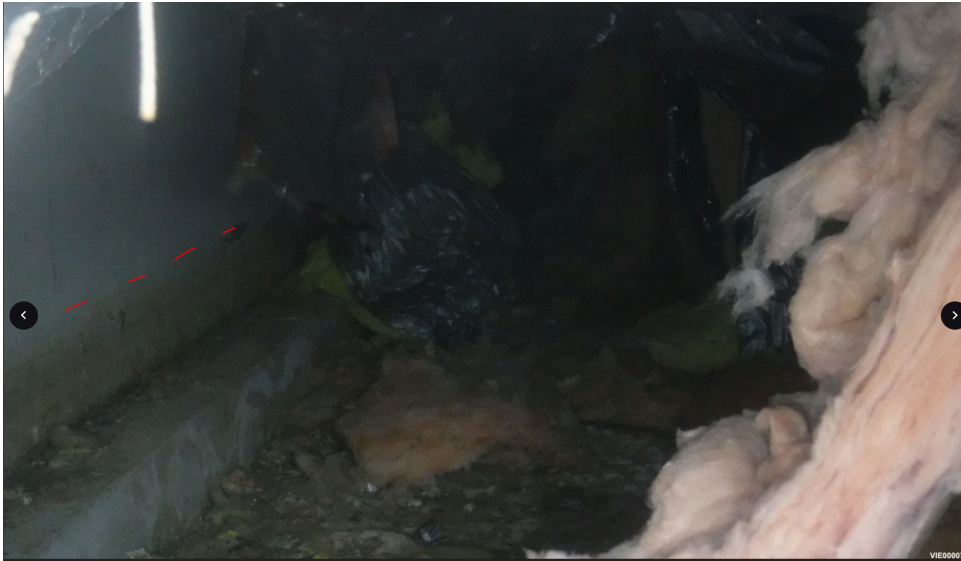
**Discovery - DSCF4025 / VIE 000078**

This is a photo of the crawl that shows a flood line in the crawl that was not reported on or provided in the report.

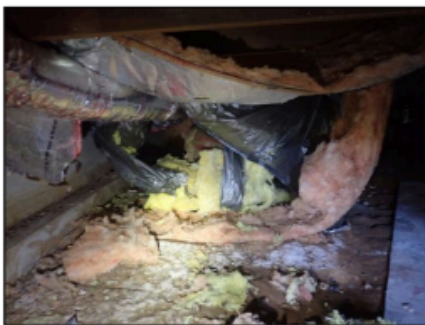
- Insulation was observed to be missing or out of place in one or more locations. Recommend upgrading to promote proper insulation and increased efficiency of home.
- **Rodent nests observed in insulation. Recommend sealing all gaps and cracks to prevent wild life entrance and consulting with a pest specialist to eliminate any future issues.**
- **Due to the high moisture content in the crawlspace. The insulations has become saturated. The additional weight of the water is causing the insulation to detached from the joists. Once insulation becomes wet it should be removed. Replacement should only occur after the moisture issue is resolved.**
- **Insulation appears to be installed incorrectly. Manufacturer's instructions typically state that the paper backing is to face the heated living space. Recommend review by a licensed insulation and ventilation contractor.**

*Damaged insulation noted.*

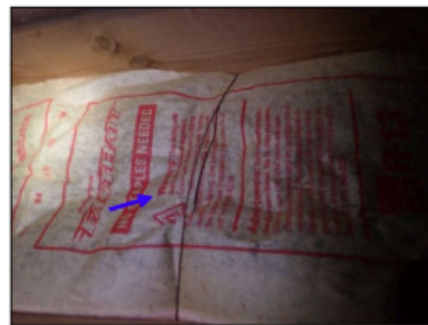
Buyer's 2021 inspection report notes the paper is supposed to face the heated surface, but even he fails to also not that the insulation needs o also be installed against heated surface to provide any insulation benefits at all.

*Insulation installed wrong side down*

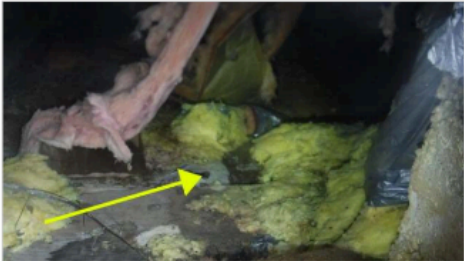
2. **Access Size**  
Satisfactory
3. **Clearance**  
Satisfactory
4. **Inaccessible Areas**  
Yes - Several Areas  
Most of the sub-structure area were not visible due to excessive debris, trash, and moisture. Issues may exist; however, we cannot visually detect or access. Further investigations when access can be gain would be necessary to determine if any adverse conditions exist. Modifications will be necessary in order to gain access. Contact a qualified trade for possibly modifications and examinations.

5. **Debris/Trash**  
Attention - rodents/trash  
There is debris, trash, and evidence of rodents/pests under the structure which should be removed. There should be no storage of debris such as wood scraps, paper products, etc., in the crawl space in order to eliminate a source of food for pests or other health related issues.

The area photographed was only about 10% of the total space. The photo was framed to create an insincere impression of condition.

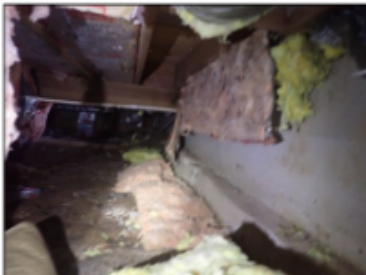
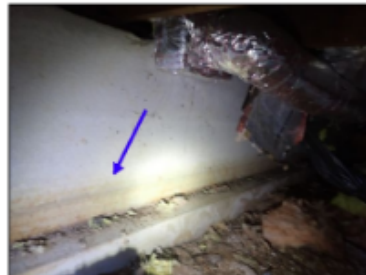
- **High water line noted at perimeter of building. Recommend an extending downspouts and a sump pump to prevent further occurrences.**

*High water line noted.*

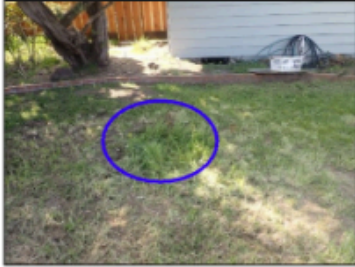
- Unprofessional drain pipe installation noted. Recommend installing an alarmed sump pump with battery backup.

*Potential drainage pit noted.*

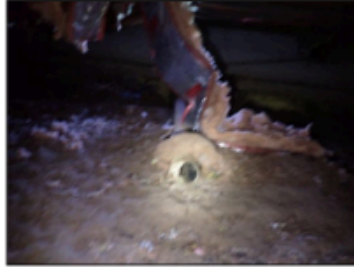
*Makeshift drain noted.*
