# Technical Bulletin

| <b>NP01</b> | <b>TB008-2022 Rev B</b> | <b>SEBECO MOTORSPORT</b> | |
| <b>Subject</b><br><b>:</b> | <b>Drive Shaft Length</b> | <b>Date:</b> | <b>2/2/22</b> |

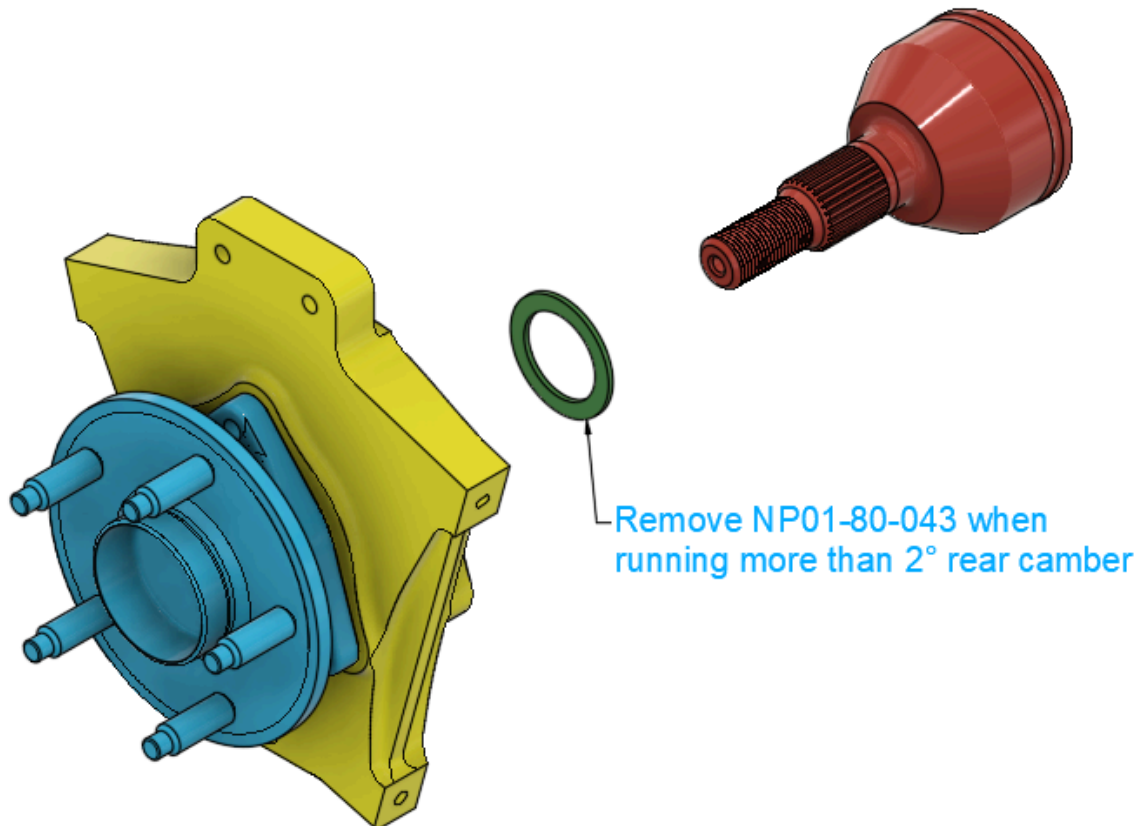
It has been found that running less than 2° rear camber the inner tripod joint can make contact with the boot flange that is bolted to the tripod cup.

In this situation it is possible that the inner CV runs out of travel and can pop the inner CV housing out of its internal C clip groove resulting in driveshaft vibration. It should be noted that the car should never be run statically with the rear wheels/tires off the ground and in gear with 2° or less rear camber. This is the very worst-case scenario for the driveshaft.

The solution is a steel 0.1” shim that will be added between the outboard end of the CV and the wheel hub bearing. This effectively moves the inner CV inboard and away from its current limitation in full suspension droop.

**This shim is part number NP01-80-043 and is available from Sebeco.**

**Please note that when running more than 2° rear camber this shim must be removed.**
