## **s2.5 - 2nd floor attic - destroyed insulation and damaged 2nd floor drywall ceiling**

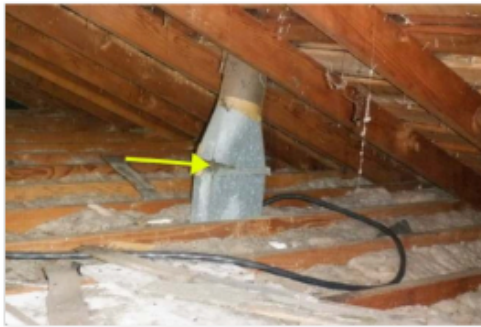
#### Maintenance- exhaust fan

The duct work from the kitchen exhaust fan is separated in the attic area. This issue can contribute to increased humidity levels in the attic space, and structural issues. Appropriate repairs are recommended to exhaust to the exterior of the structure.

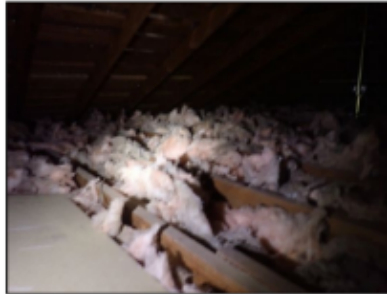
- **Tunneling observed at house insulation.**
- **The insulation installed in the rafters is disturbed by rodent activity. The house insulation is minimal. Recommend having the existing insulation replaced due to rodent damaged.**

*Found dispersed.*

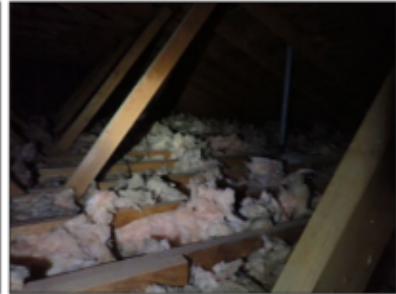
*Rodent activity noted.*

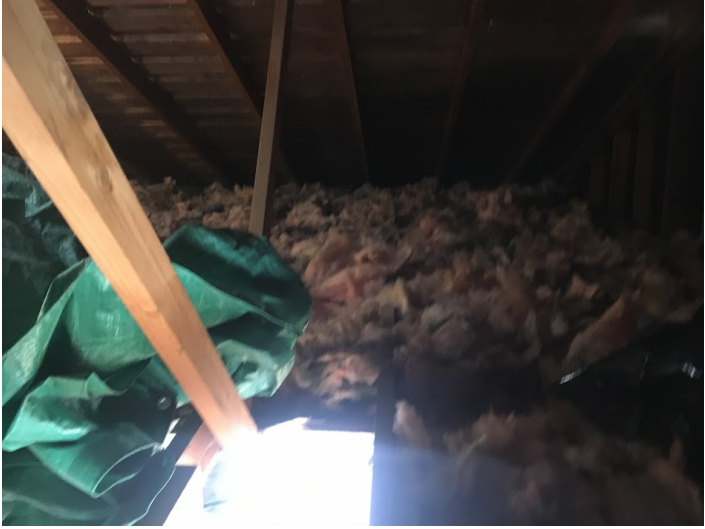
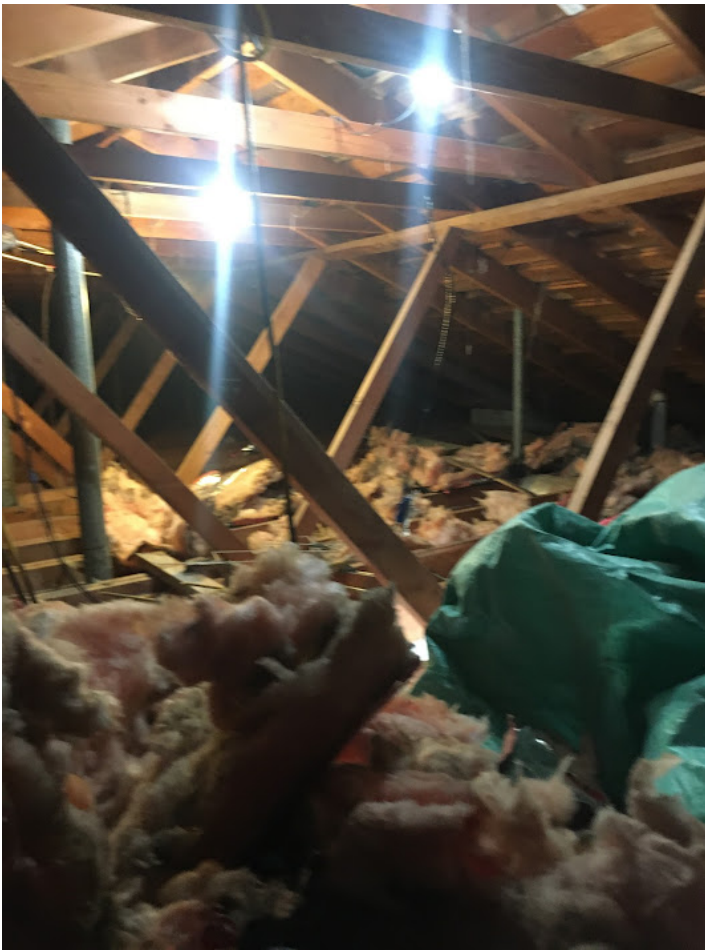
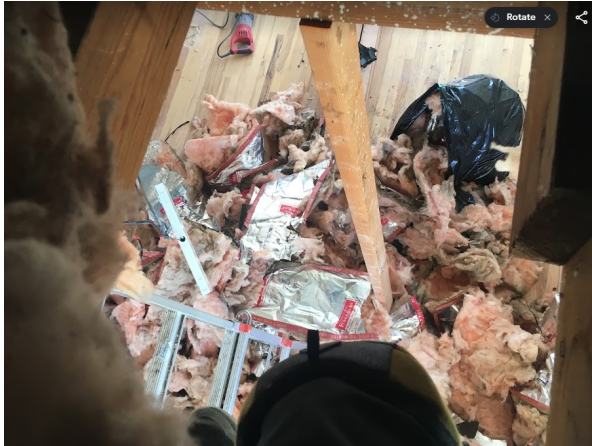
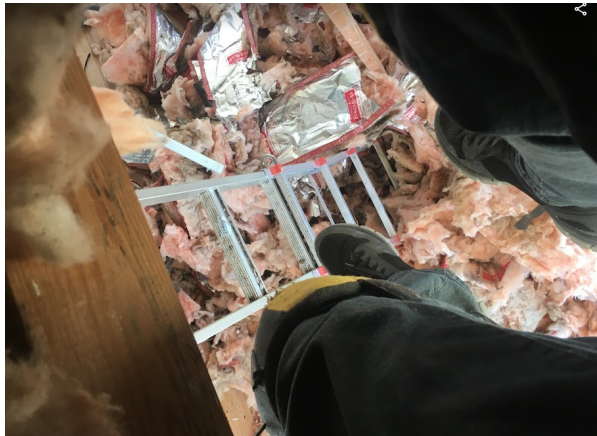
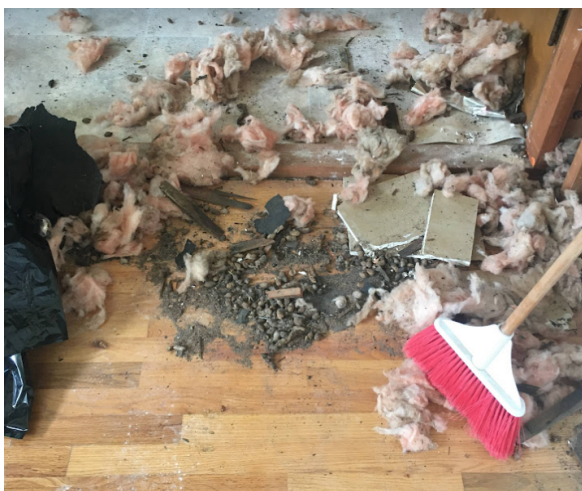
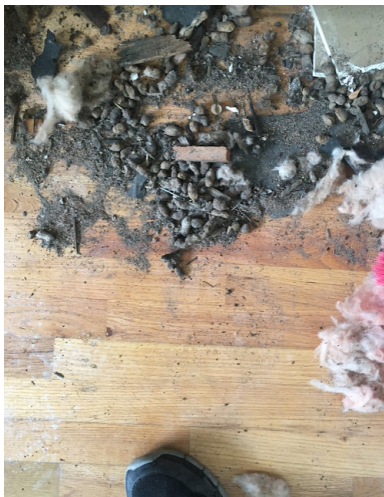
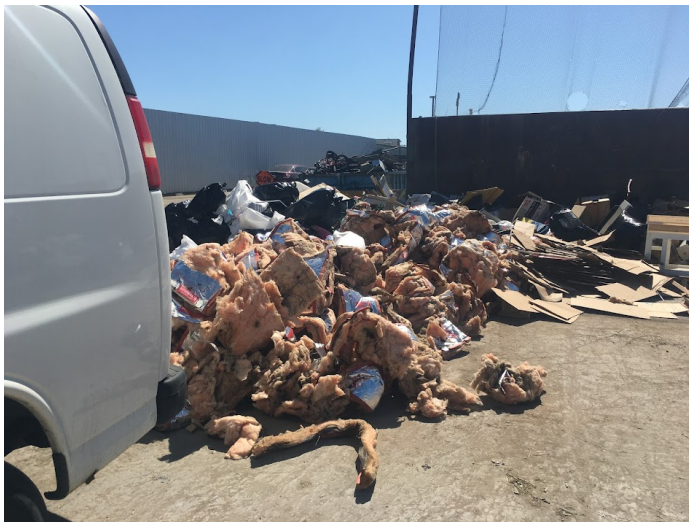
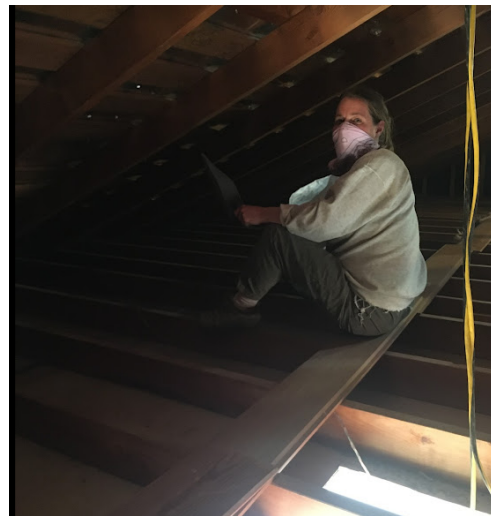
May 24, 2021 - after close of escrow - Photos

We believe it was raccoons. They talked around the issue a half dozen times without clarifying it.
