Burlington School District Attn. Lyall Smith, Director of Facilities  
150 Colchester Road, Burlington, VT, 05401

November 01, 2024

**Clerk of the Works Site Visit Report - IAA H.O. Wheeler Elementary School Project**

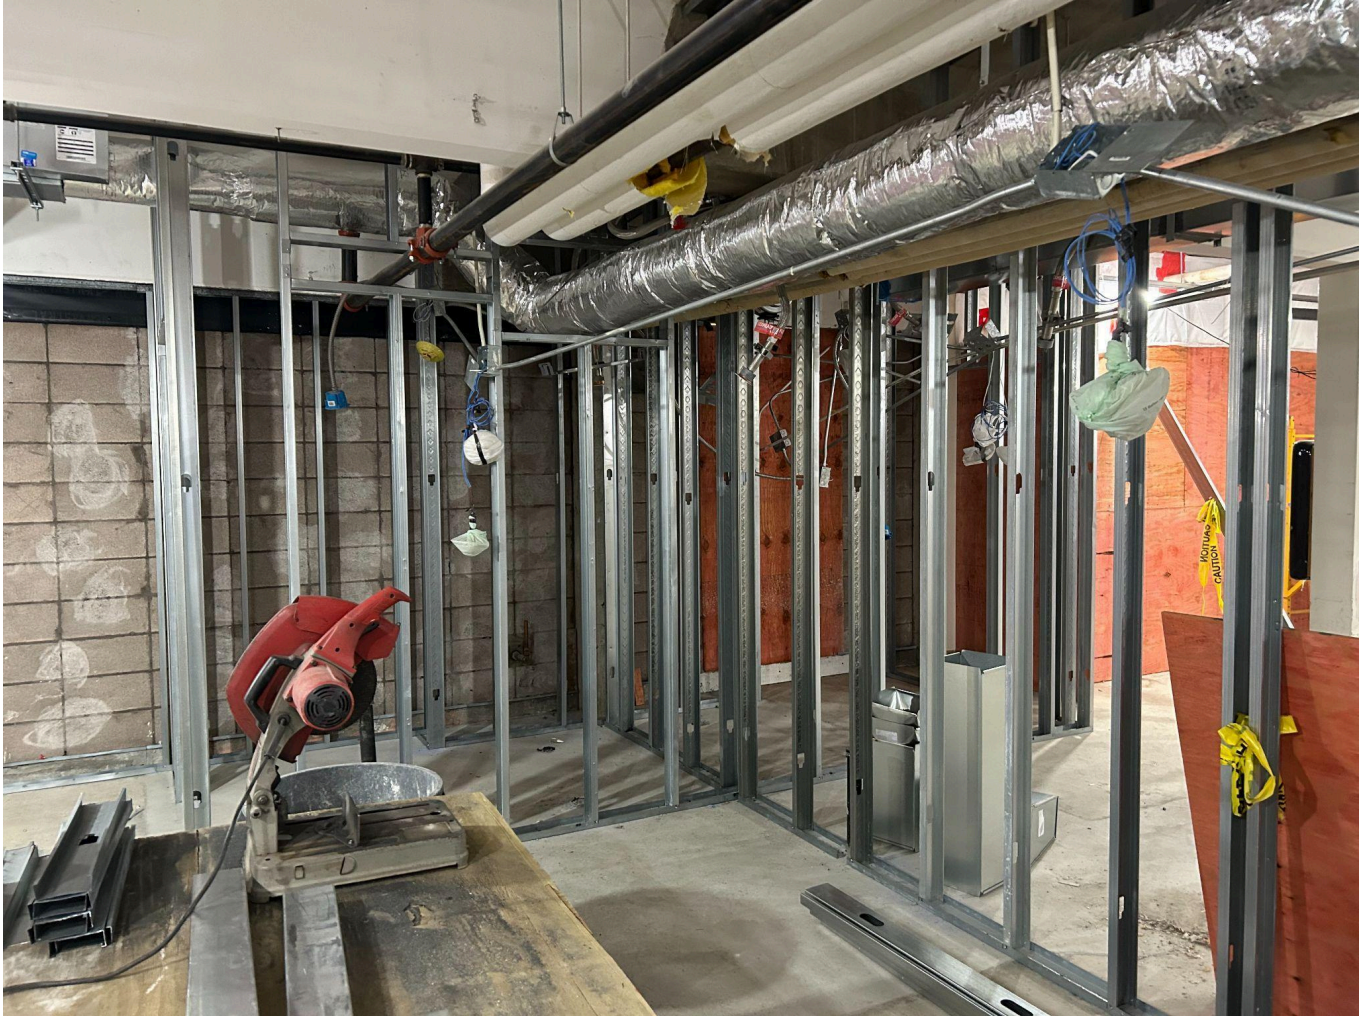
Framing is progressing on the bigger bathrooms in the 1965 wing of the building.

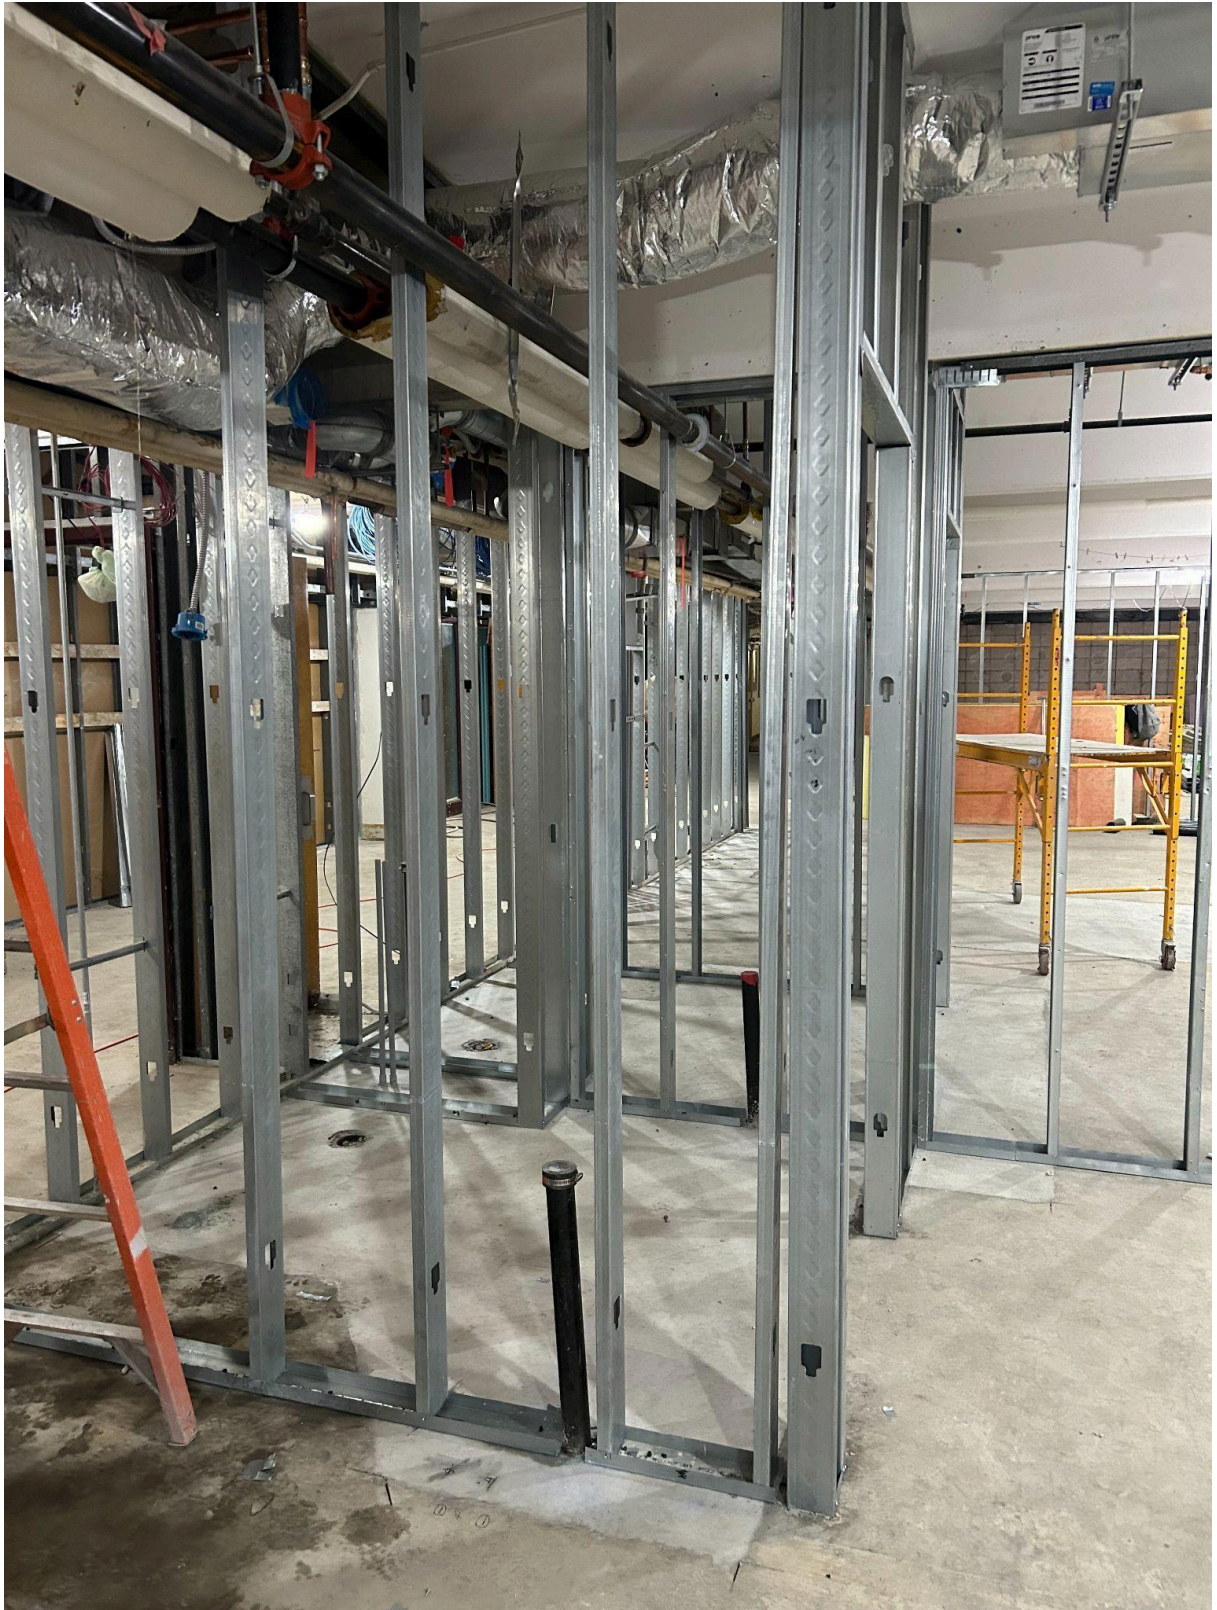
Another picture showing framing is progressing on the bigger bathrooms in the 1965 wing of the building.

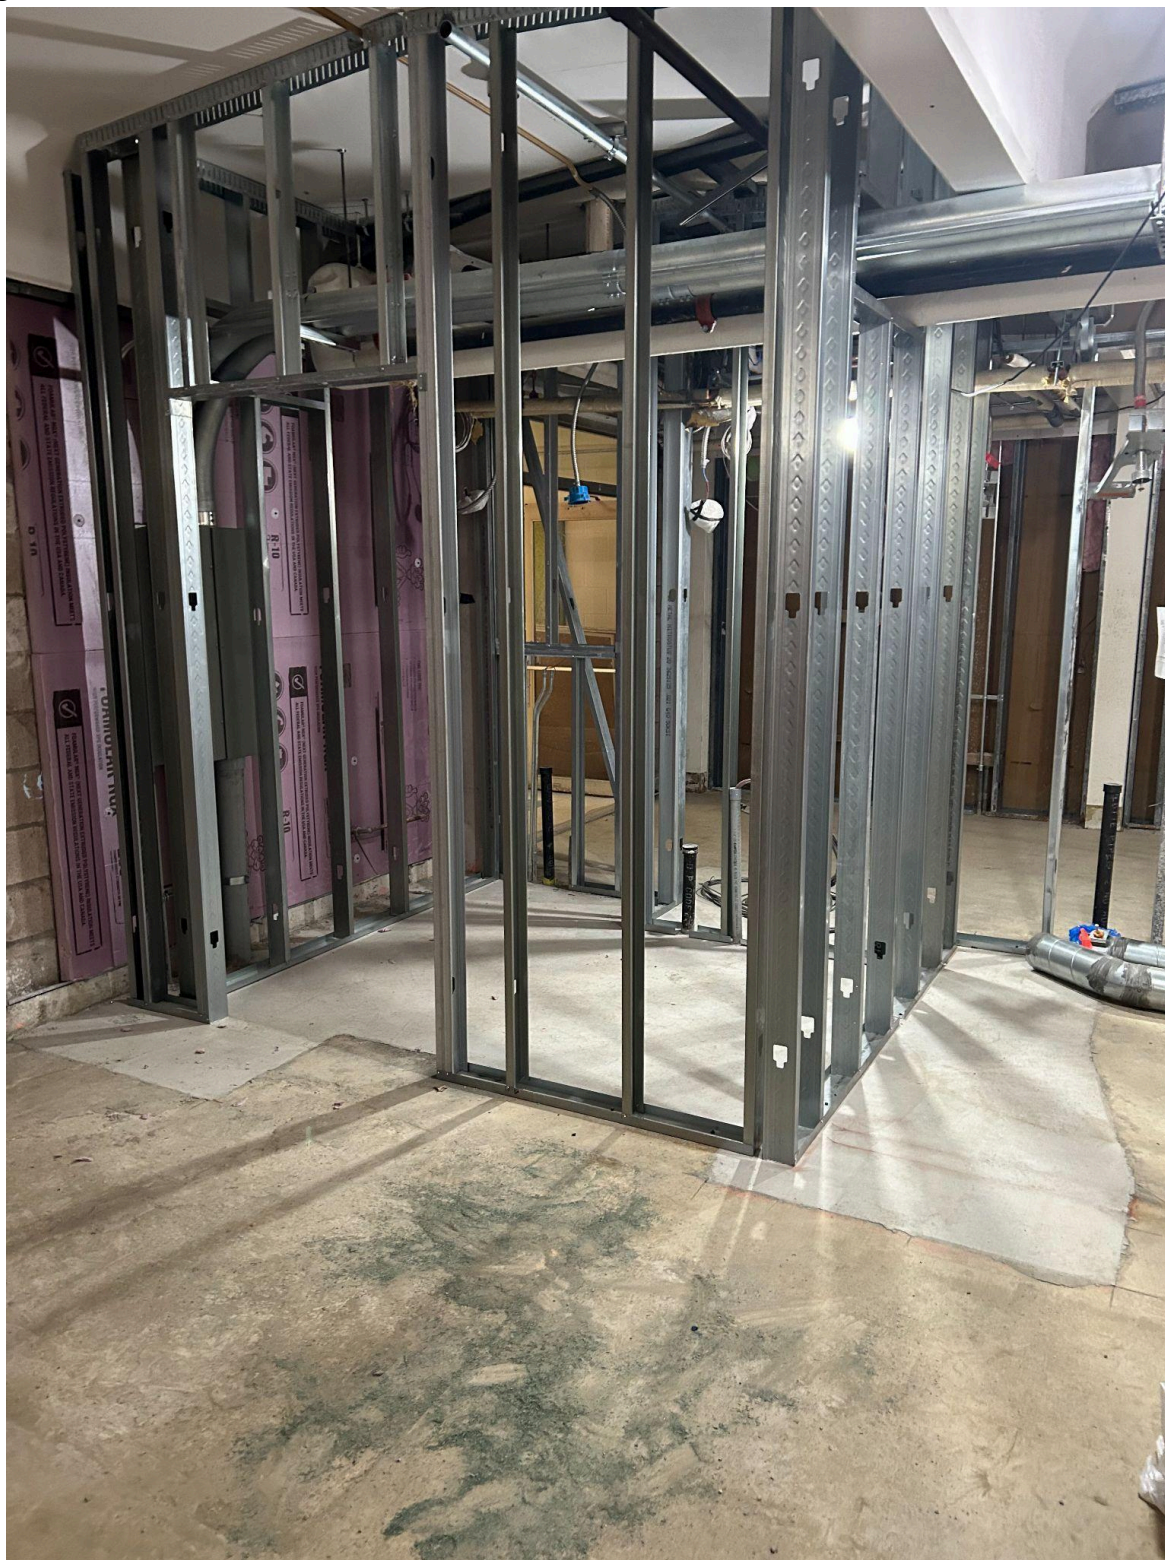
Another picture showing framing is progressing on the bigger bathrooms in the 1965 wing of the building. Insulation is being placed on the old concrete block walls for energy efficiency.

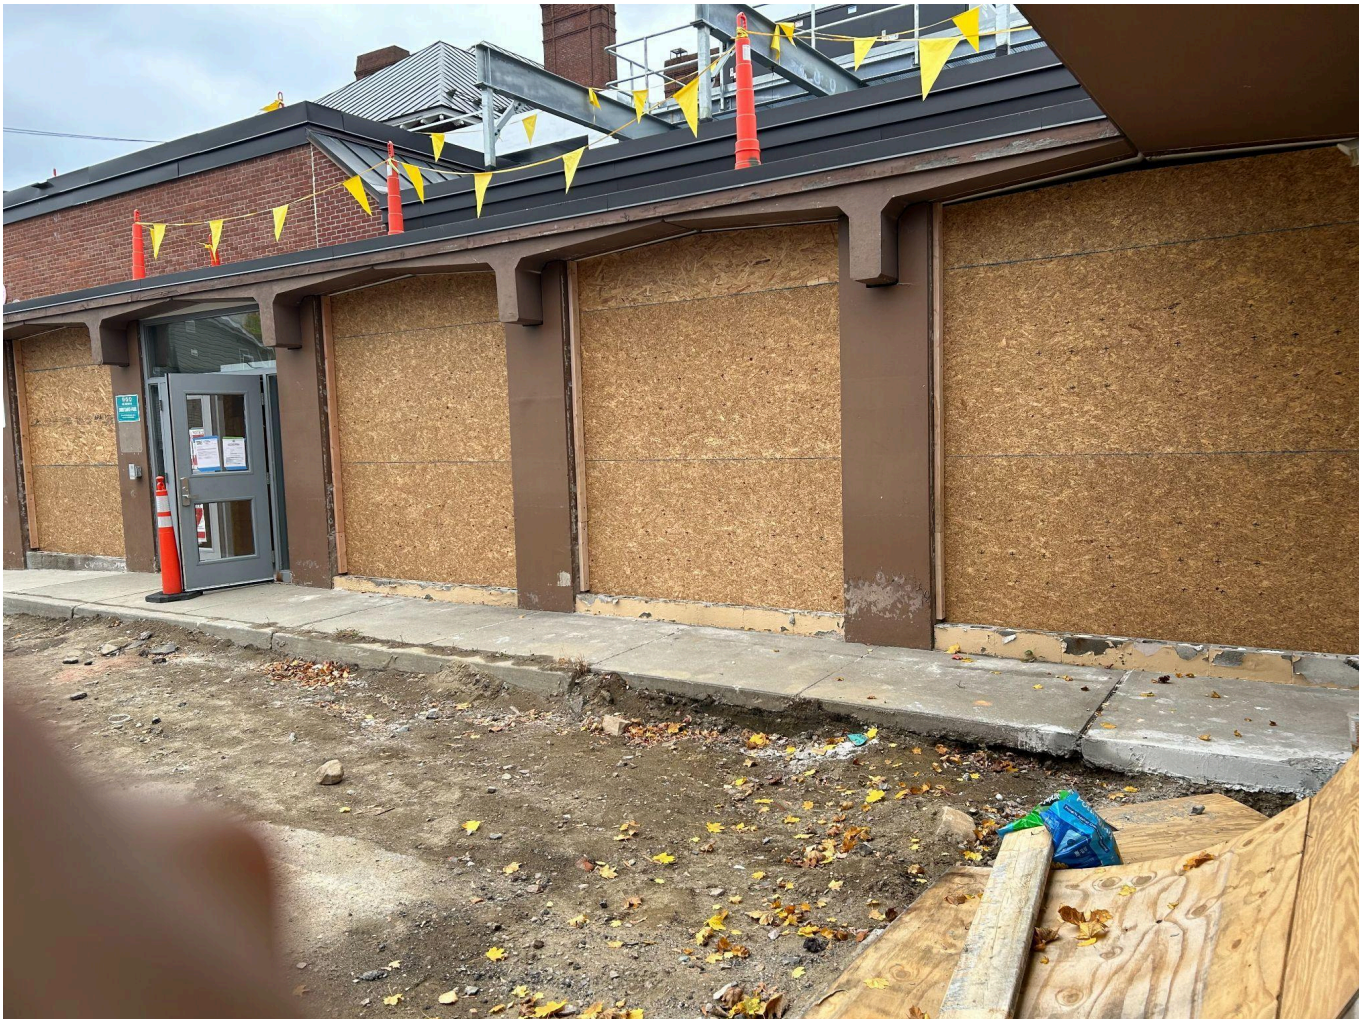
On the Walnut street side of the 1965 wing of the building, the old windows have been removed, and framing is placed for where the new windows will be being replaced.

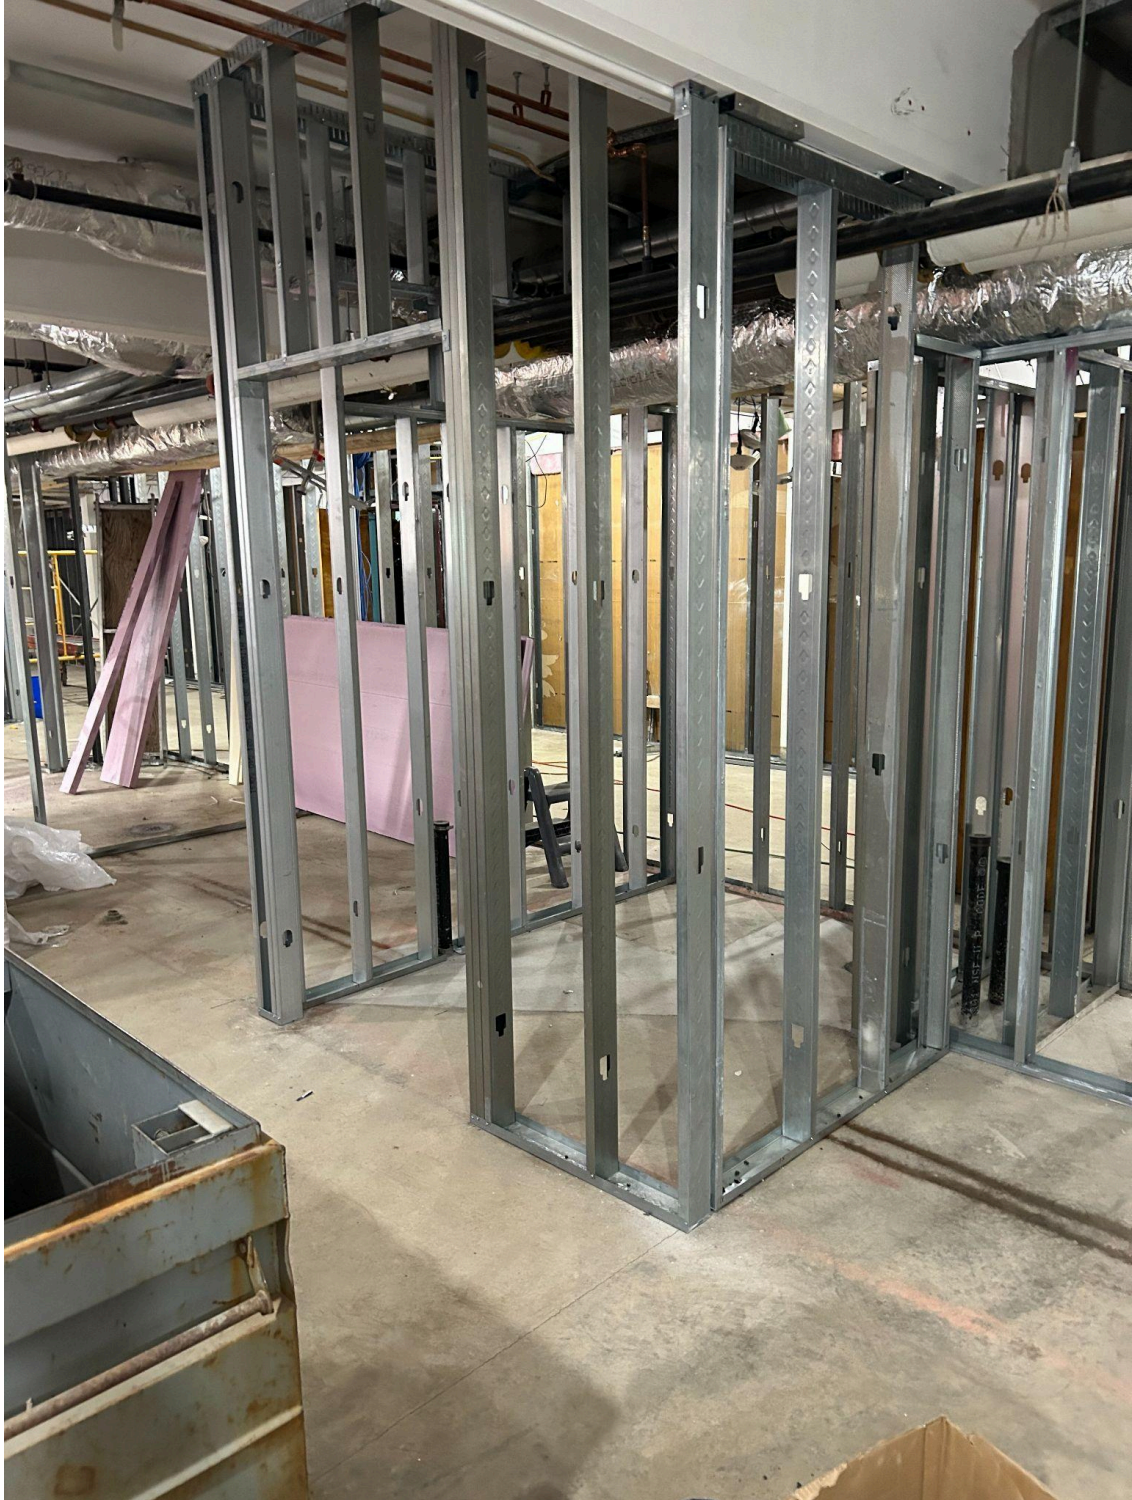
On the Walnut street side of the 1965 wing of the building, framing is placed for where a new door will go into the new bigger bathrooms for the classrooms.

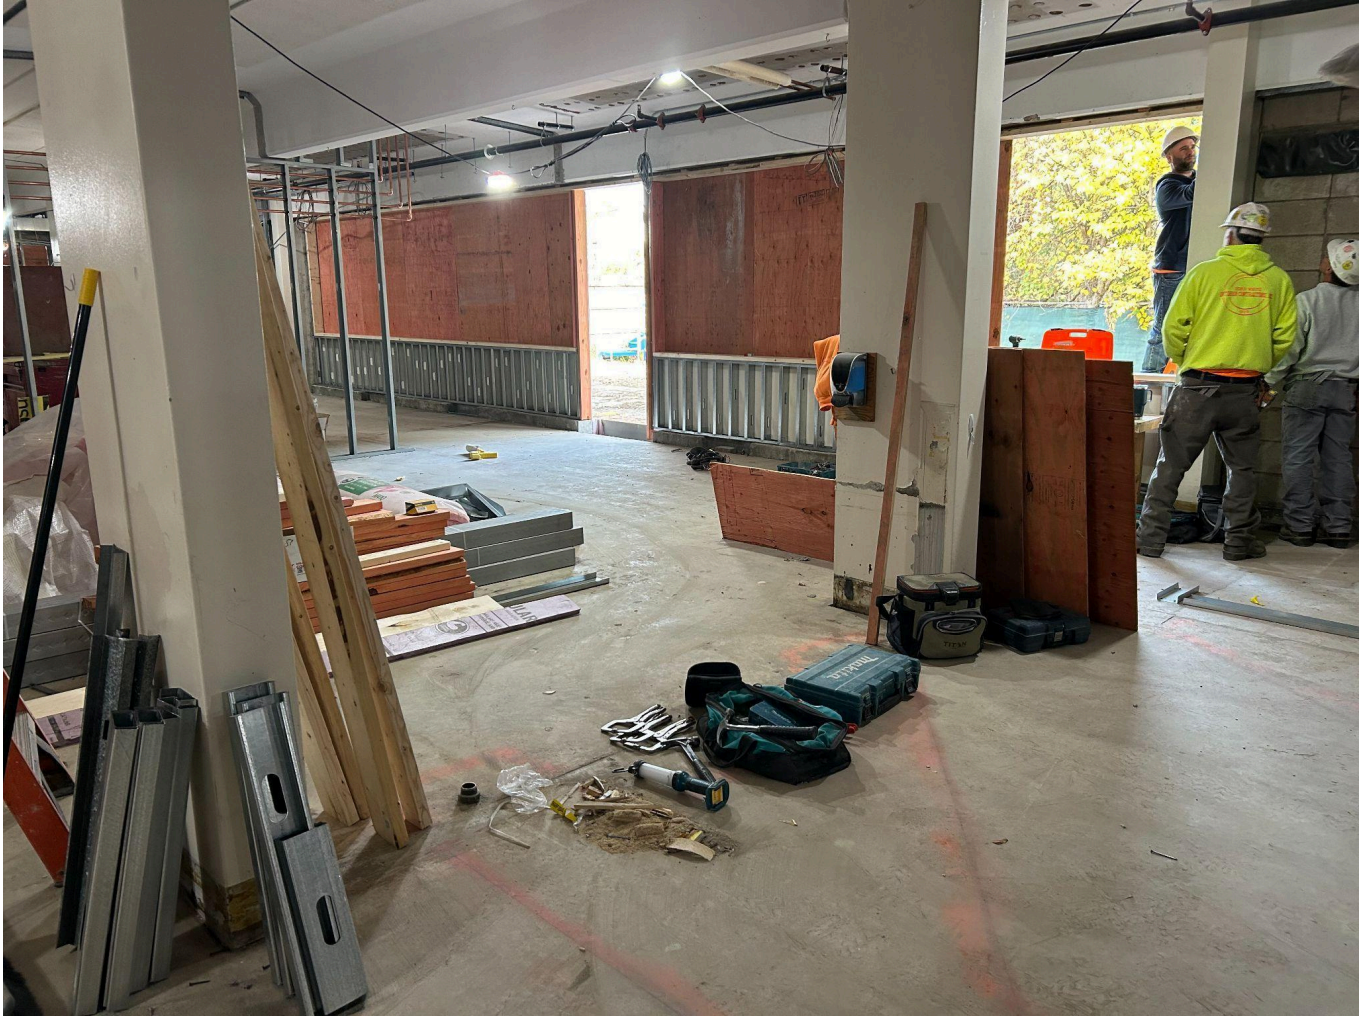
On the backside of the 1965 wing of the building, the old windows were removed, and the new framing is installed to accept the new windows. The temporary walls have been removed now that the exterior framing is complete. The new windows are not expected to be installed until sometime in February.

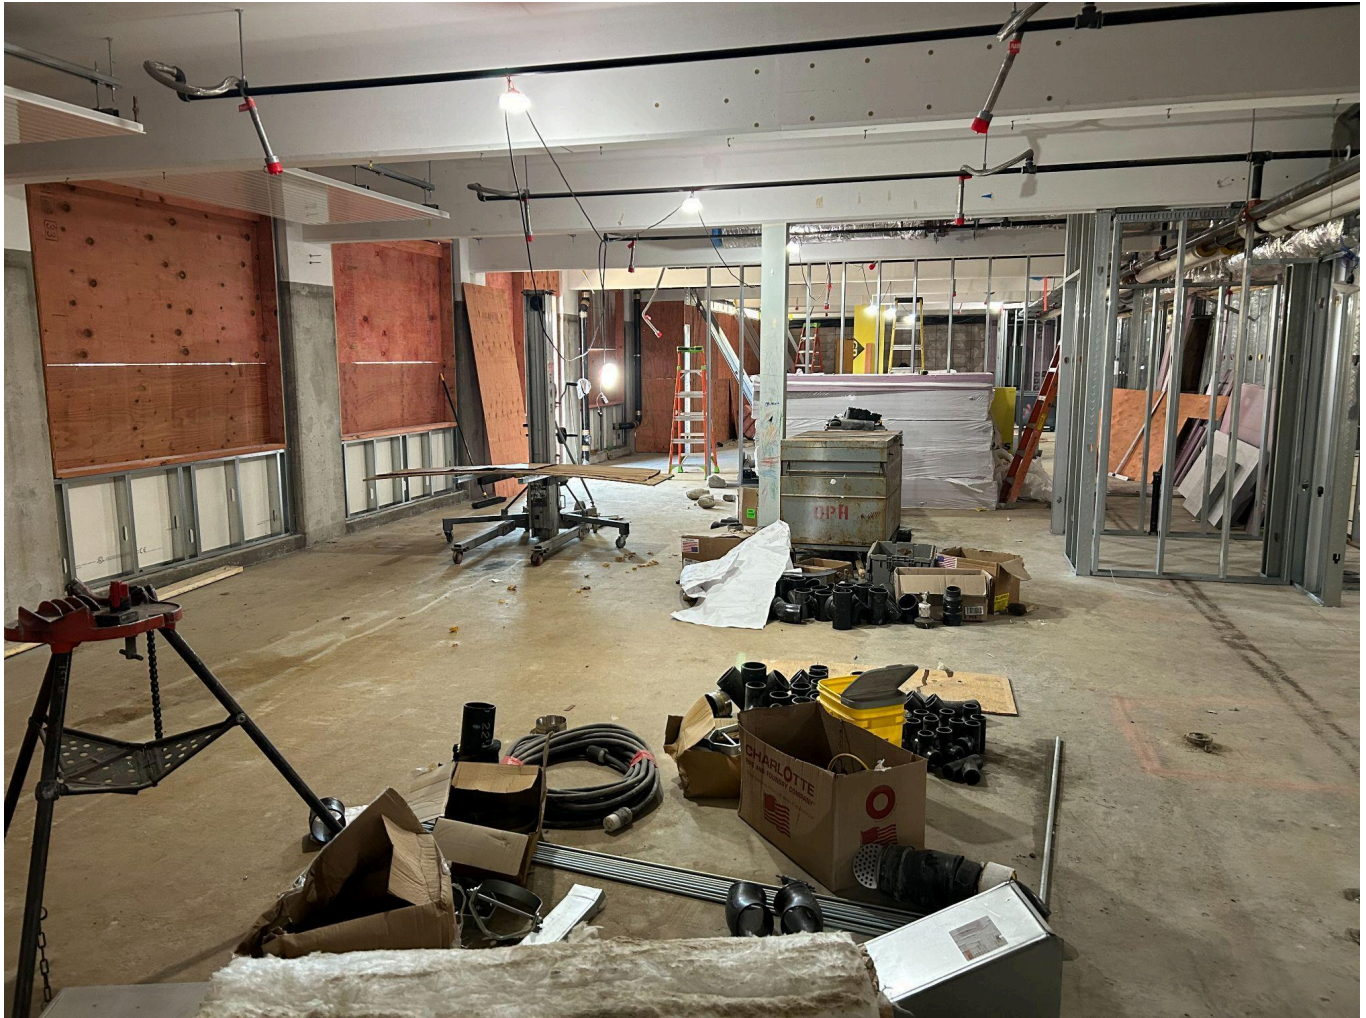
Another picture showing the progression of the framing in the 1965 wing of the building.

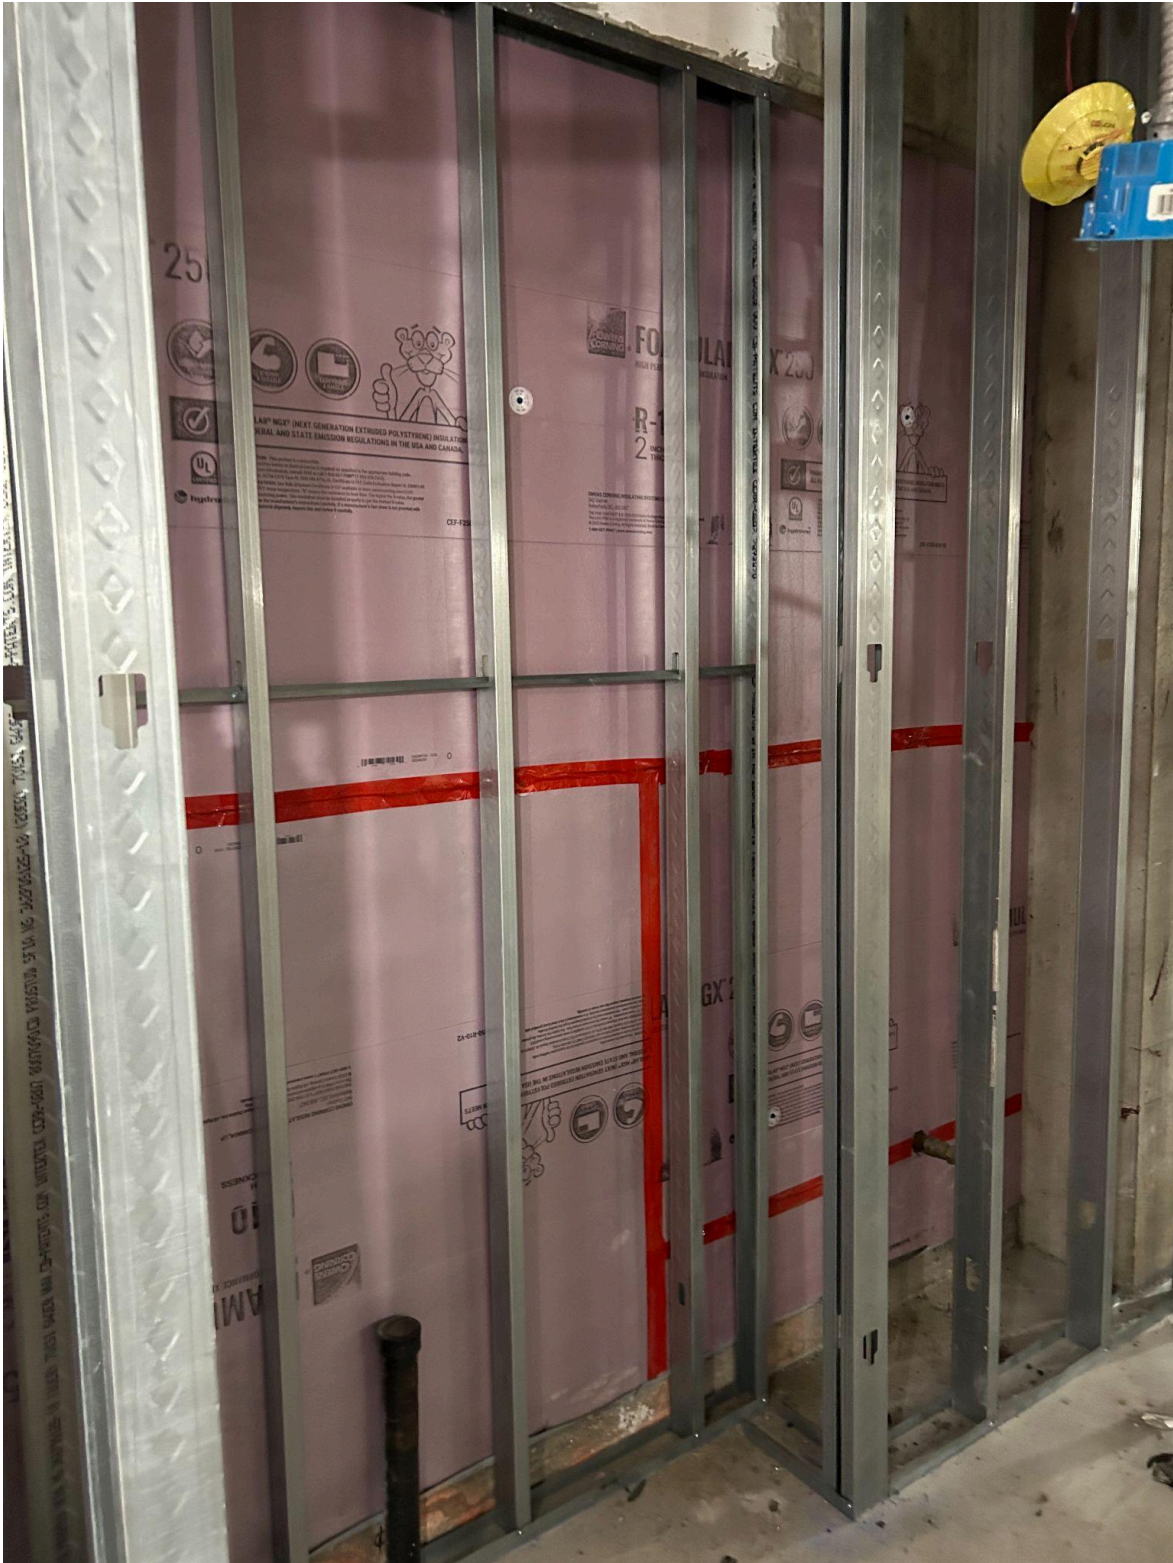
Insulation installed on the interior of the exterior walls over the old block walls that framed the exterior walls for the 1965 wing of the building.

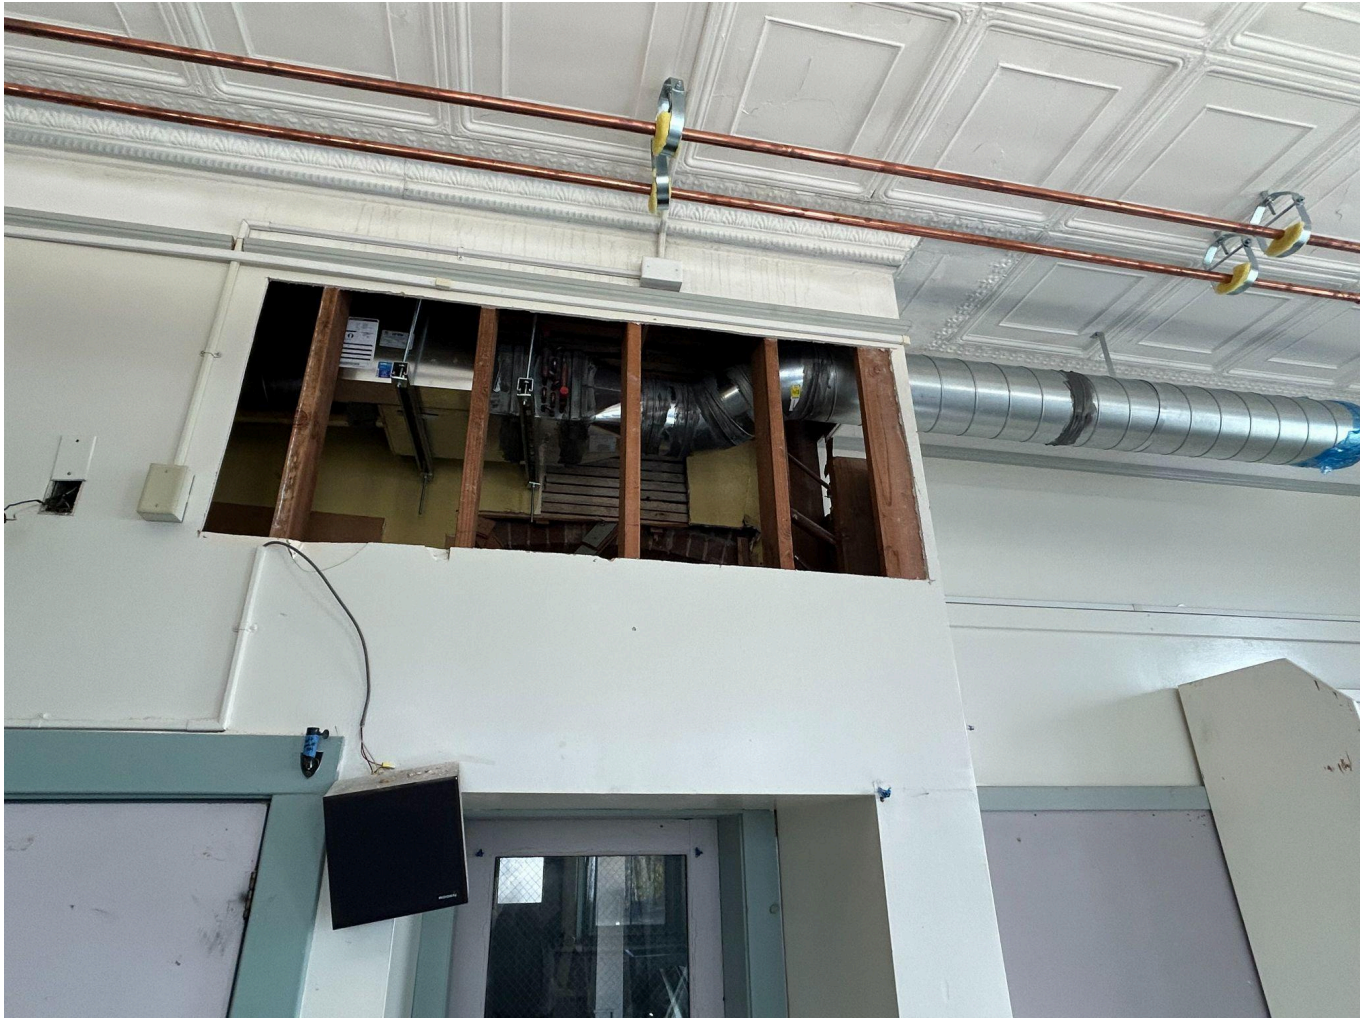
VMI is installing the ventilation equipment and ductwork in the classrooms of the 1904 wing of the building.

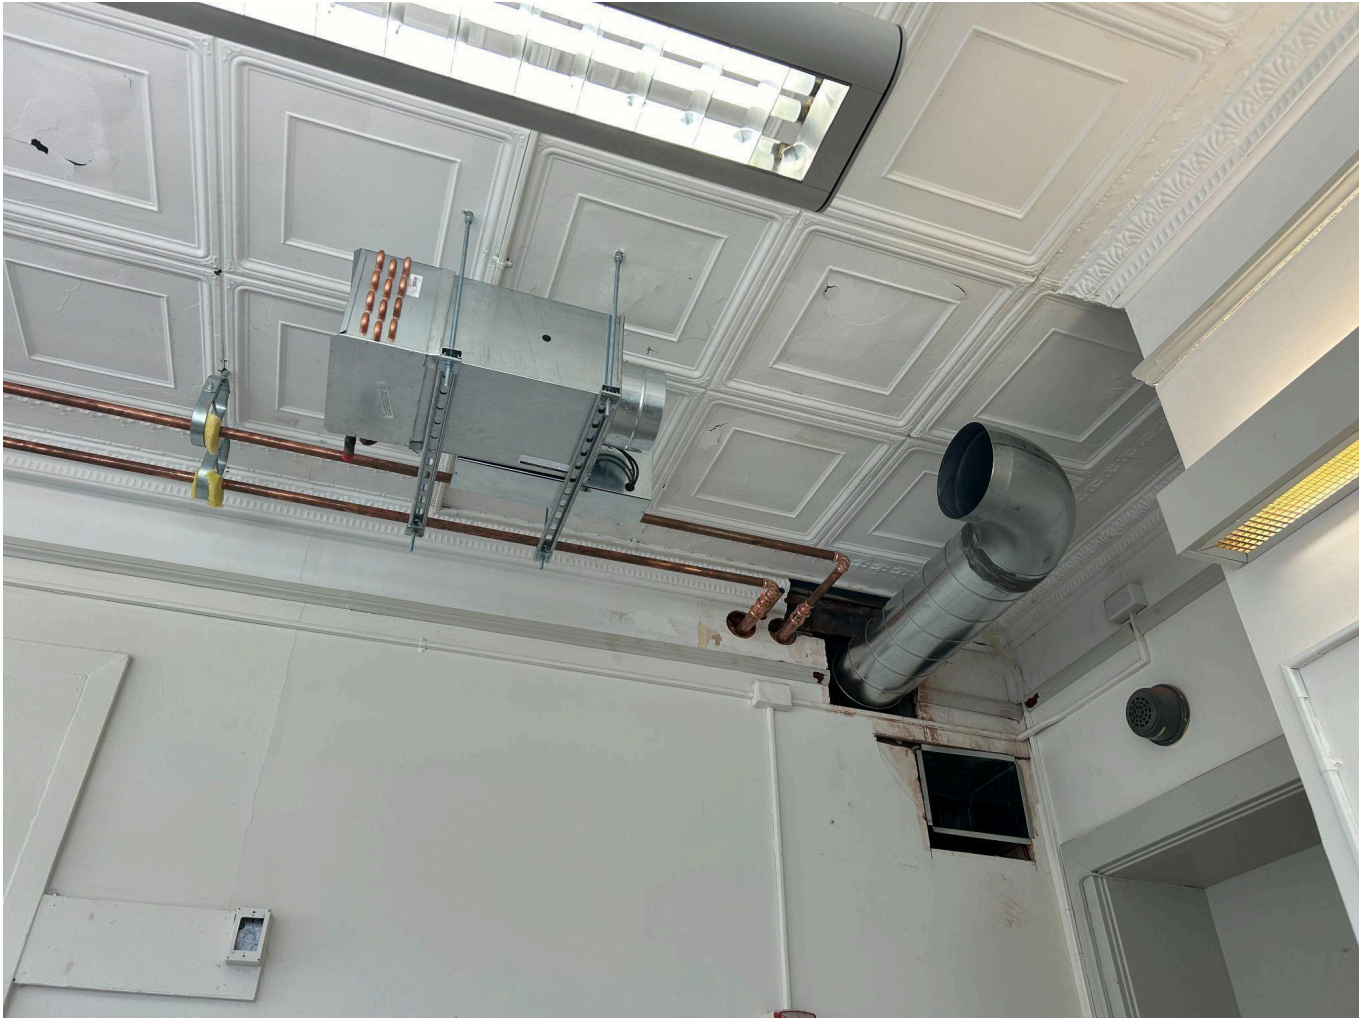
Another picture of the ventilation equipment and ductwork being installed in the classrooms of the 1904 wing of the building.

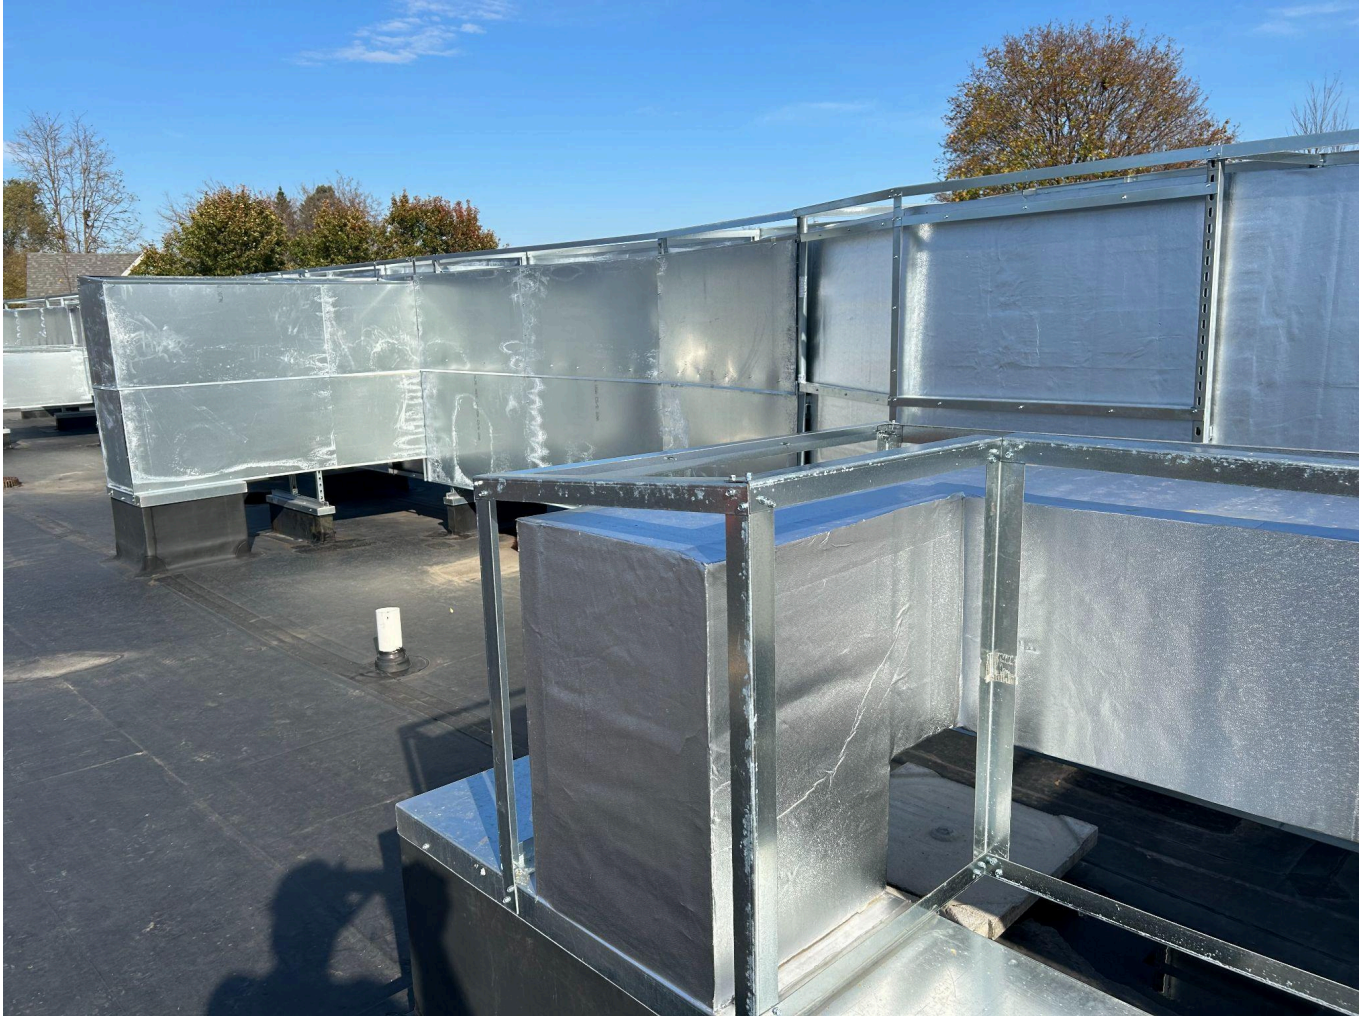
A picture of the ductwork that has been installed on the roof of the 1965 wing of the building that is being covered with sheetmetal to protect the ductwork and insulation. The shiny sheetmetal will be painted in the spring.

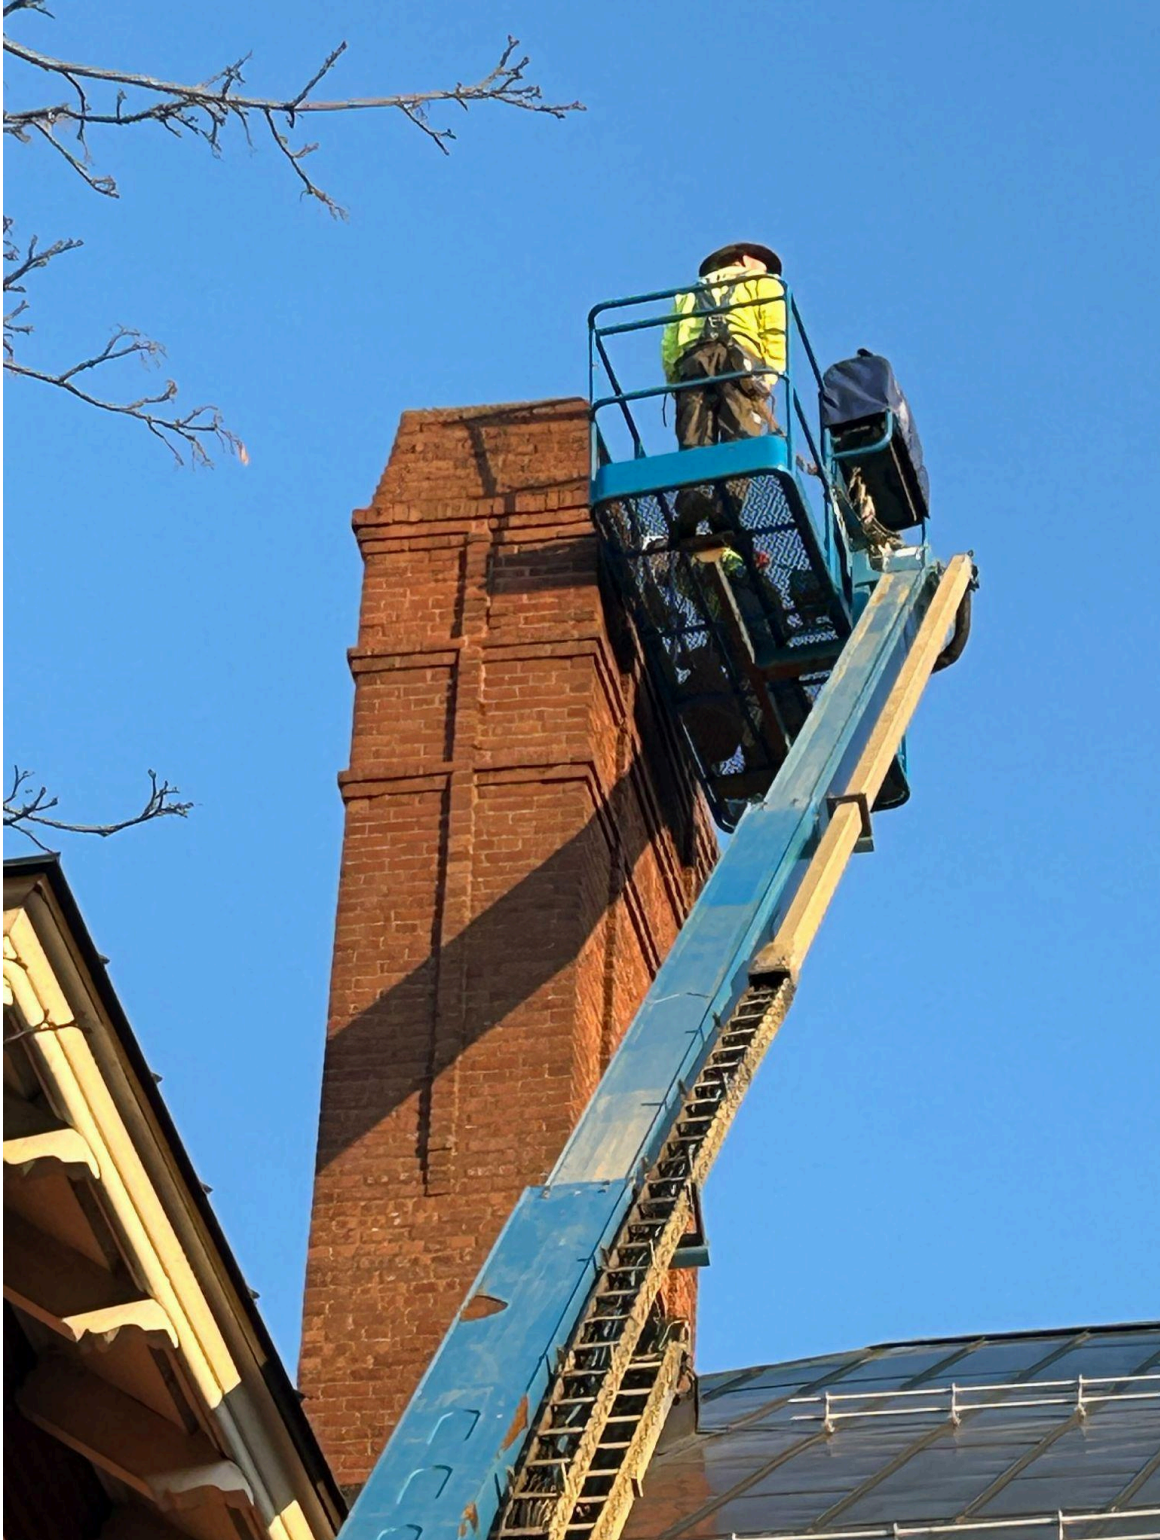
A consultant is inspecting the chimneys to give the School District a direction of what may need to be done with the four chimneys on the 1904 wing of the building.
