FRACTURE ANALYSIS OF A 1994-1997 HONDA EXHAUST MANIFOLD

Authors: Caleb Leavitt, Mariko Belle Liwag, Vivian Mac, Wyatt Taylor

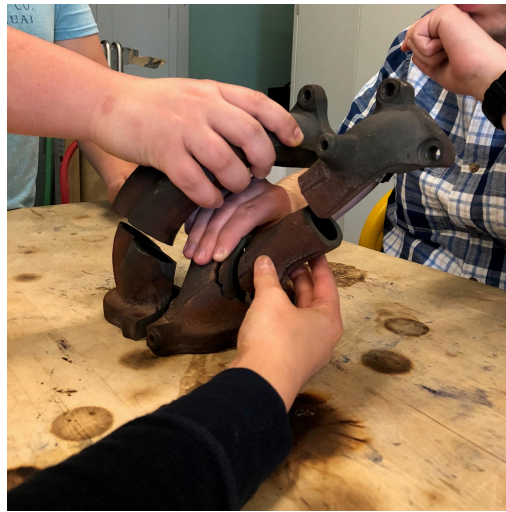
Figure 1: Configuration of how the exhaust manifold should look when all the unattached pieces are reconnected.

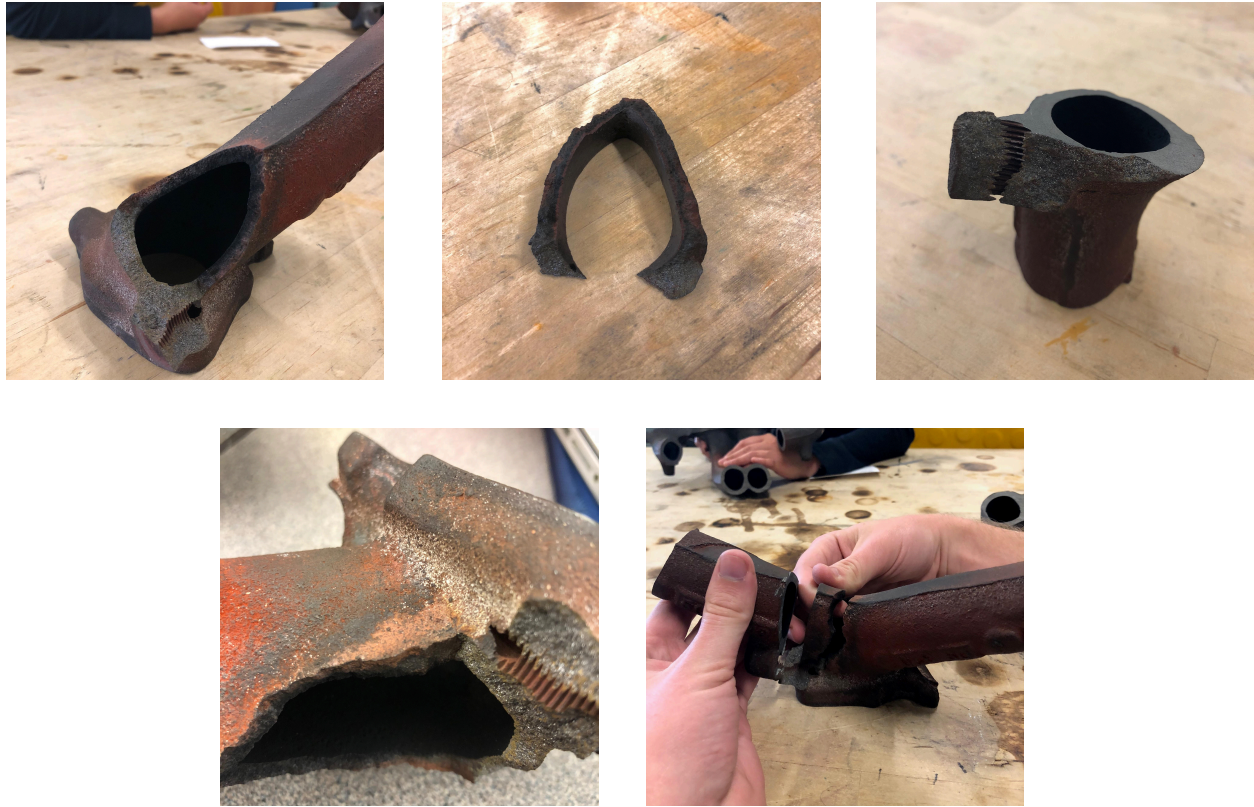
Figure 2: Dismembered pieces of the exhaust manifold given for analysis. (a) and (b) are

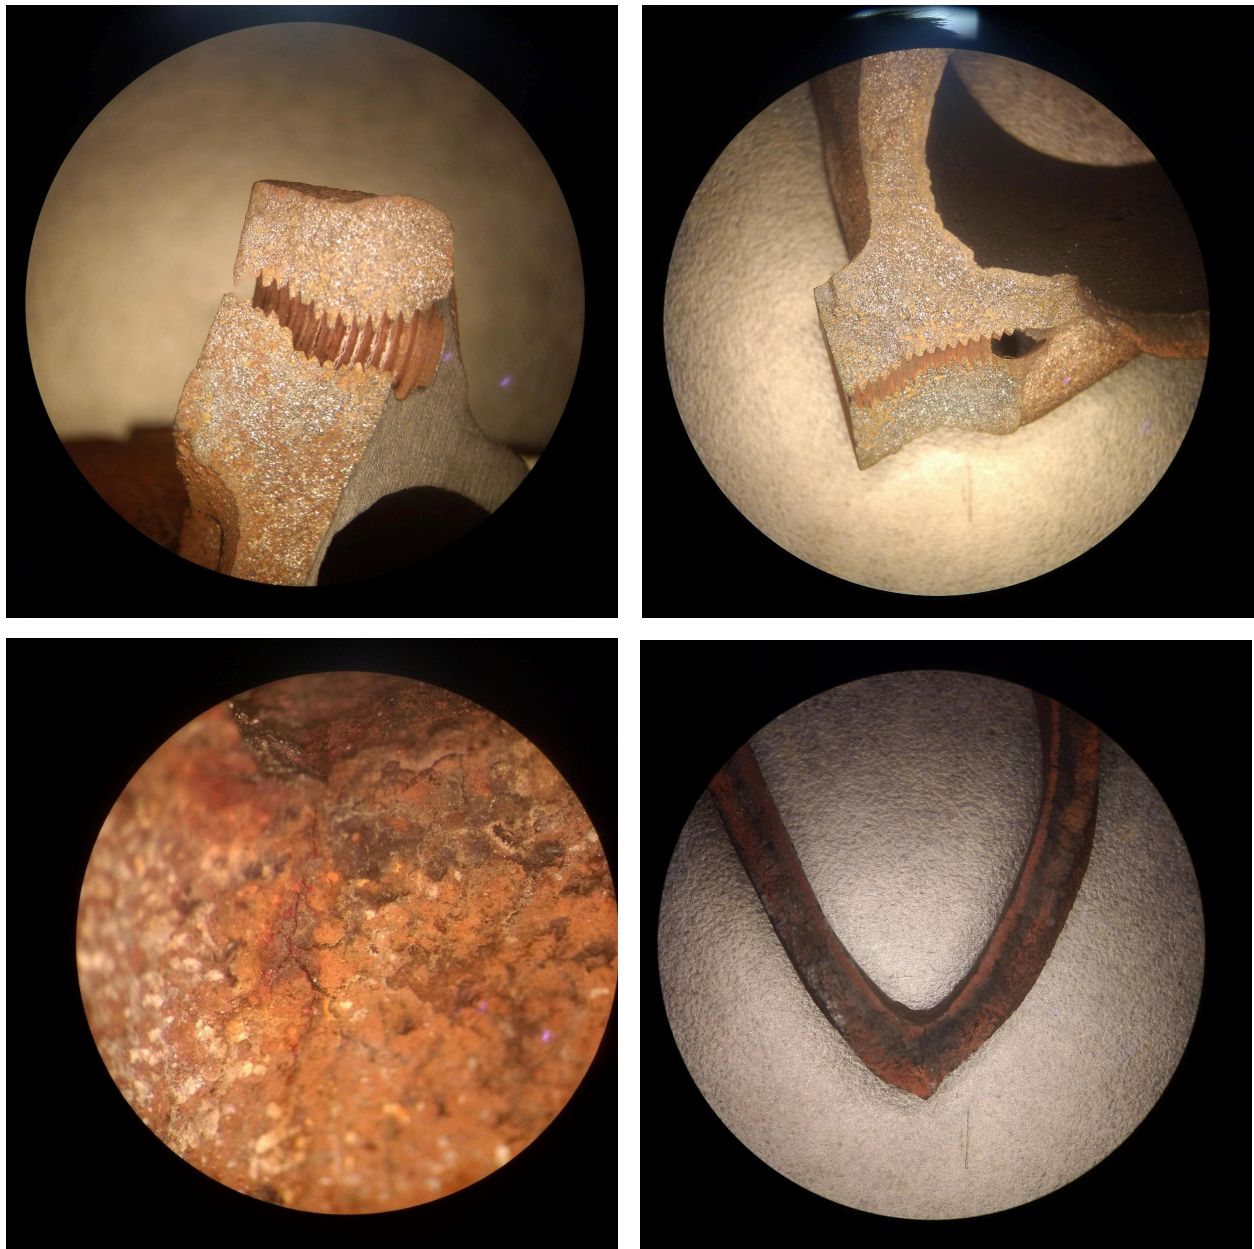
Stereo microscopy revealed a dull gray fracture surface, with some smaller cracks visible running perpendicular to the outer and inner surfaces of the casting. There was also contamination visible on sections towards the top of the “horseshoe” shaped sample (Figure 3). These contaminated areas indicated the crack growth over time, since the partially cracked sections were subjected to vibrations causing them to rub together, as well as exhaust flow escaping through the crack, contaminating and wearing down the surface. The final fracture is clearly visible as the dull gray area of the fracture surface.

Figure 3: Stereo microscopy of different fracture surfaces

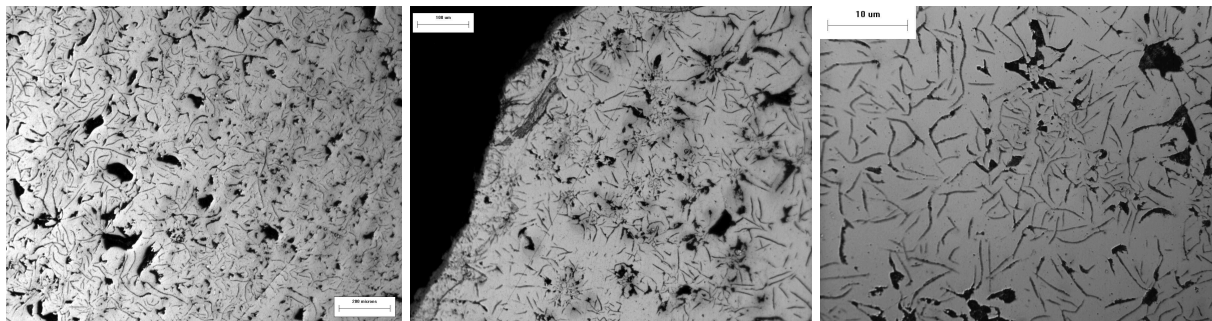
Metallography of a typical section of the manifold near the fracture was performed to evaluate the microstructure and inclusions in the metal. Grinding and polishing revealed a characteristic cast iron microstructure, with large graphite flakes clearly visible throughout the sample (Figure 4). Etching was performed to further reveal the microstructure, primarily inclusions or other particles. Etching revealed the presence of nodules in the sample, which can be clearly seen in Figure 5. These nodules and voids are intermixed with and surrounded by the graphite flakes that were visible before etching.

Figure 4: Images of polished and unetched sample. (a) shows the base metal at 50x magnification, (b) shows the inside edge at 100x magnification, and (c) shows the inside edge at 200x magnification.

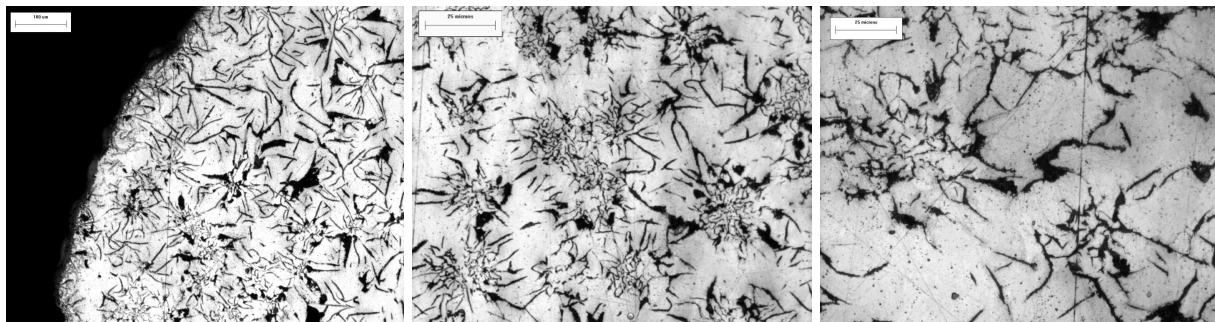
Figure 5: Images of polished and etched sample. (a) shows the inside edge at 100x magnification, (b) show the inside edge at 200x magnification, (c) show the inside edge at 500x magnification.

These manifolds are usually casted as seen by the microstructures seen in Figures 4 and 5. These result in the typical cast iron microstructure with graphite flakes which form during solidification in an austenite matrix (Figure 9). Silicon is alloyed to promote graphite formation to yield low ductility, moderate strength, and high thermal conductivity. The wear and abrasion resistance of gray cast irons usually depend on the microstructures.

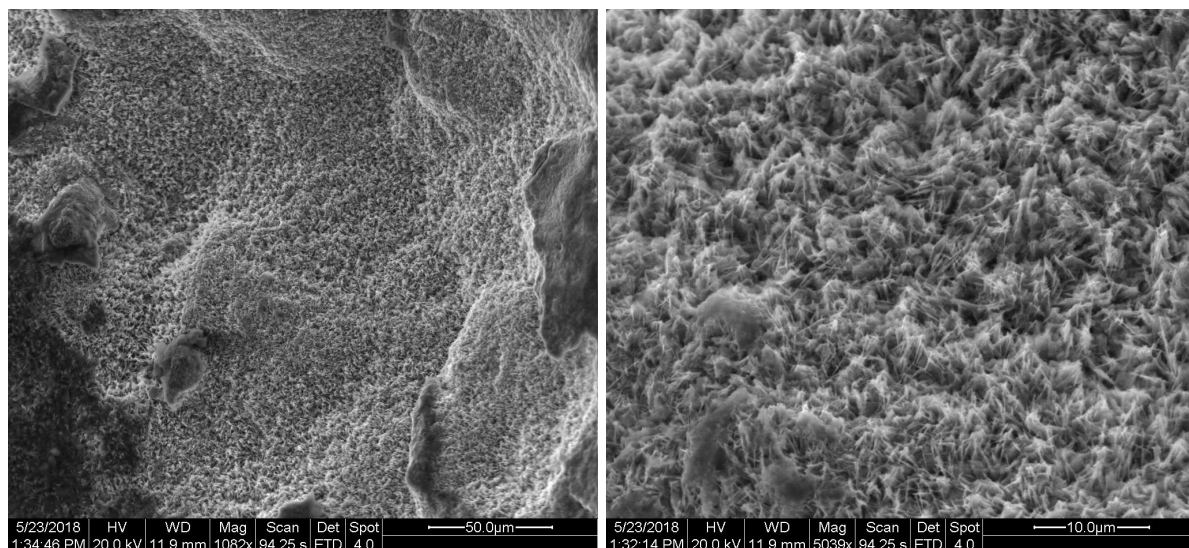
SEM imaging revealed two primary fracture surfaces. The first fracture surface is the undisturbed fracture surface, which was also characterized as a “flakey” fracture surface (Figure 6). This is because the fracture surface clearly shows the graphite flakes which were observed during metallography. Due to the fine appearance of this surface, it is most likely an untouched surface.

Figure 6: Typical undisturbed fracture surface displaying exposed graphite flakes.

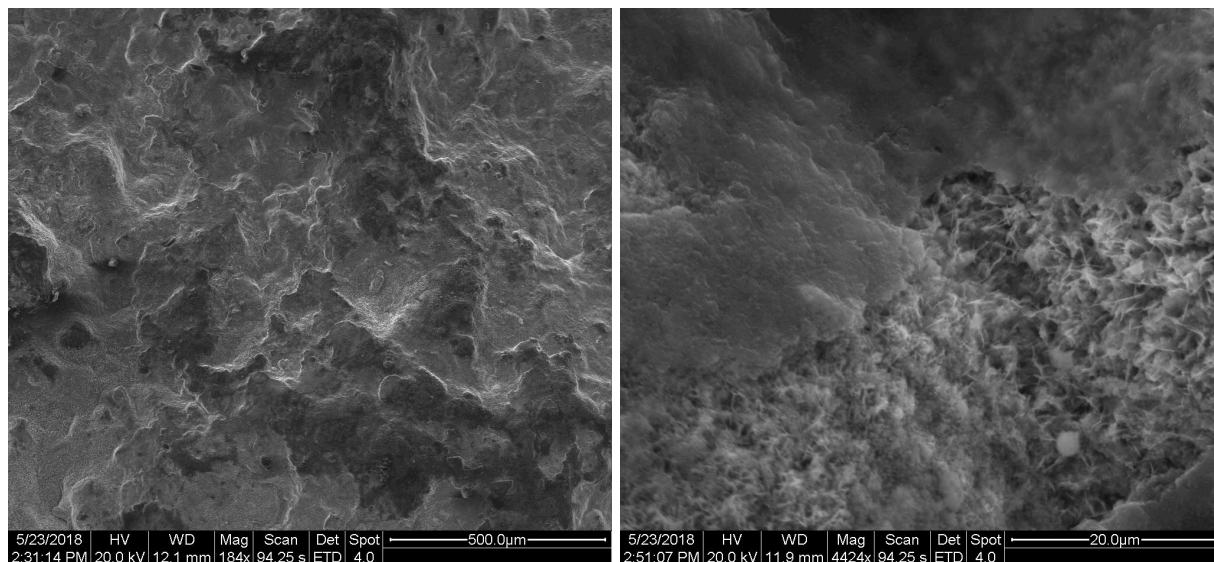
The second observed fracture surface is a typically smooth surface. This surface is formed by erosion from the flow of exhaust gases and vibrations rubbing the crack surfaces together while the part was still intact (Figure 7). This smooth surface is typically found in raised areas where the exposure to exhaust gases and other surfaces was the highest. Figure 8 shows a close up of a transition between the two surfaces, with one image being focused on the flakey fracture surface, and the other being focused on the raised smooth section.

Figure 7: Worn fracture surface shown on the left. Right image shows combination of worn and flakey fracture surfaces.

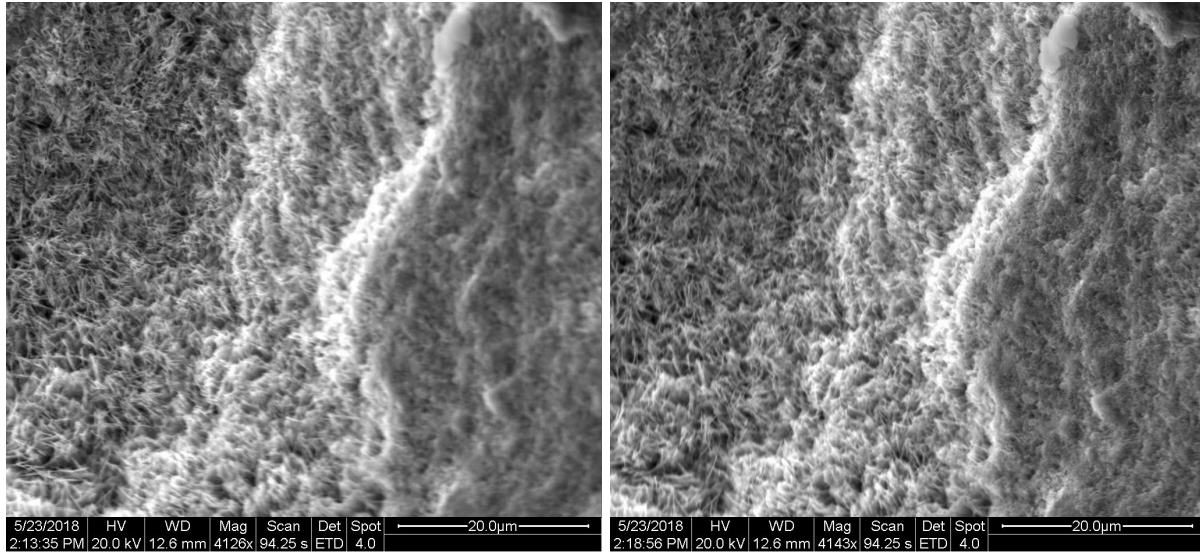
Figure 8: Contrast of two fracture surfaces found near the tip of the casting. The image on the left is focused on the lower region typical of an undisturbed or flakey fracture. The image on the right is focused on the raised region which has been eroded by exhaust flow and vibrations.

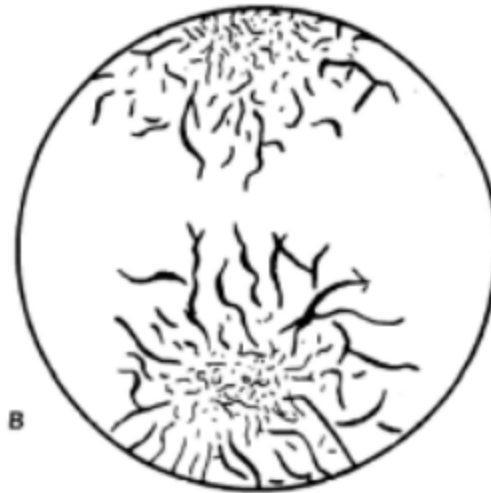
Depending on the conditions during solidification, the graphite morphology and distribution may vary. In the case of the manifold, the microstructures revealed Type B morphology (Figure 10).

Figure 10: Type B graphite morphology. This structure is the most similar to the structures seen in the manifold.

According to ISO 945, Type B morphology is due to poor inoculation. Inoculating the molten steel prior to casting introduces sites for eutectic graphite to nucleate as flakes during solidification. The precipitation of SiO_2 nuclei occurs during inoculation, which are sites for the graphite to grow. Effective inoculation results in uniform mechanical material properties and the prevention of the formation of iron carbide [5]. When the steel is poorly inoculated, there are not enough nucleation sites for the graphite flakes to distribute, producing an inhomogeneous graphite flake structure. This nonuniformity in the distribution of the flakes can be seen in the SEM images, causing localized areas of carbide formation.

1. The quality of the casting should be more tightly regulated, to prevent poor microstructures associated with poor inoculation. This should reduce the flaws which cracks can start at, and therefore increase the toughness of the manifold and increase its service life.
2. The mounting for the manifold should be revised to include a system for dampening the vibrations, such as a spring or rubber mount. The current system is hard mounted on both sides, increasing the sensitivity to vibrations. With a damped mounting system, the manifold should be less sensitive to vibrations propagating any cracks.
