## **Termite Inspector 4 - Report Marked as Complete**

## 2) 2nd Floor Attic Defects - \$7k to \$10k

### 3) Fascia Defects - \$8,000

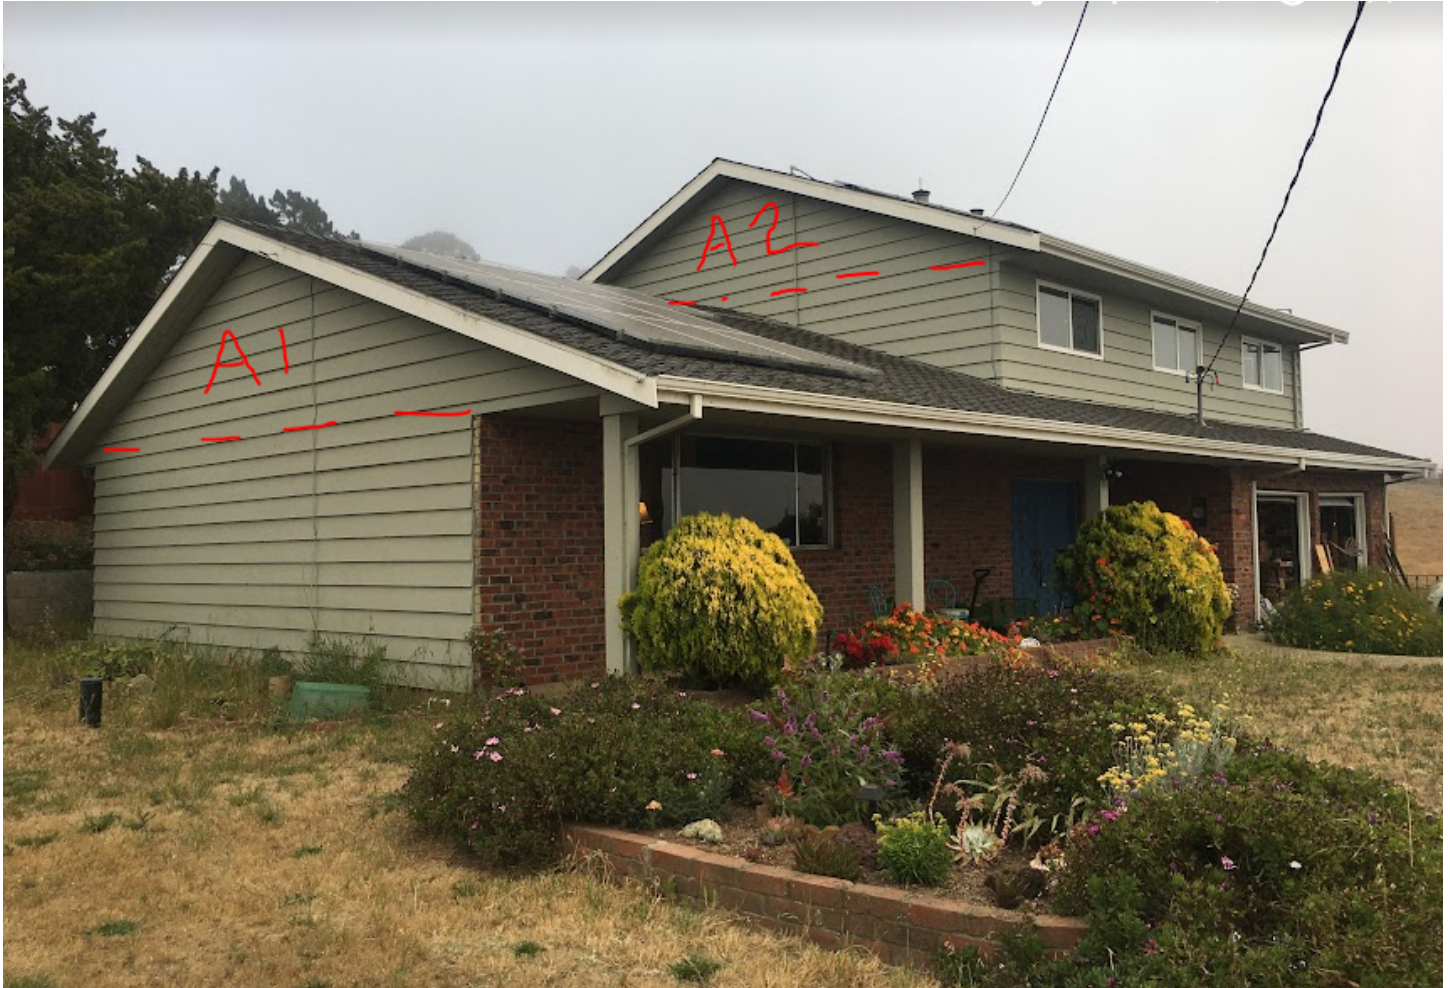
Anyone experienced with home inspections knows there are two attics to be inspected, assuming there are no vaulted ceilings, which there are not.

All experienced Home Inspectors would EXPECT two different attic access points for two different attics.

No Honest or sincere inspector would have any confusion about the idea or fact that these two attics are not connected to each other or accessible to each other.

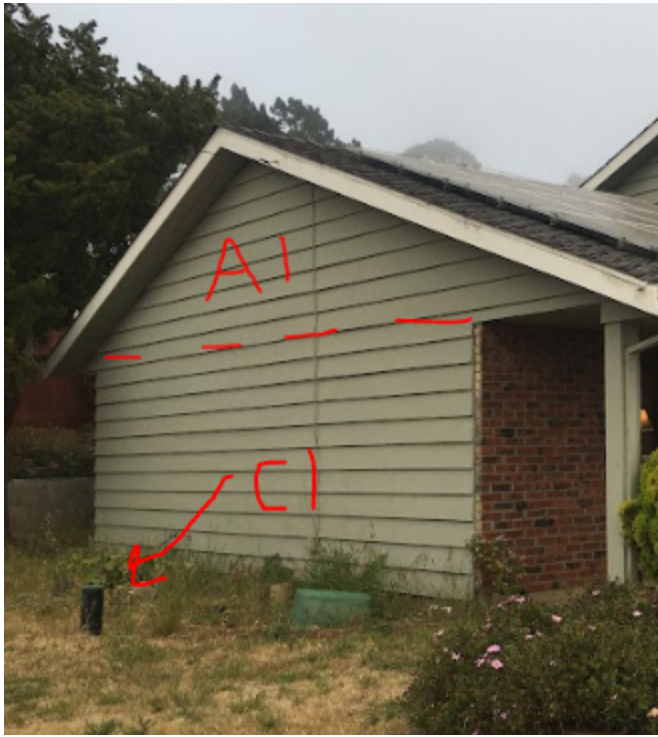
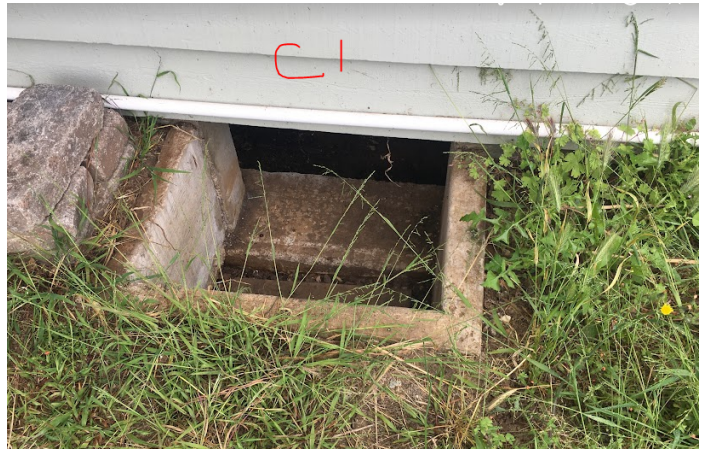
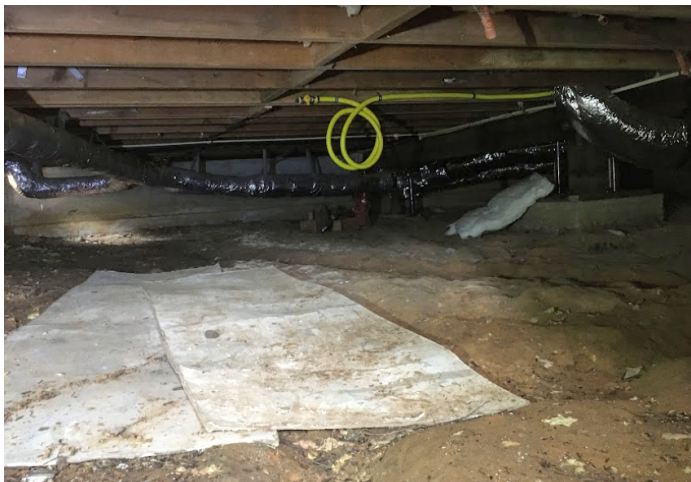
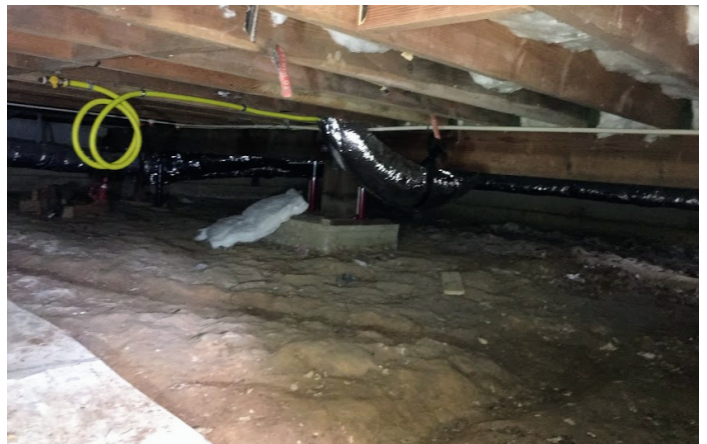
There is a 36" high crawl space under the left side of the home. (the right side is built on a slab)

**He failed to inspect the 600sf, 36” high crawl space.** The omitted inspection was NOT noted in the report summary at all. A suggestion was made on page 6 in the details. An omission of this magnitude belongs on the Report Summary in BOLD..

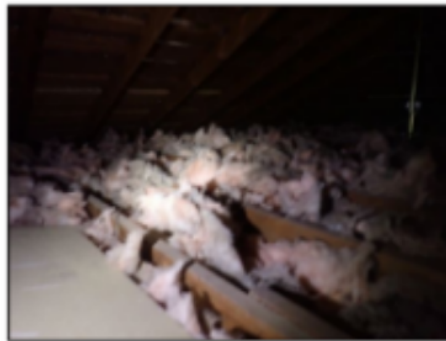
- **Tunneling observed at house insulation.**
- **The insulation installed in the rafters is disturbed by rodent activity. The house insulation is minimal. Recommend having the existing insulation replaced due to rodent damaged.**

*Found dispersed.*

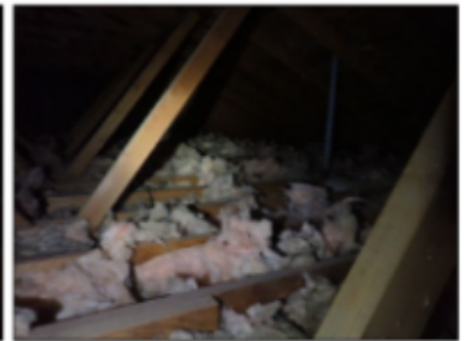
*Rodent activity noted.*

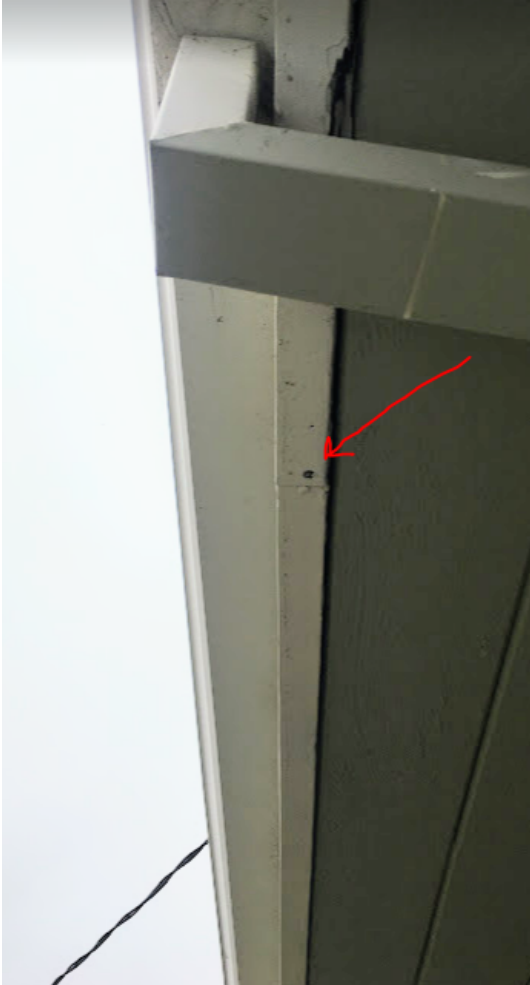
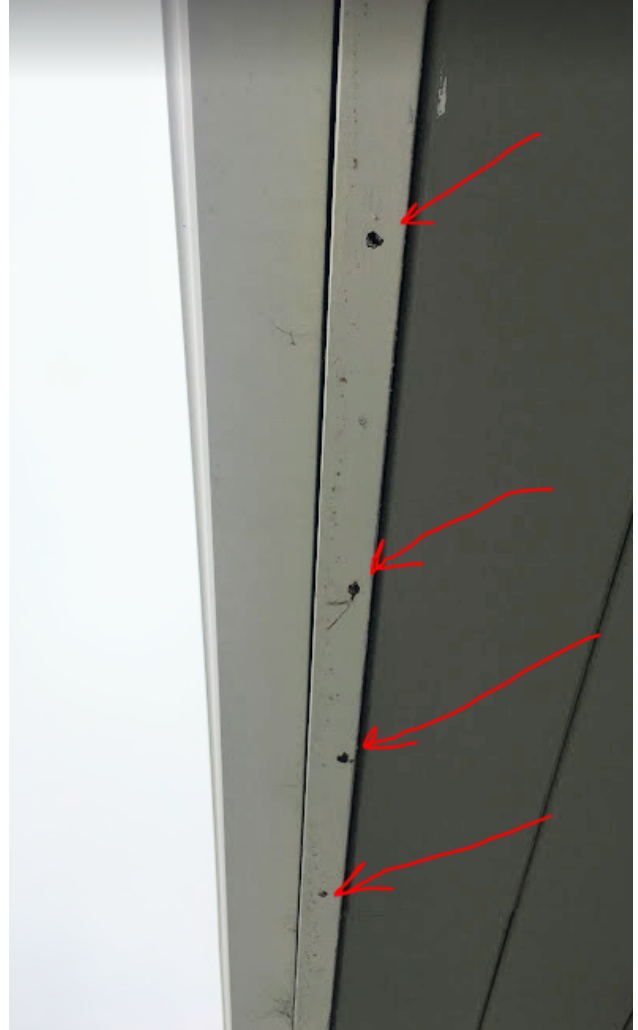
The arrow below is pointing to a perfectly round hole in the fascia. That hole was created by Alex when doing his inspection. They use a bolt on the end of a stick to push on the wood to see someone has "covered up" dry rot with putty and paint.

DRYWOOD TERMITE DAMAGE WAS NOTED TO FASCIA.

REMOVE AND REPLACE OR REINFORCE AS NECESSARY WITH TODAY'S AVAILABLE WIDTHS AND GRADES.

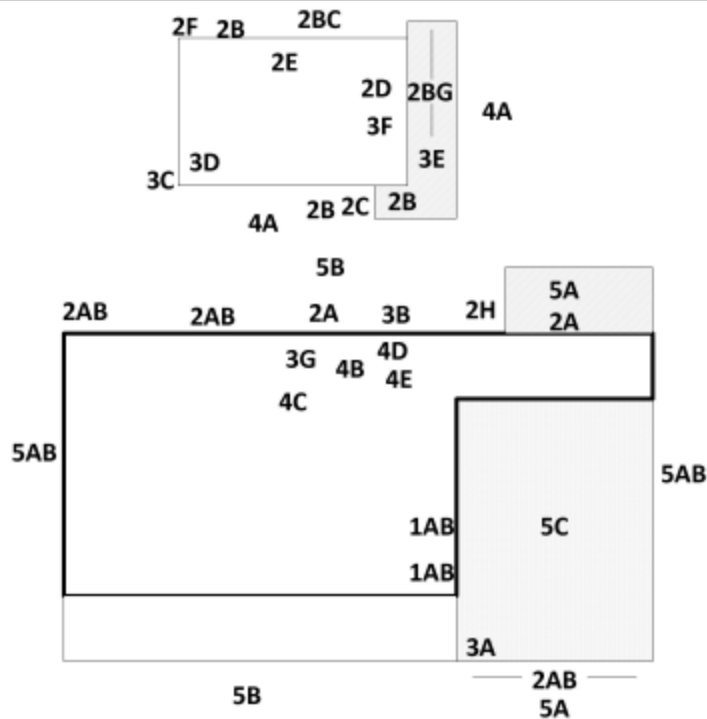
If he had filled this out honestly, it would have looked more like this.. In fact, the 8,000 would have been spread across the 2's, but you get the gist. Without a professional Inspector who pointed out the damage with a little text telling you that damage represented \$8,000 in repairs would you have known that?
