CENTER FOR ECOLOGY & NATURAL RESOURCE SUSTAINABILITY

SITE 3

Morgan

*Report Written By: Stephanie Deibel
Date of Site Visit: 15, 18, 27 June 2012
Date Finalized: 04 September 2012*

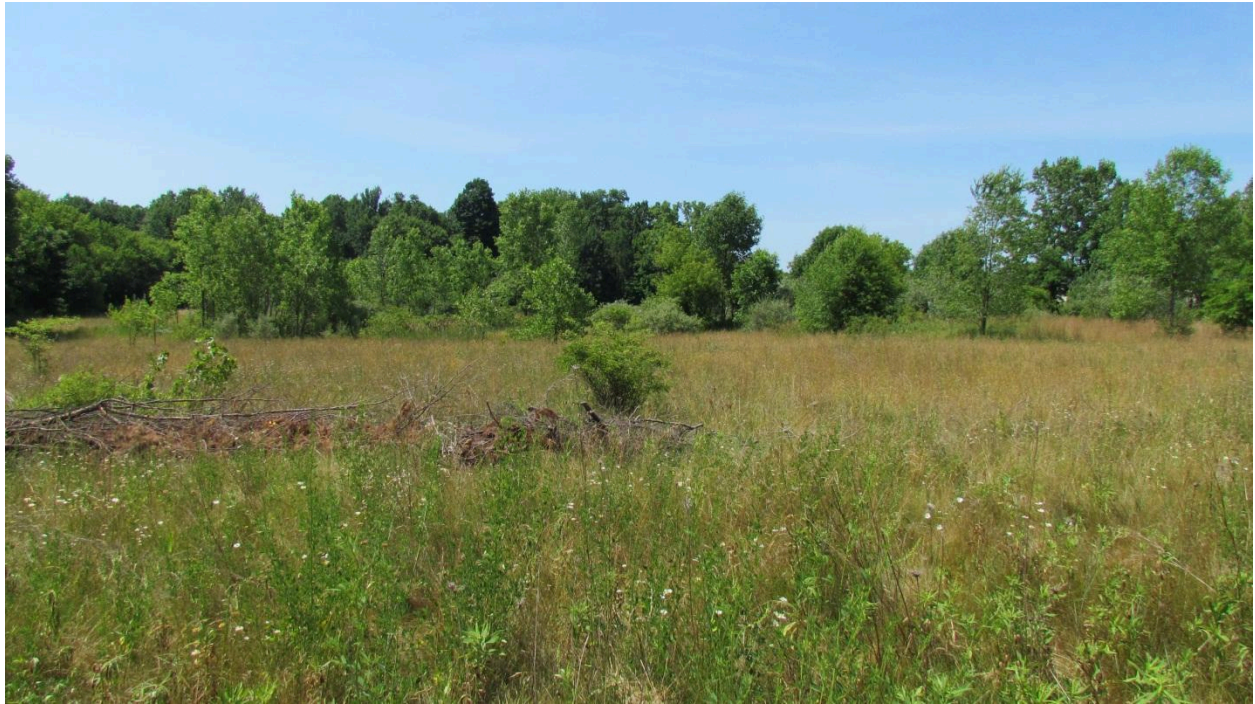
S3-02: *Open Field Area*

- An Open Field Area – Photo Point S3-02 – consists of small trees and shrubs sparsely spaced. It seems to be recovering from what use to be an old road/construction area.

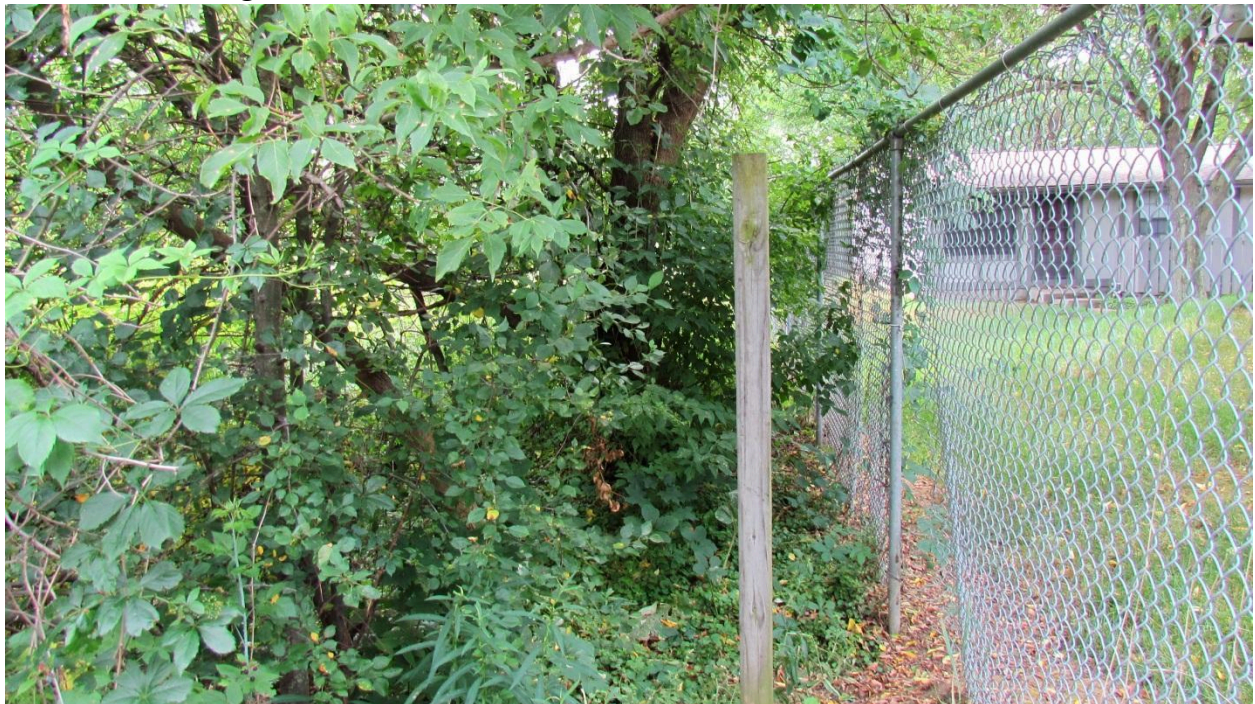
S3-04: *Western Edge*

- The Western Edge – Photo Point S3-04 – is marked by a fence. An electrical box is located in a small wooded area near this point.
- A Clearing in a wooded area – Photo Point S3-08 – is dominated by shrub growth. Looking West and North is housing. Looking East the clearing continues. Looking South is a wooded area.

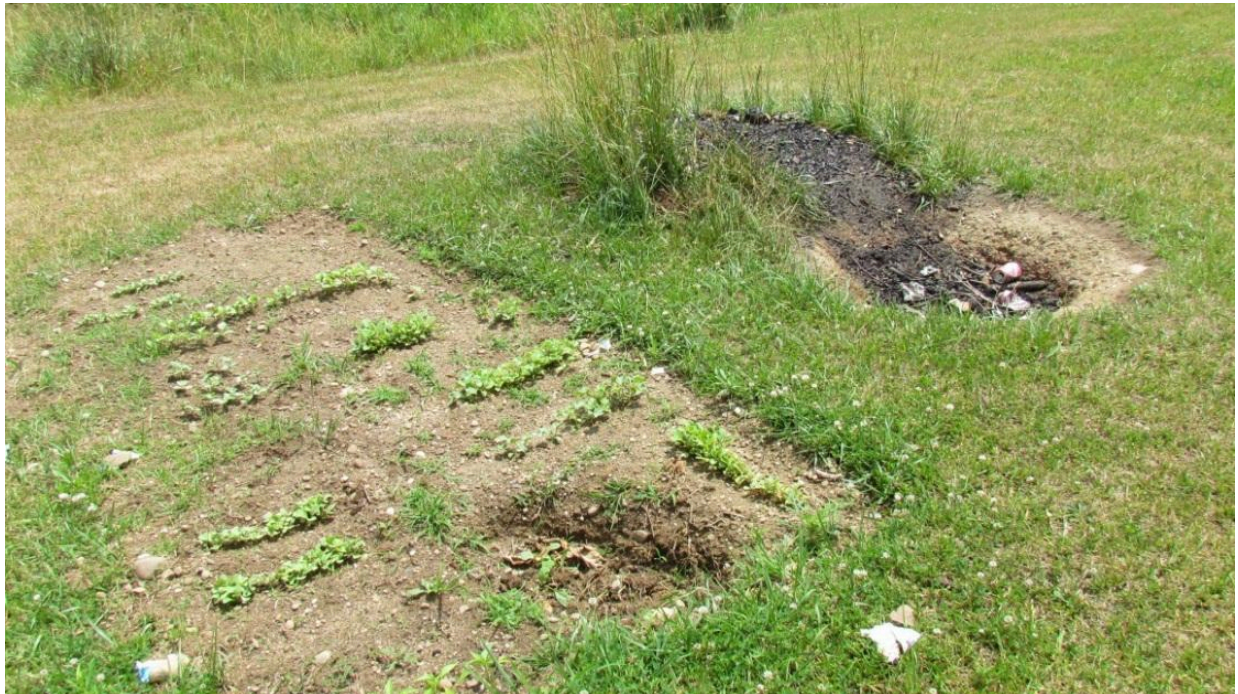
S3-06: *Residential Use 1*

- Residential 1 – Photo Point S3-06 – Tenants from the neighboring apartment complex on the western boundary line have built a fire pit, stacked fire wood, grown a garden, and made an aluminum can pile on KSU property.
- Residential 2 – Photo Point S3-07 – Tenants from the neighboring apartment complex on the western boundary line are growing a large garden on KSU property. Trash piles surround the southeastern edge of the garden.
- A BMX Bike Zone – Photo Point S3-36 – has been created by the neighboring residents. Trees are spray-painted with graffiti and numerous jumps and trails are present. Trash, including a couch, plastic bottles, and paper waste were present at time of visit.

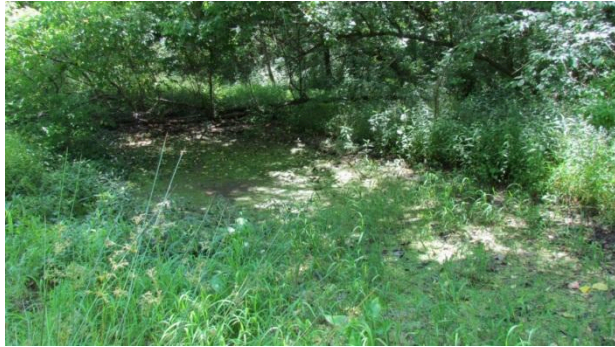
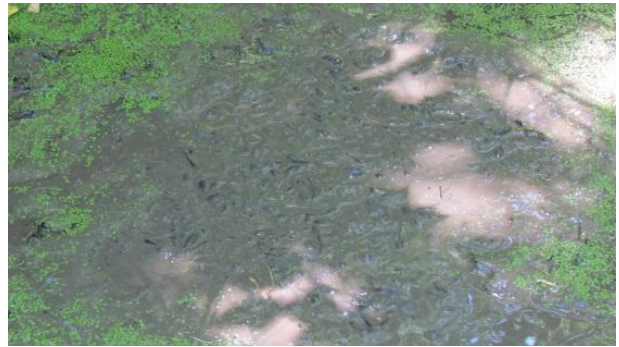
S3-10: *Ephemeral Pool*

- An Ephemeral Pool – Photo Point S3-10 – had little water present. An abundant amount of tadpoles were present during the visit. The soil around the pool area was very moist and fluffy.

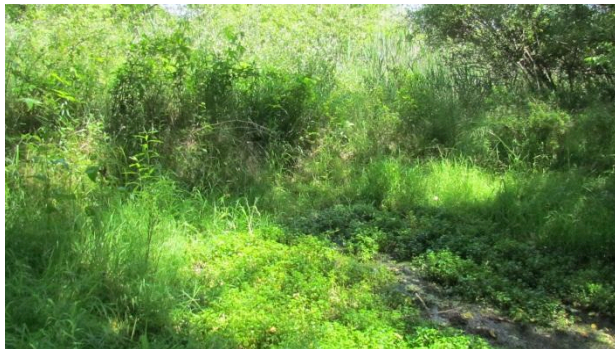
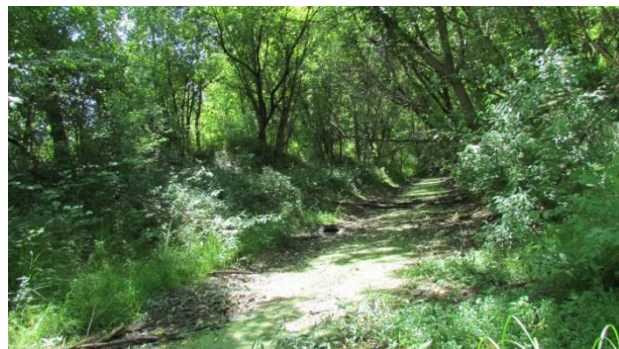
S3-11: *Pond/Stilled stream*

- A Pond/Stilled Stream – Photo Point S3-11 – seems to have been part of a stream that connected to the larger pond near photo point S3-18. From looking at old satellite images, it seems the stream was filled in at the clearing area to create a road that is no longer in use. The bottom seems to be made up of silt and has points where the depth is great, possibly old pooling areas. Woody vegetation makes up the riparian area on the East and Western sides. At the end of this area – Photo Point S3-12 – trash is located along the banks. The riparian area consists of woody vegetation with good understory growth.

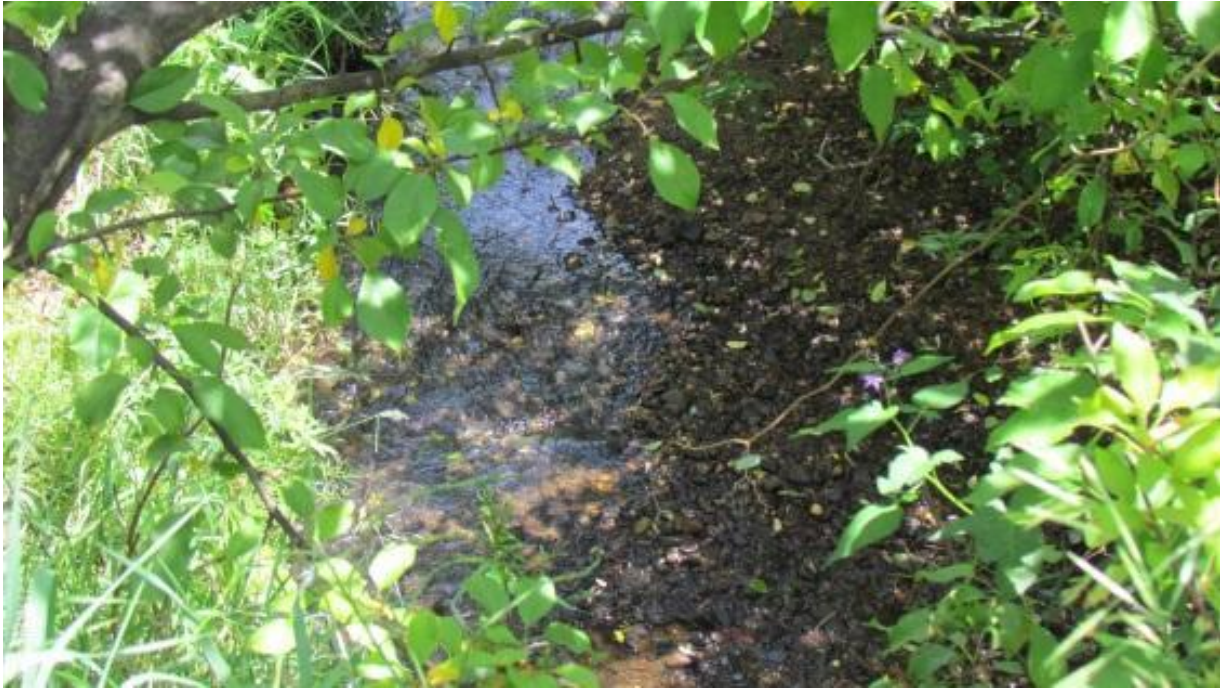
S3-13: *Corner and Creek*

- A Small Creek – Photo Point S3-13 – runs along the Southern edge of the property near photo point S3-34 and S3-35. Gravel and sand are the two dominant substrate types and both riffles and pools are present. Good riparian growth on either side of the creek makes it difficult to navigate along the sides at certain points.

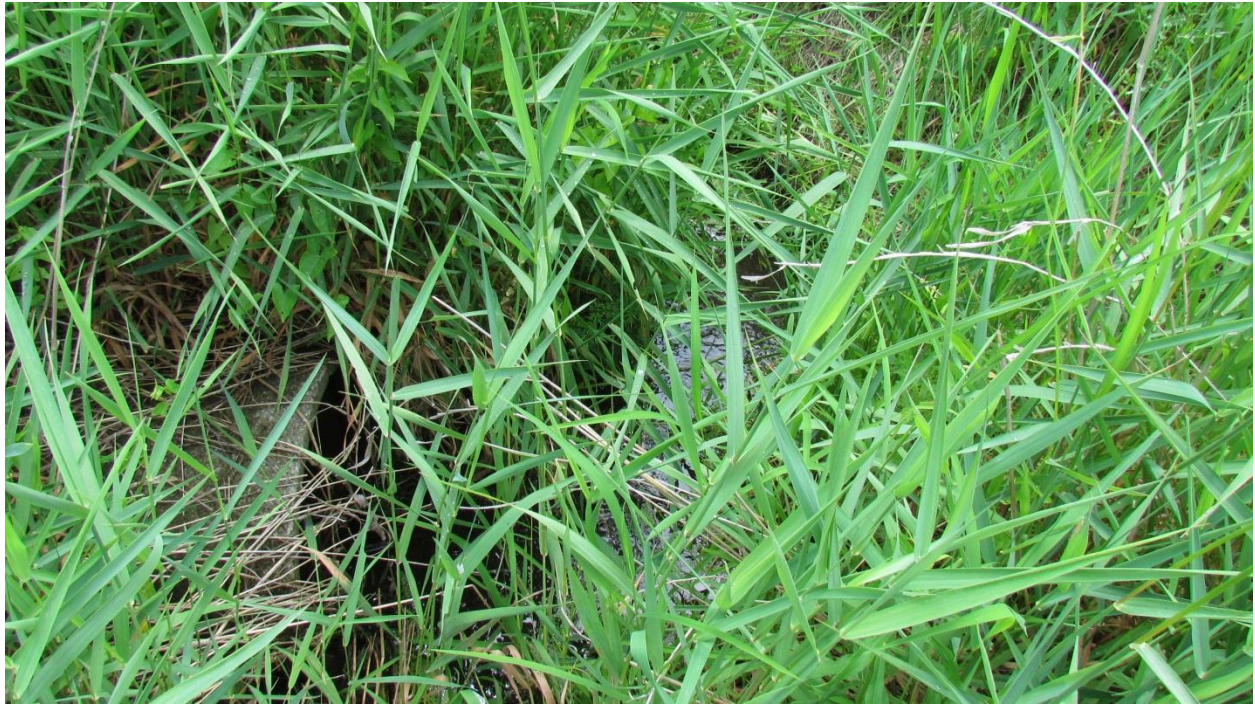
S3-17: Drain

- A Small Roadside Drainpipe - Photo Point S3-17 –drains into the pond, located centrally near the Northern property line bordering Summit Rd.
- A Large Pond – Photo Point S3-18 – has cattail growth with some shrubs mixed in around the entire perimeter of the pond. Duckweed was visible at time of visit.

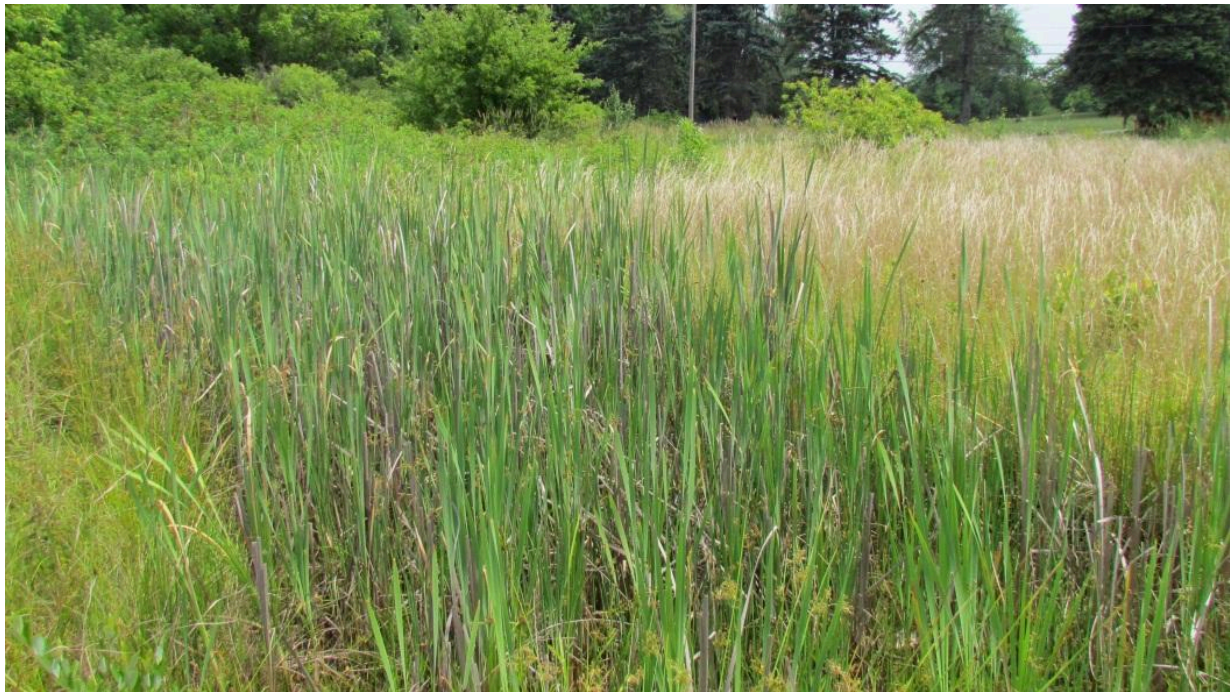
S3-22: *Possible pooling site*

- A Pooling Area – Photo Point S3-22 – is possible at this location. Similar grasses found in wet areas were observed at this point and the soil was very moist.

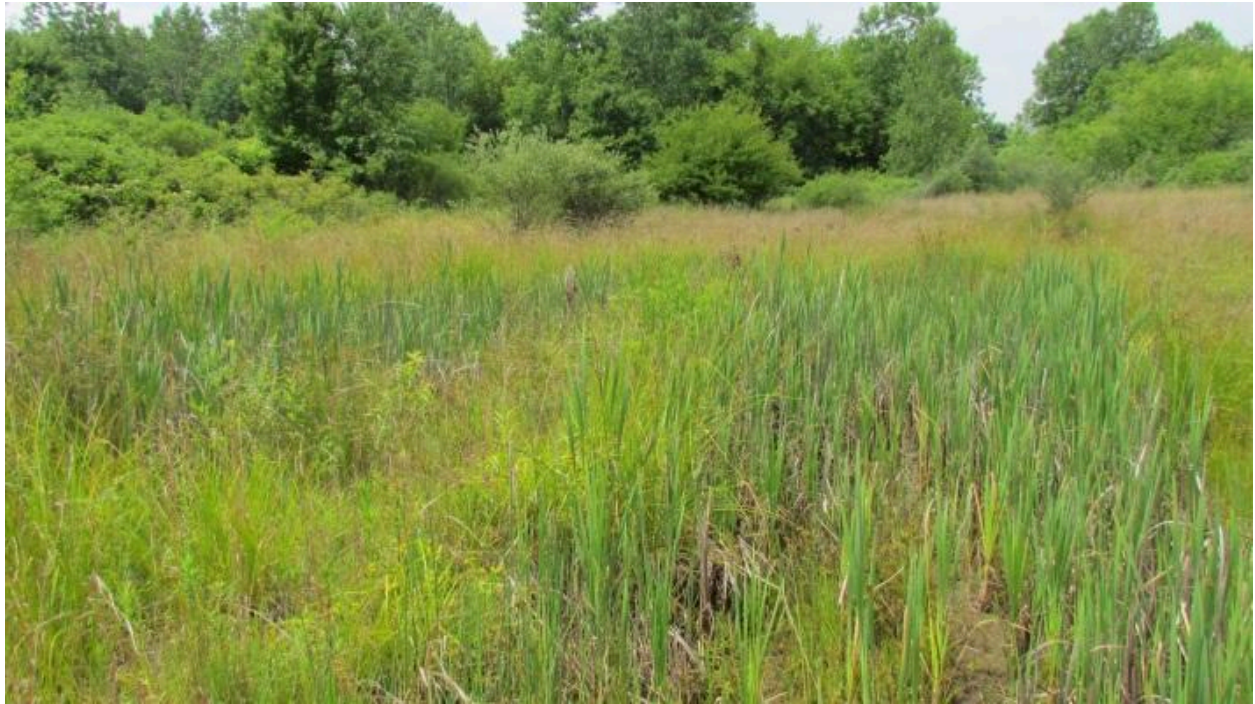
S3-23: *Small pooling area*

- Small Pooling Areas – Photo Point S3-23, S3-24 – seem to have been created by old tire marks. No water was present at time of visit, however, mud cracks were visible.

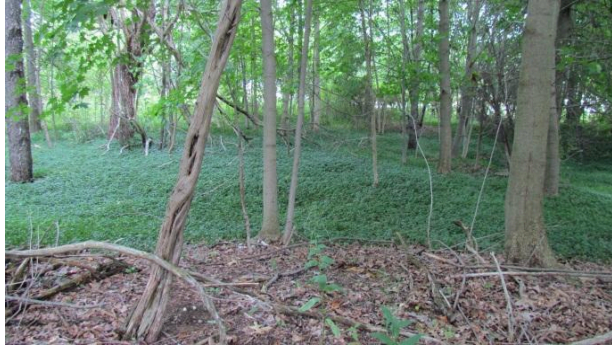
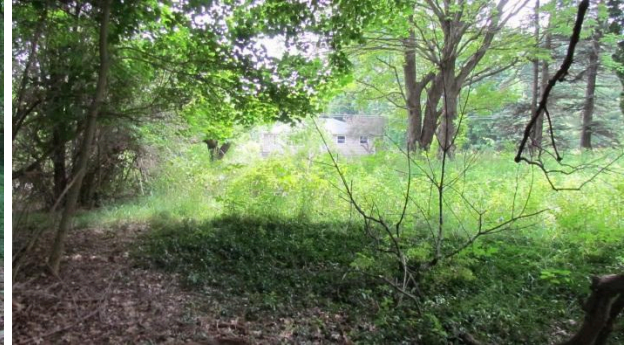
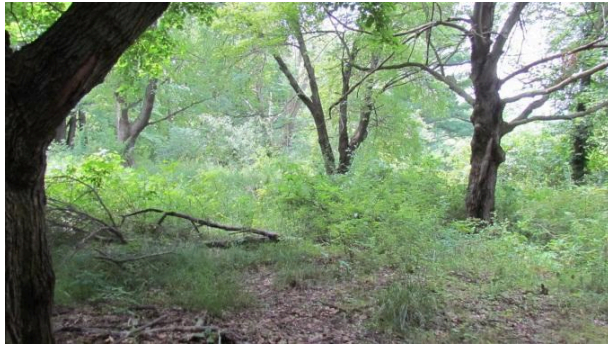
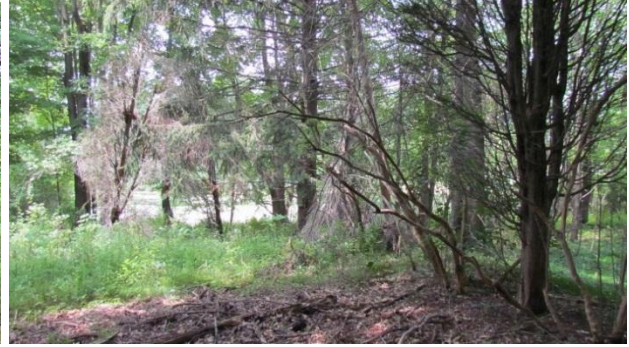
S3-26: *Clearing 2*

- A Small Clearing – Photo Point S3-26 – in the understory of an uneven aged forest I present at this point. The pond, photo point S3-18, is West, South is a wooded area with tall grass and blackberry bushes, East is a residential area, and North is a forested area with a monoculture ground cover with few large trees.

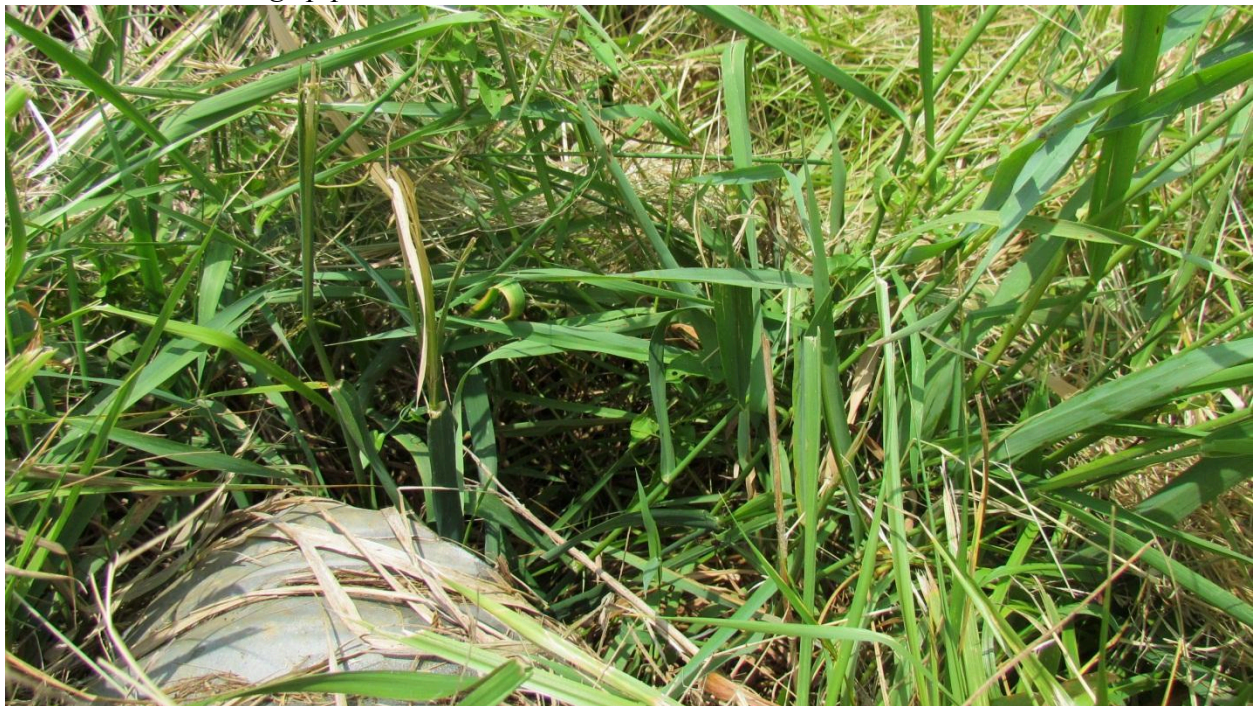
S3-27: *Metal Drainage pipe*

- Metal drain pipe – Photo Point S3-27 – is located centrally on the Eastern edge of property, West side of Burnett Road.
- Cement drain pipe – Photo Point S3-28 – feeds small creek that ends at photo point S3-29. Sand and silt substrate make up the bed of this creek. Bluegill and spawn beds were seen at time of visit. The creek meets a pooling area at photo point S3-29 which is connected to the large pond at photo point S3-18.

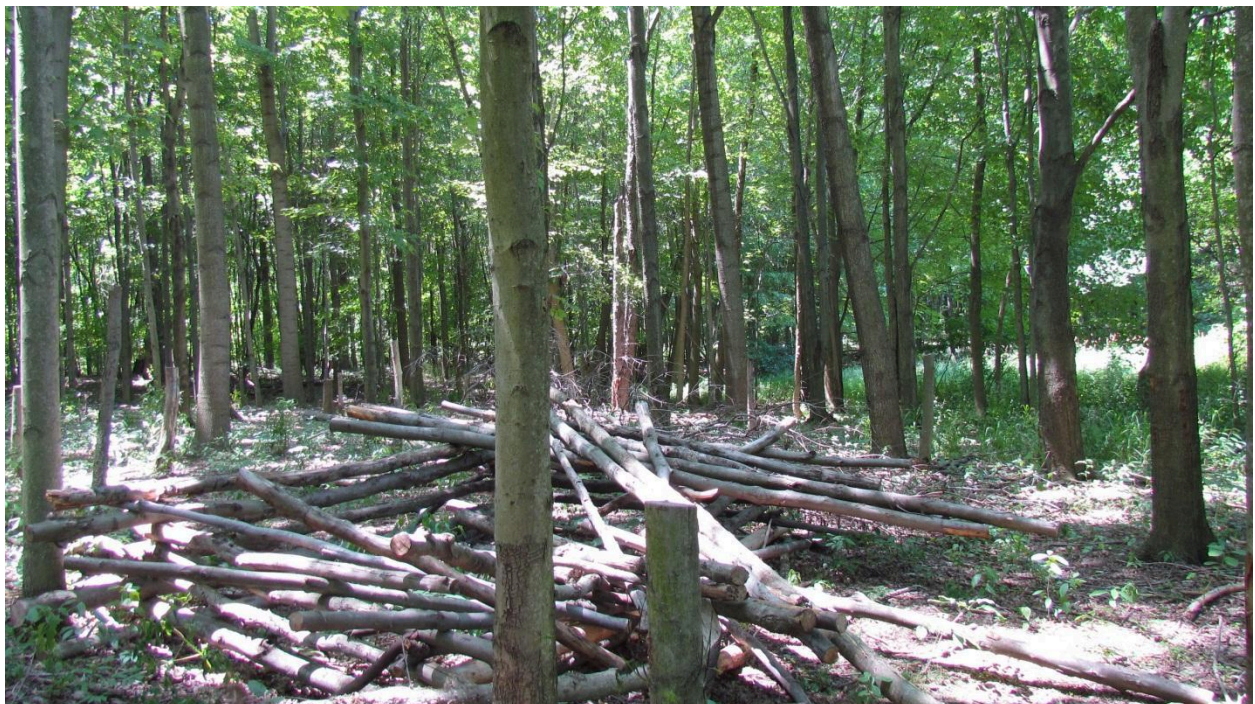
S3-30: *Trees cut down*

- Old tire and oil can dump –Photo Point S3-25 – old truck tires, oil cans, and other plastic bottles were abundant in this area.
- Tree cutting and fort building – Photo Point S3-30 – Trees ranging from 6-10" in DBH have been cut down with what appears to be a chainsaw. The cuts were very smooth and the trees were used to build a fort, in a "Lincoln Log" method. Could be utilized as brush pile for wildlife.
- Couch and miscellaneous plastic bottle dump – photo point 36 – old couch, laundry detergent bottles, and other plastics bottles are abundant in this area.

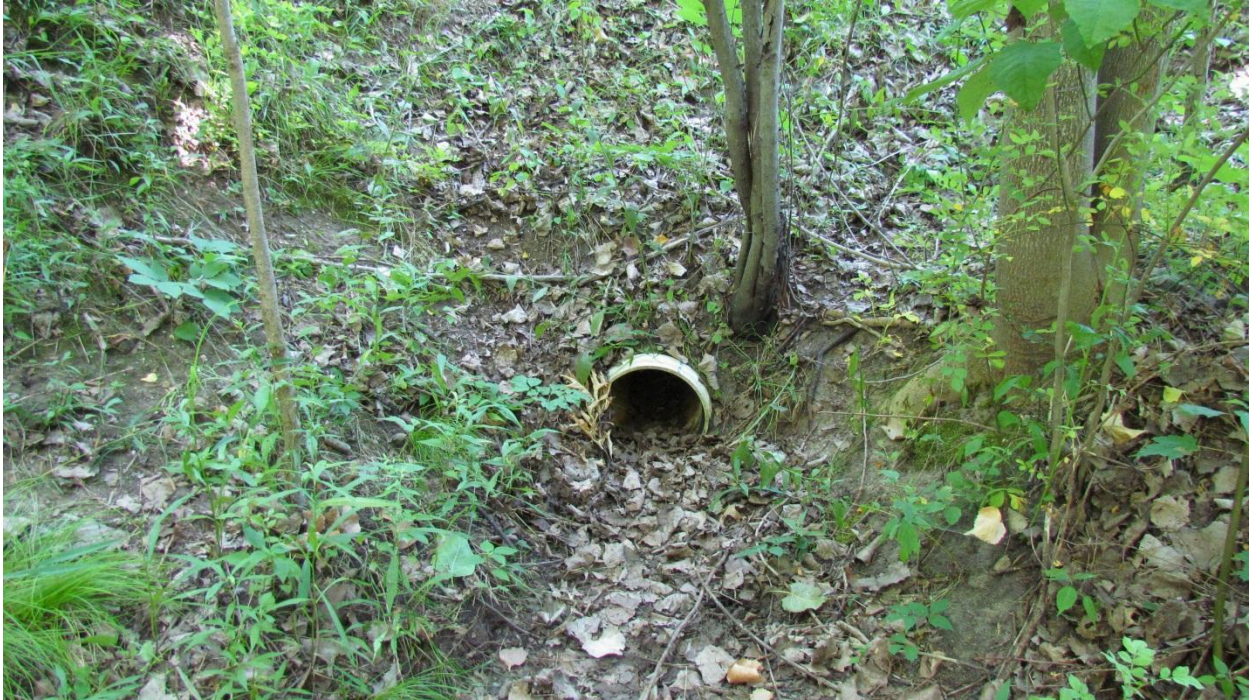
S3-33: *Drainage Pipe*

- A Pooling Area – Photo Point S3-33 - is adjacent to the small creek near photo point S3-13. No water was present at time of visit. A visible drainage pipe is likely to be the source of water in this area.

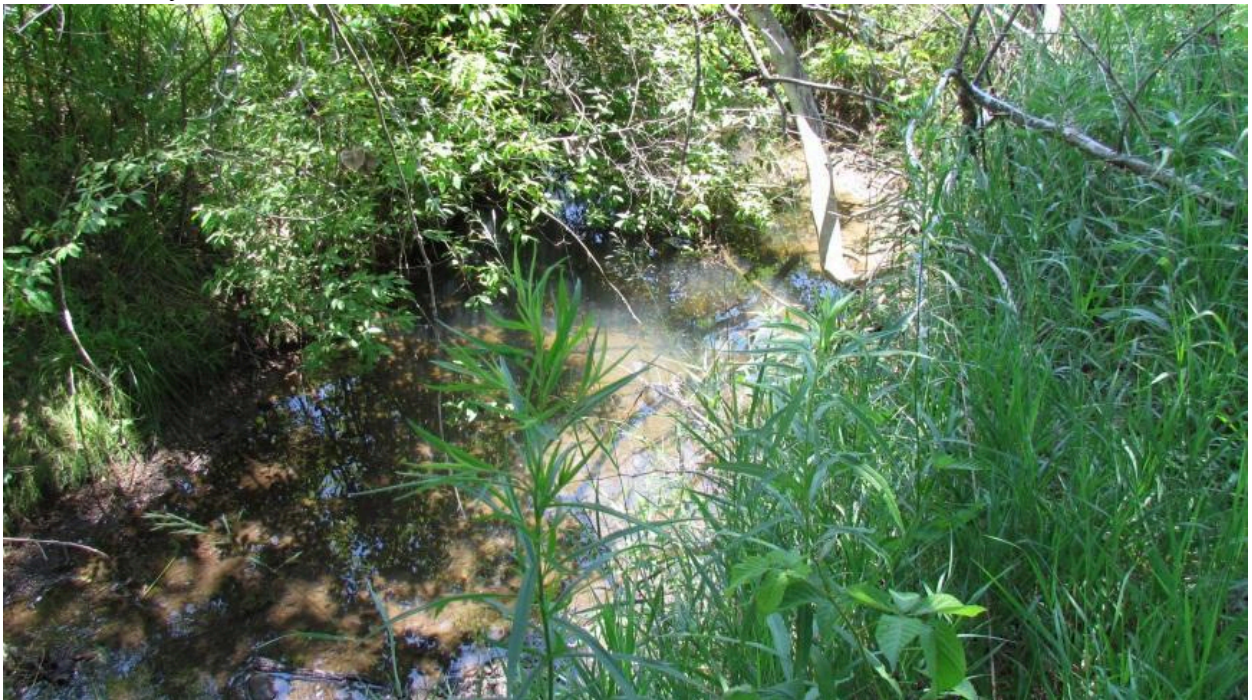
S3-34: *Part of creek near 13*

- Photo Point S3-34 represents a portion of the creek near photo point S3-13. Riffles and two pools are visible at this location. The water flows West to East. Cobble bottom with sandy pools make up the substrate. Good, heavy riparian growth on both sides shades the creek and can be difficult to walk through at certain times.

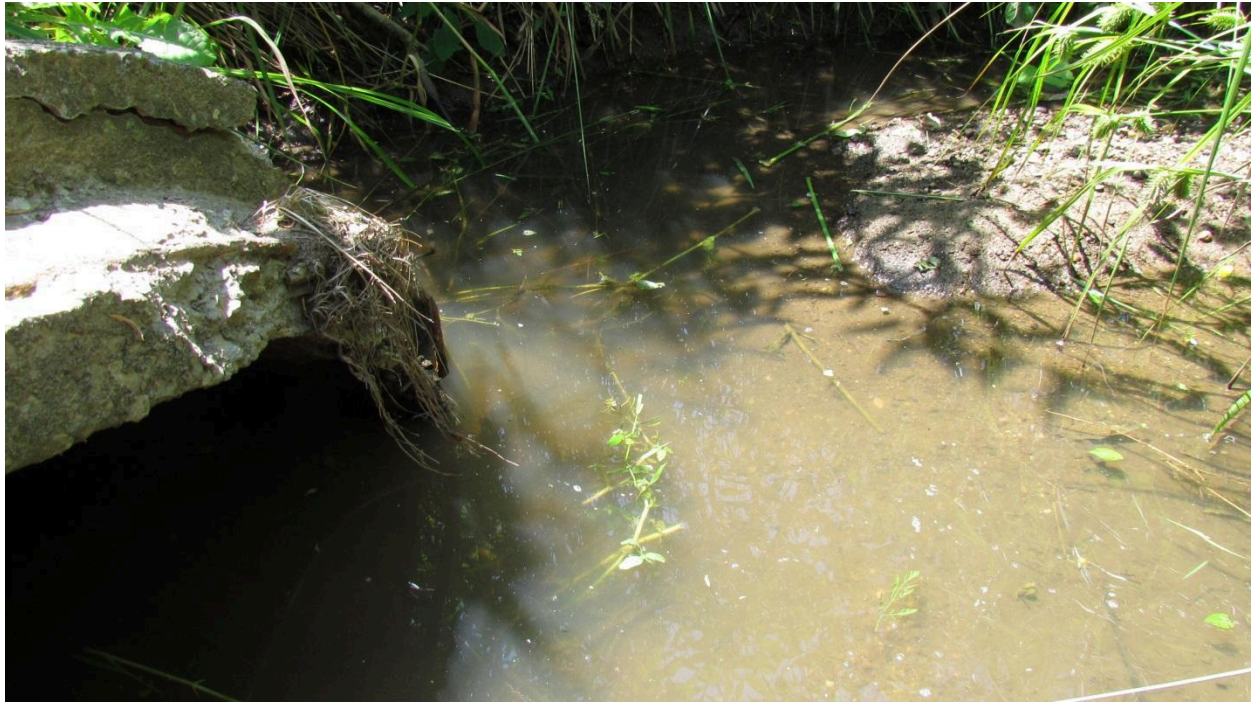
S3-35: *Drain outlet into creek*

- Large, Cement drain pipe – Photo Point S3-35 – outlets into creek near photo point S3-13. The creek substrate consists of sand and gravel. The Southern 261 boundary fence is no longer visible. The Northern side of creek (stream right) has heavy shrub growth. The Southern side of creek (stream left) has little riparian growth. Damselflies, crawfish, and small fish were spotted in this area.

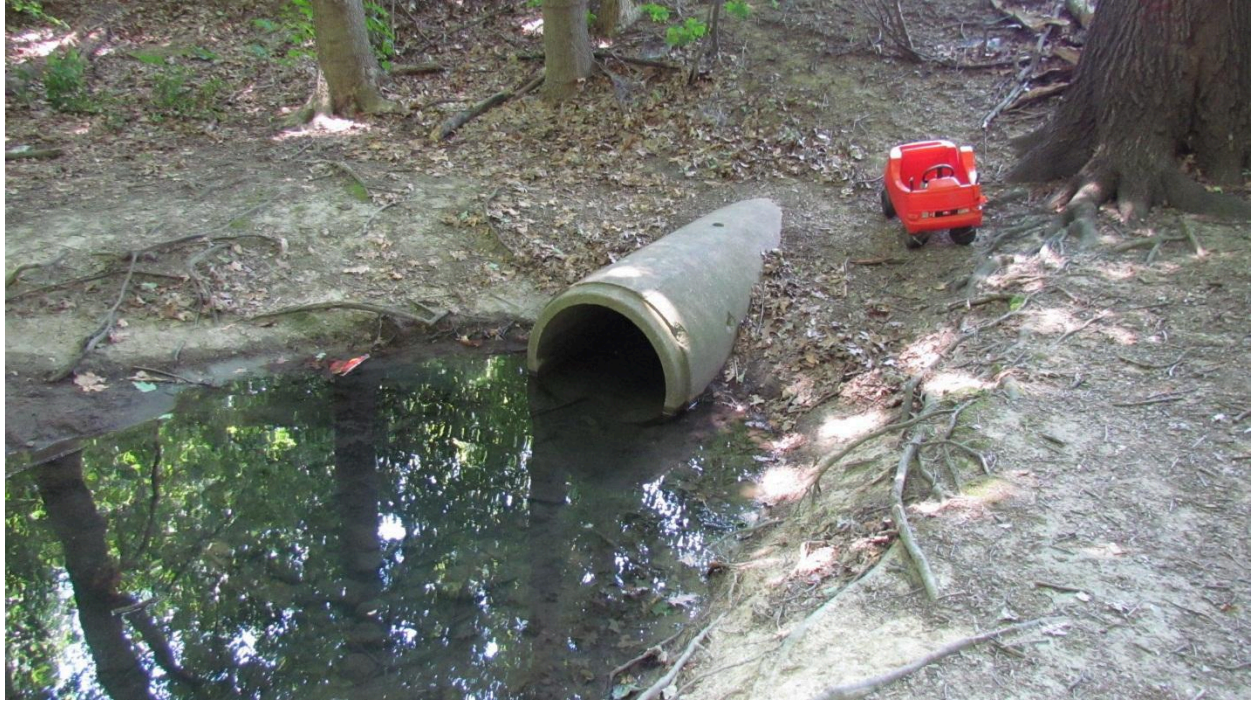
S3-37: *Drain pipe*

- Cement drain pipes – Photo Point S3-37 – empty into a pooling area. Unclear whether connected to small creek (13). Frogs spotted in pooled area.
