# CENTER FOR ECOLOGY & NATURAL RESOURCE SUSTAINABILITY

## **SITE 14**

### **Herrick Fen**

*Report Written By: Stephanie Deibel  
Date of Site Visit: 26 March 2013  
Date Finalized: 30 April 2013*

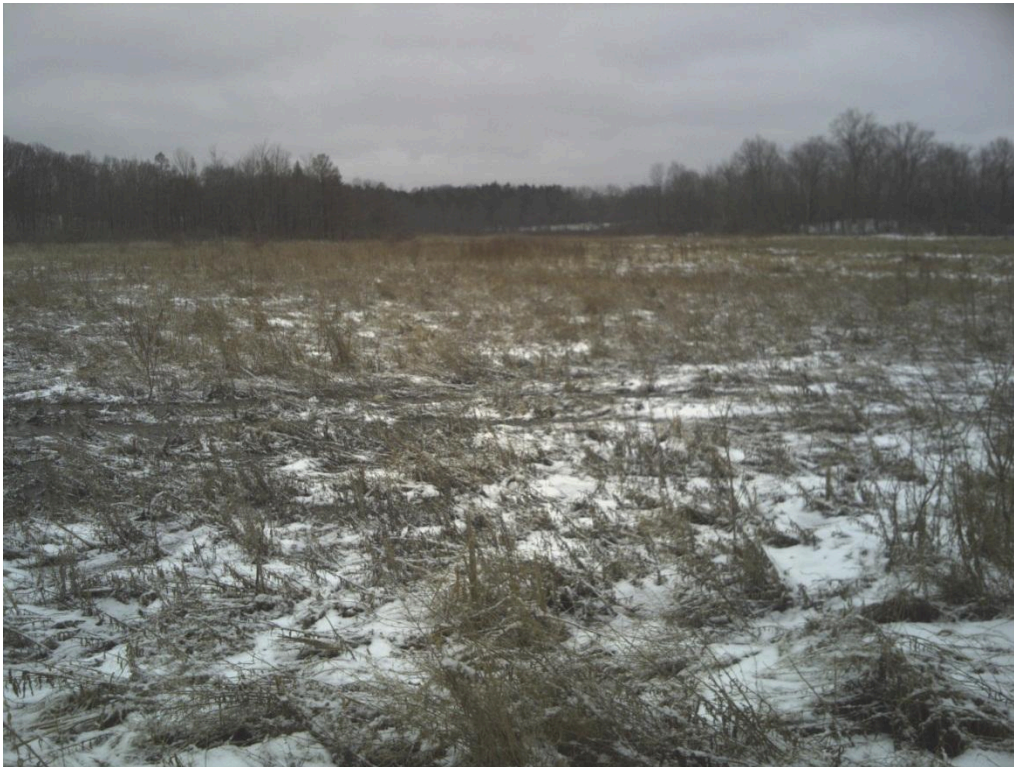
**S14-01:** *Boardwalk*

- Boardwalk – Photo Point S14-01 – starts at this location. Tire marks can be seen in the fen habitat. It is unknown whether the Nature Conservancy made these marks.

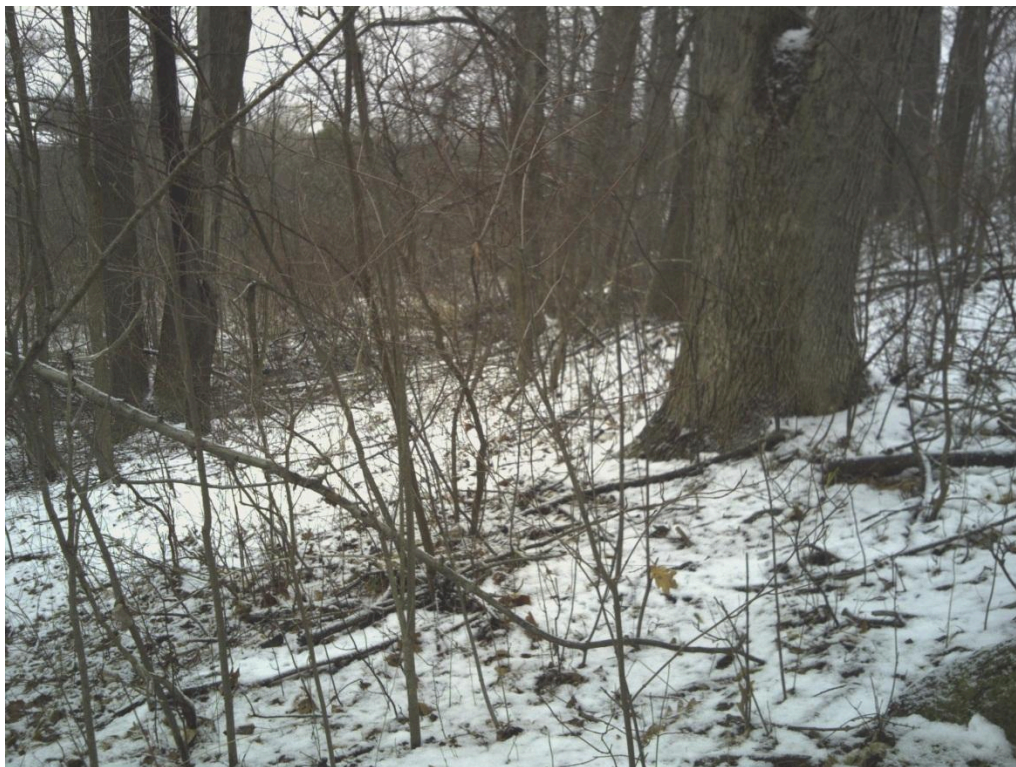
**S14-02:** *Corner*

- Corner – Photo Point S14-02 – is not clearly marked. This point is located on top of a hill and is surrounded by forest. The boardwalk is visible and marks the transition between the forest area and the fen.

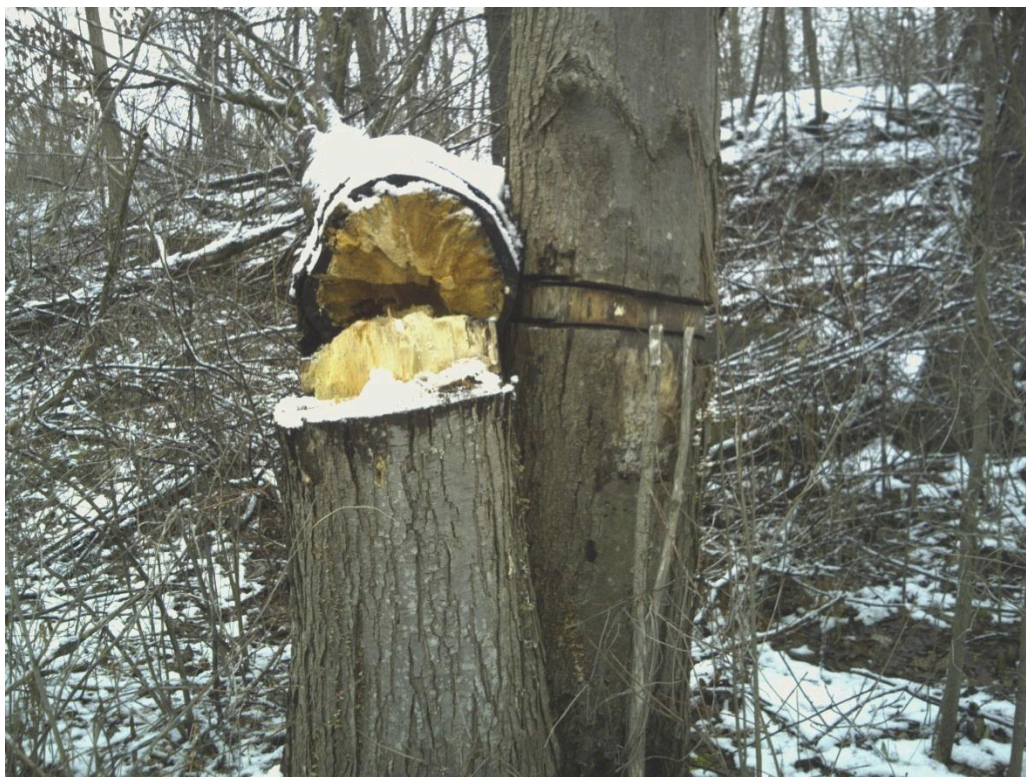
**S14-03:** *Tree*

- Tree – Photo Point S14-03 – has been cut at this location. Could be possible living brush pile.
- Heavy Cattail Growth – Photo Point S14-04 – has vehicle tire marks present at time of visit.

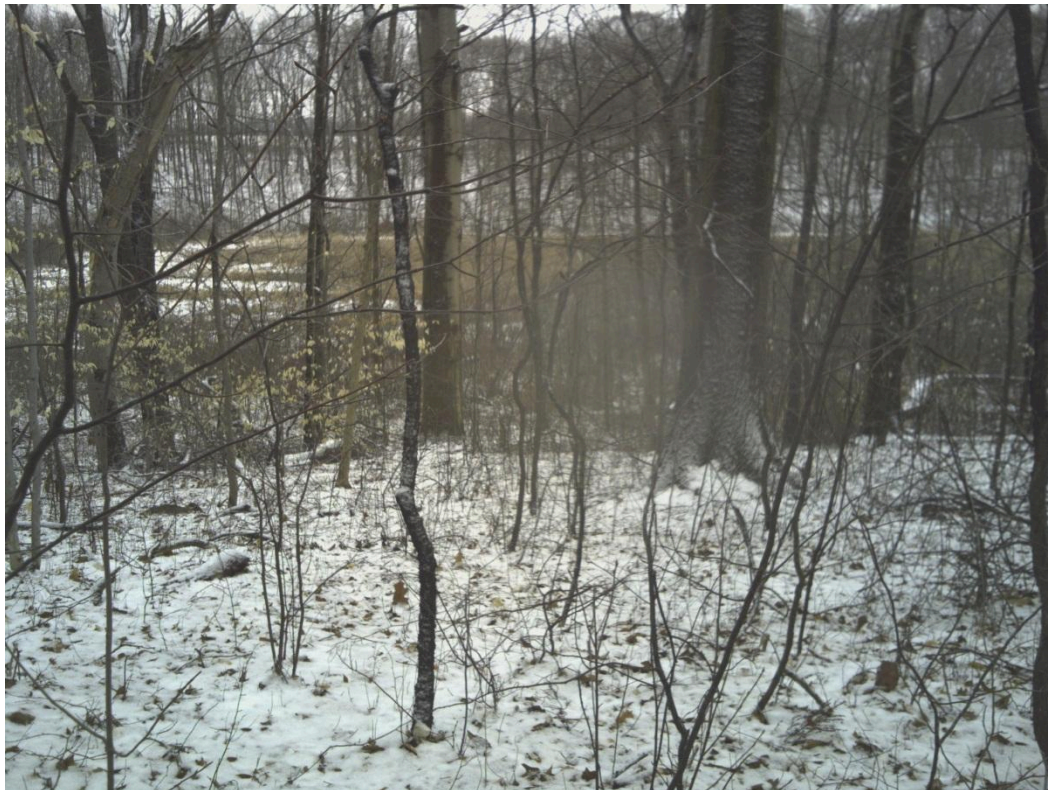
**S14-05:** *Corner*

- Corner – Photo Point S14-05 – is located at the end of the boardwalk.
- Foot Path – Photo Point S14-06 – splits at this point. From this location, you have a good visual overview of the fen.

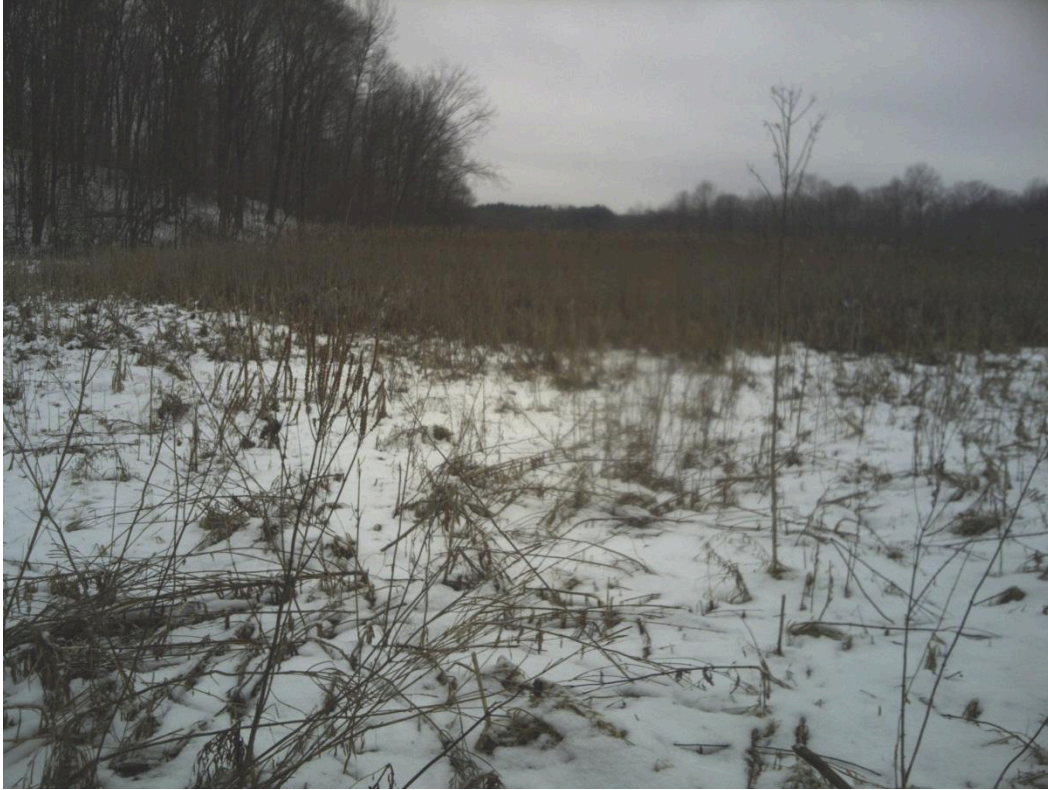
**S14-07:** *Corner*

- Corner – Photo Point S14-07 – can be depicted by the shrub growth before the forested area.
- Corner – Photo Point S14-08 – is clearly marked by a green and white metal stake, which seems to have been placed there by the Nature Conservancy.

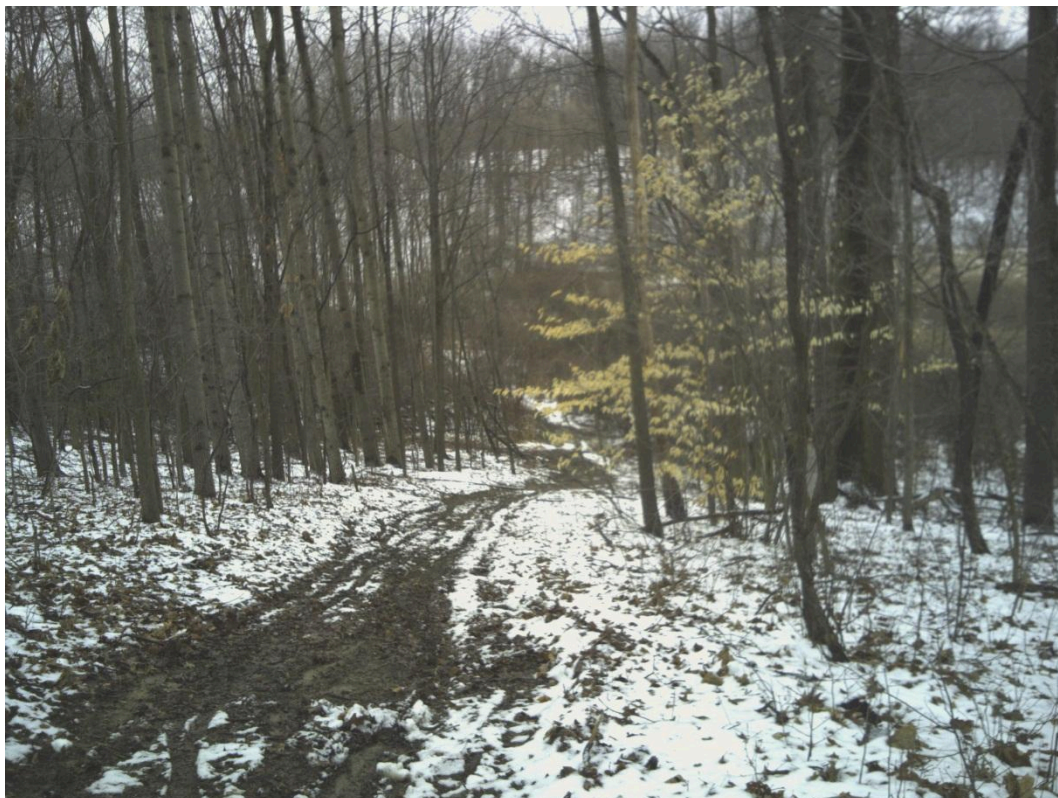
**S14-09:** *Corner*

- Corner – Photo Point S14-09 – is marked by a green and white stake. A path, not on KSU property, is adjacent to the boundary, which is being use by ATV and dirt bikes.

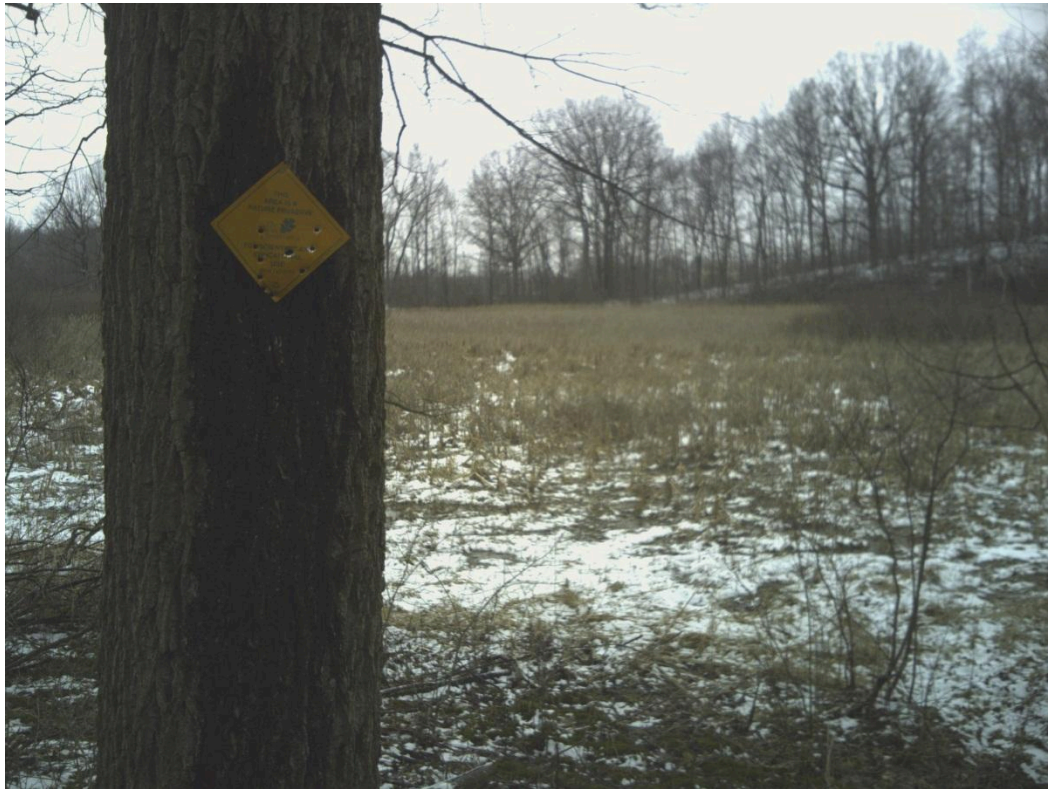
**S14-10:** *Corner*

- Corner – Photo Point S14-10 – is marked by a green and white stake. A good example of edge effect (open to shrub to forest) can be seen here. A Nature Conservancy sign has been placed on a tree and has been shot at with a pistol.

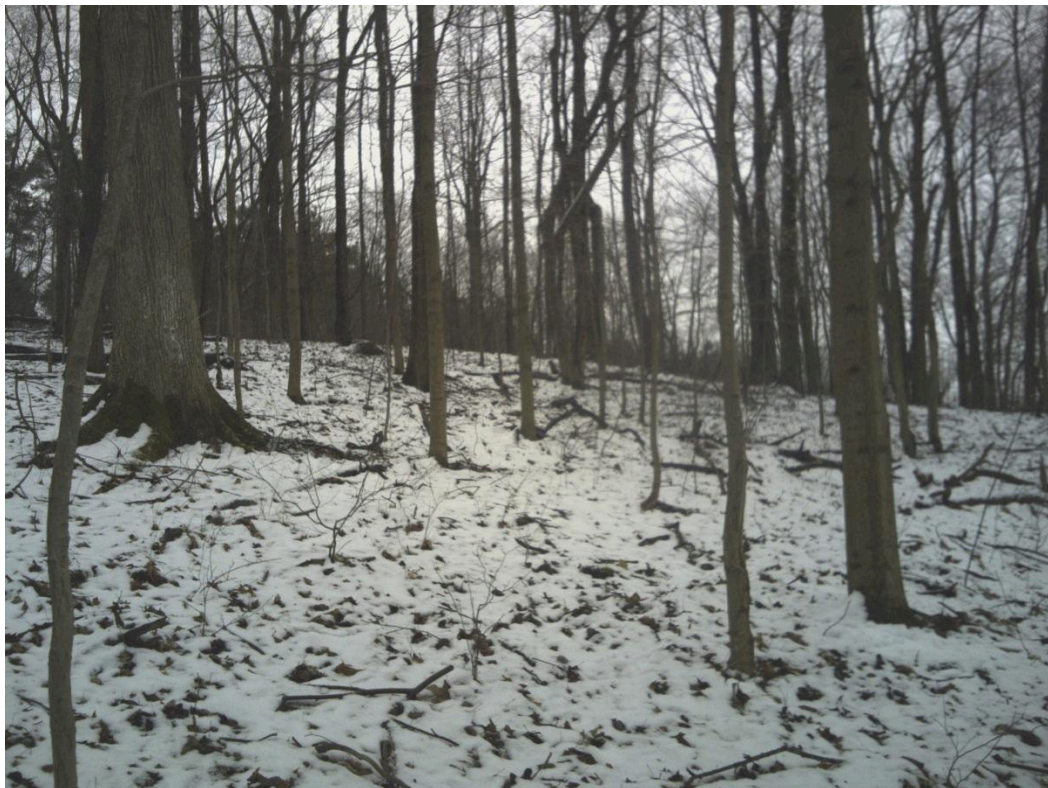
**S14-11:** *Forested Area*

- Forested Area – Photo Point S14-11 – is natural and uneven aged. The age range is Early/Mid-Successional with DBH ranging 6”-16”. This hardwood forest is dominated by Maples. The understory is open with diverse sapling growth.

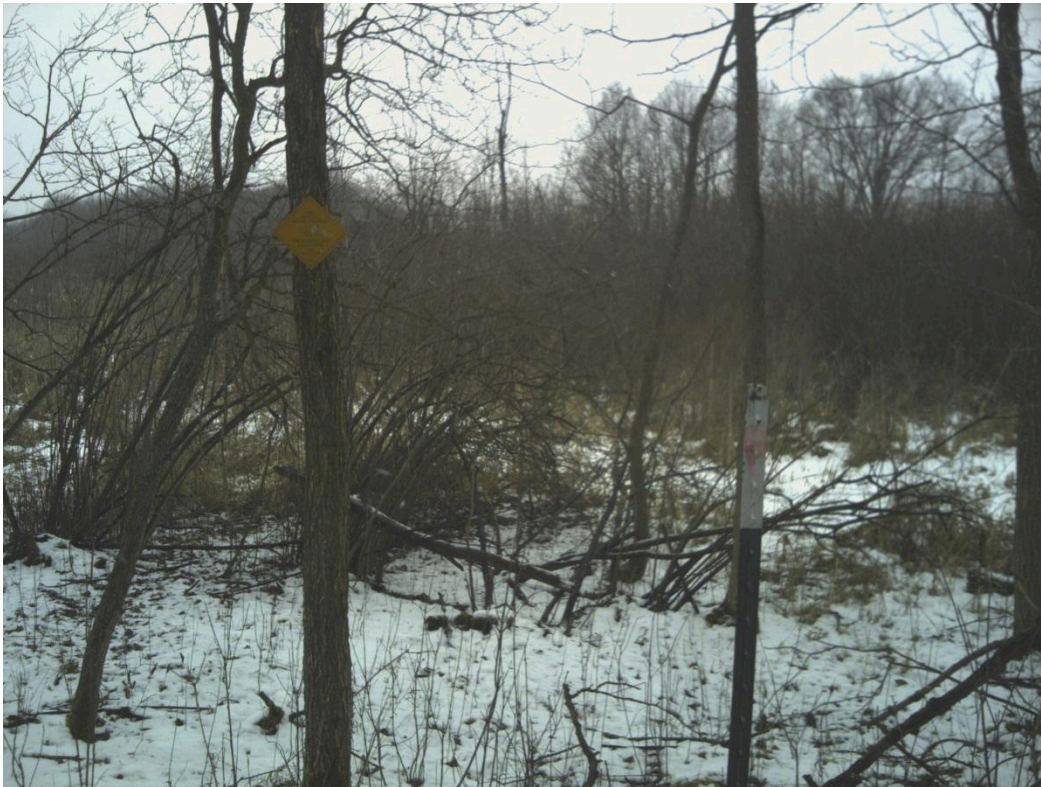
**S14-12:** *Corner*

- Corner – Photo Point S14-12 – is clearly marked with a green and white stake as well as a Nature Conservancy sign.
- Pond – Photo Point S14-13 – is small, less than 0.5acre in size. Microtopography is present. Mature forest and wetland surrounds the area. Heavy leaf debris is present in the pooling area.

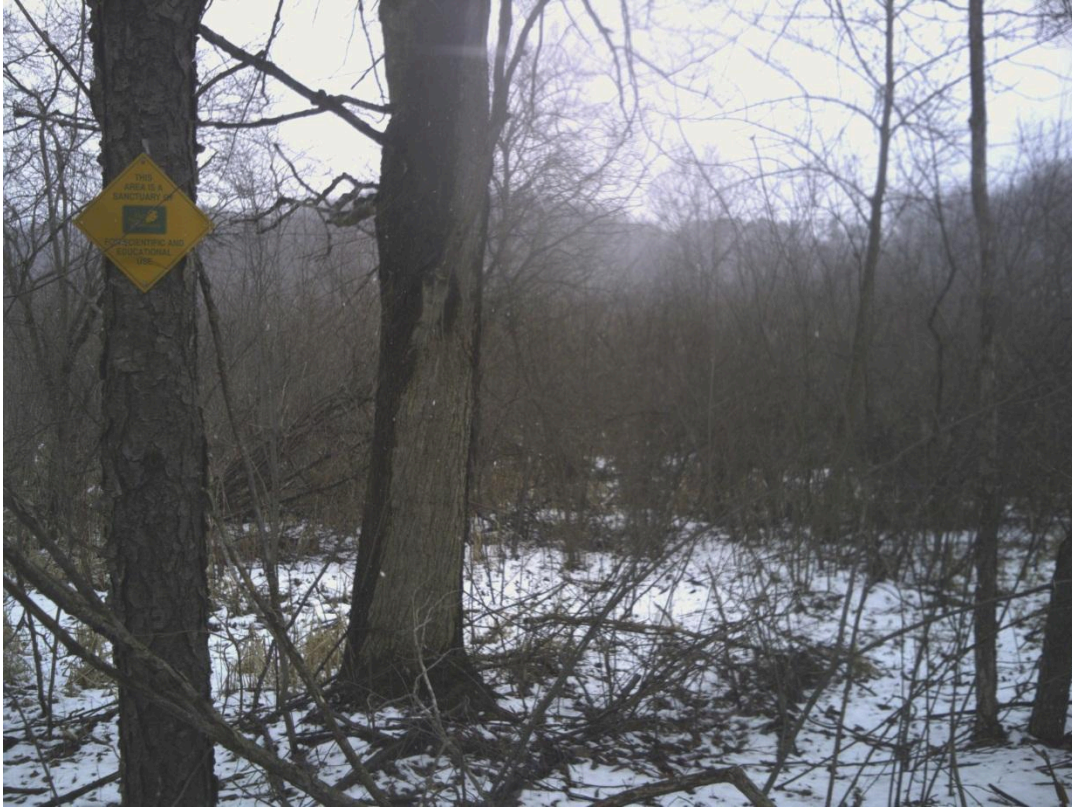
**S14-14:** *Corner*

- Corner – Photo Point S14-14 – is clearly marked with a green and white stake. A lake, Gressard Lake, is adjacent to the boundary and is shown at photo point S14-15. The area is woodland with some heavy shrub growth..

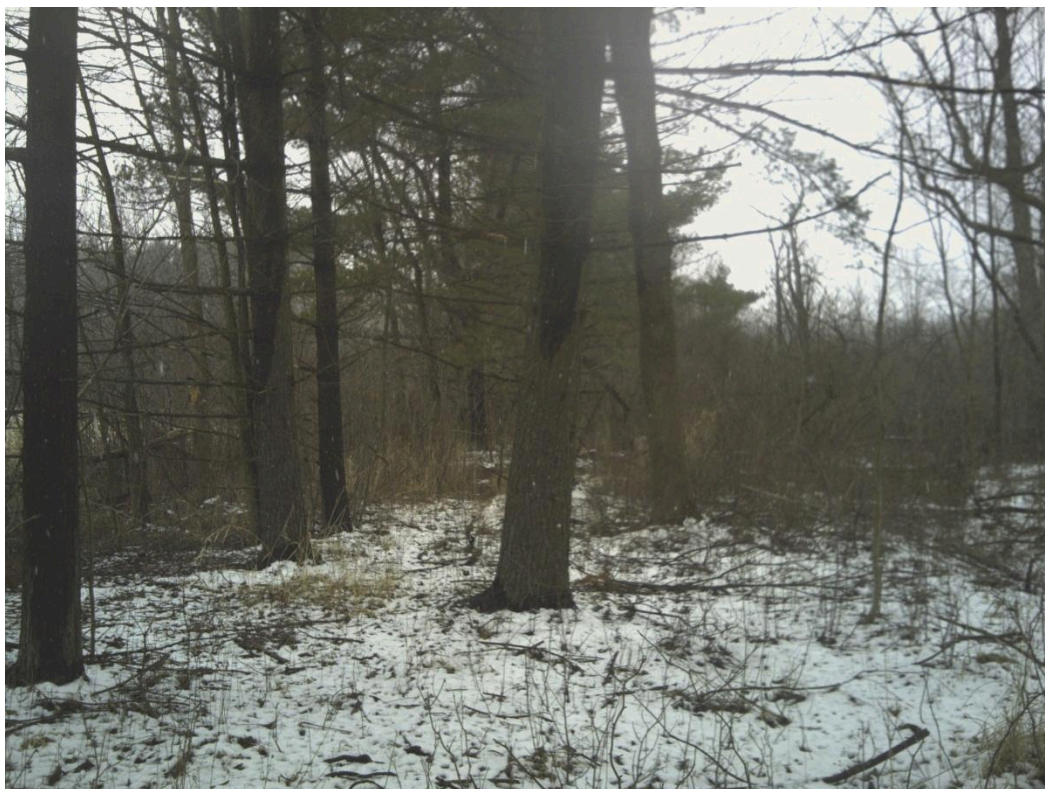
**S14-16:** *Forested Area*

- Forested Area – Photo Point S14-16 – is natural and uneven aged. The age range is Early/Mid-Successional with DBH ranging 6”-16”. This mix forest is dominated by white pine. The understory is dense with diverse shrub growth. Some areas are open with sapling growth.

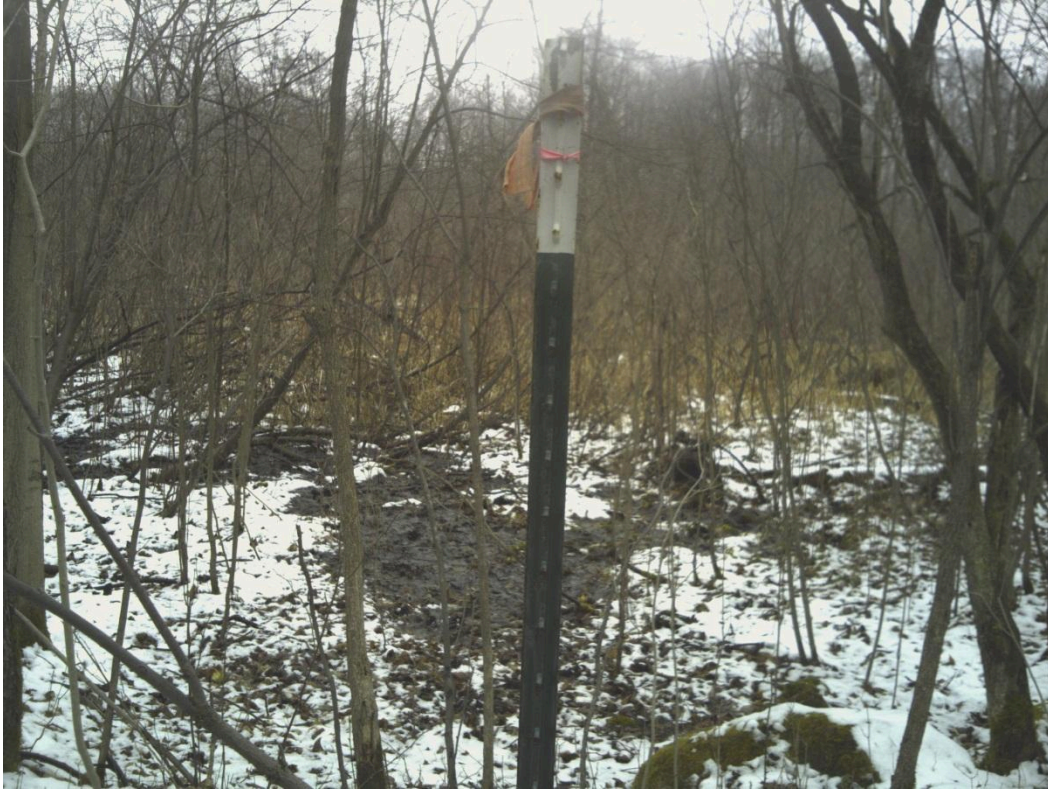
**S14-17:** *Corner*

- Corner – Photo Point S14-17 – is clearly marked by a green and white stake. The surrounding area is shrub growth and wetland habitat.
- Heavy Shrub Growth – Photo Point S14-18 – is dominate in a moist soil area. Reed canary grass may be present. North of this area is forest habitat.

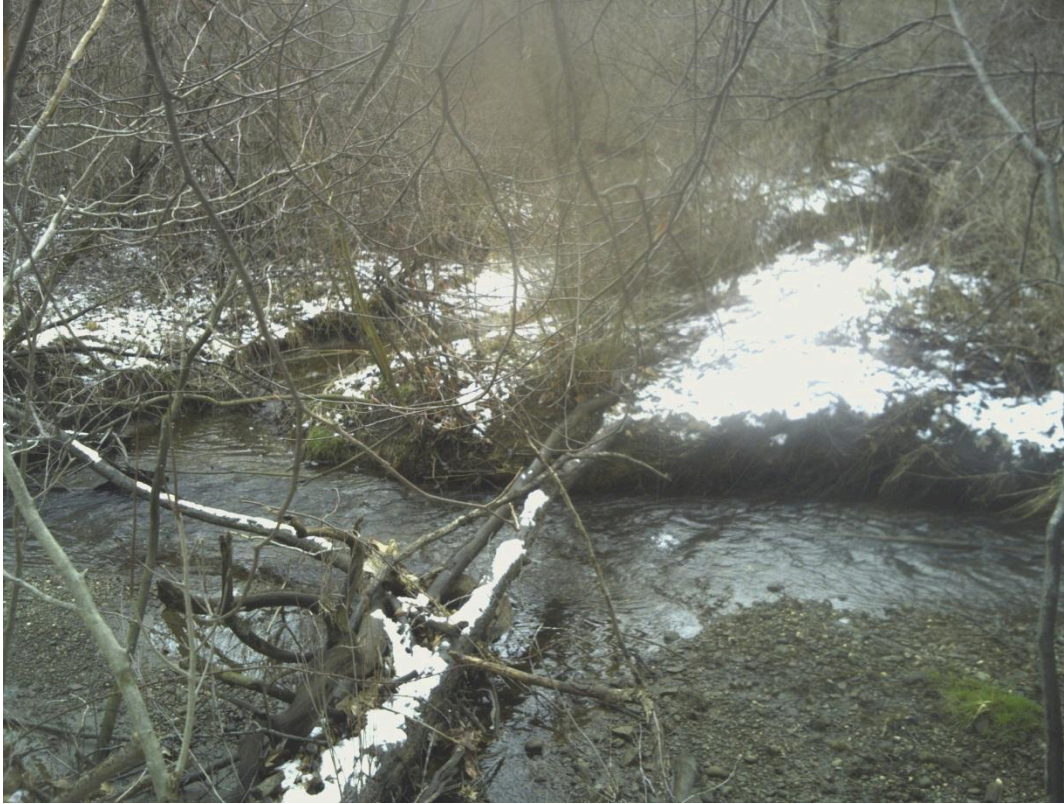
**S14-19:** *Stream*

- Stream – Photo Point S14-19 – is perennial and natural with sinuous banks. The dominate substrate is cobble, gravel, and sand with banks are eroded. The riparian area is wide with

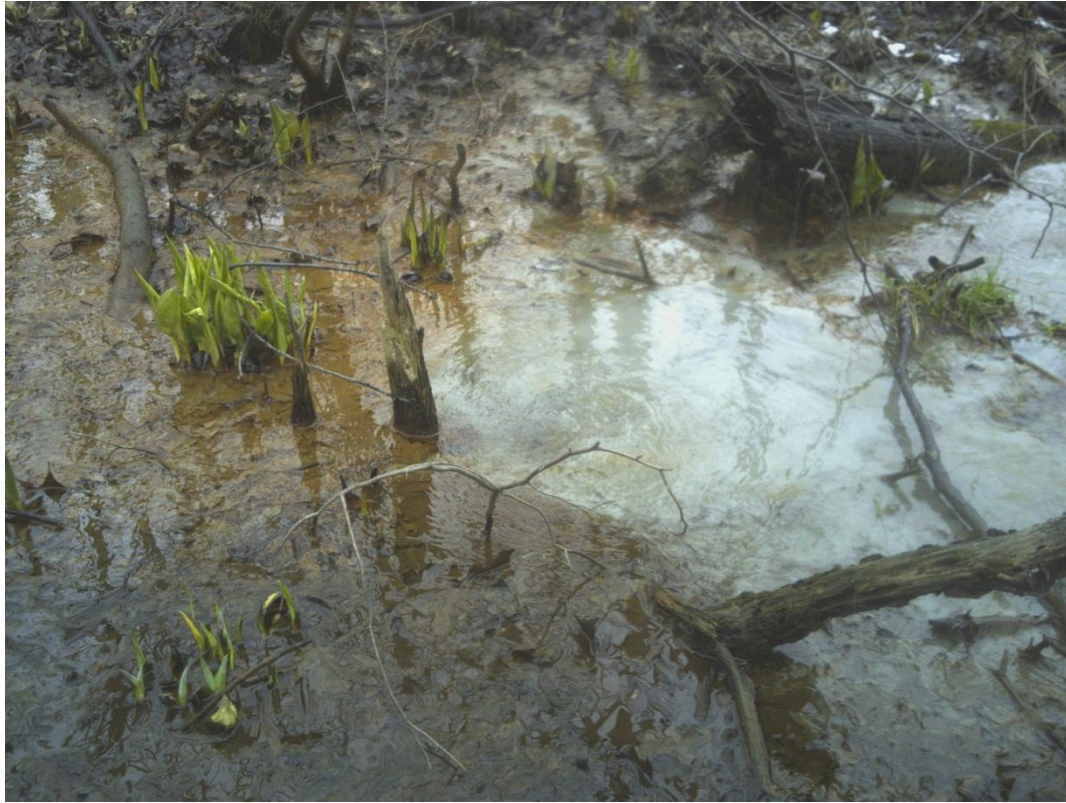
**S14-20:** *Stream – iron deposit*

forest growth on both river right and left. An extra photo, photo point S14-20, was taken to document the bubbling water with heavy iron deposits.

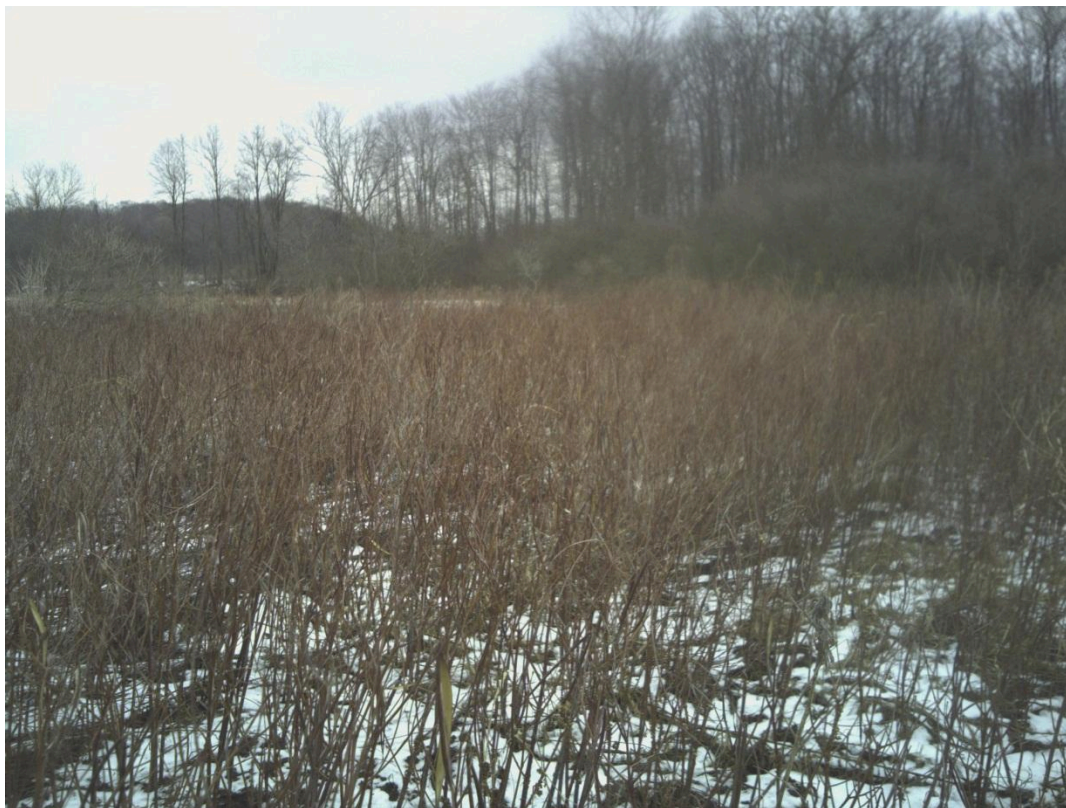
**S14-21:** *Corner*

- Corner – Photo Point S14-21 – is not clearly marked. Open field habitat is to the north and shrub habitat is south of this point. A stream is located in the south direction.
- Corner – Photo Point S14-22 – can be found by a switch in habitat type. The area owned by Kent is open field, which is adjacent to shrub growth
- Algae – Photo Point S14-23 – bright green in color has a bubbly texture.
- Shotgun Shell – Photo Point S14-24 – was found at this location at time of visit.
