**SITE 11**

**Slates South Property**

Franklin Township  
Portage County, OH

*Report Written By: Stephanie Deibel  
Date of Site Visit: 28, 29 November 2012  
Date Finalized: 18 December 2012*

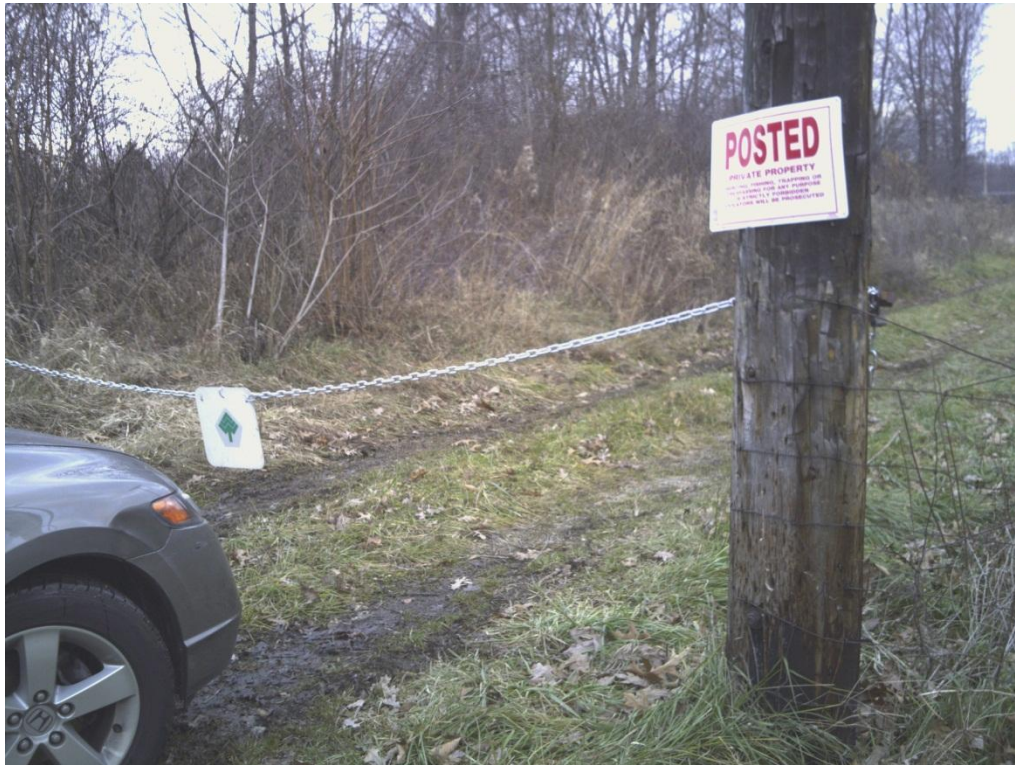
**S11-01:** *Corner*

- Corner – Photo Point S11-01 – is marked with a chain and fence.
- Beware of Dog Sign – Photo Point S11-03 – has been placed on a telephone pole.
- Boundary Line – Photo Point S11-04 – is not clearly marked. A stream runs near the southern boundary

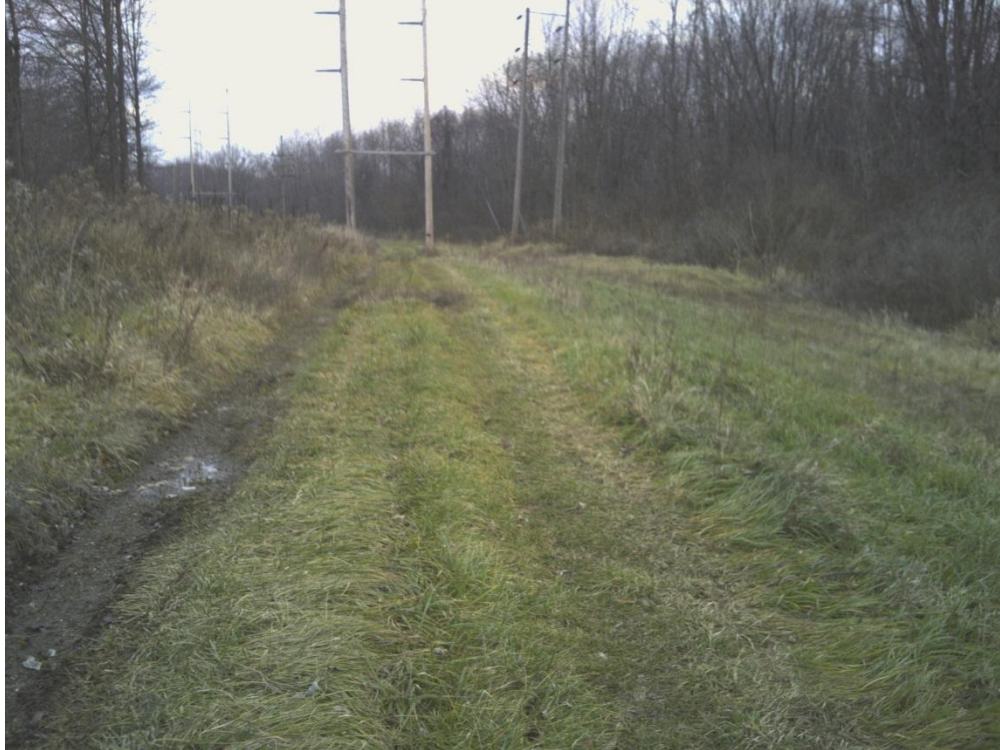
**S11-02:** *Mowed Grass Path*

- Corner – Photo Point S11-30 –is not clearly marked. A pond/wetland area is near.
- 4.2 Access Roads and Trails/Parking
- Mowed Grass Path – Photo Point S11-02 – is surrounded by shrub growth on sides and runs along the northern property line.
- 4.3 Dumps, Disturbances, or Environmental Hazards
- No signs of the above were seen while inventorying the site.
- 4.4 Encroachments/Trespassing
- Various indicators of hunting were found while inventorying the site including tree stands, feeders, and an armed hunter.

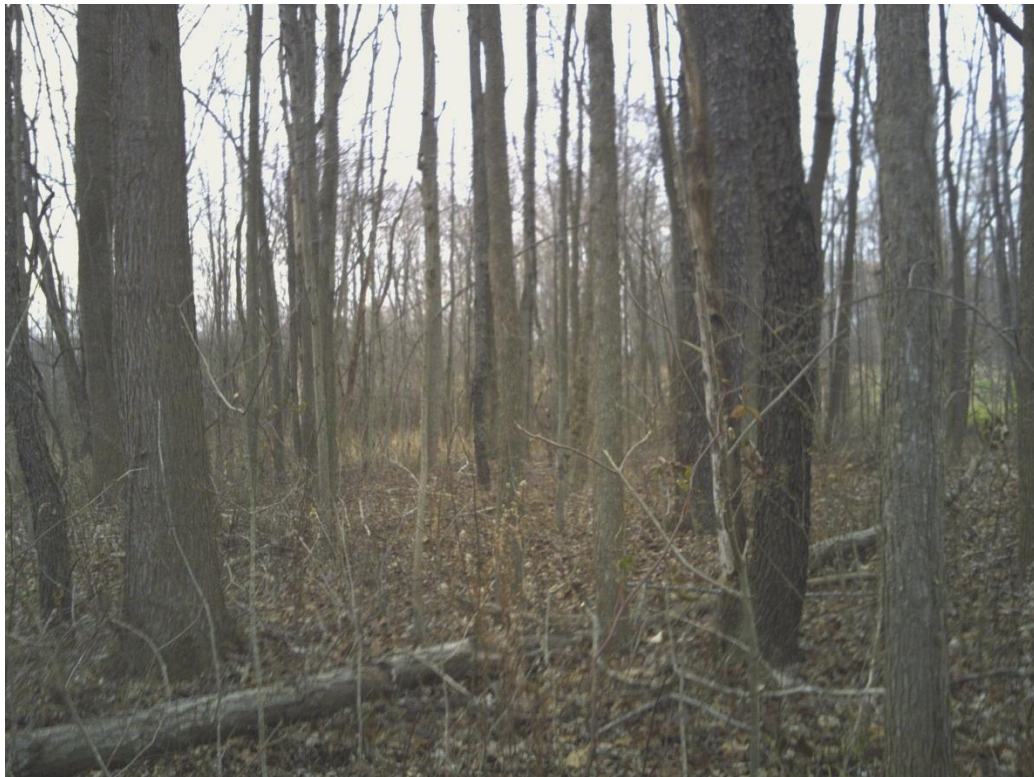
**S11-05:** *Forested Area*

- Forested Area – Photo Point S11-05 – is natural and uneven aged. The age range is Early/Mid-Successional with DBH ranging from 6"-16". This hardwood forest is a mix of Oak, Maple, Black Cherry. The understory is open with diverse shrub growth.

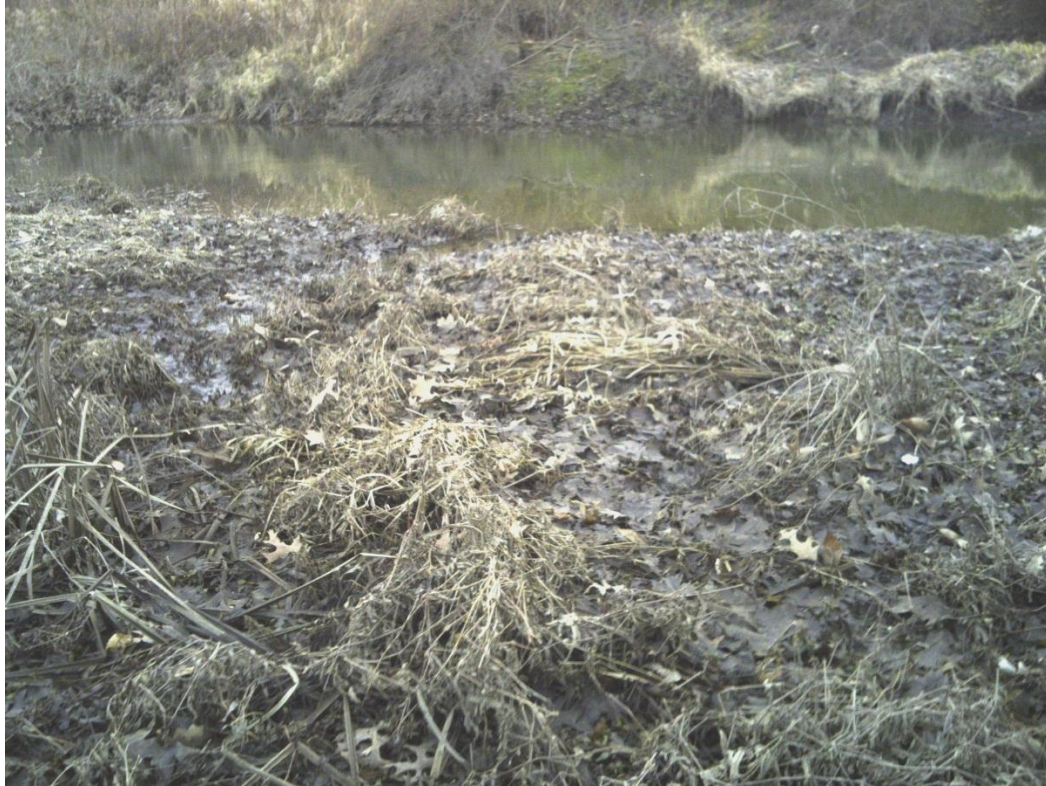
**S11-06:** *Flooded Area*

- Flooded Area – Photo Point S11-06 – acts as an overflow area for the stream just south.
- Pond – Photo Point S11-07 – is medium sized ranging from 0.5-1.0 acre in size. Microtopography is present and the surrounding area is forest.

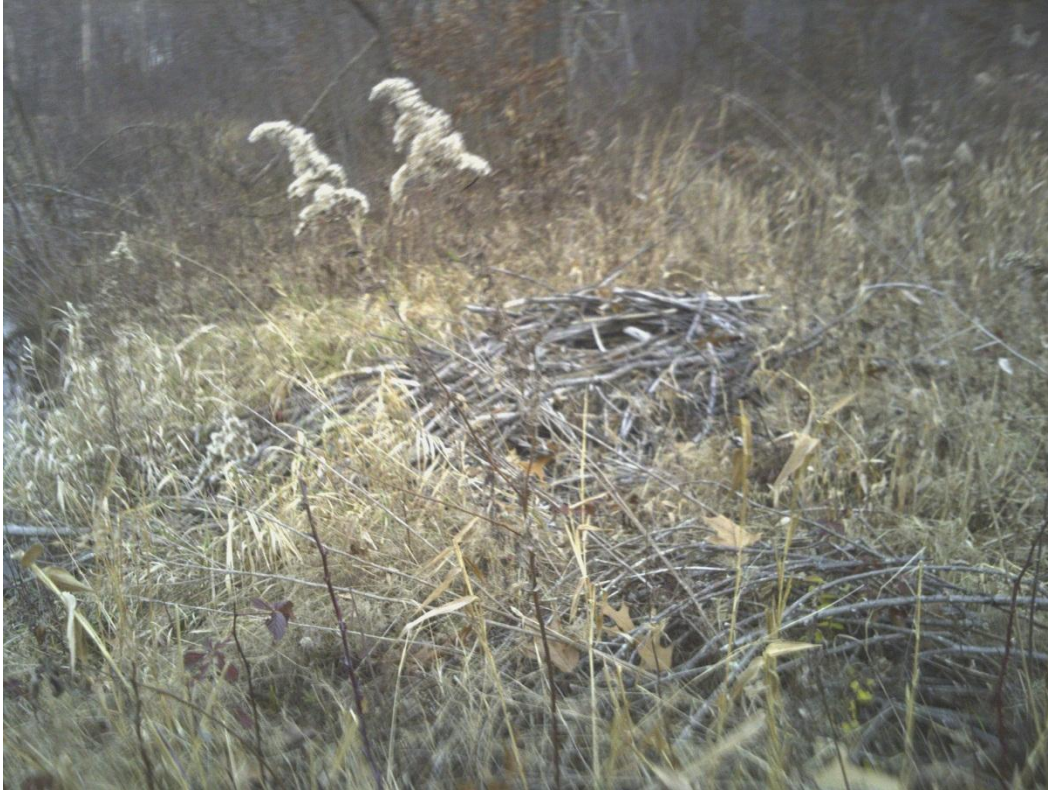
**S11-08:** *Beaver Dam*

- Beaver Dam – Photo Point S11-08 – is marked by this point.
- Wet Area – Photo Point S11-09 – is dominated by reed canary grass.
- Corner – Photo Point S11-10 – is not clearly marked. A defined trail under the power lines can be observed.

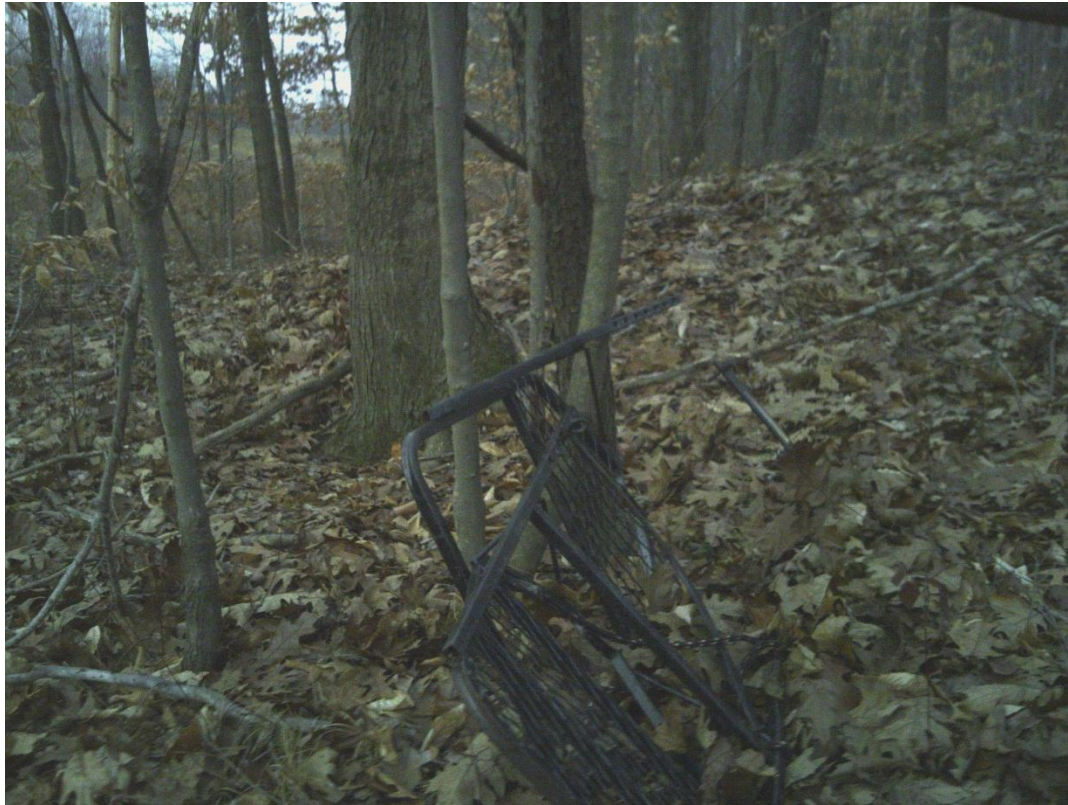
**S11-11:** *Old Tree Stand*

- Old Tree Stand – Photo Point S11-11 – was found on the property.
- Private Property Sign – Photo Point S11-12 – was found on a tree.
- Small Pond – Photo Point S11-13 – is less than 0.5 acre in size. Microtopography is present. The surrounding area consists of immature forest.

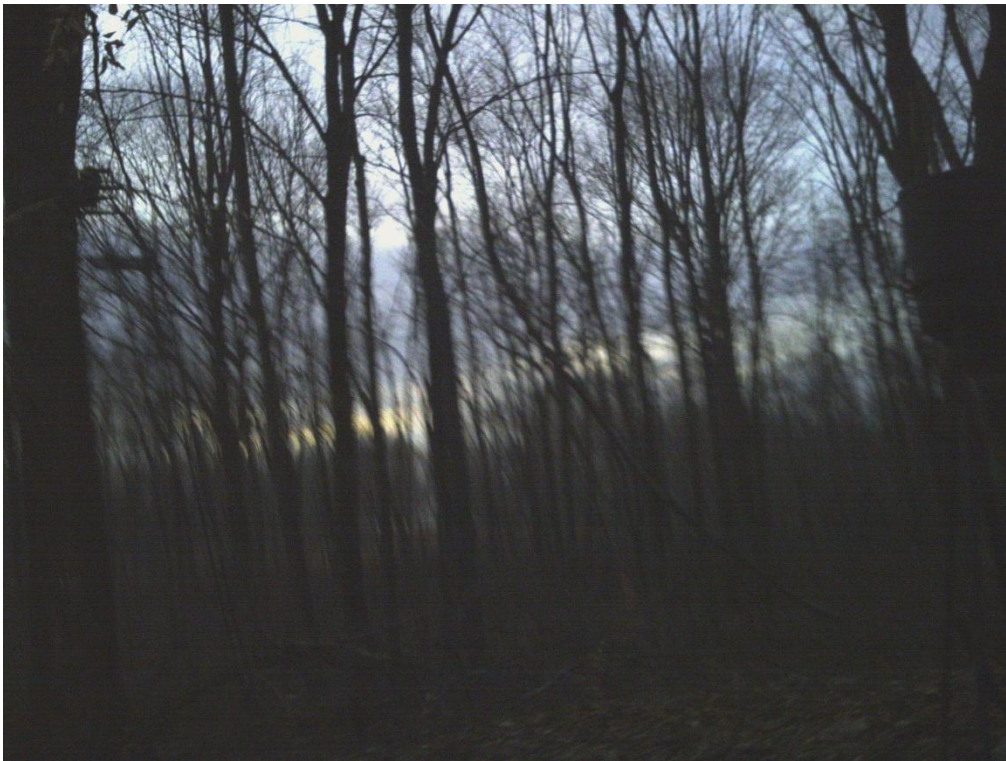
**S11-14:** *Feeder*

- Feeder – Photo Point S11-14 – possibly for deer was found on the site.
- Corner – Photo Point S11-15 – is clearly marked with a sign placed by the City of Kent.

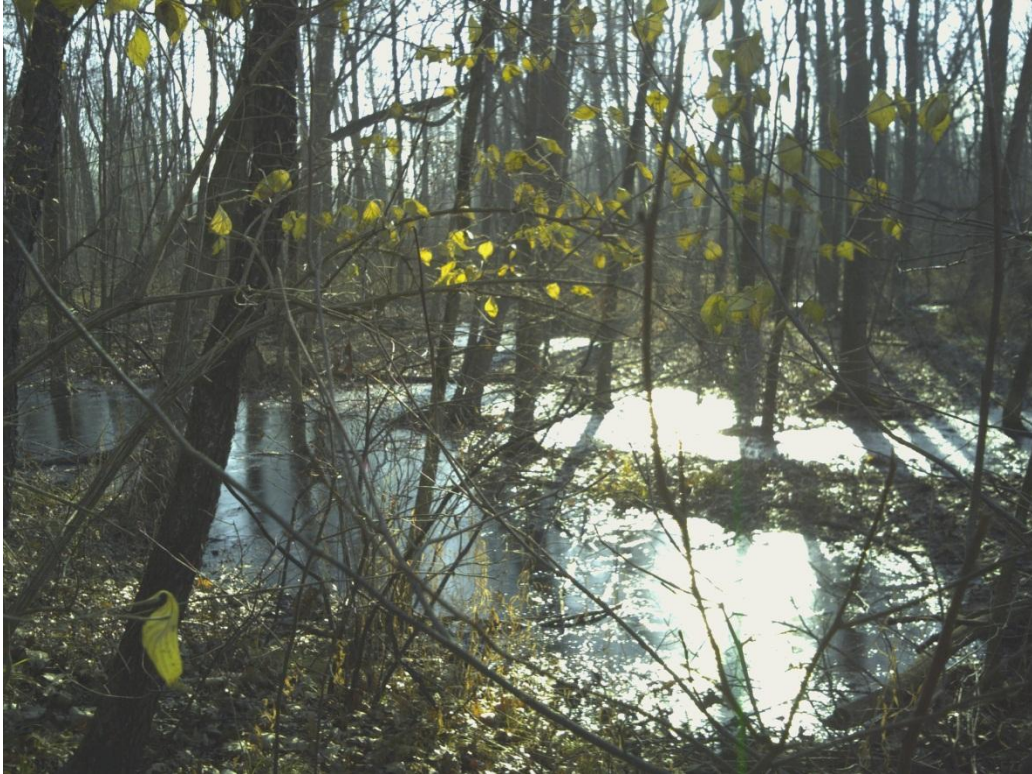
**S11-18:** *Pond*

- Pond – Photo Point S11-18 – is between 0.5-1.0 acre in size. Microtopography is present. The surrounding area consists of mature forest and wetland.
- Corner – Photo Point S11-19 – is clearly marked with a City of Kent sign.

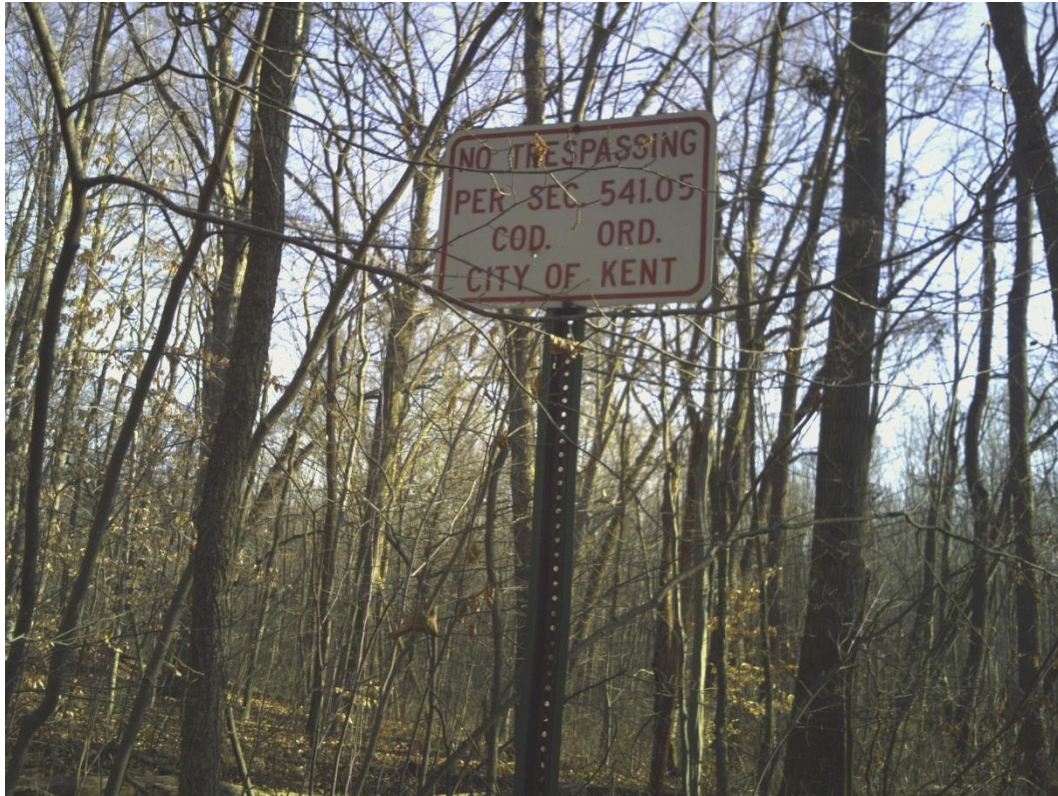
**S11-20:** *Corner*

- Corner – Photo Point S11-20 – is clearly marked with a City of Kent sign.
- Corner – Photo Point S11-21 – is not clearly marked. A stream does run along the southern side.

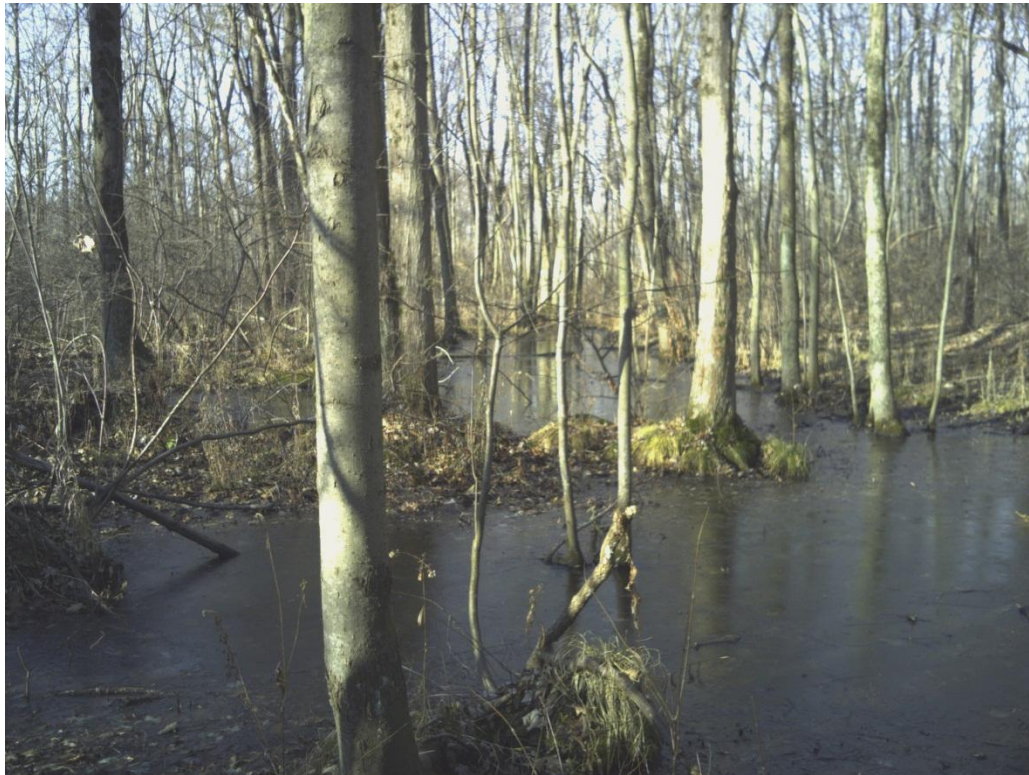
**S11-22:** *Wet Area*

- Wet Area – Photo Point S11-22 – is greater than an acre in size. Microtopography is present. Mature forest and wetland surrounds the area.
- Forested Area – Photo Point S11-23 – is natural and uneven aged. The age range is Early/Mid-Successional with DBH ranging 6"-16". This hardwood forest is dominated by Oak. The understory is dense with diverse shrub growth.

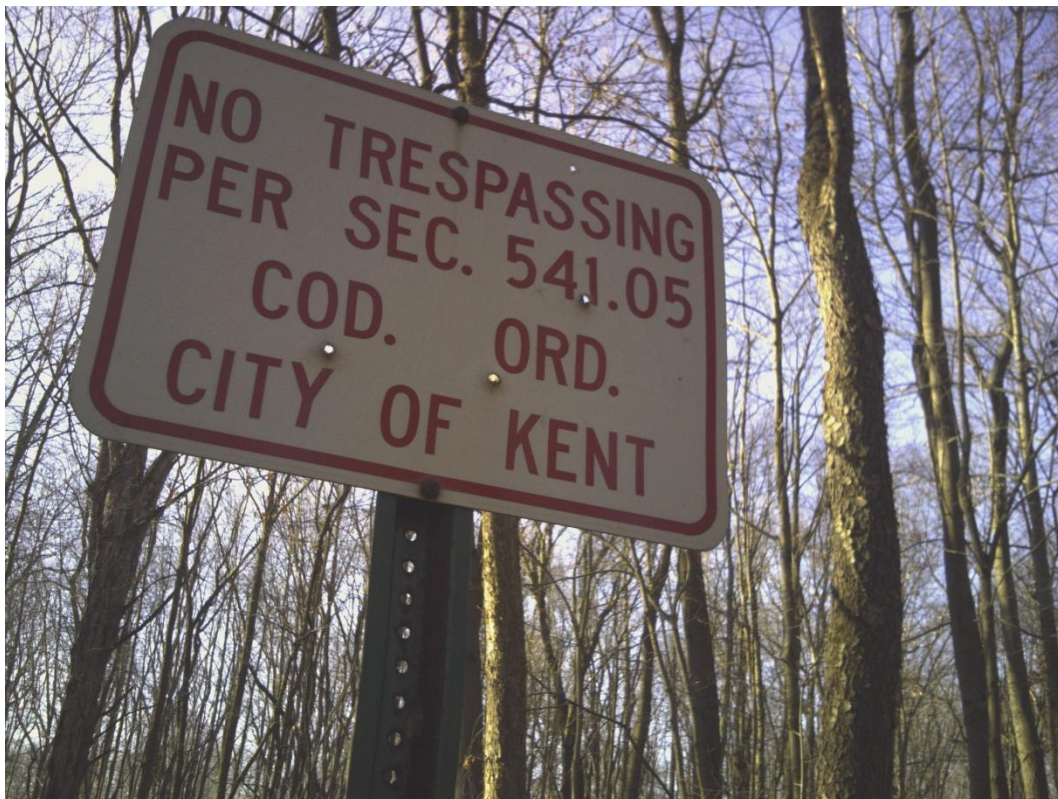
**S11-24:** *Corner*

- Corner – Photo Point S11-24 – is not clearly marked. It's unclear where the property ends.
- Unknown Feature – Photo Point S11-25 – is located at this point. It's unclear whether it's on KSU property.

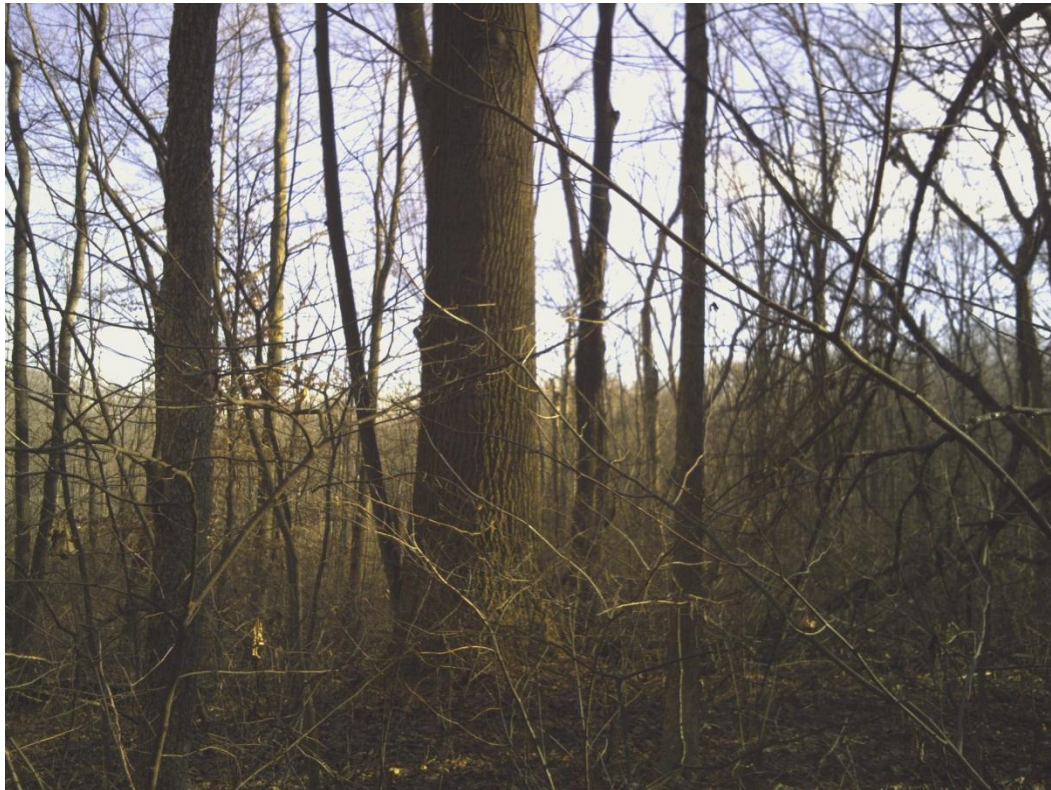
**S11-26:** *Forested Area*

- Forested Area – Photo Point S11-26 – is natural and uneven aged. The age range is Mid-Successional. The understory is dense with diverse shrub growth

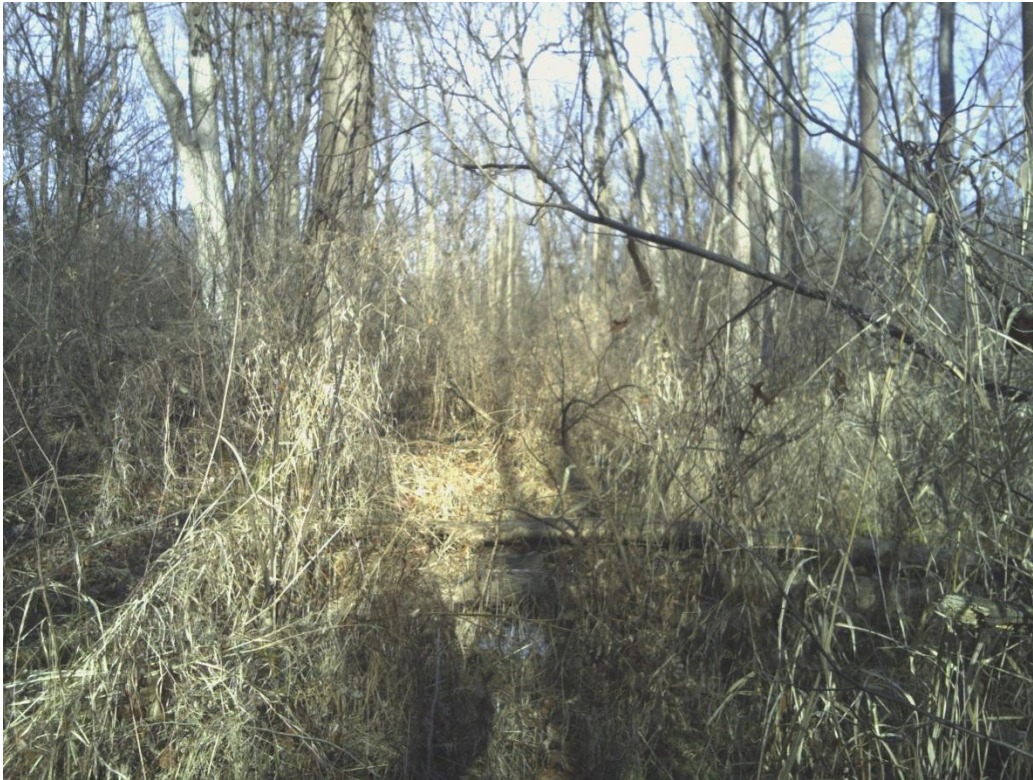
**S11-27:** *Wet Area*

- Wet Area – Photo Point S11-27 – is dominated by what looks to be reed canary growth. The area is located within a forested area.
- Creek – Photo Point S11-28 – appears natural with ephemeral flow. The banks are muck with wide riparian areas consisting of forest and shrubs on either side.

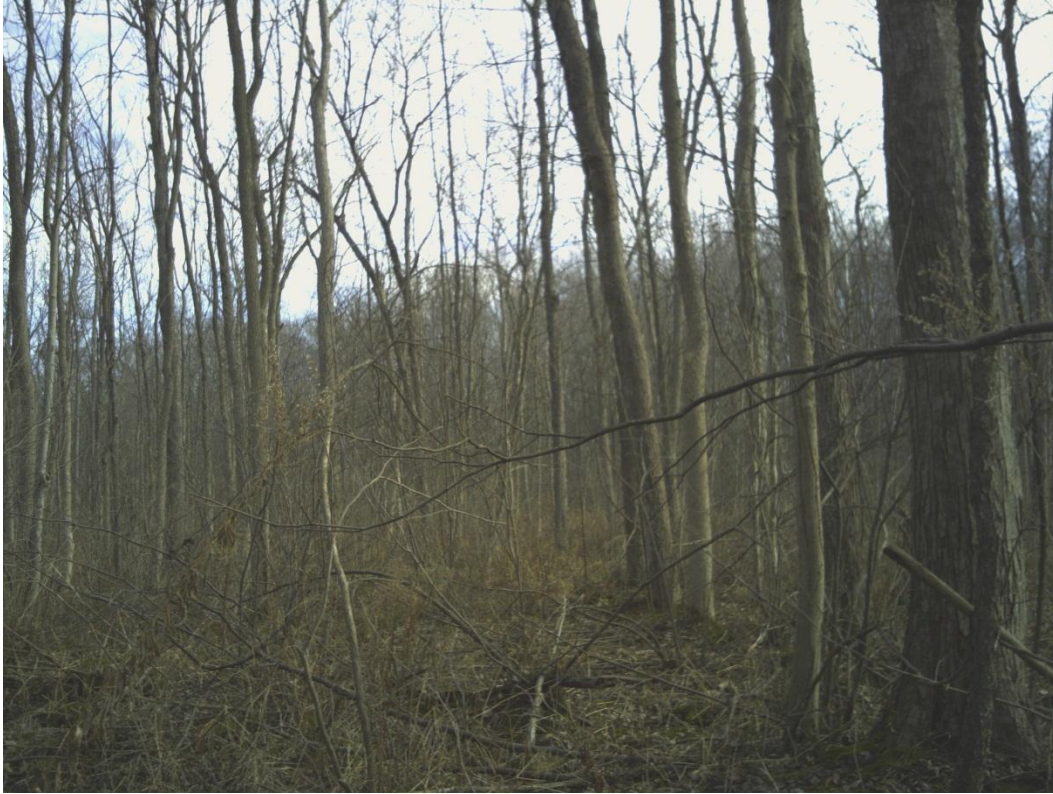
**S11-29:** *Forested Area*

- Forested Area – Photo Point S11-29 – is natural and uneven aged. The age range is Early/Mid-Successional with DBH ranging from 6"-16". The understory is dense with diverse shrub growth.
