CENTER FOR ECOLOGY & NATURAL RESOURCE SUSTAINABILITY

SITE 6

Ensinger

Franklin Township
Portage County, OH

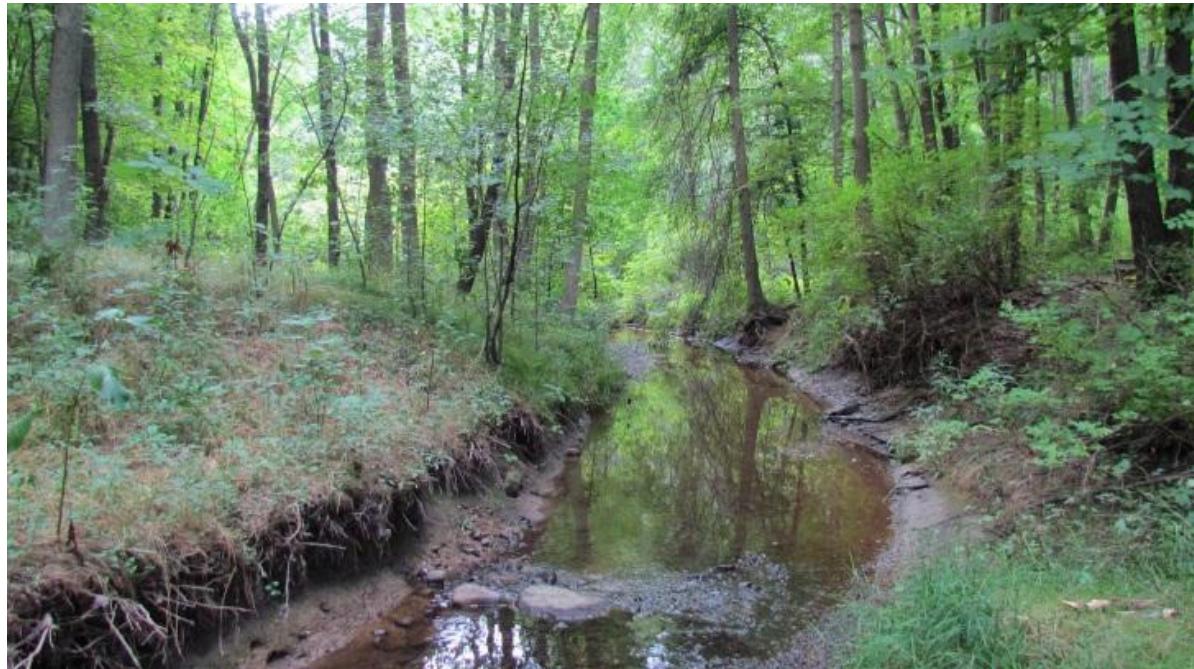
S6-02: *Small Creek*

- A Small Creek – Photo Point S6-02 – has a sandy bottom with some gravel and cobble. The flow appears North to South with some riffle areas. Fish, frogs, and damselflies were observed while in the area.

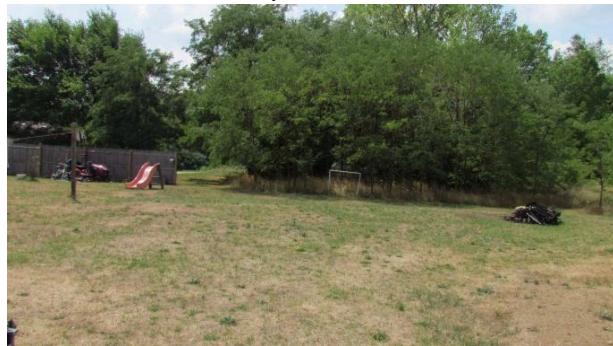
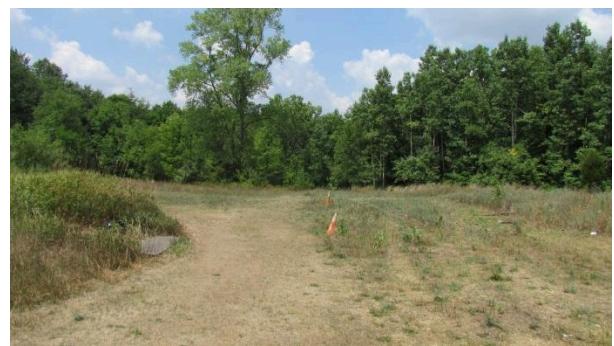
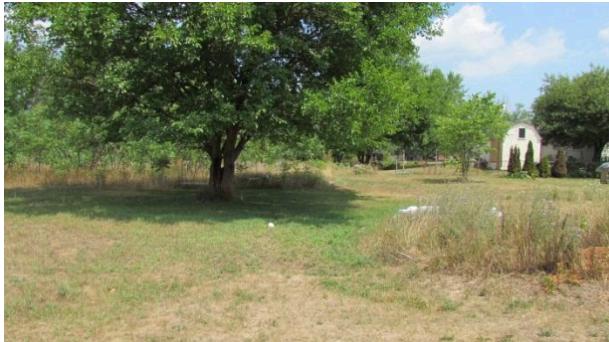
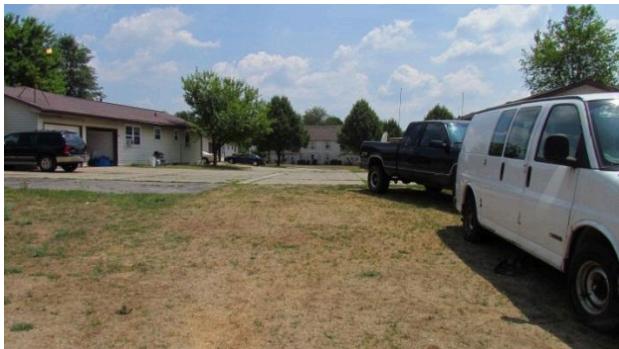
S6-03: *East Boundary*

- The open-field area – Photo Point S6-03 – has evidence of off-roading/4x4. Some trash, cones, and other debris can be found in this area.
- What looks to be a pet cemetery – Photo Point S6-04 – is located just west of the open-field area adjacent to the residential area.

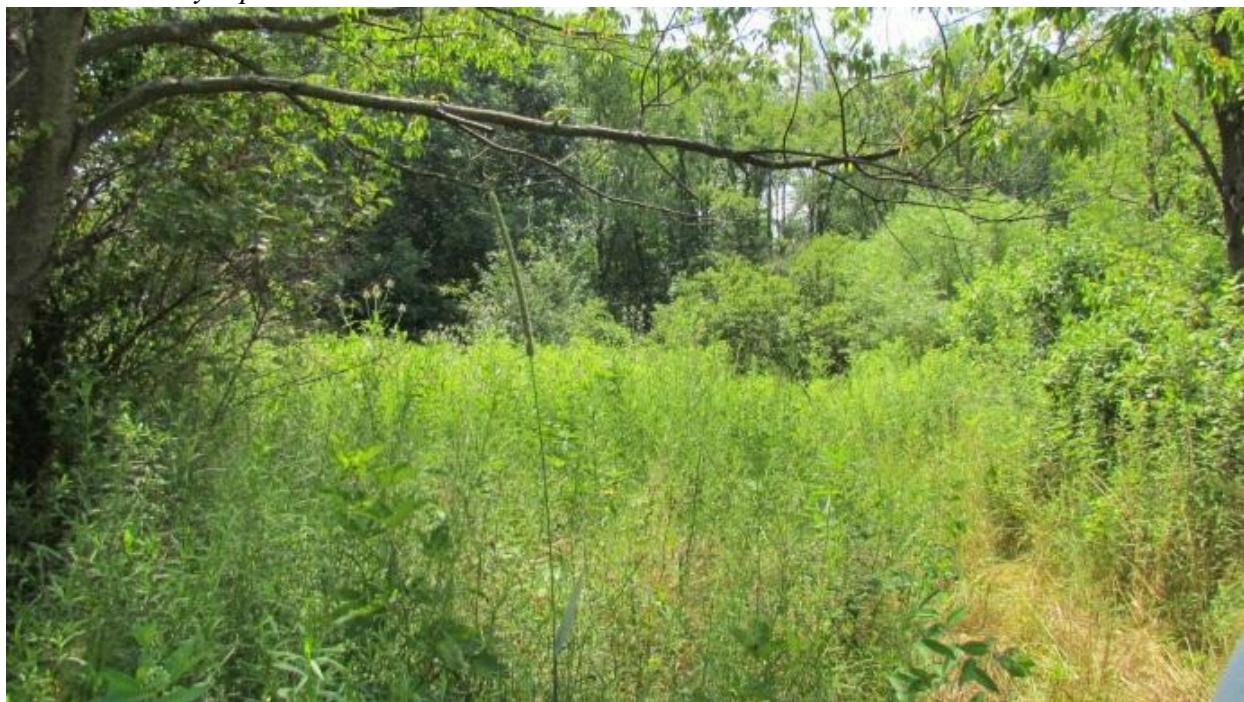
S6-05: *Partially Open Area*

- Partially Open Area – Photo Point S6-05 – consists of meadow weeds, grasses, and small shrubs. A few solitary trees are scattered throughout.
- An Open Area – Photo Point S6-06 – is dominated by a few grass species with small shrubs and trees growing sporadically.

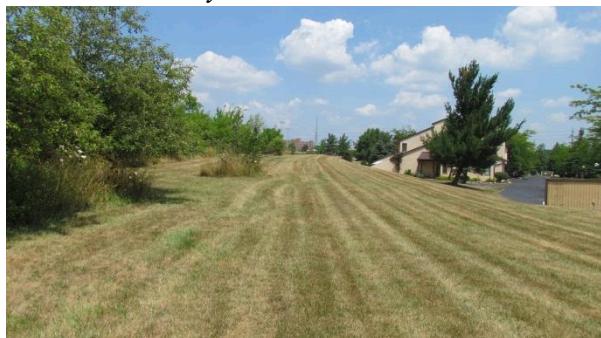
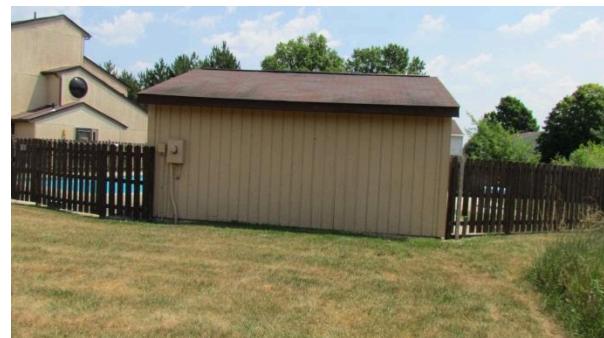
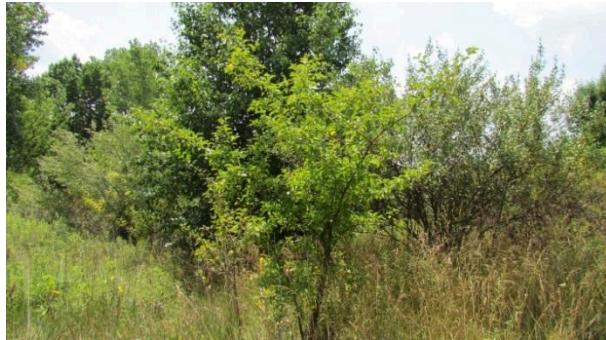
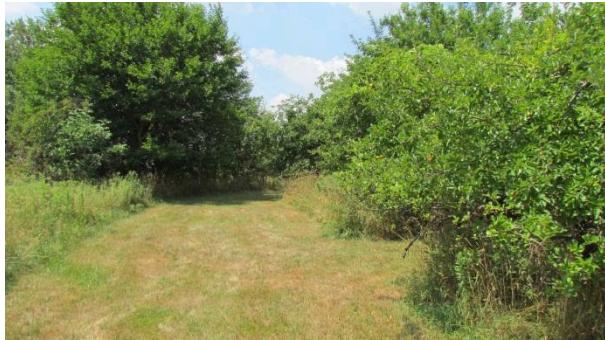
S6-07: *Boundary Mark*

- A Mowed Area – Photo Point S6-07 – is adjacent to an apartment complex. The area consists of a small mowed path amongst taller grasses and seems to be maintained by KSU.

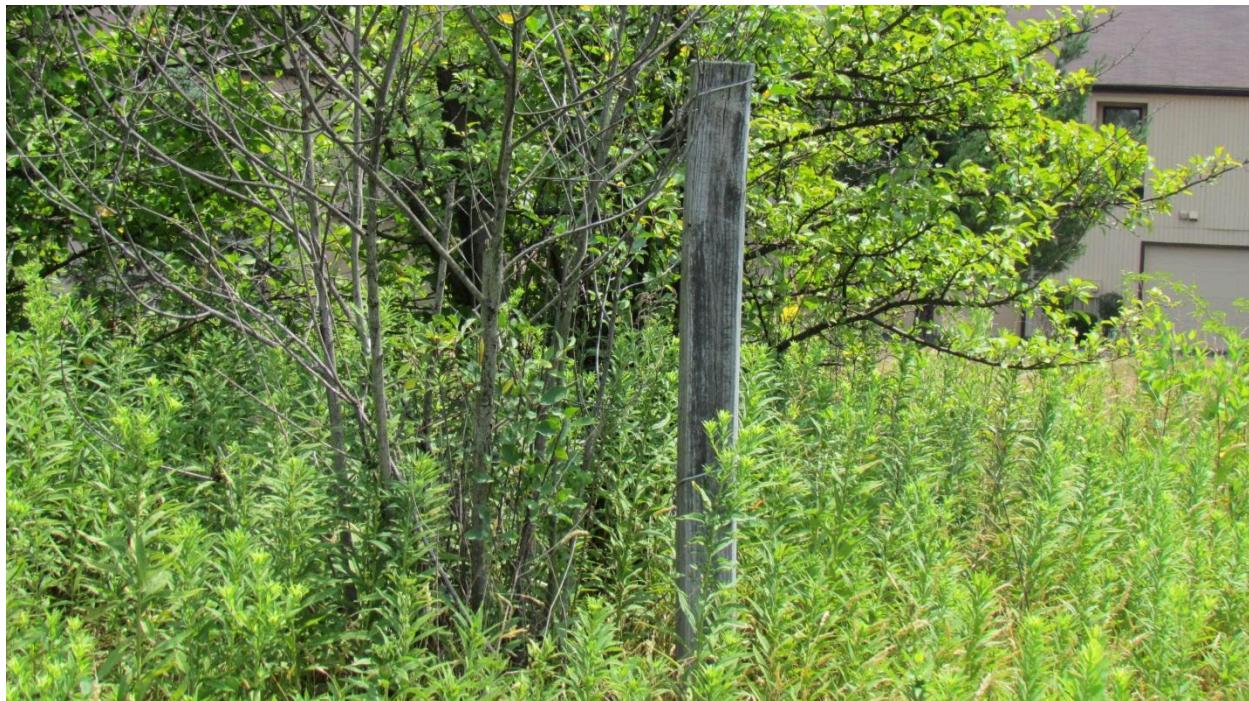
S6-08: Old Fence Post

- Old fence post – Photo Point S6-08 – may be represent the boundary line with the apartments.
- Private Property Sign – Photo Point S6-09 – may represent the property line of the apartment complex. It's unclear who put the sign there.

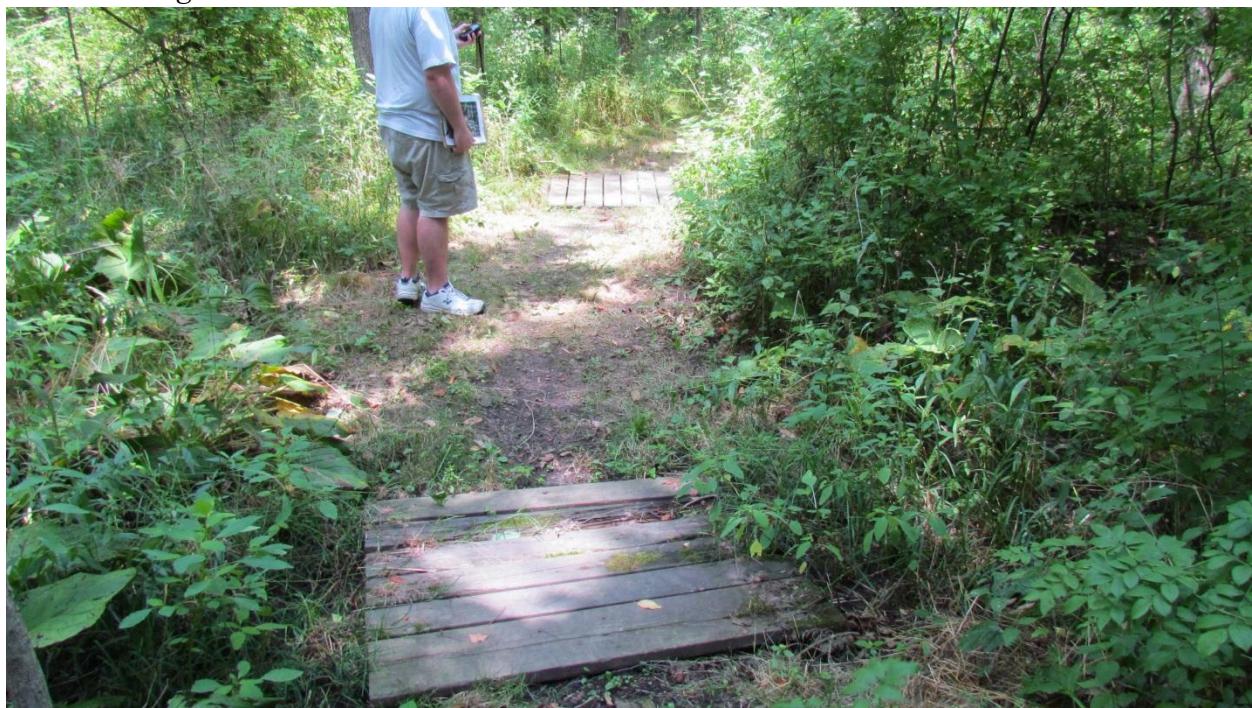
S6-10: 2 Bridges

- 2 wooded bridges – Photo Point S6-10 – are positioned over a small creek at the lower end of the property. When inventoried, no substantial amount of water was visible.

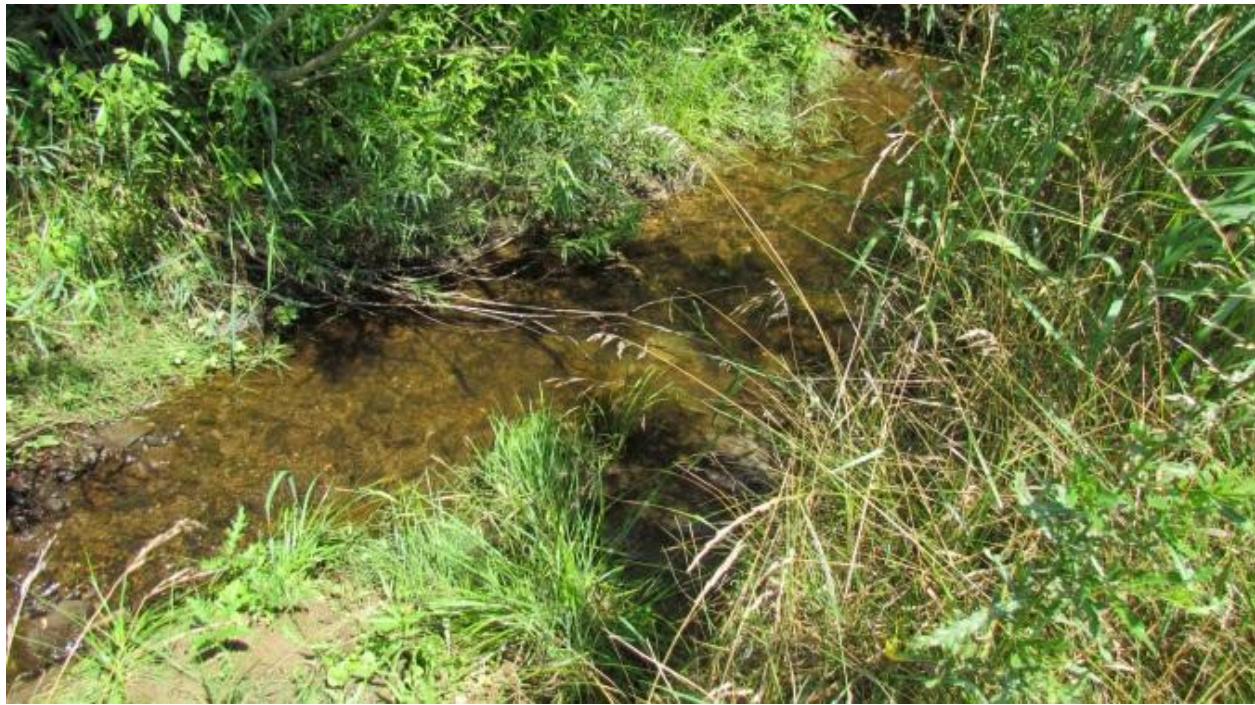
S6-11: Creek continued

- The Small Creek Continued – Photo Point S6-11 – from photo point S6-02 has lots of vegetation growth in the riparian zone. The bottom is sand with some gravel throughout.

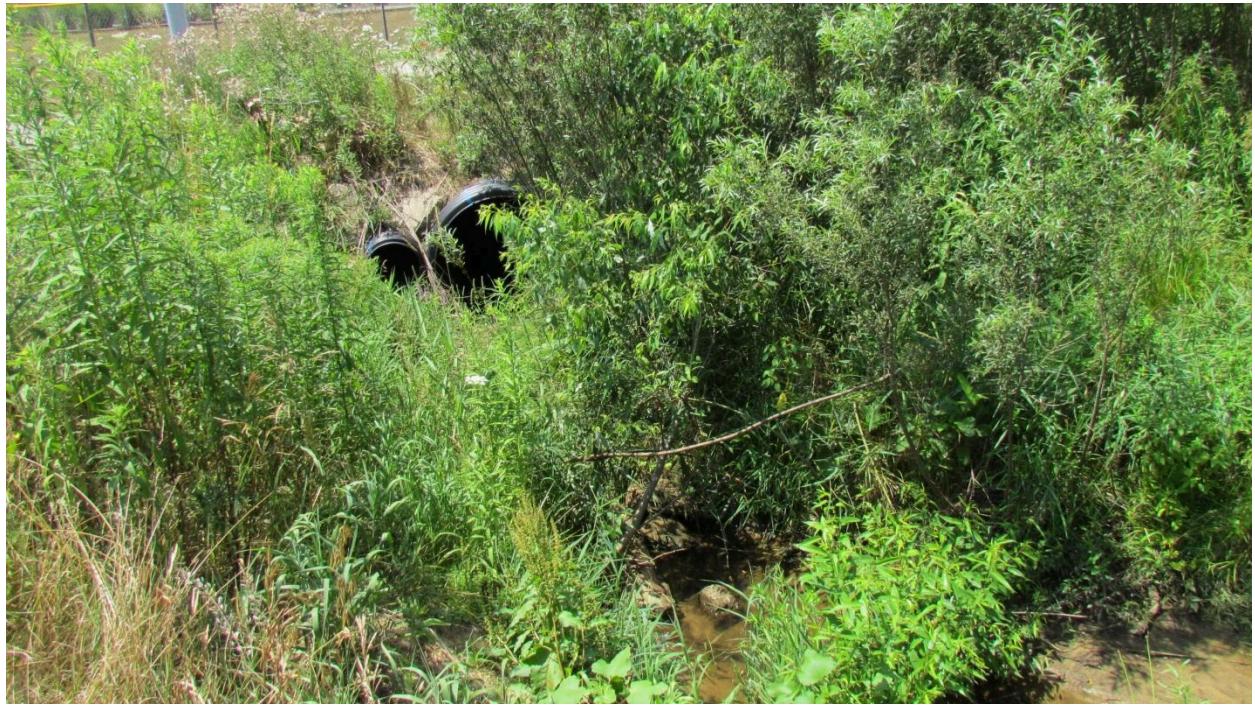
S6-12: Drainpipe

- A Drainpipe – Photo Point S6-12 – feeds the small creek mentioned above. Damselflies were observed at time of visit.
