# RCPowers F117 Build Log

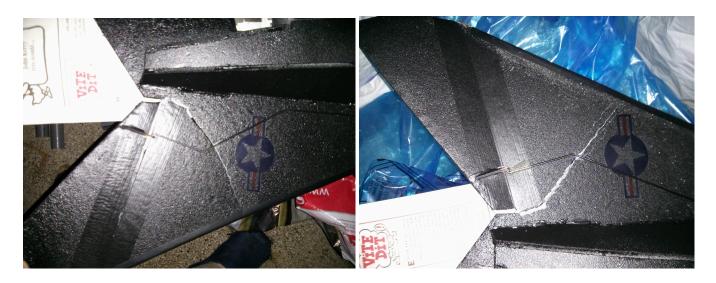
<u>This video</u> shows how well she flew, until both wings cracked and only by incredible pilot skill did she make it back, inverted, in one piece.

I guess the Noma Plan foam is not as rigid as Depron. My plan is to reinforce the wings with a carbon spar, and carbon rods on the leading edges. We'll see how that works out!

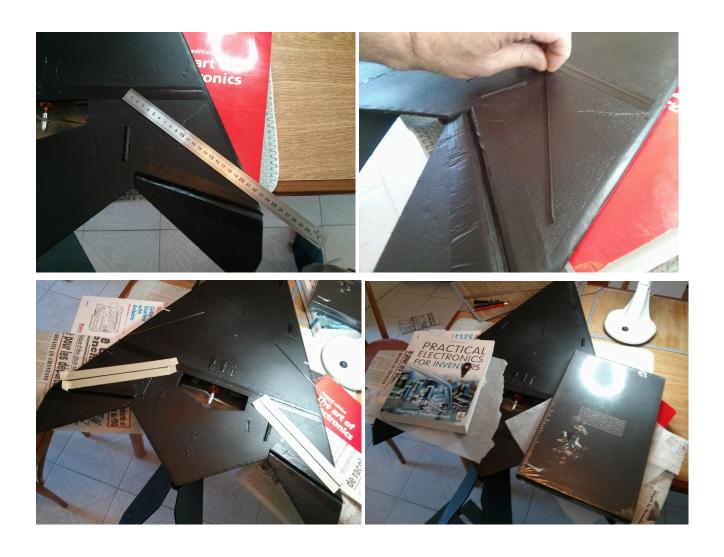
# Wingtip Reinforcement

When epoxying, I was disappointed to find that the beams would not fit flush any more. The epoxy must have been thick enough to keep them raised a bit, sigh.. In any case, the beams will be covered with strapping tape once the epoxy hardens...

I will put in 20cm long diagonal spars made from flat carbon put in "vertically", i.e. NOT laid flat, but "standing up" so to speak

Once the carbon beams fit in snugly, I removed them and protected the surrounding part of the intrados with masking tape, to avoid making a mess with the epoxy. Note how the end of the masking tape is folded on itself to allow for a "grip" when removing.
