Sherwood Park\_\_\_ Adopt-a-Patch  
Site Assessment – Physical Characteristics

Date: June 6, 2021

Park/Ravine Name: Sherwood Park

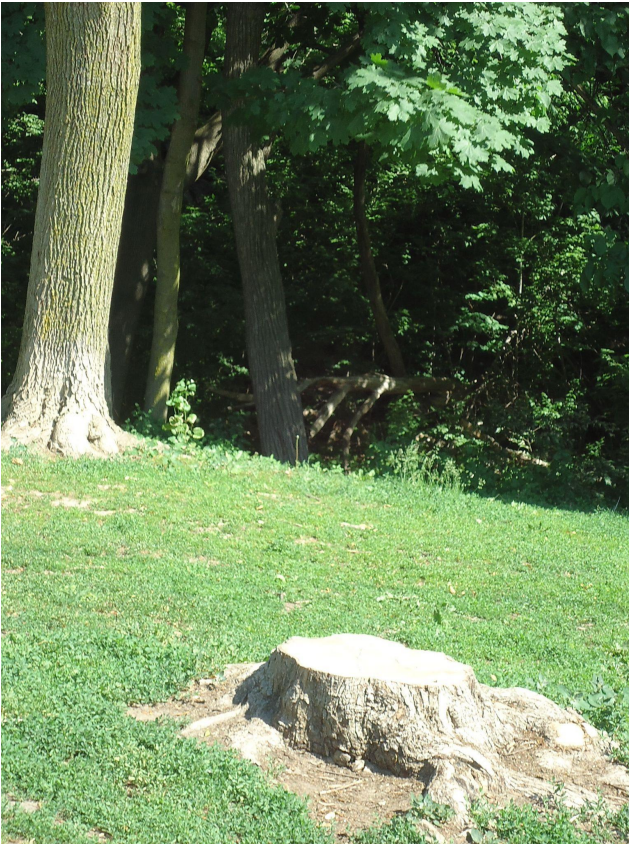
southwest corner of site--linden tree center background--stump in foreground is 2nd from gate

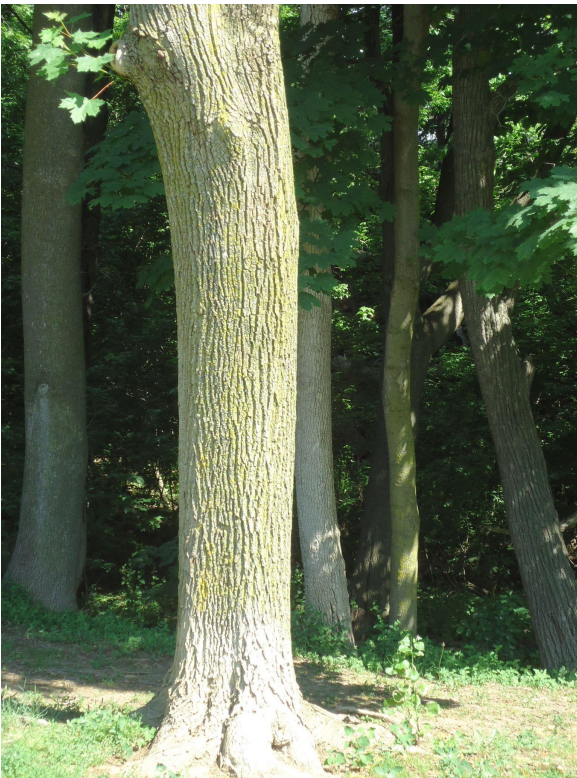
SW corner (closer)--linden far right

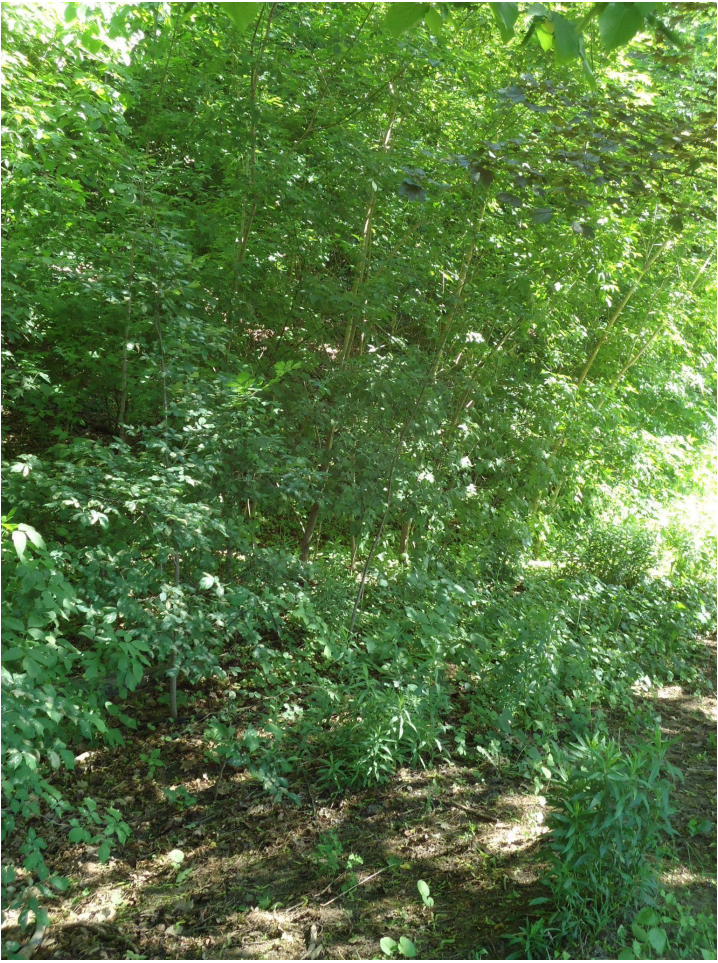
from linden VP facing south

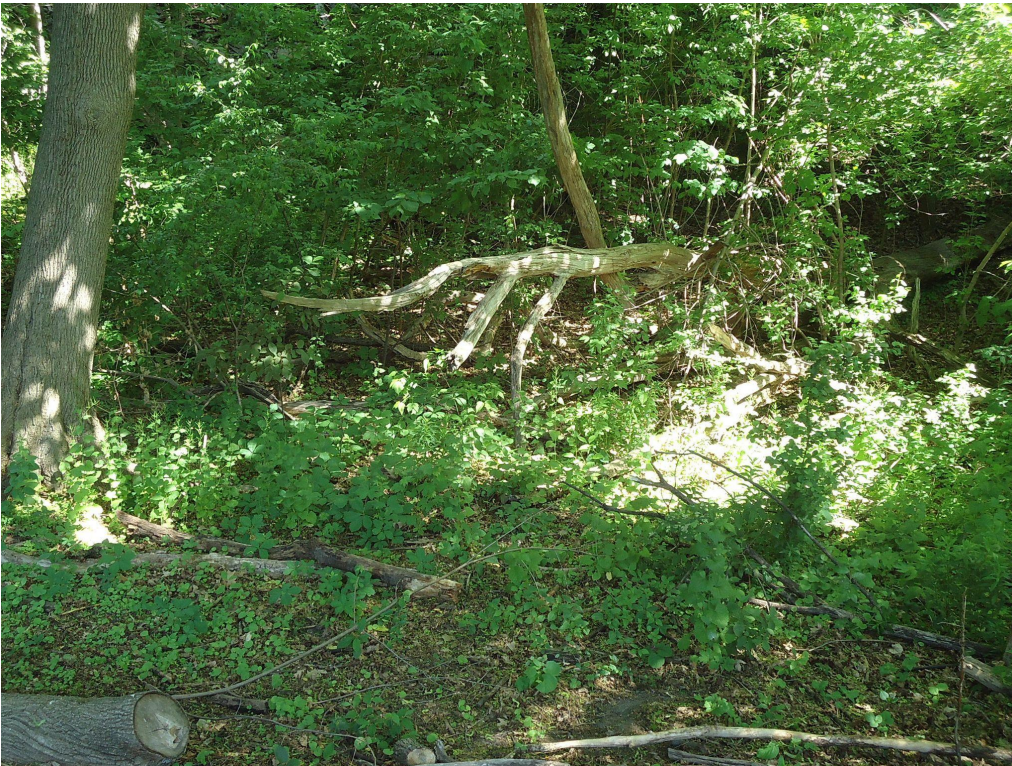
from linden VP facing north

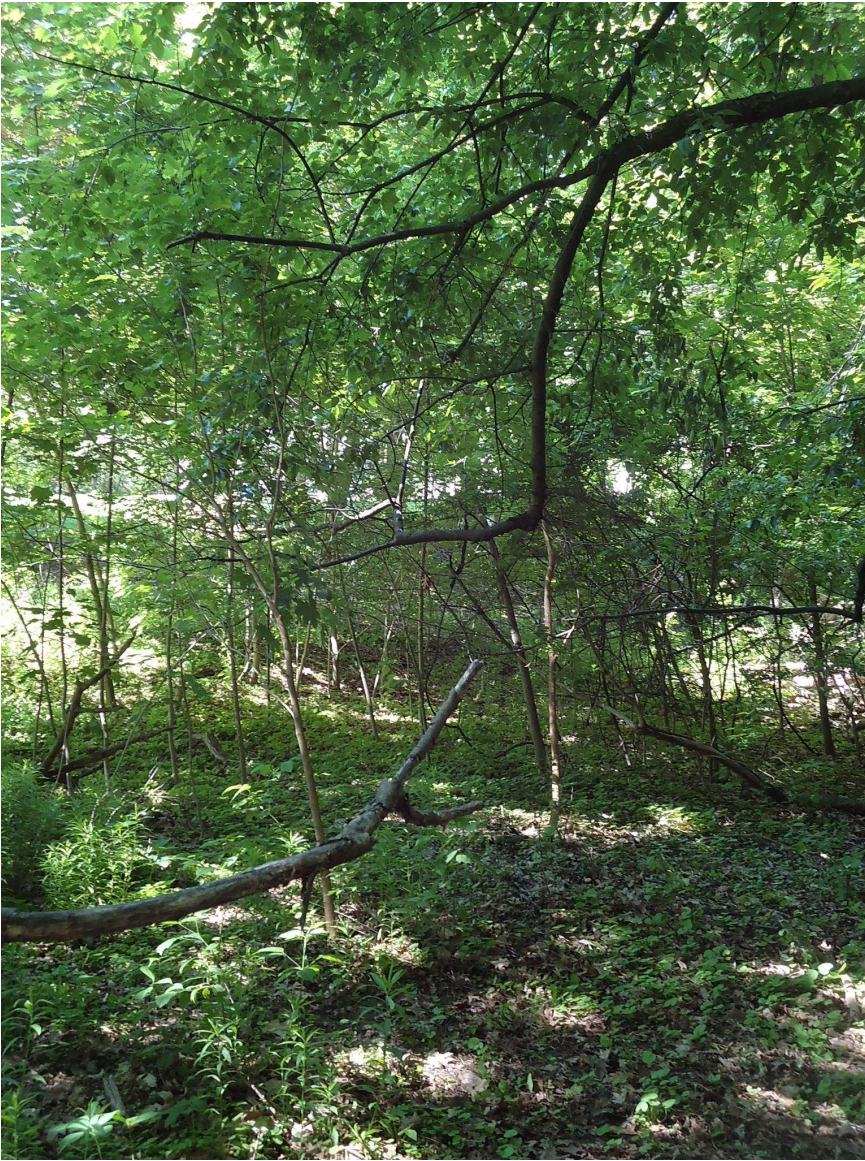
from east fence point looking south

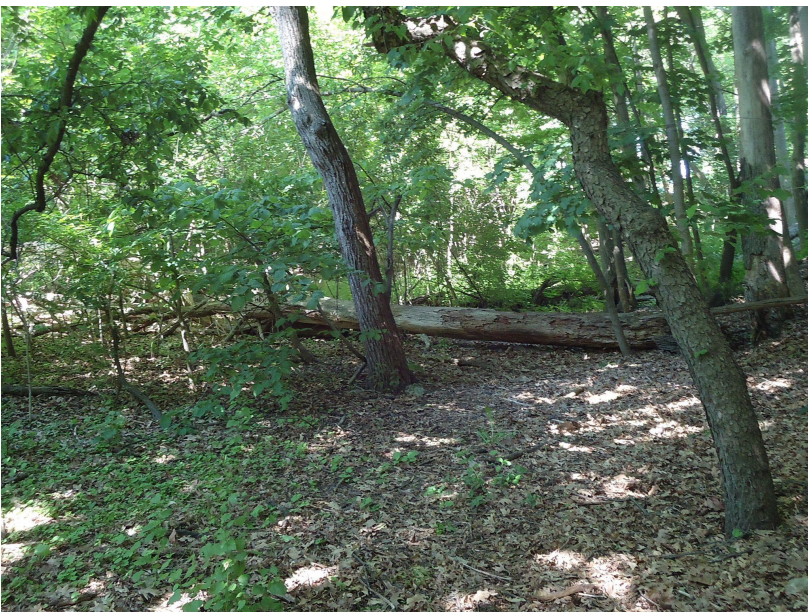
from east fence point looking north
