Site Assessment – Physical Characteristics

Riverside - Middle Mill
44 Beechwood Drive, Toronto/East York

Last updated March 10, 2022

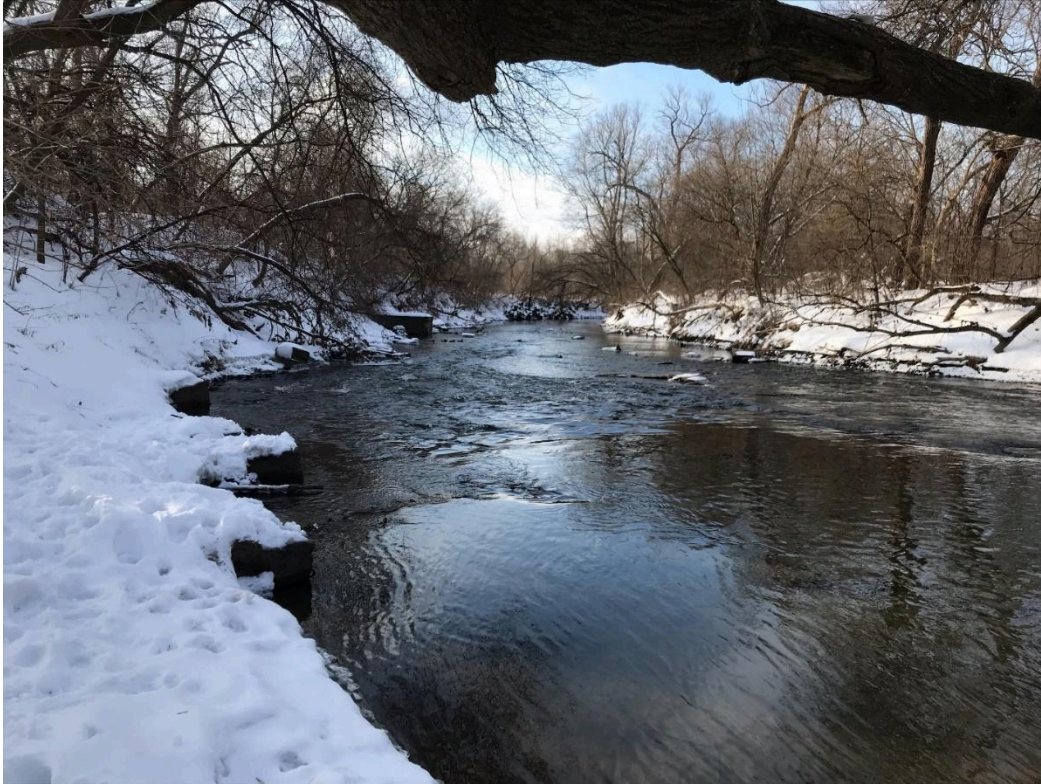
Riparian Reference Point looking Southwest

There is a flat sand beach at the north most end and then sharply narrows heading towards the southern boundary. Soil is mostly sand and landfill with a high rubble component. Vegetation on the riverbank is mostly low shrubs and Manitoba maples.

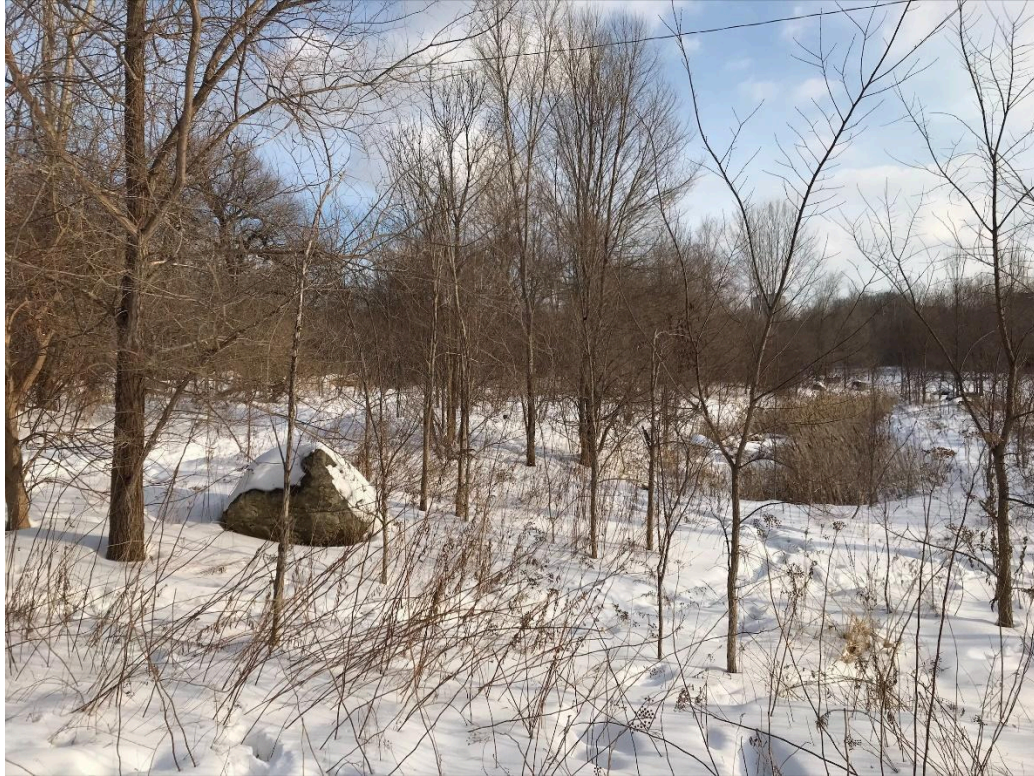
Woodland RP looking Northeast

Mostly comprised of Manitoba Maples and Buckthorn with a few scattered cedars and native deciduous trees. There are a few informal trails running north south that are heavily used.

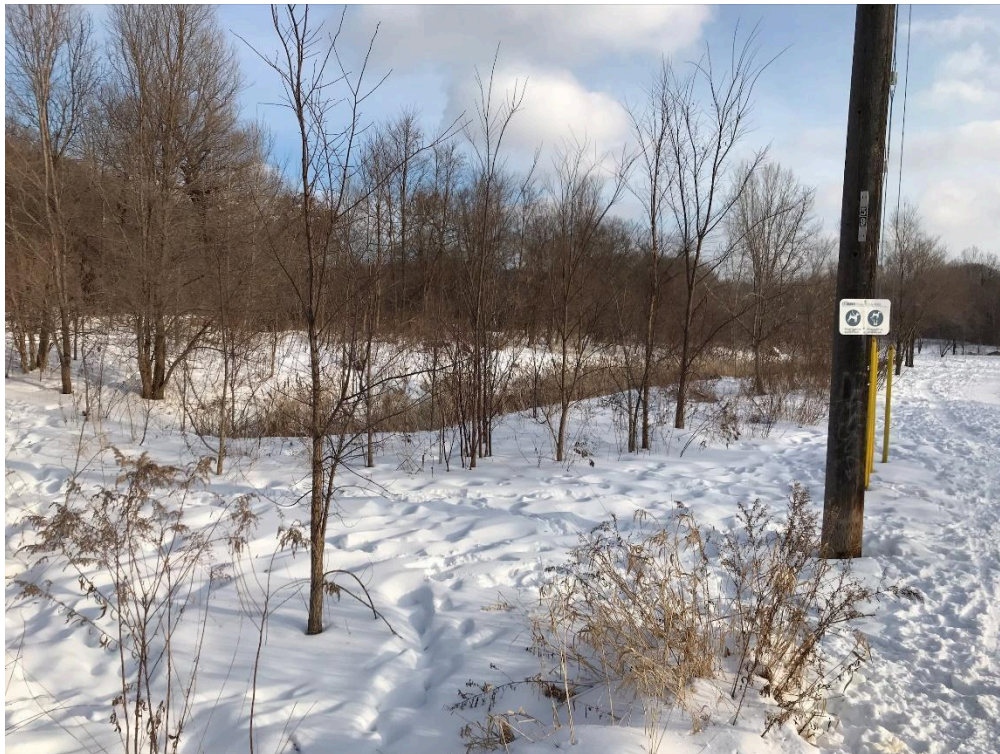
Seasonal Wetland RP looking Northeast

At the south end running north about 20m there is an engineered gully that takes run off from the upper slope. It seems to have a high content of bull rushes and very little phragmites.
