SITE 15

Trumbull Reserve

Hudson Township
Summit County, OH

*Report Written By: Stephanie Deibel
Date of Site Visit: 29 March 2013
Date Finalized: 30 April 2013*

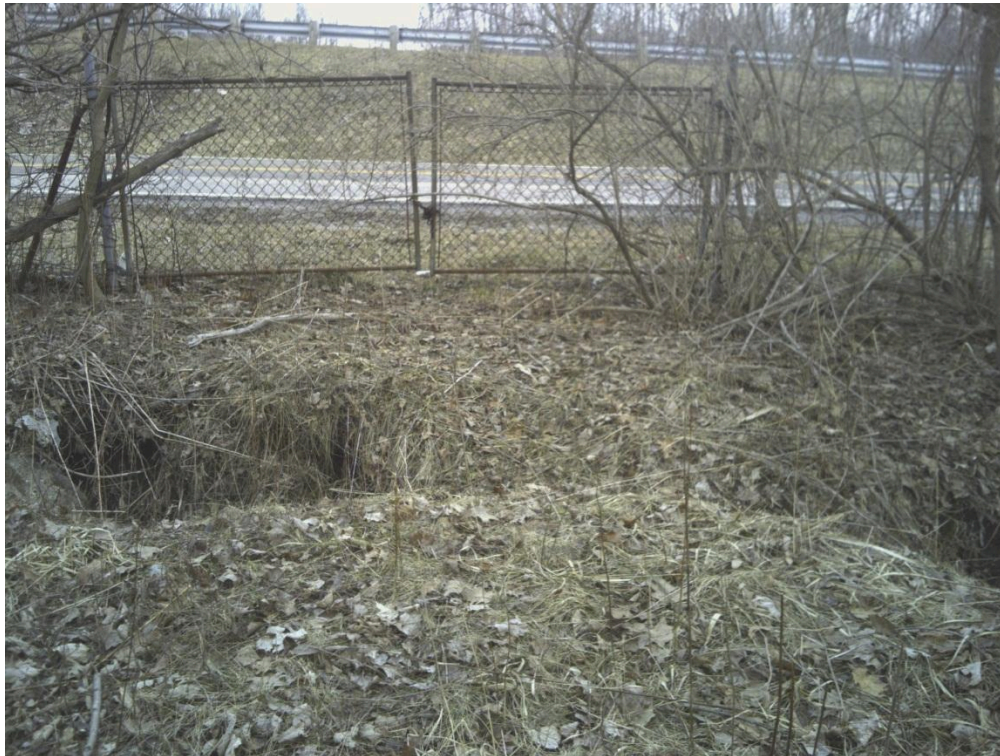
S15-01: *Corner*

- Corner – Photo Point S15-01 – is clearly marked. A chain linked fence is visible, which could be used as another access point. There is a broken red pipe at this location, possibly part of a drainage system. A mink was observed in the adjacent wetland.

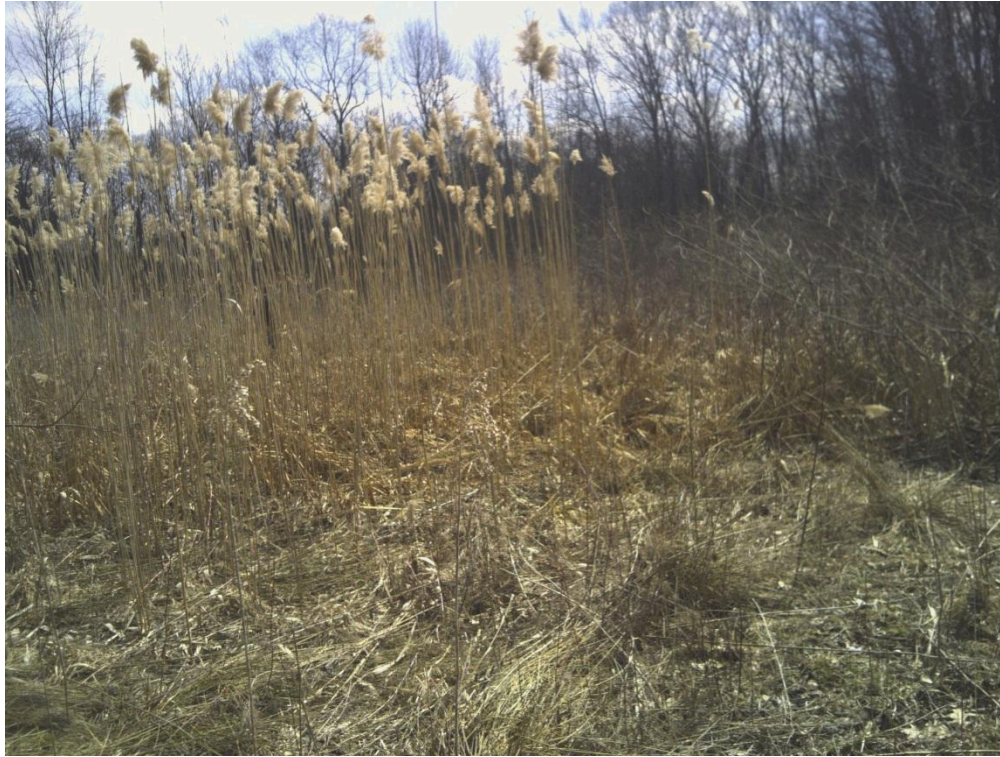
S15-02: *Wetland*

- Wetland – Photo Point S15-02 – consists of common reed and cattail growth. Some shrubs are growing in the area.
- Creek – Photo Point S15-03 – is perennial and seems to be natural, however, may have been channelized at some point. The dominate substrate is silt and the riparian area is wide with forest habitat on both river right and left.

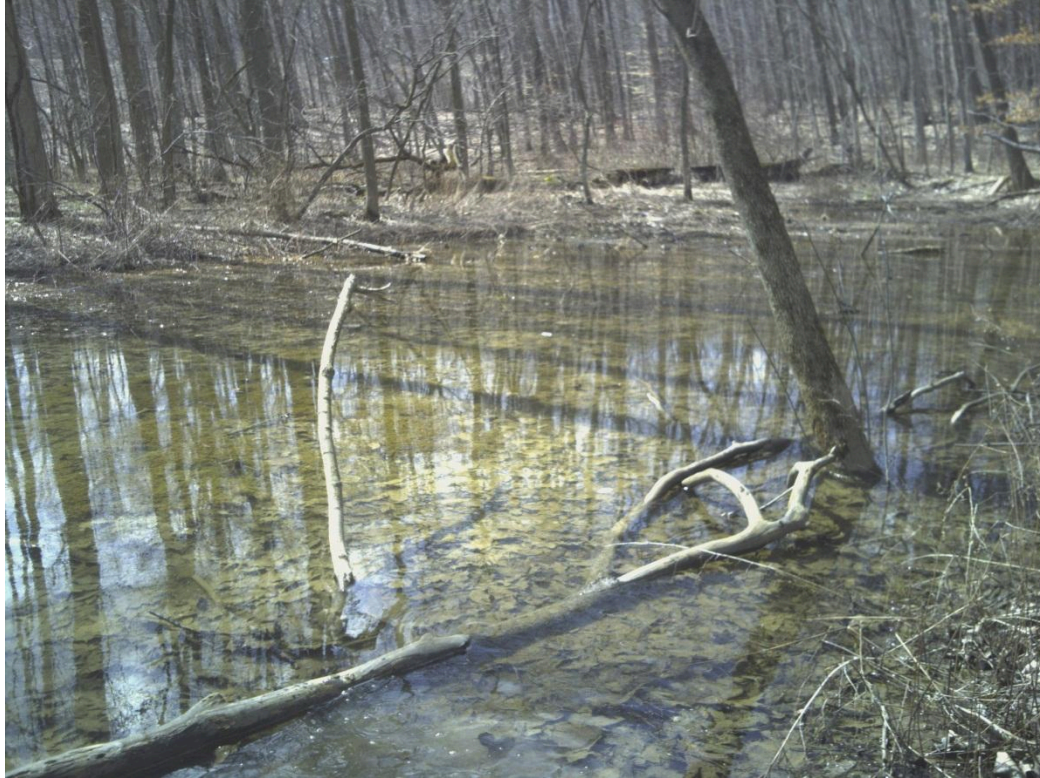
S15-04: *Pond Area*

- Pond Area – Photo Point S15-04 – is small, less than 0.5 acre in size. The area is surrounded by forest habitat. The pond is filled with leaf debris.

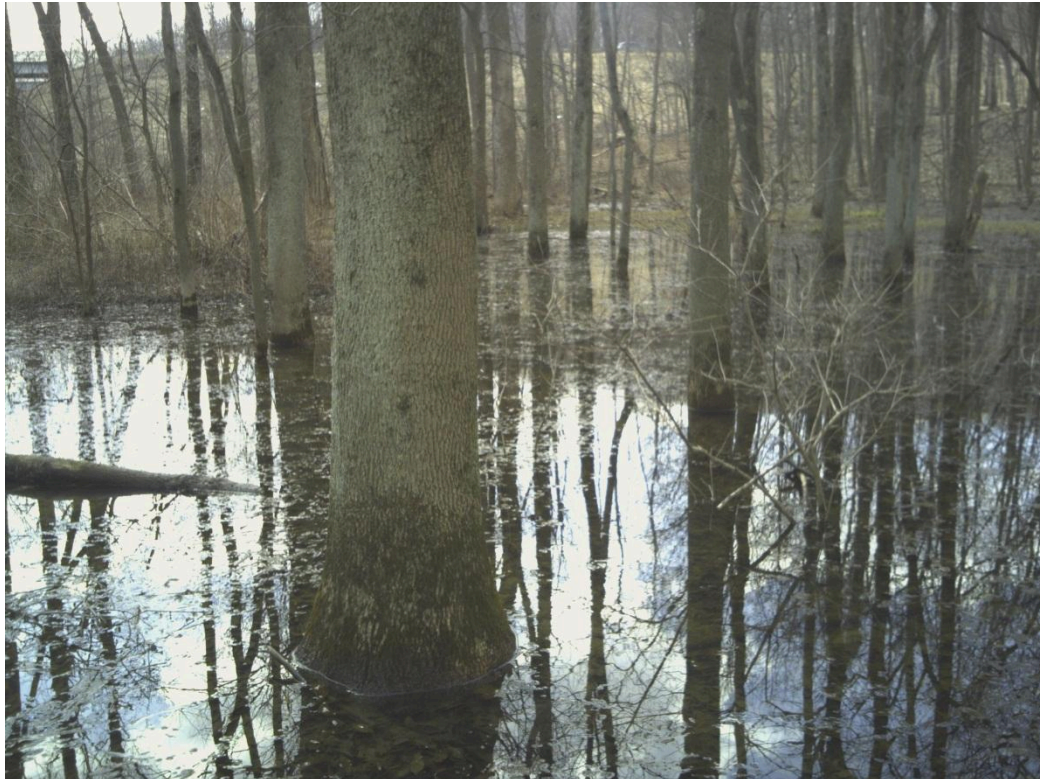
S15-05: *Pond Area*

- Pond Area – Photo Point S15-05 – is small, less than 0.5 acre in size. Microtopography is present. The area is surrounded by forest and is located near highway 14 and Tinkers Creek.

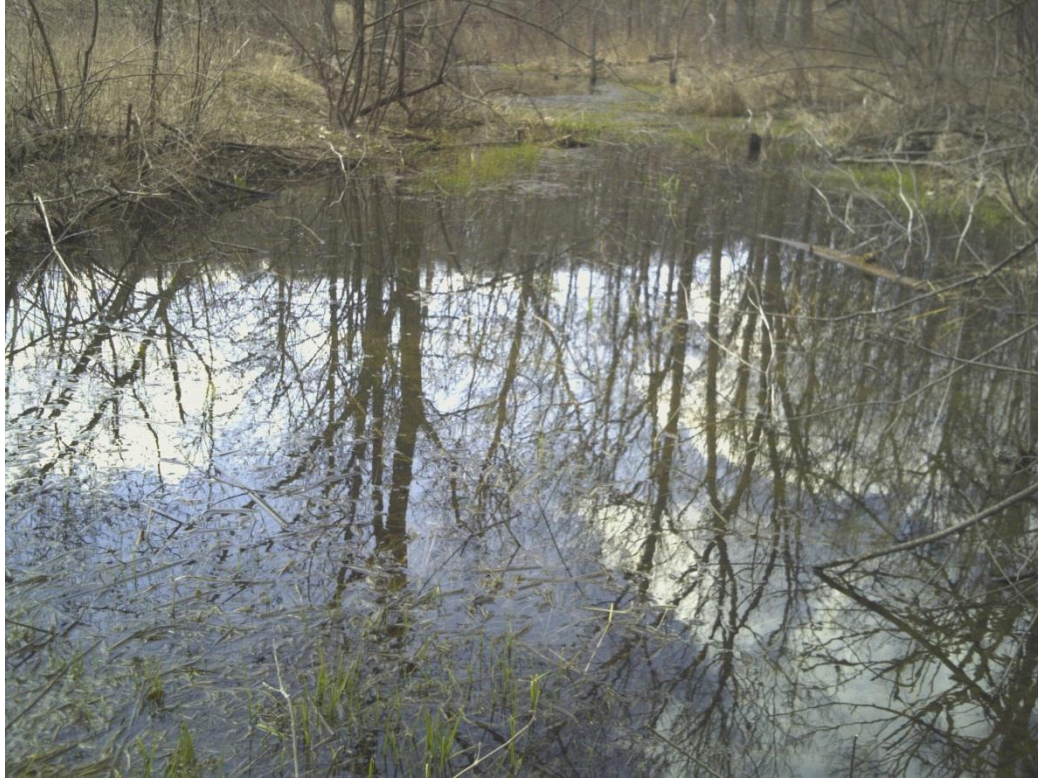
S15-06: *Pond Area*

- Pond Area – Photo Point S15-06 – is small, less than 0.5 acre in size. The area is surrounded by forest and is near highway 14 and Tinkers Creek.
- Corner – Photo Point S15-07 – is clearly marked by a fence. Accessing the true corner of the property requires crossing the creek, which was not probable at the time of the visit.

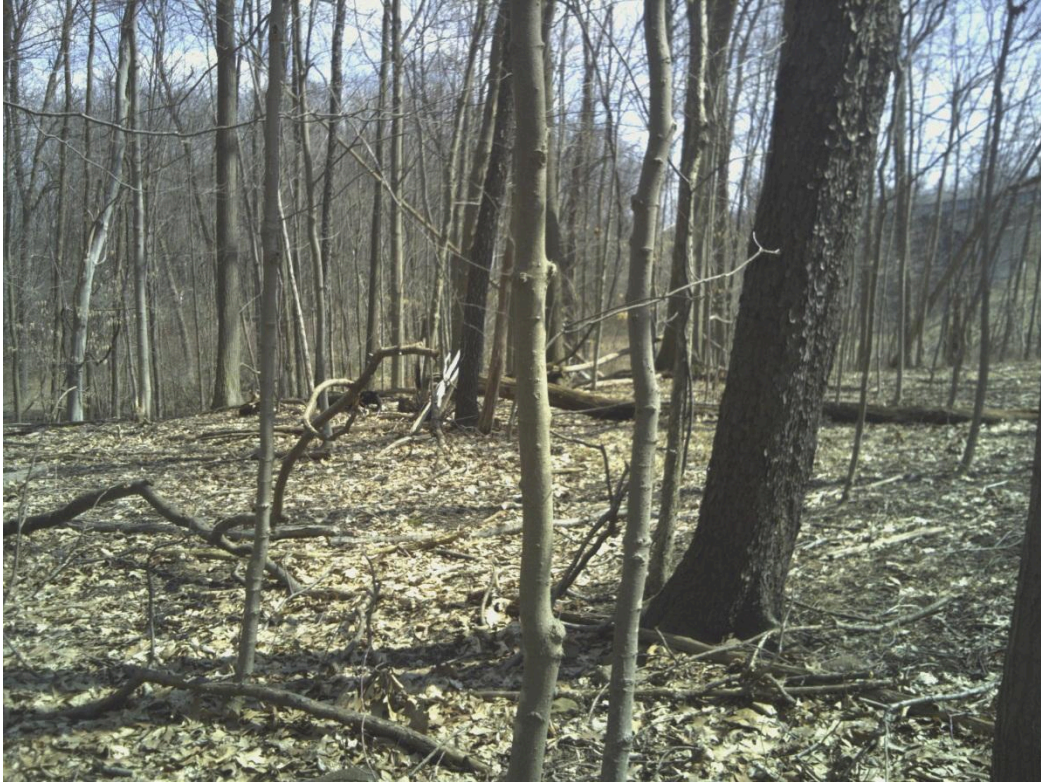
S15-08: *Forested Area*

- Forested Area – Photo Point S15-08 – is natural and uneven aged. The age range is Early/Mid-Successional with DBH ranging 6”-16”. This hardwood forest is dominated by Oaks. The understory is open with diverse sapling growth.

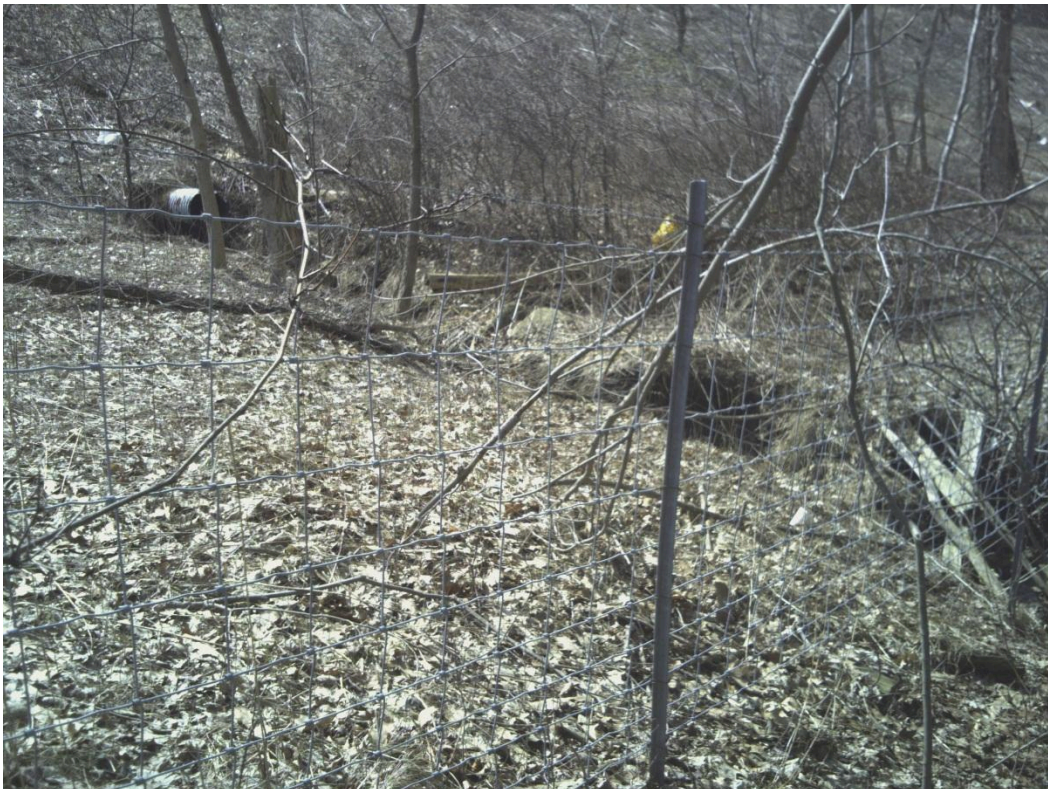
S15-09: *Corner*

- Corner – Photo Point S15-09 – is marked by a fence. A drainpipe is present, which seems to feed this portion of Tinkers Creek.
- Forested Area – Photo Point S15-10 – is natural and uneven aged. The age is Early/Mid-Successional with DBH ranging 6”-16”. This hardwood forest is dominated by Maples. The understory is open with diverse sapling growth.

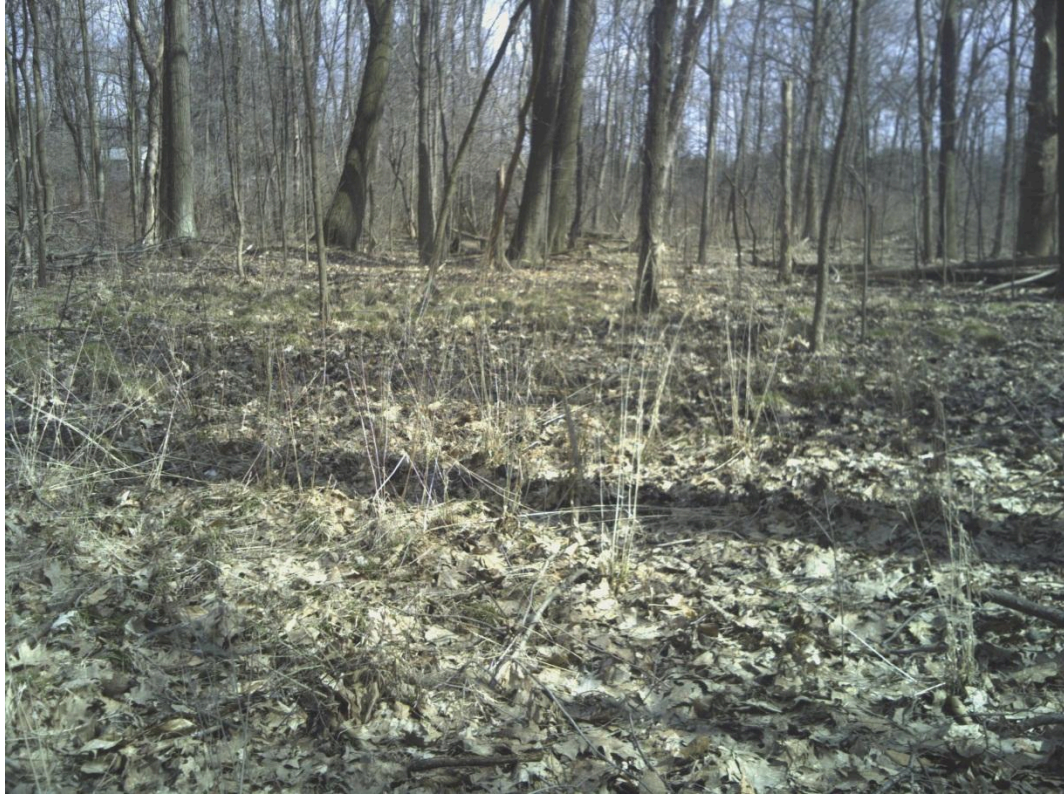
S15-11: *Forested Area*

- Forested Area – Photo Point S15-11 – is natural and uneven aged. The age range is Early/Mid-Successional with DBH ranging 6”-16”. This hardwood forest is dominated by Maples and Oaks. The understory is open with diverse sapling growth. A wet area/vernal pool is located in the area.
