# Dairy Green Ltd

8 August 2022

Sealach Ltd

## **Drop Test Results: Sealach Ltd, Effluent Pond, 9 - 10 July 2022**

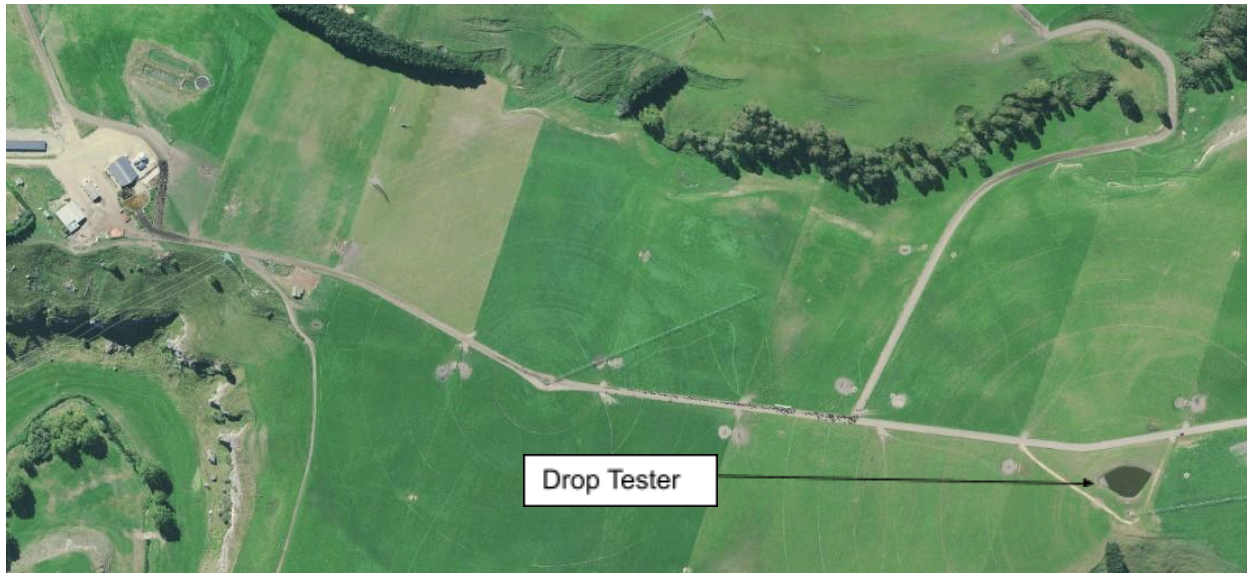
The pond surface area at water level during the test period was 1218.1 m<sup>2</sup> and the total catchment area was 1592.1 m<sup>2</sup>.

*Below is an aerial photo that shows pond and dairy shed. The laser drop test unit was installed at the west corner of the pond, as marked.*

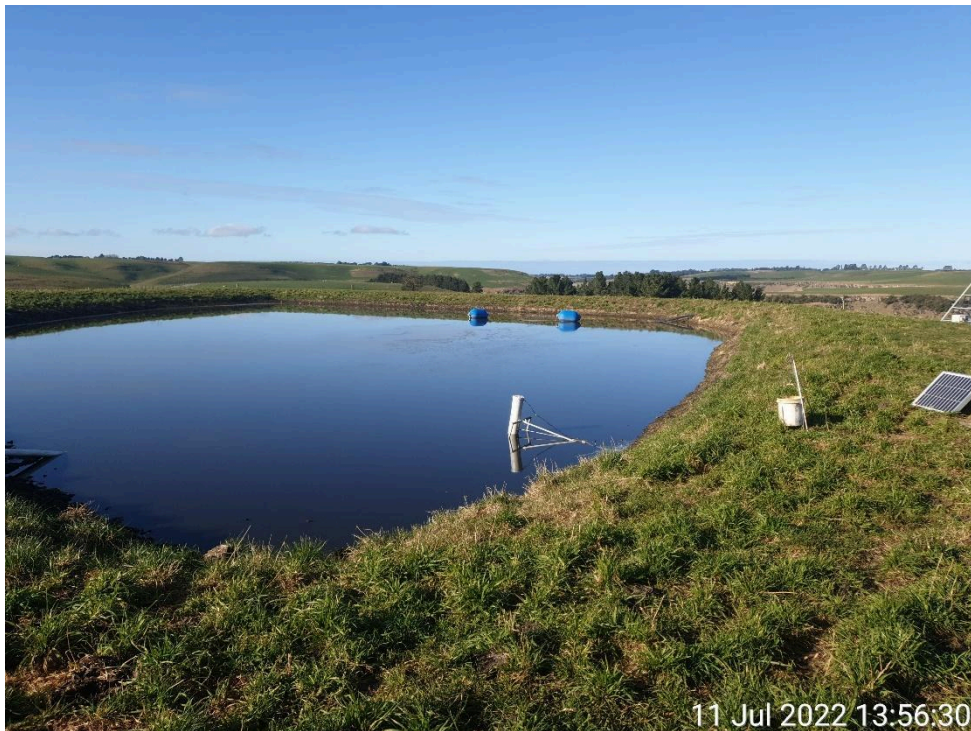
A laser distance measuring unit was set up vertically over the pond surface. A reflective disc was placed on the pond surface to ensure constant, repeatable readings.

The laser was set up within a PVC pipe which acts as a stilling well.

- When a period of 24 hours or more has lapsed the information is downloaded and the results interpreted.
- The GPS location of the pond and equipment set up is recorded. For this test the equipment was located at E1418581.21 N5023629.45, at the west corner of the pond.

*Laser at the west corner of the pond.*
