Sealach Ltd

Drop Test Results: Sealach Ltd, Effluent Pond, 9 - 10 July 2022

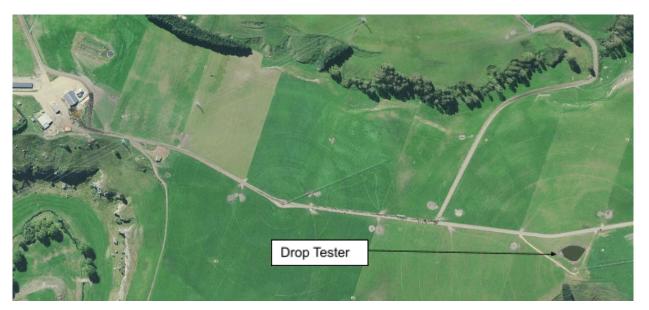
Below is an aerial photo that shows pond and dairy shed. The laser drop test unit was installed at the west corner of the pond, as marked.

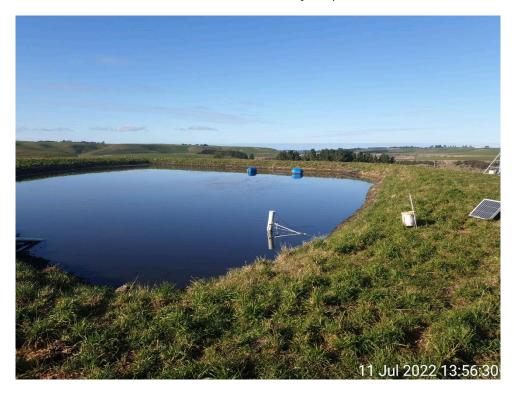
Laser at the west corner of the pond.

A laser distance measuring unit was set up vertically over the pond surface. A reflective disc was placed on the pond surface to ensure constant, repeatable readings.

The laser was set up within a PVC pipe which acts as a stilling well.

- When a period of 24 hours or more has lapsed the information is downloaded and the results interpreted.
- The GPS location of the pond and equipment set up is recorded. For this test the equipment was located at **E**1418581.21 **N**5023629.45, at the west corner of the pond.
