## Alumizu Keycap Acceptable QC

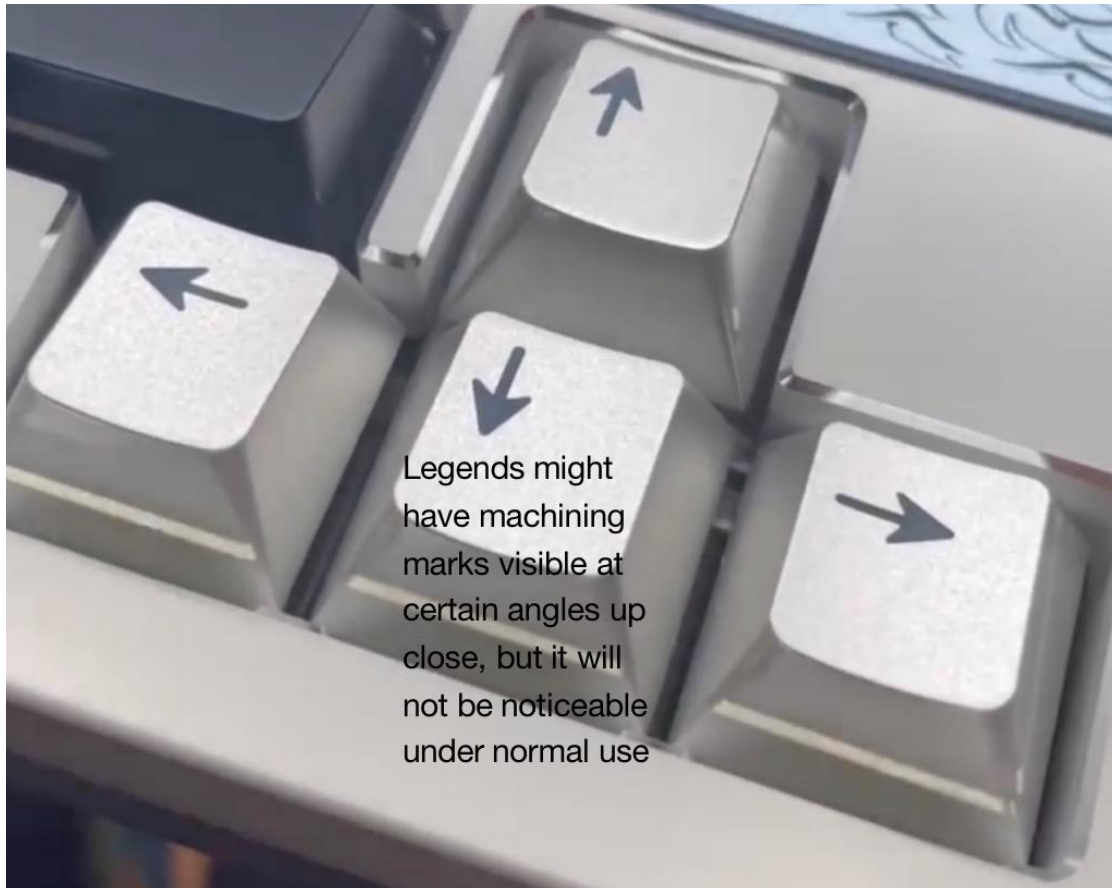
Caps with legends might have small machining marks when you see it from some angle and under direct light. We kept changing many different angles for 2-3 minutes and found the mark shown below under direct light. It's unnoticeable in normal usage. Please refer to this video to check more: <https://i.imgur.com/E0HhPQw.mp4>

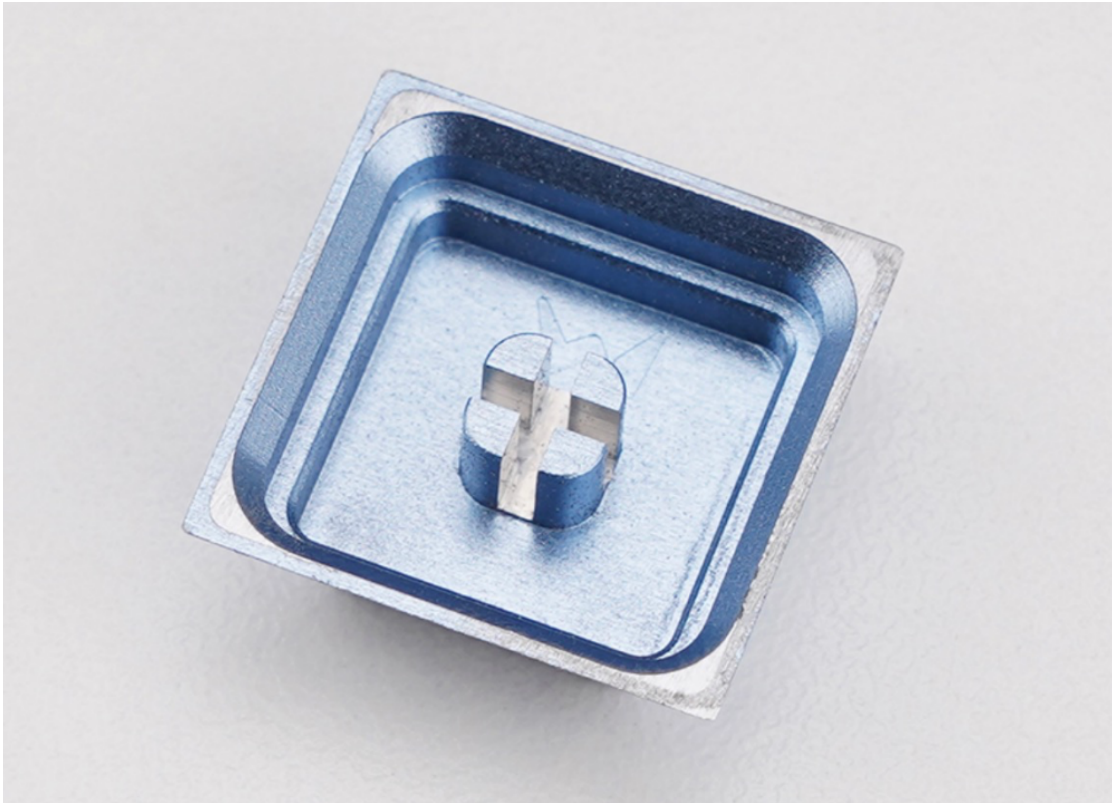
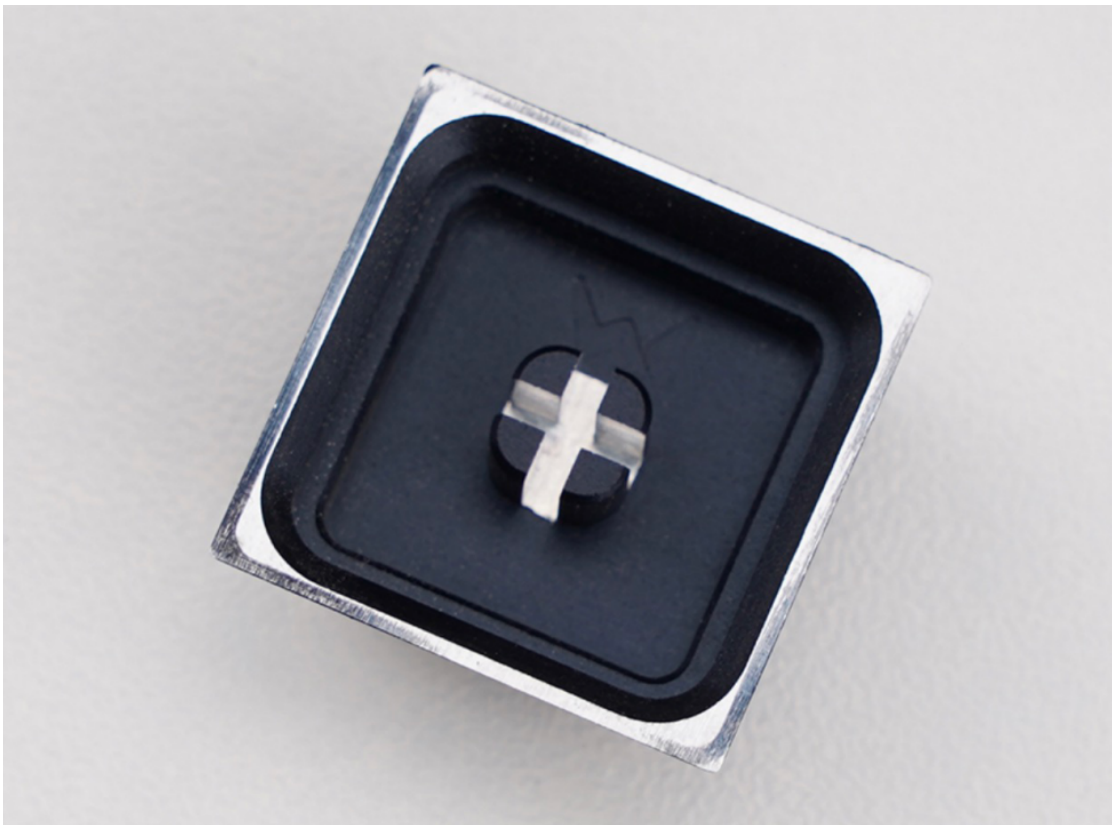
The underside of these caps will be raw aluminum on the finishing surface. Internal machining marks may exist.
