# **Catchment Degradation from Mining in the Dikhow Basin and Its Role in the Upper Assam Flood Disaster of July 2026**

*A geomorphological and hydrological assessment based on multi-temporal satellite imagery  
(2010-2026), official flood and rainfall records, and headwater rainfall climatology*

Study area: Naginimora sector, Dikhow (Dikhu) river  
Mon District (Nagaland) - Charaideo / Sivasagar Districts (Assam)  
Event: 19 July 2026 onward

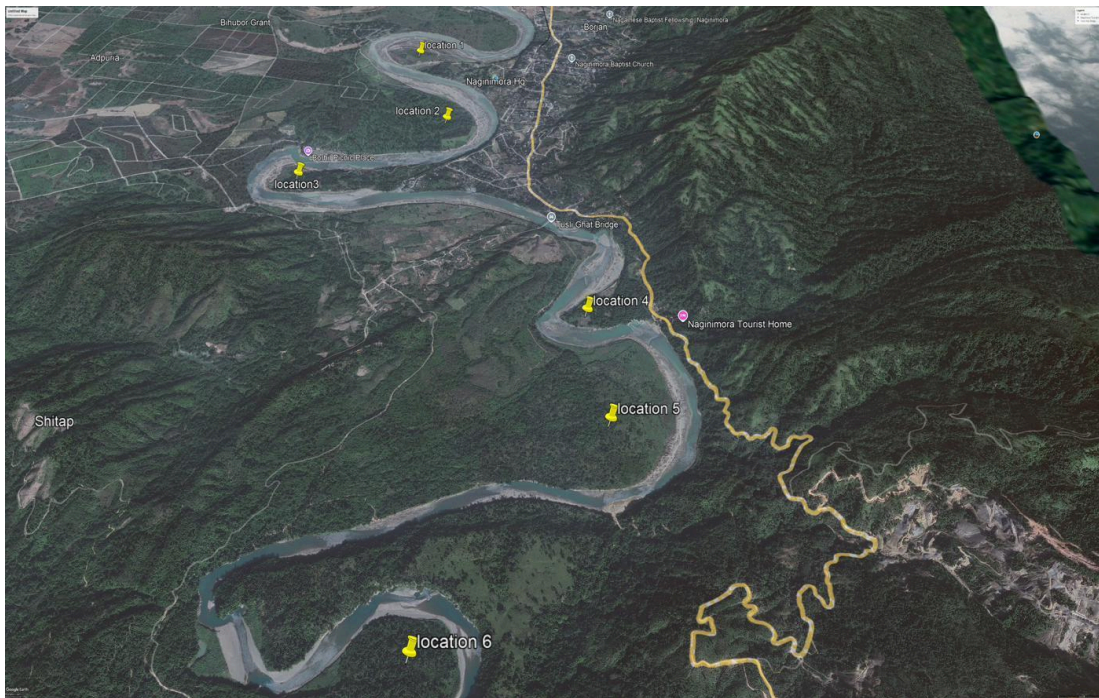
**Figure 1. Study reach, Naginimora sector, Dikhow river: catchment overview**

*Figure 1a, 2010. Continuous hill forest; a single confined open-cast working at lower right; narrow, well-defined channel with limited exposed bar surface.*

Figure 1 shows the study reach in both epochs with the six assessment locations marked. Read it for three things: the extent of the pale mining scar in the south-east quadrant; the density of the haul-road network penetrating the hill forest; and the width, colour and braiding pattern of the Dikhow channel.

Comparing the two epochs at catchment scale:

- The open-cast complex in the south-east has **expanded by a large multiple**, with an extensive new haul-road network radiating into previously forested hill terrain.
- Hillslope forest cover between Naginimora and the mine complex has been substantially fragmented by new access tracks and clearings.
- The Dikhow channel is **visibly wider, paler and more braided** along its entire mapped length in 2026, with much larger exposed sediment surfaces, the surface expression of a large increase in coarse sediment supply.
- Extraction is present on **both banks**, that is, on both sides of the interstate boundary.

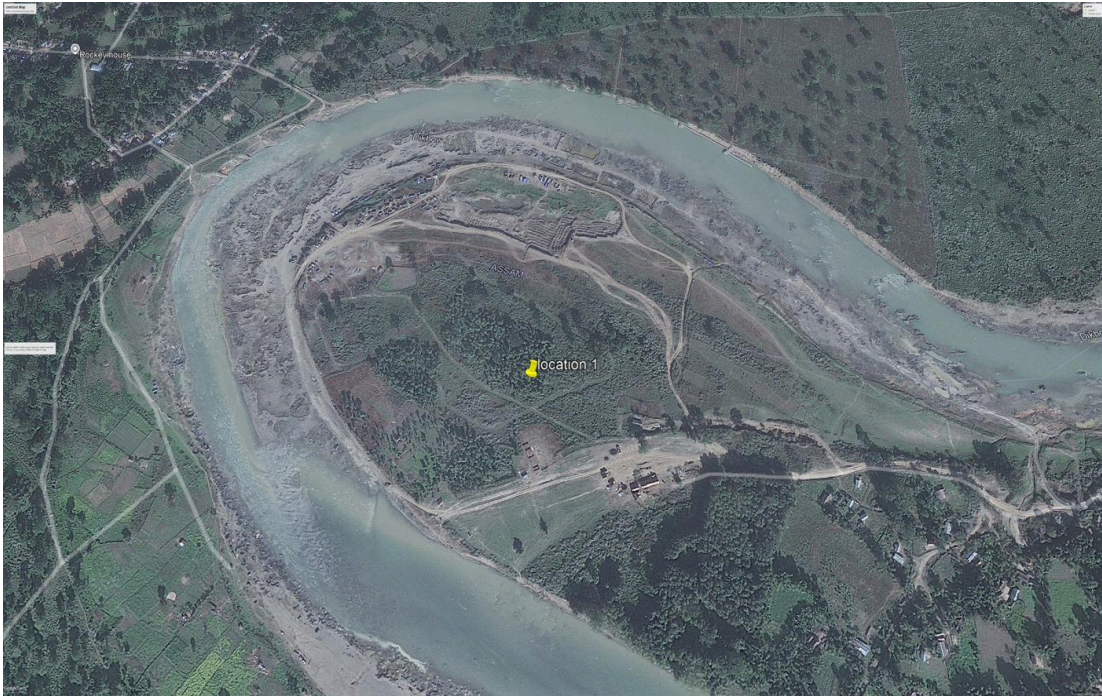
**Figure 2. Location 1, meander core at the Assam boundary**

*Figure 2a, 2010. Vegetated meander core with mature tree cover, small cultivated plots and a settlement along the eastern margin. Extraction confined to a terraced working on the outer point bar. Single dominant channel thread.*

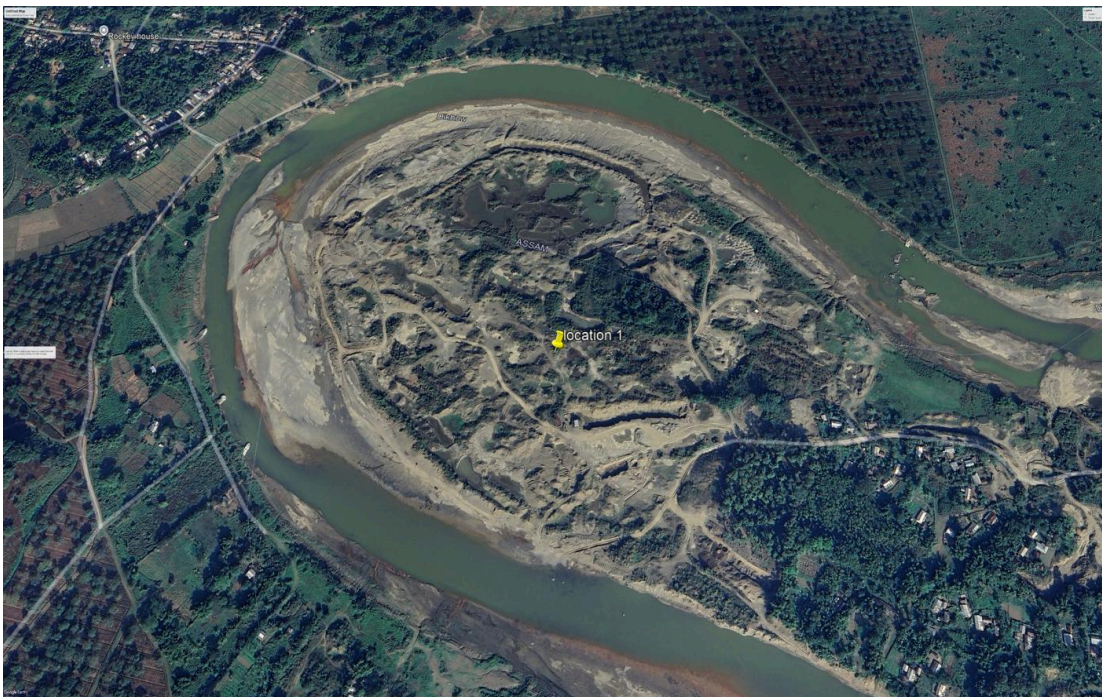
*Figure 2b, 2026. Vegetated core effectively eliminated; the interior is stripped to bare substrate and reworked into excavation pits, spoil ridges, benched faces and haul tracks, with standing water in the deeper cuts. Orange-red staining visible on parts of the channel margin.*

**2026.** The vegetated core has been **effectively eliminated**. The entire meander interior is stripped to bare substrate and reworked into a mosaic of excavation pits, spoil ridges, benched faces and haul tracks, with standing water in the deeper cuts. The floodplain surface has been lowered and disaggregated. Riparian vegetation on the channel margin is gone. A distinct orange-red staining is visible along parts of the channel margin.

*Interpretation:* wholesale removal of a floodplain block: the loss here is not only of vegetation but of the floodplain sediment body itself, together with its roughness, storage and cohesion.

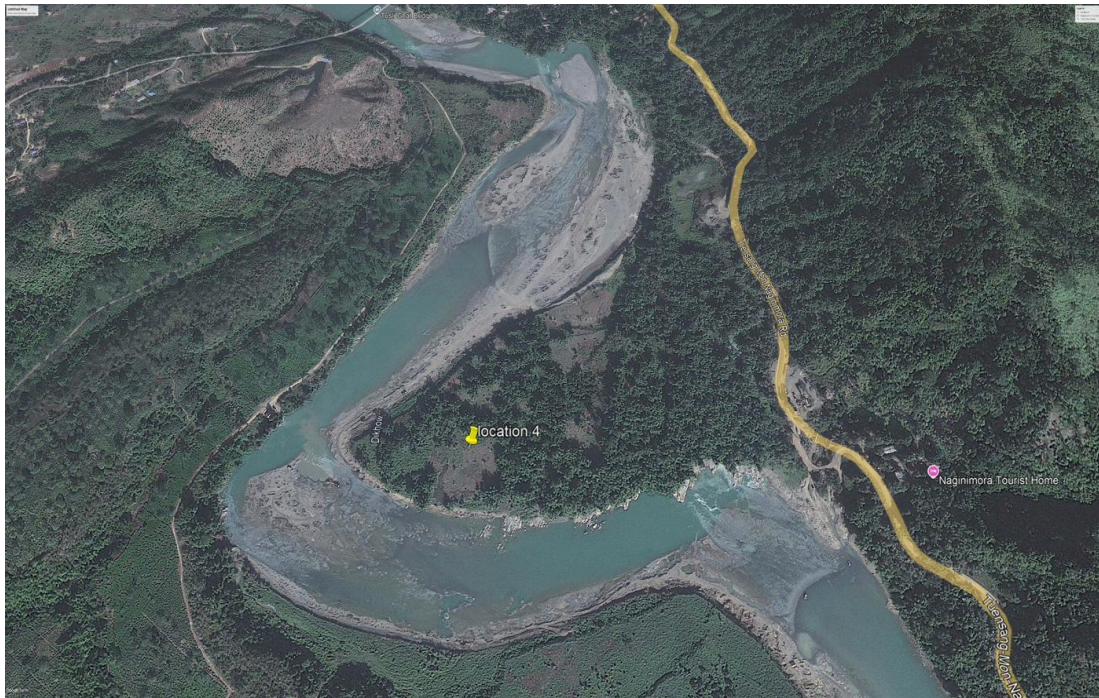
**Figure 5. Location 4, meander below Tusli Ghat Bridge**

*Figure 5a, 2010. Meander core fully forested; channel carrying clear blue-green water; point bar a natural, unworked gravel surface.*

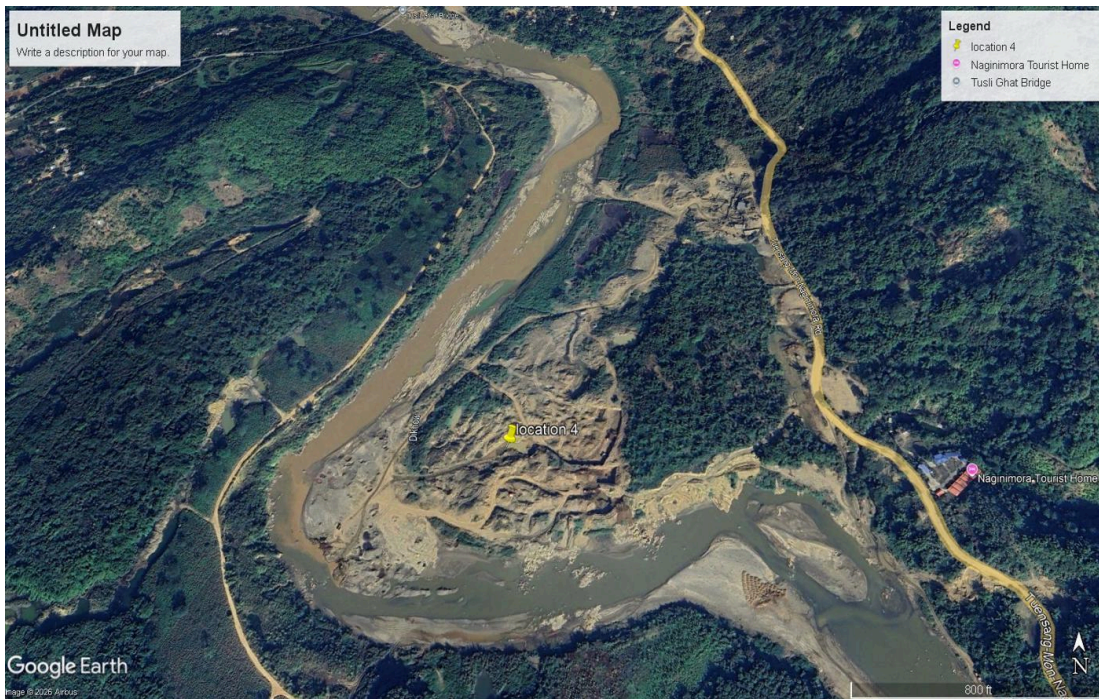
*Figure 5b, 2026. Core completely excavated into terraced benches, spoil heaps, a dense haul-road network and working faces cut into the former floodplain terrace. Water in the upstream limb is heavily turbid brown. Bar surfaces markedly enlarged; low-flow channel narrowed and displaced. This frame carries a scale bar (800 ft) and imagery credit (© 2026 Airbus).*

**2026.** The core is **completely excavated**: terraced benches, spoil heaps, a dense haul-road network, and working faces cut into the former floodplain terrace. The water in the upstream limb is **heavily turbid brown**, in sharp contrast to the 2010 condition. Bar surfaces are markedly enlarged and the low-flow channel is narrowed and displaced.

*Note:* this frame carries a scale bar (800 ft) and an imagery credit (© 2026 Airbus), making it the best candidate for quantified digitisation.

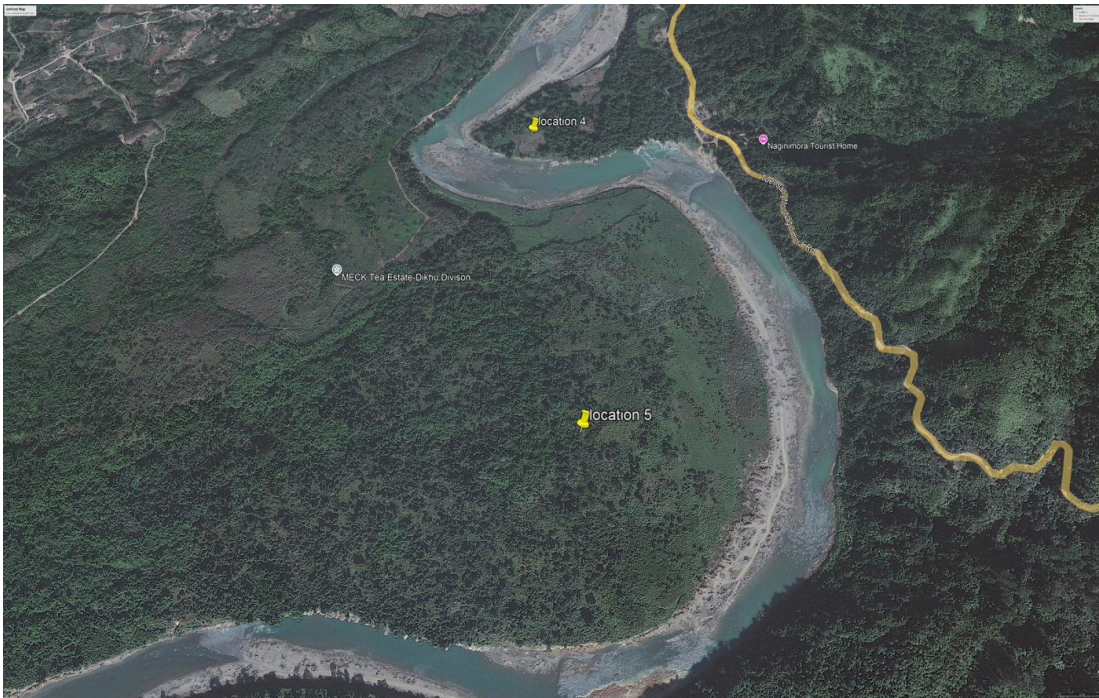
**Figure 6. Location 5, meander loop below Naginimora Tourist Home**

*Figure 6a, 2010. Continuous dense forest across the entire loop interior and up the valley side; the MECK Tea Estate (Dikhu Division) label sits within unbroken canopy. Clear-water channel with clean lateral bars.*

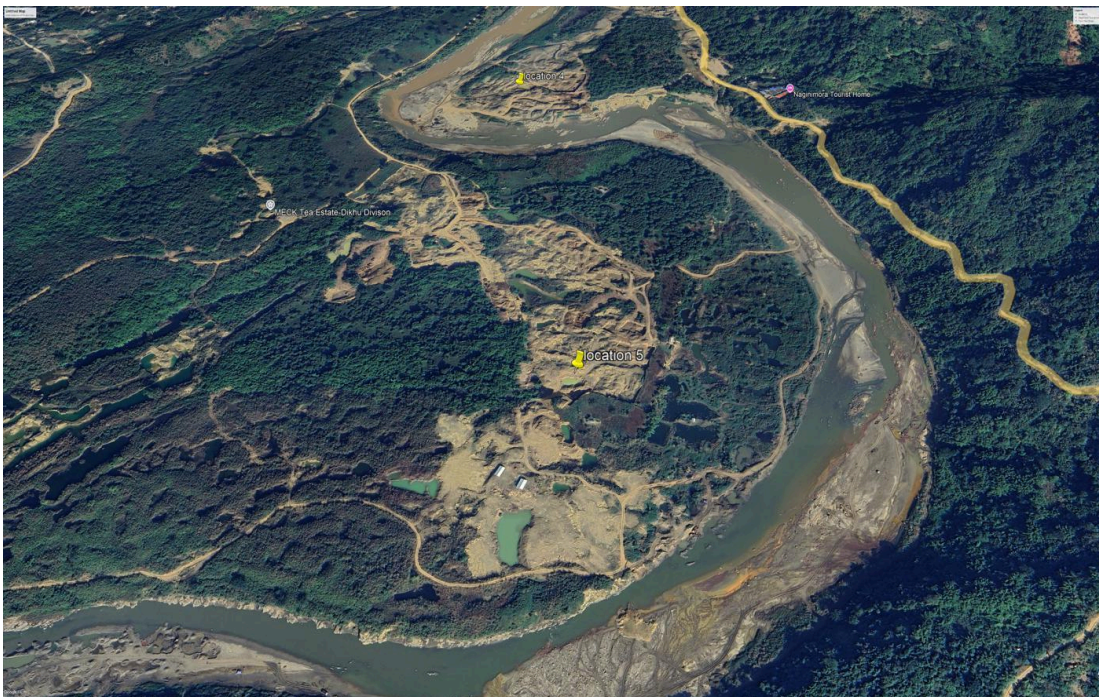
*Figure 6b, 2026. The most severe change in the sequence: a large excavation complex with working faces, spoil, settling ponds, haul roads and structures, extending from the bank up onto the hillslope. Bars greatly enlarged; channel choked with sediment; pronounced orange-ochre staining on bar surfaces and along the channel margin downstream of the workings.*

**2026.** The most severe change in the sequence. The loop interior has been opened into a **large excavation complex** (working faces, spoil, settling ponds, haul roads and structures) extending from the bank up onto the hillslope. Forest loss extends well beyond the floodplain into the valley sides. Bars are greatly enlarged and the channel is choked with sediment. **Pronounced orange-ochre staining** is visible on bar surfaces and along the channel margin downstream of the workings.

*Interpretation:* the ochre staining is the characteristic signature of iron-oxide precipitation from acid or ferruginous mine drainage, that is, from sulphide-bearing, coal-associated material in contact with water. This is a water-quality finding of independent regulatory significance and warrants direct sampling (pH, Fe, SO<sub>4</sub>, conductivity, total suspended solids).

The ochre staining at Location 5 (Figure 6b) indicates ferruginous or acid mine drainage entering the river. During floods this material is remobilised and carried downstream onto agricultural land and into water supply intakes, including the five PWSS schemes reported damaged at Amguri. A compounding harm distinct from the flood hydraulics.

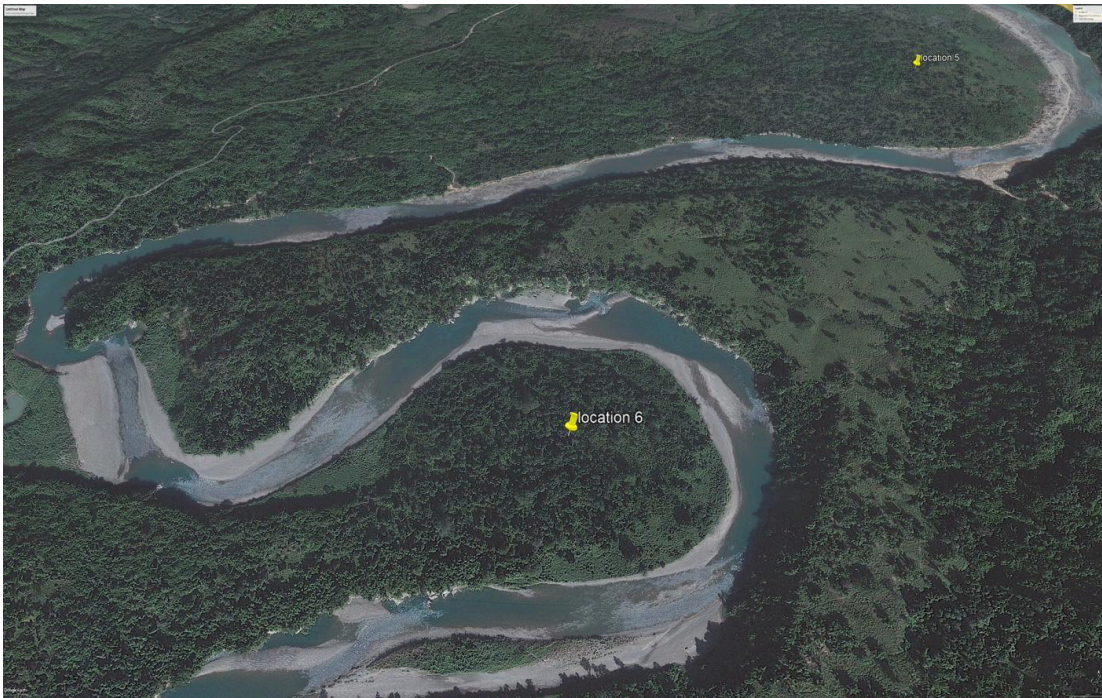
**Figure 7. Location 6, downstream meander pair**

*Figure 7a, 2010. Both meander loops fully forested with clean, well-defined bars. This reach is essentially pristine.*

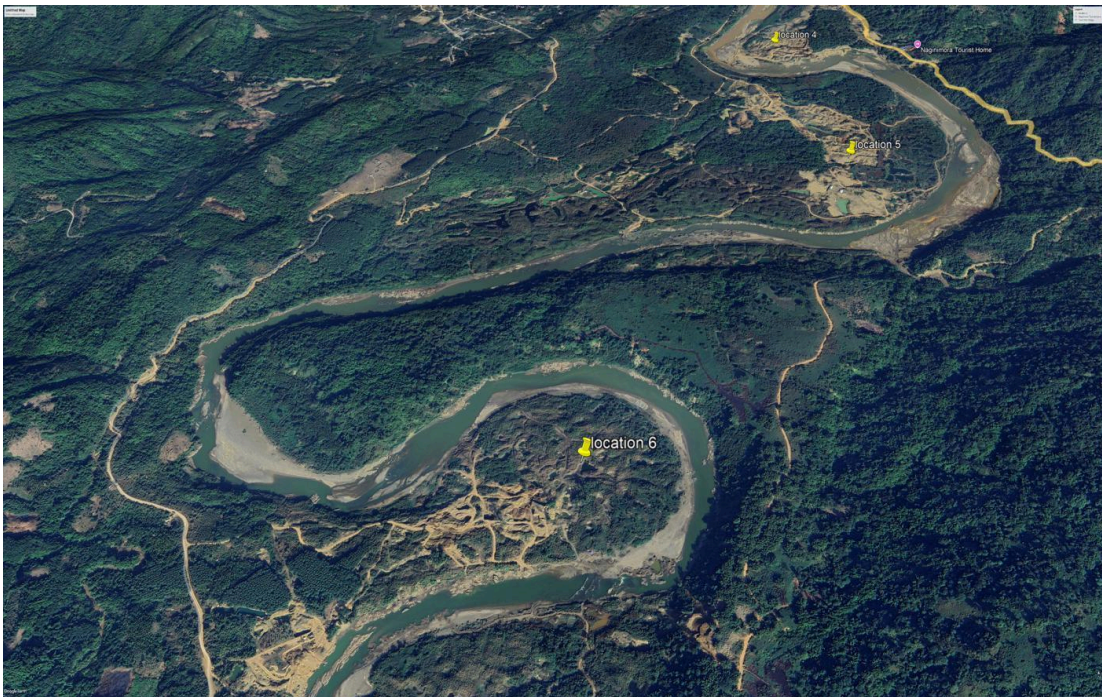
*Figure 7b, 2026. Southern loop core stripped and dissected by an extraction and track network; new access roads penetrating the surrounding hill forest; bar surfaces throughout the reach conspicuously widened and pale, with increased braiding.*

**2026.** The southern loop core has been **stripped and dissected** by an extraction and track network. New access roads penetrate the surrounding hill forest. Bar surfaces throughout the reach are conspicuously widened and pale, and the channel shows increased braiding.
