## CONSERVATION: *The Citadel and the Minaret*

### ***Conservation at the Tower of David Museum***

***Yotam Carmel, Conservation Manager, Ken Hator Engineering Ltd.***

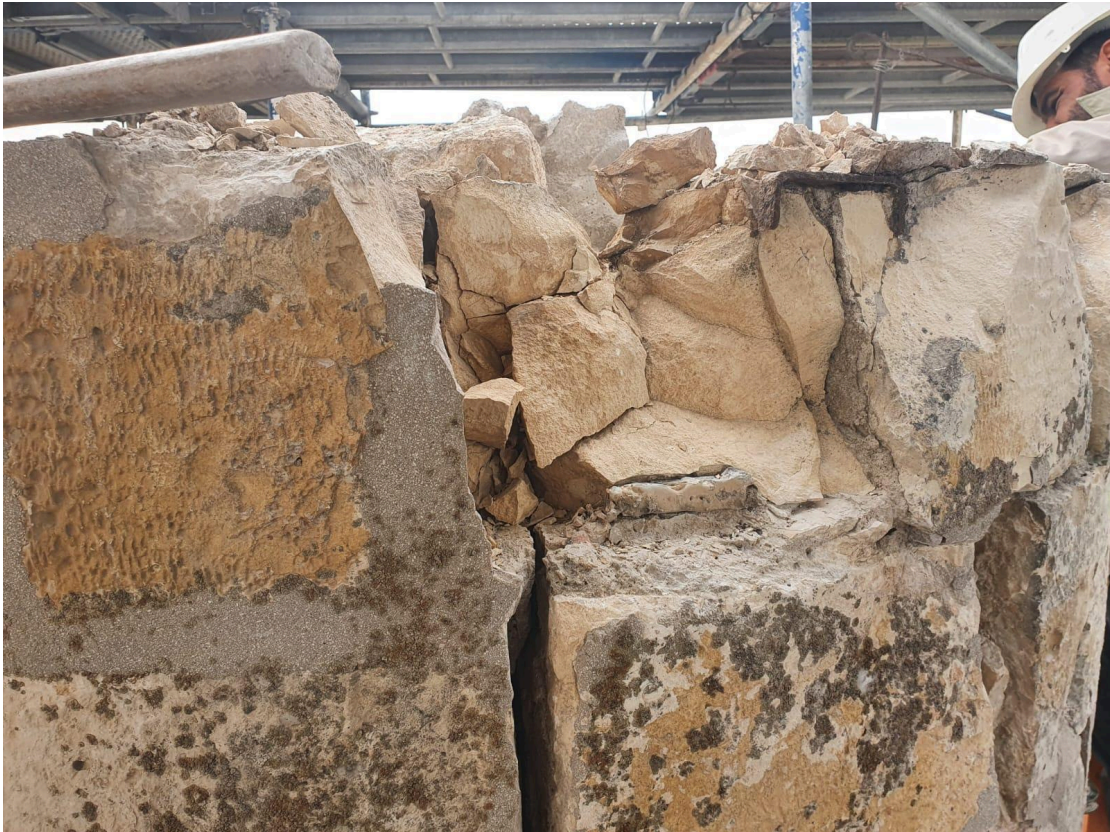
The minaret of the Tower of David, built in 1635, illuminates the Jerusalem skyline and has been the iconic symbol of the city for centuries. During the conservation of the citadel, the iconic minaret underwent a thorough conservation plan as, after almost 400 years of watching over Jerusalem, the structure itself was in urgent need of preservation. The beautiful winding staircase inside the minaret tower leads to the highest lookout point in Jerusalem's Old City, affording a breathtaking view of both the Old and New cities of Jerusalem, was no longer accessible as six large cracks were discovered in the structure.

Cracks in the top of the minaret. Credit Ricky Rachman

***Yossi Vaknin, Israel Antiquities Authority:*** The conservation of minaret required a high degree of skill, knowledge and a deep understanding of early building techniques. Before beginning preservation work on the minaret, the project conducted thorough research and investigations to ensure the stability of the archaeological remains and the minaret for many years to come. We are very proud of the complex conservation work that was carried out and now, eight months later, we are excited to see the minaret standing once again now that the scaffolding is down and the work is complete.
