## **CONSERVATION:** The Citadel and the Minaret

## Conservation at the Tower of David Museum

## Yotam Carmel, Conservation Manager, Ken Hator Engineering Ltd.

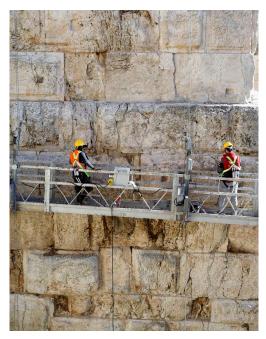
Conservation on King Herod's Phasael Tower. Credit Ricky Rachman

In conservation of this kind, traditional materials such as lime plaster and traditional techniques such as stone carving are used in conjunction with high-tech solutions. Conservation engineering techniques including reinforcement, lime plastering and rendering, lime pointing, mortar injection, traditional stonework, stabilization, and temporary reinforcement.

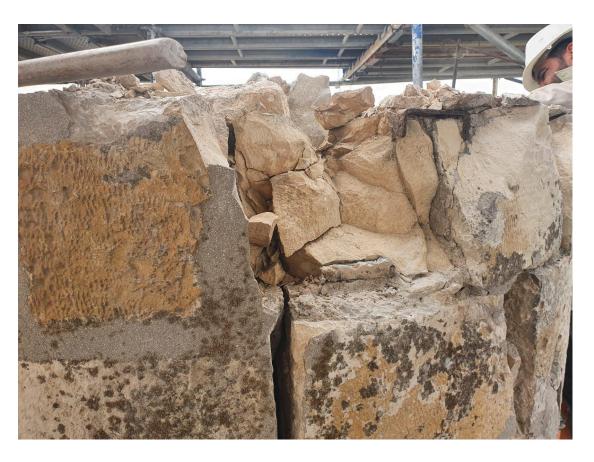
The minaret of the Tower of David, built in 1635, illuminates the Jerusalem skyline and has been the iconic symbol of the city for centuries. During the conservation of the citadel, the iconic minaret underwent a thorough conservation plan as, after almost 400 years of watching over Jerusalem, the structure itself was in urgent need of preservation. The beautiful winding staircase inside the minaret tower leads to the highest lookout point in Jerusalem's Old City, affording a breathtaking view of both the Old and New cities of Jerusalem, was no longer accessible as six large cracks were discovered in the structure.

Cracks in the top of the minaret. Credit Ricky Rachman

**Yossi Vaknin, Israel Antiquities Authority**: The conservation of minaret required a high degree of skill, knowledge and a deep understanding of early building techniques. Before beginning preservation work on the minaret, the project conducted thorough research and investigations to ensure the stability of the archaeological remains and the minaret for many years to come. We are very proud of the complex conservation work that was carried out and now, eight months later, we are excited to see the minaret standing once again now that the scaffolding is down and the work is complete.
