# FERGUS FALLS PUBLIC SCHOOLS

## New Elementary School Proposal FAQ

**Q: What were the results of the ATS&R Facilities Study?**

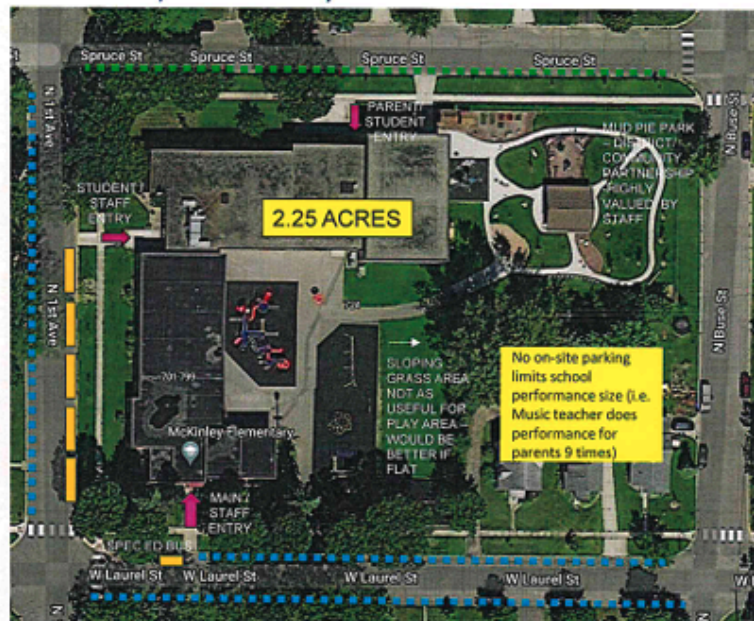
## McKinley Elementary School

- Site Size (2.25 Acres is very small, MDE is 13-18 acres for this enrollment)

- Easily Accessible, convenient location
- Removed from noise/traffic
- Space for Expansion (none)

- Drop Off (on-street only – park and walk in)
- Pedestrian (these grade levels do not walk)
- Bike Traffic (these grade levels do not bike)
- Traffic Flow (all on-street parking/drop-off/ buses requires timing coordination for safety)

- Adequate Parking (no parking)
- Bike Racks (N/A)
- Athletic Fields (limited fields for school/ community use)
- Outdoor classrooms (Mud Pie Park)
- Environmental learning (Mud Pie Park)

MDE Elementary School Site Requirement: 10 -15 acres + PLUS: one additional acre for each 100 students of estimated student enrollment and community use/partnership program capacity, including possible additions = 13 - 18 acres

City of Fergus Falls Zoning Code: Off-Street Parking Requirement: 2 parking spaces per classroom x 15 = 30 spaces min. (should also have spaces for other pull-out staff and admin.)

Actual = NONE

More adverse impact for neighbors and street traffic due to buses, drop-off/pick-up, and all parking being on streets.

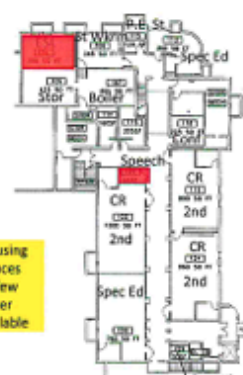
First Floor

Cafeteria #202 (Original gym) - adequate size at 1580 as compared to MDE. Size according to number of lunches served and # of lunch periods - generally 2-3 at 12-15 square feet per student.

Kitchen & Dish room - limited function due to size, designed for a different time and food service delivery model.

Gym addition - very small at 2440 sf, MDE 6-8,000 sf. (also cafeteria is small when used as a gym)

Admin/Nurse - 800 sf - very small - MDE 1840 min. Privacy issues between visitors/admin functions and ill students / student discipline

Library/ Media Center - 1 room at 1070 sf - undersized and lacking seating and support spaces such as small group, conference, office, study area

Music - 1 room at 870 sf - inadequate, MDE 1,000-1,500 in multiple activity spaces.

Special Ed using full CR reduces capacity - few other smaller spaces available

Limited variety of spaces, most are classroom size - missing large group and small as well as sufficient program support spaces - specials, pullouts, etc. Double loaded corridor, "cells & bells", no flex space, lack flexibility to team.

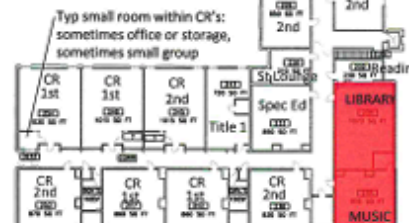
Second Floor

2 sets of restrooms this level with limited accessibility; particularly poor condition & inadequate at south addition. Remodeling recommended.

No Art/Science space

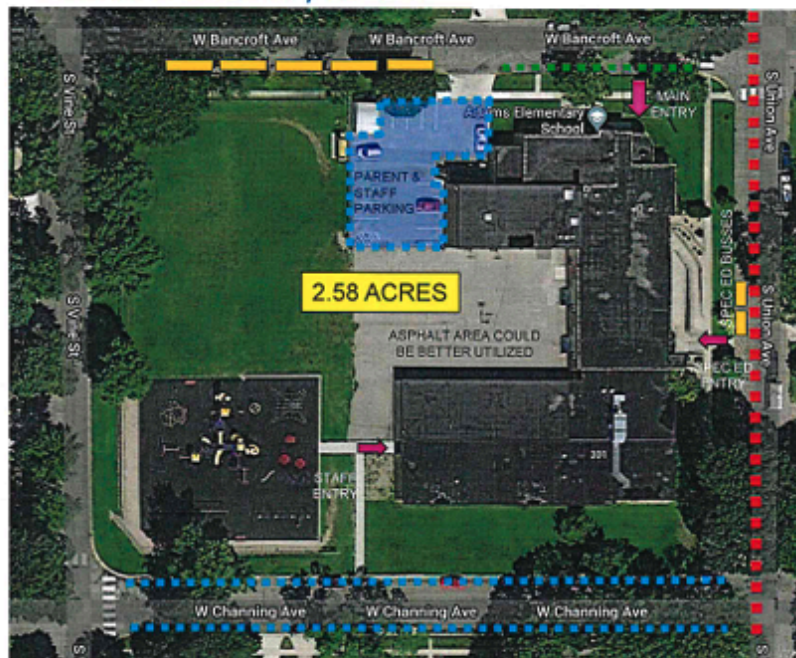
## Adams Elementary School

- Site Size (2.58 Acres is very small, MDE is 13-18 acres for this enrollment)

- Easily Accessible, convenient location
- Removed from noise/traffic
- Space for Expansion (none)

- Drop Off (limited length, on-street only)
- Pedestrian
- Bike Traffic (this grade level does not bike)
- Traffic Flow (lot access conflict with bus/drop-off requires limitations on access to parking lot)

- Adequate Parking (Limited off-street staff/visitor/parent parking)
- Bike Racks (N/A)
- Athletic Fields (limited fields for school/community use)
- Outdoor classrooms
- Environmental learning

MDE Elementary School Site Requirement: 10 - 15 acres + PLUS: one additional acre for each 100 students of estimated student enrollment and community use/partnership program capacity, including possible additions = 13 - 18 acres

City of Fergus Falls Zoning Code: Off-Street Parking Requirement: 2 parking spaces per classroom x 18 = 36 spaces min. (should also have spaces for other pull-out staff and admin.) Actual = 15 spaces

More adverse impact for neighbors and street traffic due to buses, drop-off/pick-up, and almost all parking being on streets.
