## **Rav4 EV drive unit “Milling” noise repair.**

I recently purchased a used Rav4 EV with 126,000 miles, which had very loud whine, and scraping sounds at low speeds.

This uses an early Tesla drive unit, virtually identical to the 2013 vintage Model S drive unit, the main difference being the Rav4 has a parking pawl added, where the Model S does not need one.

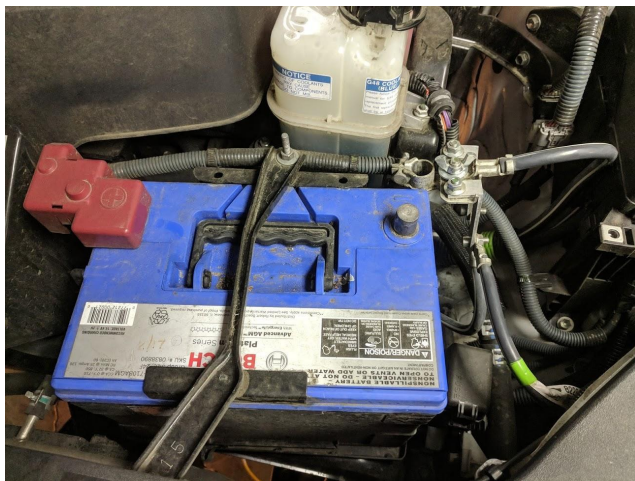
Before exposing any of the high voltage connections on any EV, it is critical to disconnect the power. First I disconnected the 12V battery:

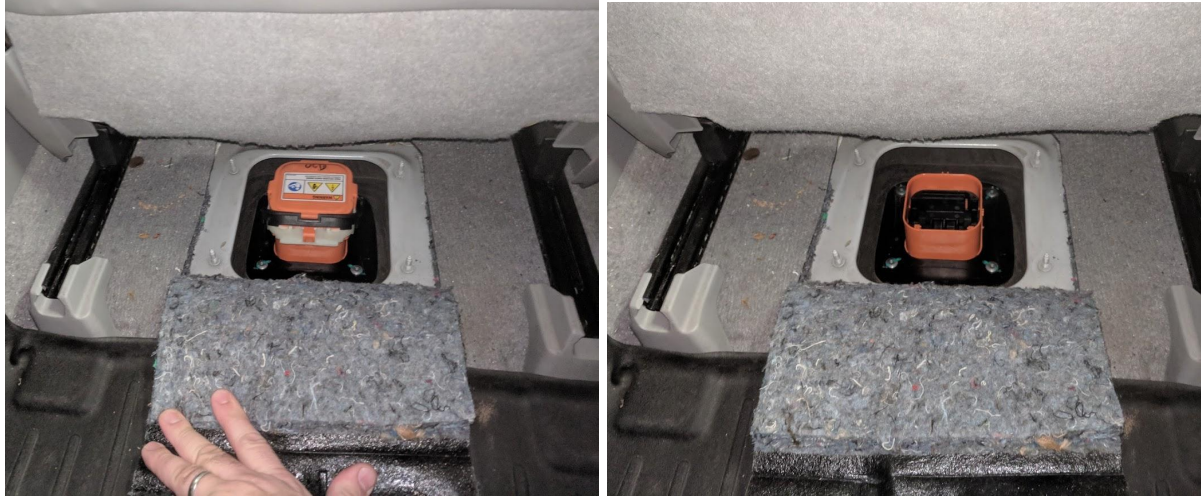
The HV battery disconnect is located under a cover under the passenger seat. Remove the cover, then remove the disconnect block, which I believe is also a pyrofuse.

Make sure to test any connections you expose for voltage before you put a wrench on it or touch it! Measure between the terminals, and between each terminal and the chassis.

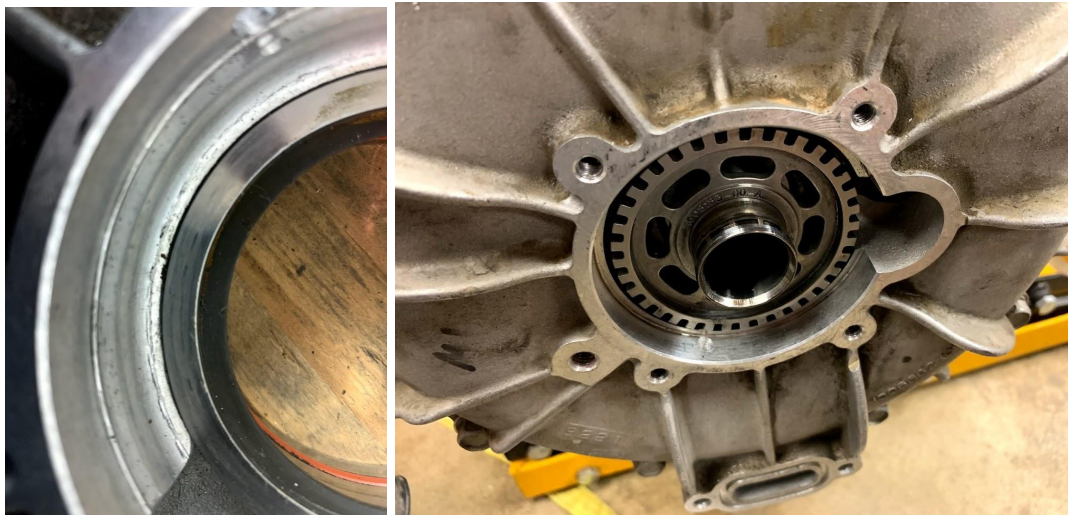
- The right side axle seal was leaking.
- The motor rotor coolant seal was leaking coolant into the motor housing.
- The motor rotor bearings had excessive axial play, which allowed the encoder wheel to rub against the motor housing.
- The gearbox pinion gear motor-side bearing had fretting damage, which caused the majority of the noise.

After removing the end cover, I found that the encoder wheel was scraping against the end cover. I believe this is due to axial play in the motor bearings. Here you can see marks left by the encoder wheel:

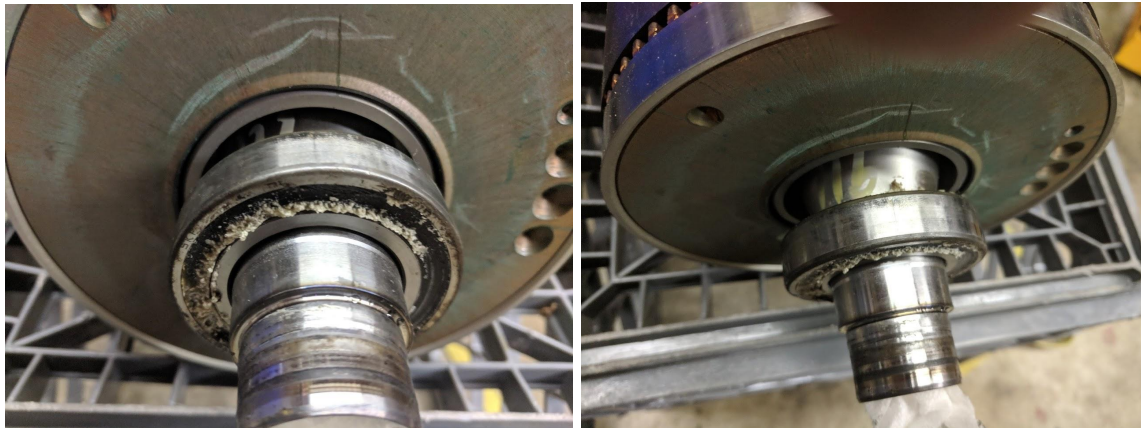
Motor rotor seal side bearing and seal surface. Notice the green discoloration on the rotor caused by the coolant leak.

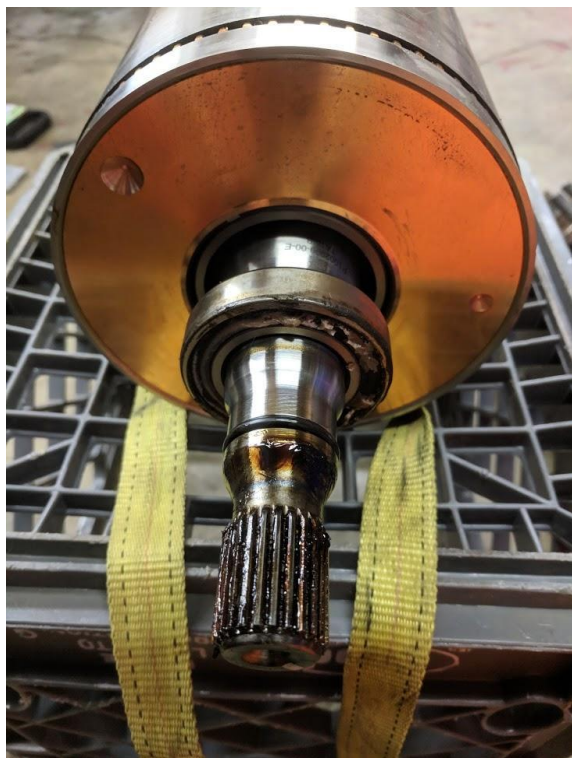
This is the gearbox side of the rotor. Notice how bright that copper is!

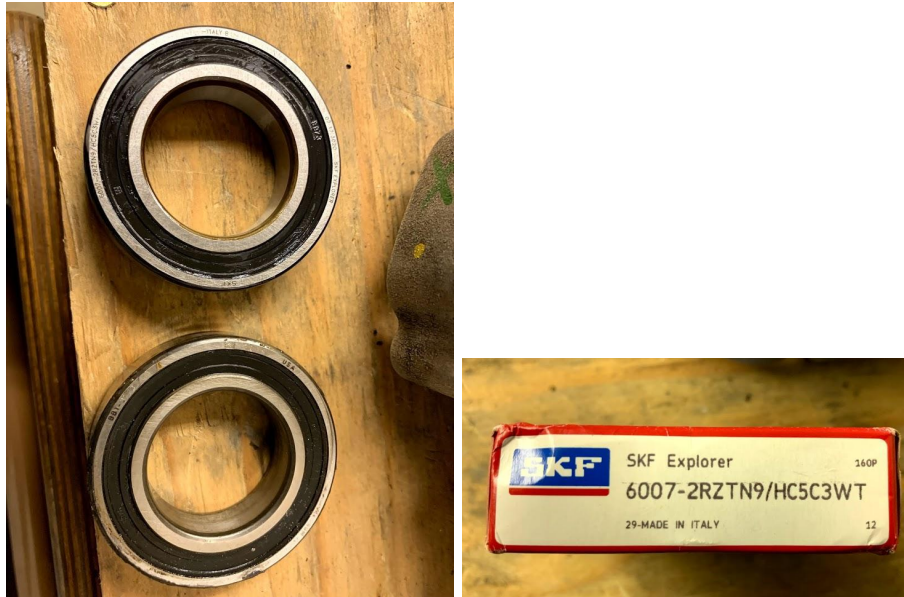
The rotor bearings are a hybrid ceramic bearing. After thinking about the engineering, I decided that this was the correct choice. One of the downsides, is that the only path left for any rotor voltages is through the gearbox bearing, which may be why it failed. I couldn't cross reference the part on the factory bearings to anything, so I found the closest bearing I could to the ones shipped from the factory.

Factory bearing on the bottom, new bearing on the top:

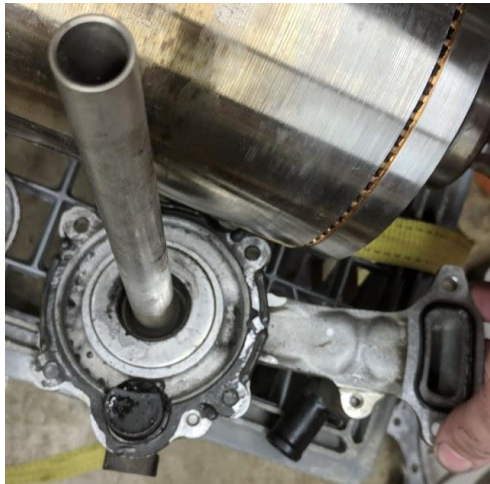
The rotor cooling system is quite ingenious. Water flows into a tube in the center of the rotor, then presumably goes through passages internally, then is returned on the outside of that tube. Only one mechanical seal is required to seal the rotating motor shaft. Unfortunately for me, this seal had failed, and I could not find a direct replacement. The seal dimensions are 30x55x8mm. It is a double-lip teflon seal with an excluder. If you happen to know where I could get these, please let me know!

Here is the housing with the seal:

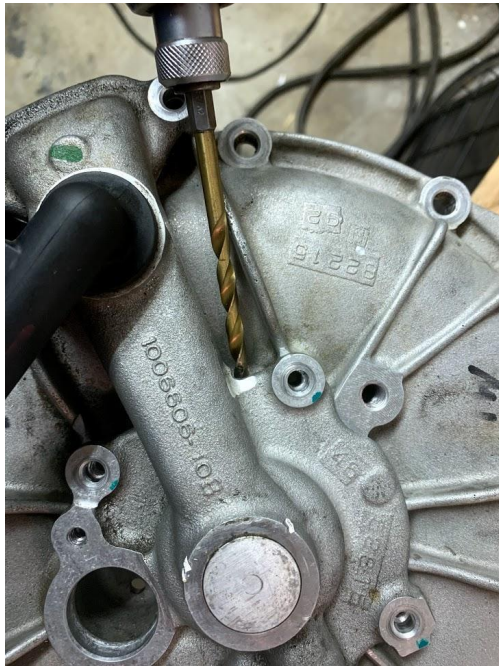
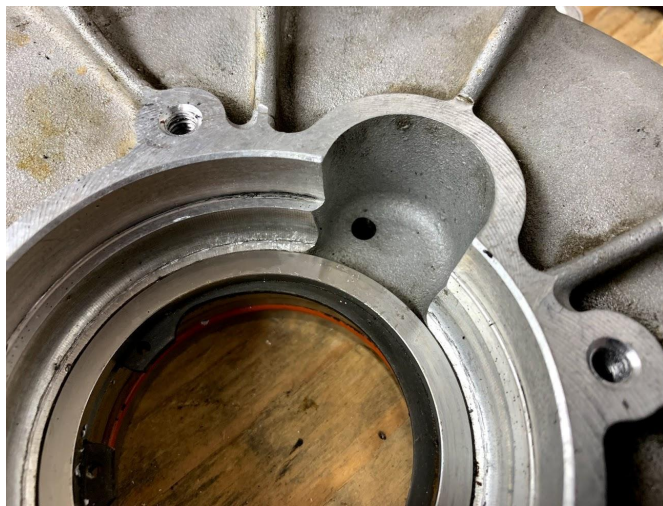
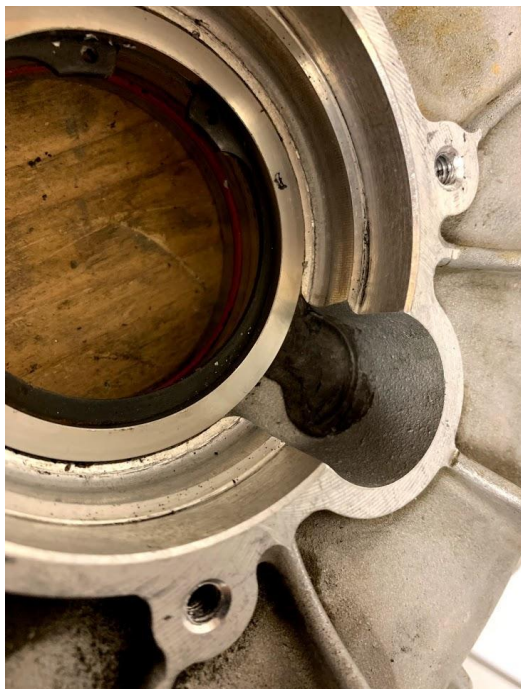
Here's the fun part, due to the way the motor is built, a leak at this seal will allow coolant into the motor, where I think it could pass through the power conductor passage into the inverter housing. I decided I'd rather dump the coolant overboard if it were to leak again. (which I anticipate it will, since I don't think my replacement seal is as good as the original)

I drilled a hole into the housing to function as a drain, then plugged the vent into the motor with JB Weld.

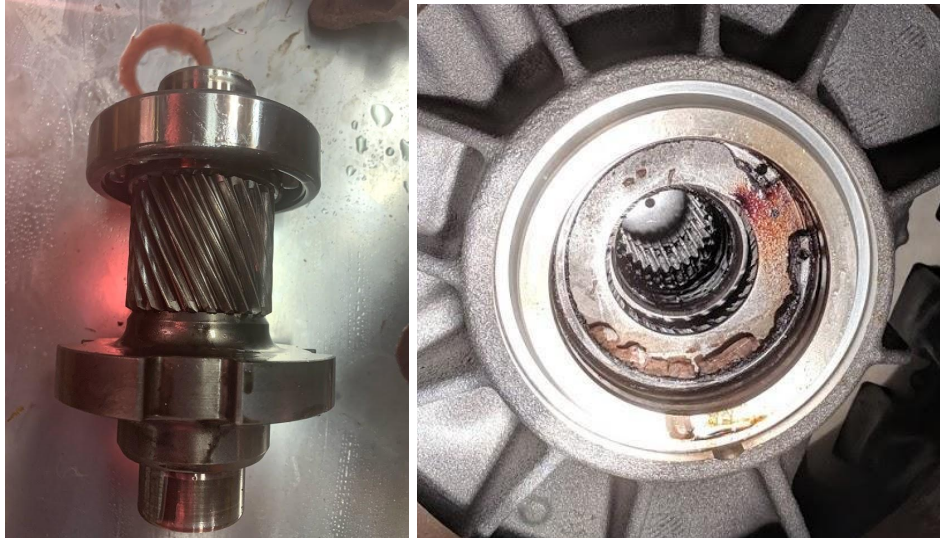
The pinion bearing shown here was in very bad condition. Based on the fretting pattern on inner surface of the outer race, I believe the failure was caused by electrical current flowing through the bearing while it was rotating. Tesla did attempt to mitigate this by adding a carbon brush ring between the motor and gearbox.

All bearings in the gearbox are C3 clearance. I would not recommend anything tighter due to the high RPM.

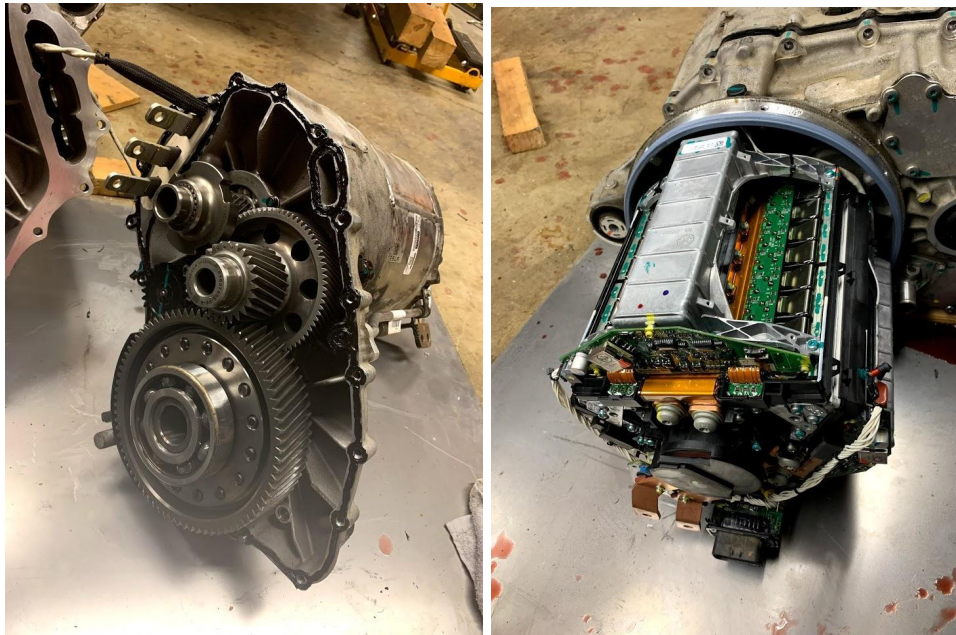
When disassembling the gearbox, watch out for the thermistor cable that goes between the case halves. I had to cut some zip ties in the inverter, and disconnect it from the PCB.

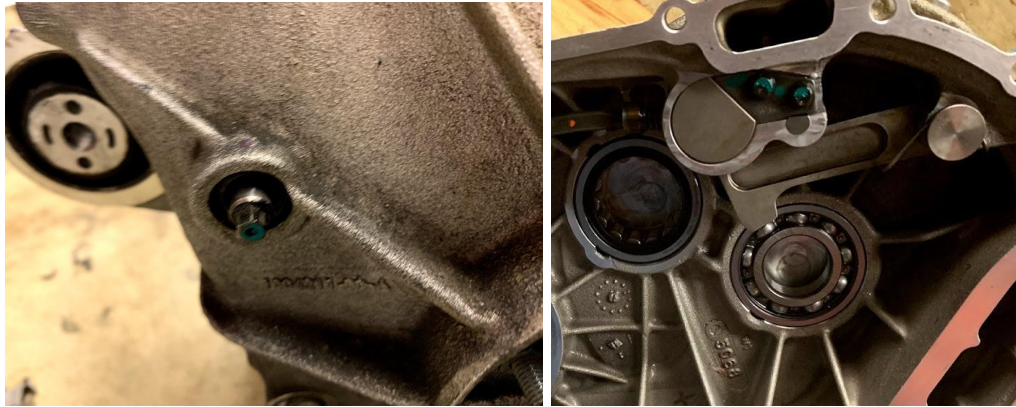
When reassembling the gearbox, make sure the parking pawl is disengaged. (picture shows it engaged) You can manually disengage it with a  $\frac{1}{4}$ " socket. If the case halves don't go together easily, it's probably the parking pawl.
