Burlington School District Attn. Lyall Smith, Director of Facilities 150 Colchester Road, Burlington, VT, 05401

January 31, 2025

## Clerk of the Works Site Visit Report - IAA H.O. Wheeler Elementary School Project

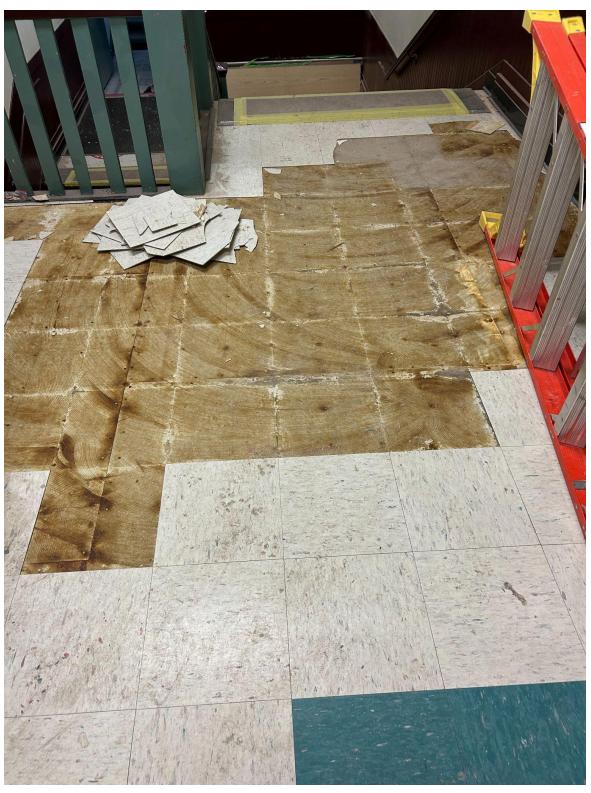
The floors are starting to be taken up.

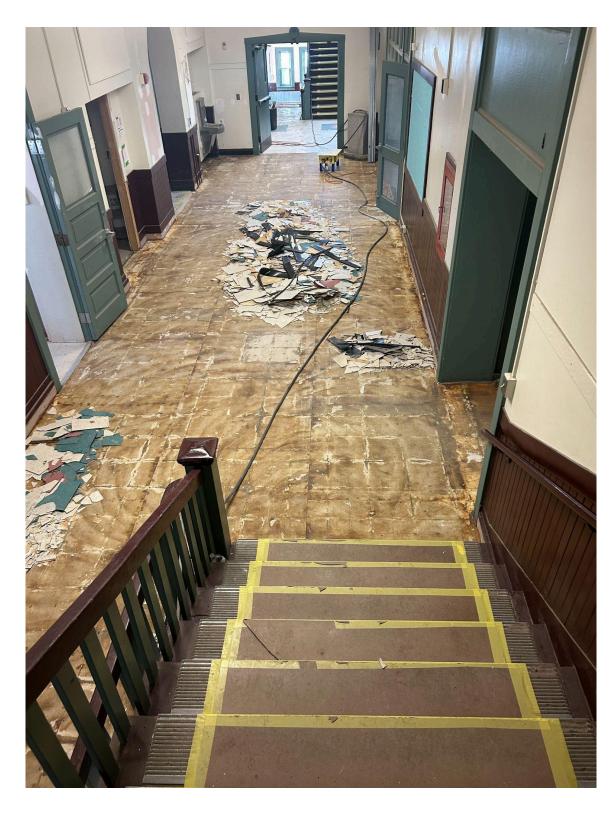
The finished picture of the old linoleum floors being completely removed before the pile of debris is brought out to the construction dumpsters.

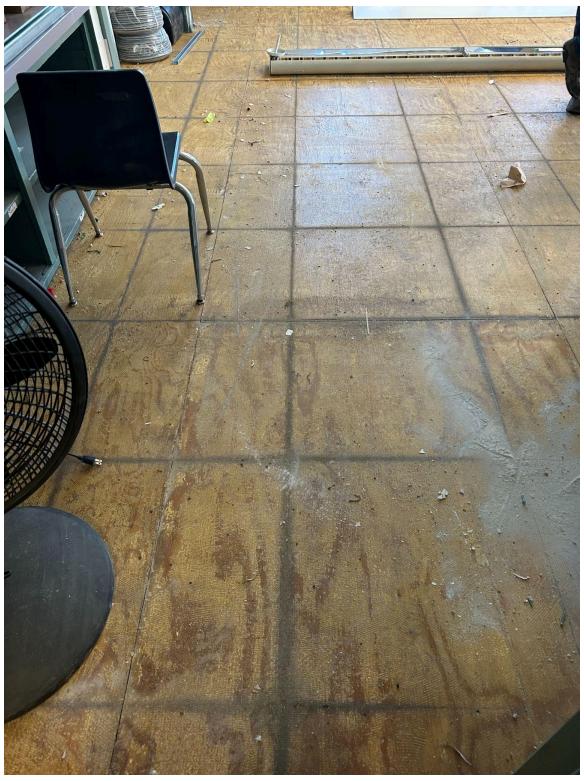
Even the classroom flooring has been removed. There were six workers from Elegant Floors working on site this week, and the entire 1904 wing of the building floors have been completely removed..

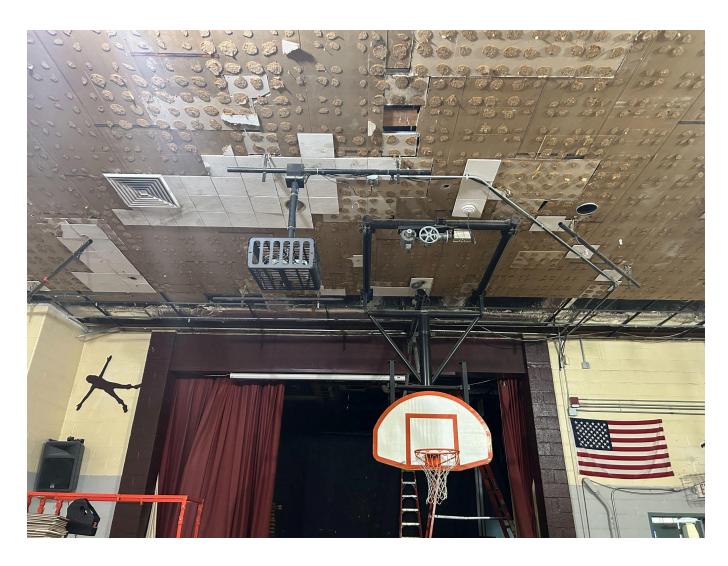
Benoit Electric has removed all of the old stage lighting in the Gym.

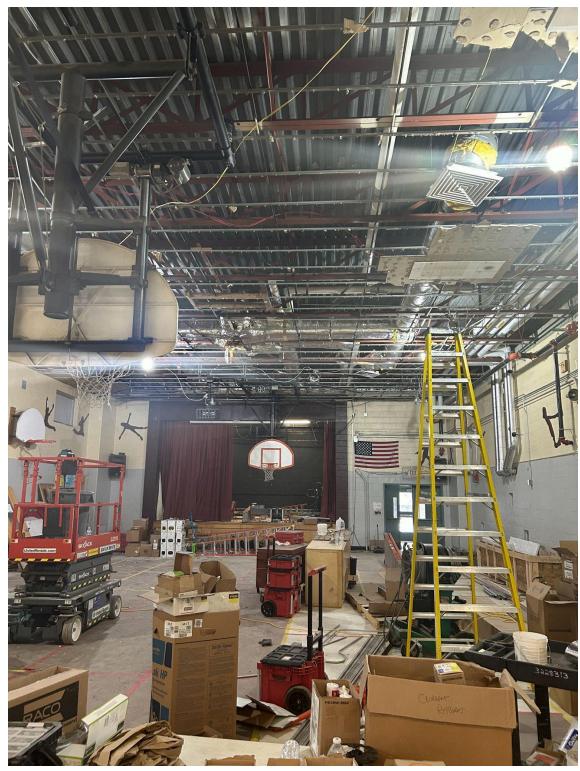
Now that the old piping insulation has been removed, and the stage lighting has been taken down, the rest of the GYM ceiling has been removed.

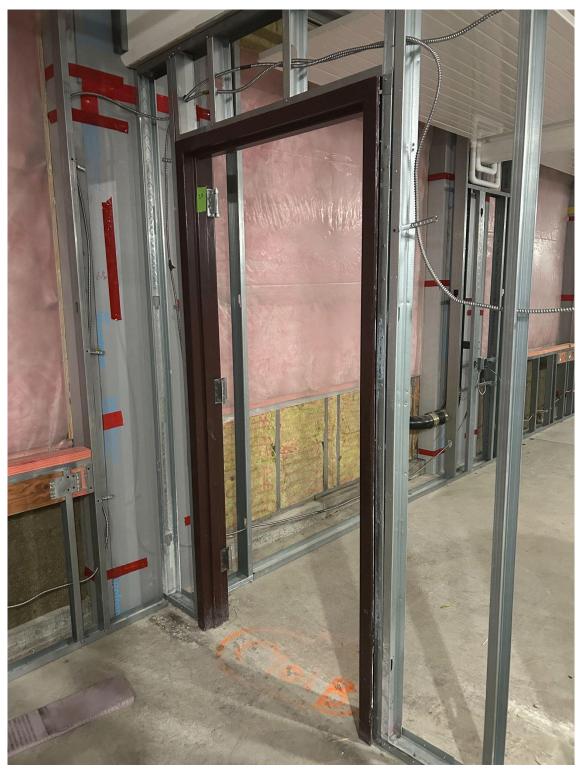
A door frame has been installed in the classroom in the 1965 wing of the building. This door is the door that allows people to go from classroom to classroom without having to go out into the corridor.

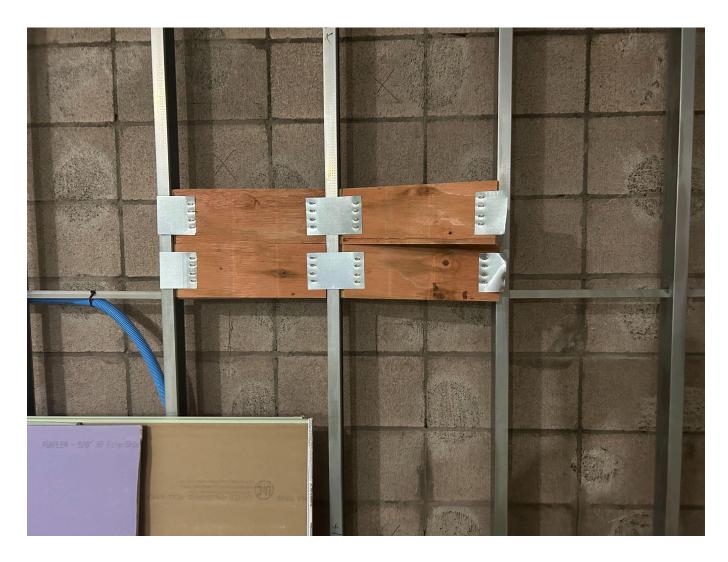
An example of the wood wall blocking that is being installed. More pictures of this will be shown next week.

Denis-White, the framing contractors, has started placing blocking in the walls to help in the future when things need to hung up on the walls. This extra blocking helps so that the sheetrock will not break when something heavy is hung on the wall, it's an added extra support. This is common practice to do this type of wall blocking in commercial construction. Door frames are being installed. Once these types of items as mentioned above are complete, the rest of the sheetrock will be hung; with the tapers right on their toes. See the pictures at the end of this report.

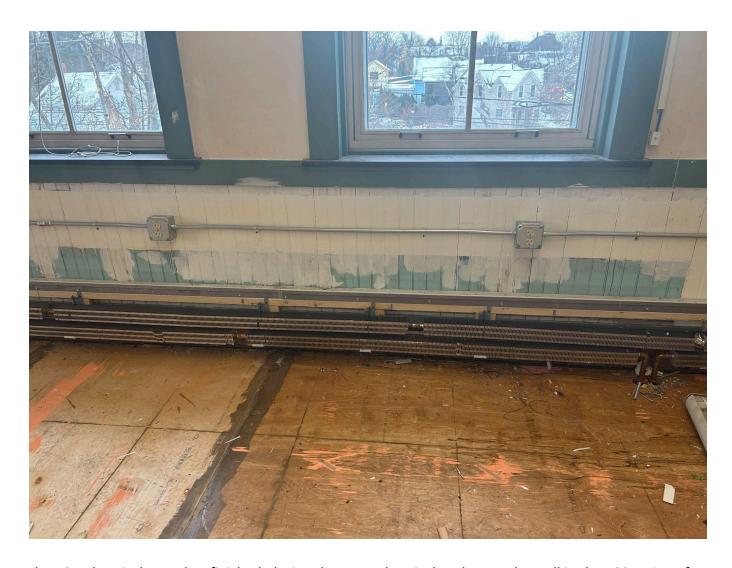
The BSD electrical team has finished placing the extra electrical outlets on the wall in the 1904 wing of the building. They are mostly completed on the first floor, and will soon be completed on the second floor.

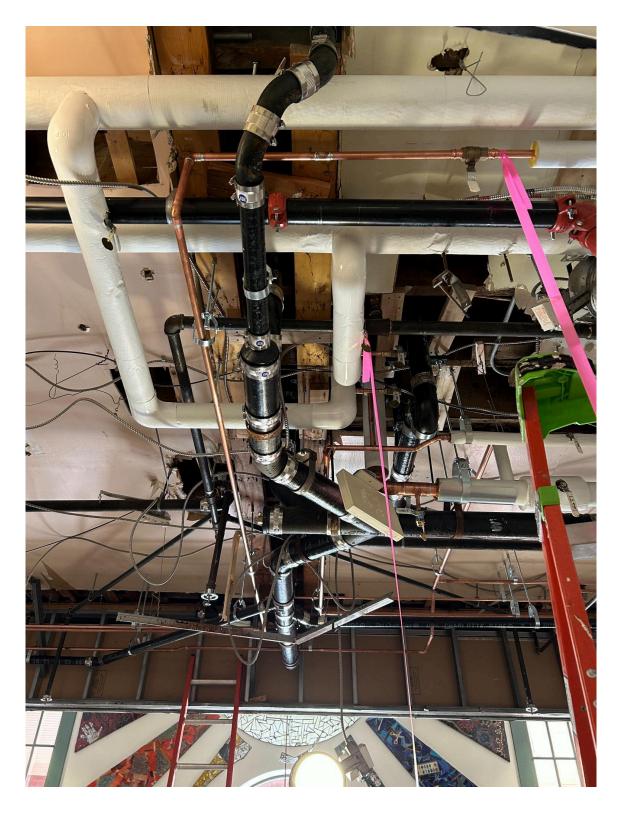
Last week, we showed this piping being installed. This week, the piping insulator is going behind the plumbing contractor and insulating that piping. We don't want condensation from the piping dripping on the new ceilings that will be installed to cover all of this piping up.

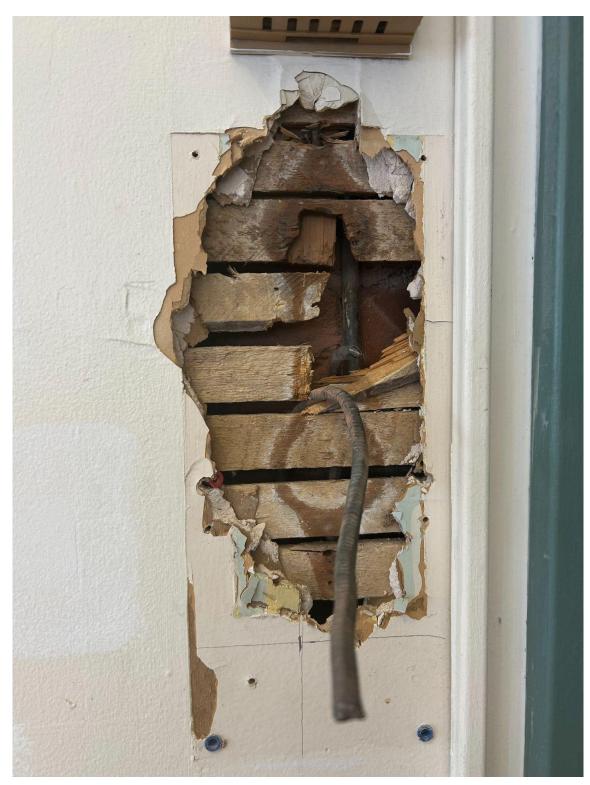
The electrical contractor is finishing up the last of their demolition of extra electrical items in the walls of the classrooms in the 1904 wing of the building. We believe that the gray pipe that comes out of the wall and bends down is the old original gas piping that was for the gas lights in these classrooms. Yes gas piping for lighting in the original 1904 wing of the building.

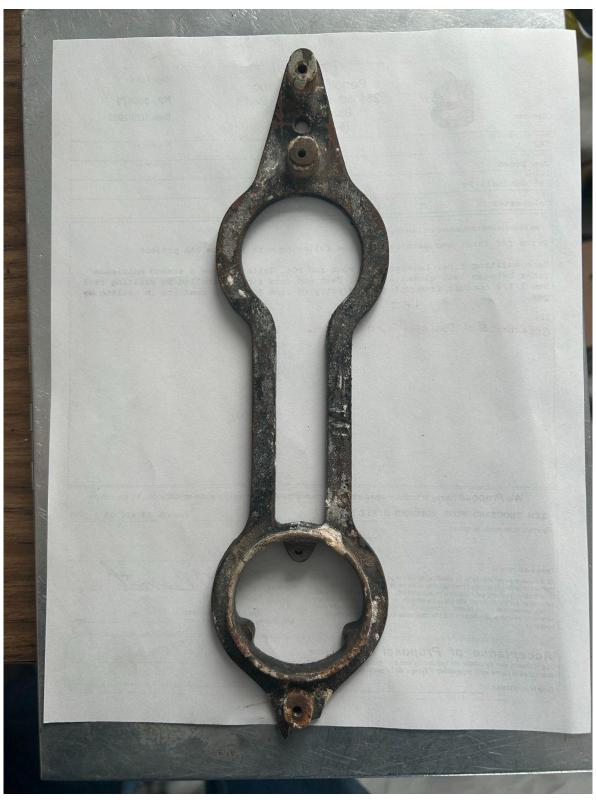
A picture of the wall bracket that would have held not only the switch for the gas light, but the gas light fixture itself. We are trying to do some history on these. That is why the hole in the walls in the picture on the page before is so big. This wall bracket is about 10 inches tall.
