Criminal Complaint Intro / Summary for DA, AG and the CSLB Alex Carriaga, Structural Pest Control Inspector Non-bonafide report produced with DECEIT for a future Buyer he had never met

Alex Carriaga, Structural Pest Control Inspectors Non-bonafide report produced with DECEIT for a future Buyer he had never met

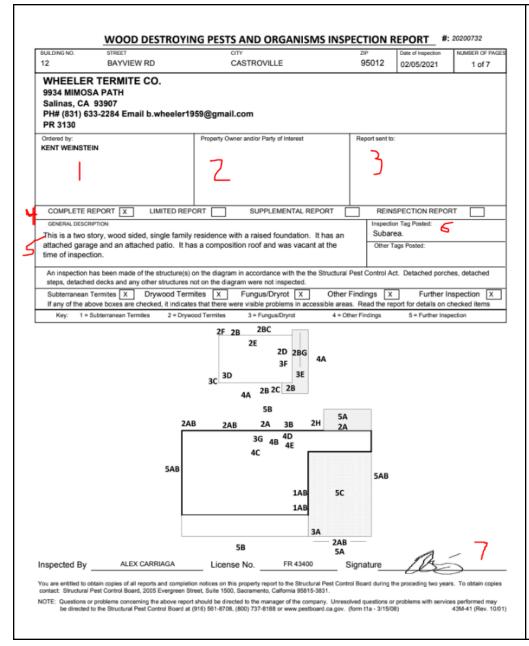
Page 1 - numerous concerns

- 1) ordered by real estate agent
- 2) property owner blank (violation)... think blank prescription from Dr for meds...
- report sent to blank (violation)
- 4) "Complete Report" suggestively misleading given he said he did NOT get into attic when questioned after the fact
- 5) Raised foundation inaccurate description. Partial raised foundation partial slab (violation)
- 6) This says he posted an inspection tag in the sub area. None was found there and he failed to note 5k in dry rot damage in crawl
- 7) signature is related to attestation that all work done in accordance with SPC Act

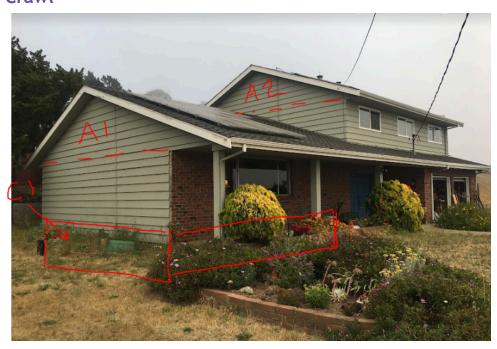
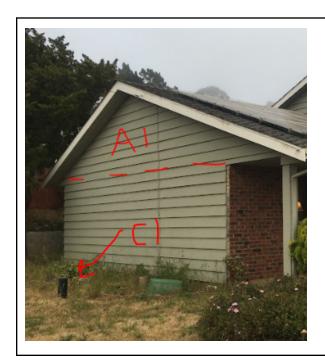
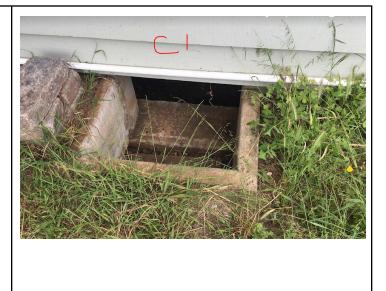
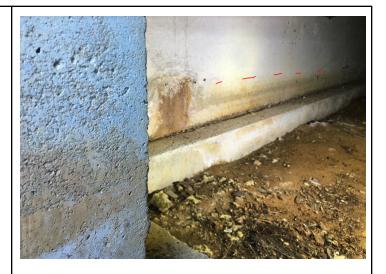
12" high water line

- 8. \$5,000 in Omissions 600sf Crawl Space On 4/4/2021 we discovered major material defects in the 36" high, 600 sf crawl space that was Carriaga's responsibility to call out. A 12" high water flood line was around the entire foundation. Significant water inflow concerns were apparent from the foundation vent. The Structural Column in the middle of the crawl space was severely dry-rotten and structurally unsound. It was apparent it too had been affected by as much as 12" of flooding prior. The Structural Column at the end of the main girder had dry rotted and affected by termites. A new column had been installed but it was not done properly and it has shifted. These defects were documented several days later in photos by a home inspector for purposes of dialogue with the Seller and those responsible for enforcing discipline and penalties on Carriaga and/or the Seller. A review of Carriaga's report showed no defects in the crawl space AND no notes that it was not inspected. In the conversation with Carriaga after Close of Escrow, direct reference to these defects were omitted after he had stated he had not gotten into the attic and forgotten to note it. It seemed apparent he had been involved in some type of criminal scheme, and we didn't want to give away all the facts known to us at that time, in order to encourage as much dialogue as possible. A review of the report by the CA State Investigator revealed it did have a note on it suggesting that he did get in the crawl space. (1573 - Constructive Fraud)

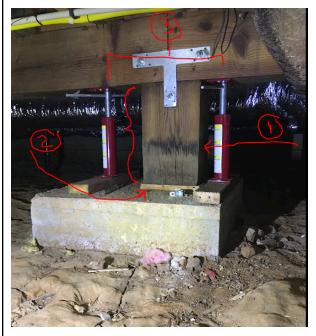
Dry rot damag and partially compressed post

<< (1) original post had dry rotted and termite damage and was replaced with small footing and post (2) that had also dry rotted

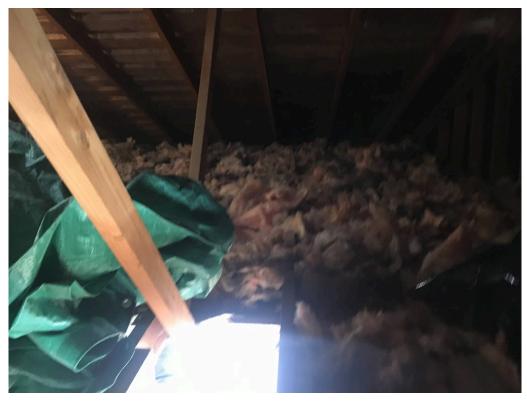
The Batt insulation looked like Blown due to Raccoon Infestation...

This is NOT normal. This is NOT just rats or mice. (It was Raccoons) If this has been seen, it warranted comments.

- 6. On 3/31/2021 buyers were notified of contract acceptance. Title to the property Transferred to them at that time per clause 13B of the contract.
- 7. **\$10,000 in Omissions 900sf 2nd floor Attic** On 4/4/2021 we discovered major moisture related defects in the 1000'sf, 5' high 2nd floor attic. The attic had suffered from a racoon invasion that lasted

several weeks, and the racoons had destroyed all the insulation and used the 1000sf attic as a littler box. The insulation was filled with feces and the insulation and drywall had been urinated over a great deal. The presence of weeks worth of raccoon urine was absolutely Carriaga's responsibility to call out. Calling this out would have drawn attention to a portion of \$10,000 in raccoon related damage in the attic. A review of Carriagas report after our discovery showed no problems in the Attic AND it had no notes indicating he had not inspected the attic. A conversation with Carriaga after close of escrow revealed he had not gone in the 2nd floor attic and simply "forgotten" to note that on the report. (1573 -Constructive Fraud) The information about the Raccoon invasion was obtained from the seller's agent at the time we found the damage. His statement that day indicated he and the seller had committed disclosure fraud

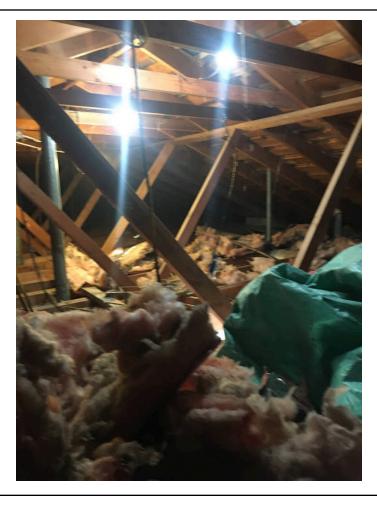
This insulation is NOT supposed to look like cotton candy.

This is batted insulation and it's supposed to be sitting in between the joists.

This damage was done by raccoon burrowing.

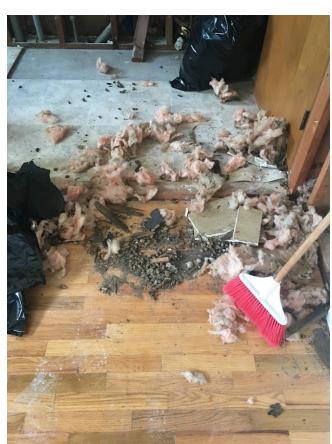
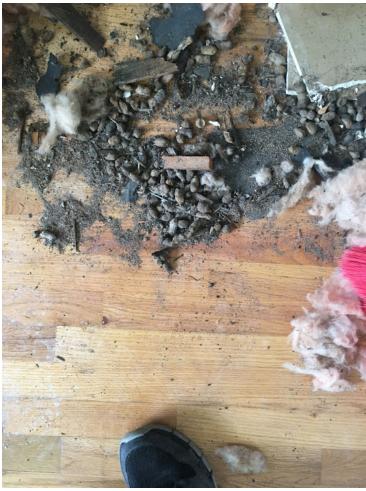
That is a small portion of the feces from raccoons that were living in the attic. The odor with the attic hatch open was mesmerizing.

Photos were tough to get but shadows are visible.

The stains ranged from silver dollar size to 3-4 inches. There were 30-40 stains. Mostl;y in the two south bedroom ceilings but some minor in others. (May 22, 2021)

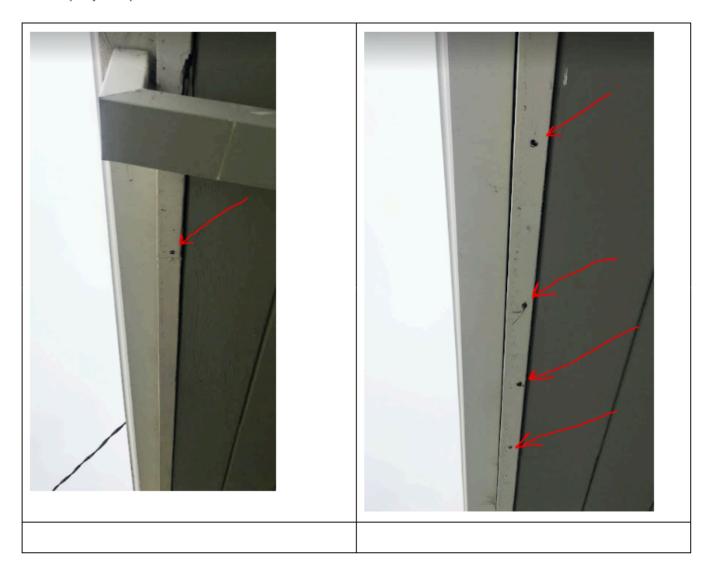
Images of Defect Testing

The arrow below is pointing to a perfectly round hole in the fascia. That hole wsa created by Alex when doing his inspection. They use a bolt on the end of a stick to push on the wood to see someone has "covered up" dry rot with putty and paint.

#1 represents the hole from his bolt test.
#2 transpired as we checked into it. Almost 1" of putty was used to build up the surface to make it smooth so it could be painted to look satisfactory.

It just seems odd there was no additional note that said, "The Bolt Test was used to determine fascia condition. It appears some level of concealment of damage may have transpired".

It's also odd that there is no way to know if he's talking about the 1st or 2nd floor.

- 9. \$8,000 in Omissions 150 If of Fascia On 4/4/2021 we discovered major material defects in the fascia that totaled \$8000. The fascia had undergone a cosmetic cover up process. Marks on the fascia that correspond with notes on the report indicate Carriaga had become aware not only of defects but if the nature in which they had been concealed. Only a few locations of damage with no notation of concealment or quantification of damages were included on the report. No one looking at the report as it was presented could have known if he was calling out \$20, \$200, \$2,000 or \$20,000 in damage and no one could have known he had become aware of cosmetic concealment as part of his reporting process. (1573 - Constructive Fraud)

Without repair pricing on the Report, which is not required, there was no way to know this was \$8,000 in damage. We should be pursuing the Termite Inspector for this "vague reference", but because he is not required to provide pricing it seems best to pursue the Seller and his Agent for this.

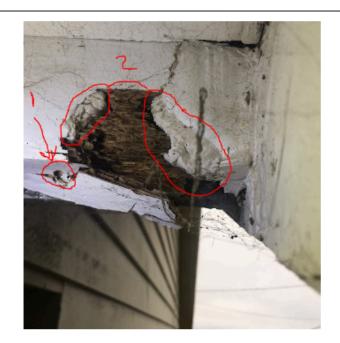
The concealment work would have been done by a Painter, for example. Carriaga's bolt test was specifically designed to test for concealment. He found concealment but only noted it on his report as having found pest / dry rot damage.
