Hudson D. Preece

Objective

Project

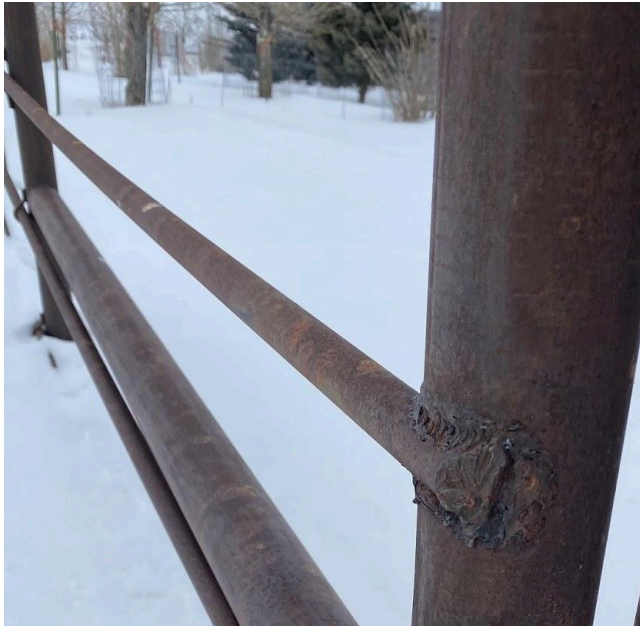
Length of succor rod:	40 ft = 480 in
Change in temperature:	-27.78 (K)
Change in length:	-0.167 in
Strain:	-3.471×10^{-4} in/in
Stress from Strain:	10.31 ksi
Axial Force from Thermal Deformation:	4554.7 lbs

A 40ft piece of succor rod was welded to a drill pipe using an E6010 Weld Rod. Overnight, when the temperature dropped, the pipe broke from weld. It was only welded at each end and supported by clips throughout the length of the fence. We assumed that because only one end of the rod failed, it experienced all the force from the thermal deformation.

This led us to believe that the E6010 weld rod had produced a brittle weld that could barely support the axial force from the thermal deformation. Combine that with less-than-perfect weld conditions, it makes sense why the weld failed.

Our studies led us to believe that a more appropriate weld rod should have been used to prevent failure. We concluded that an E7018 rod should have been used.
