Auto 155 Lab Experience Report

2016 Mazda 3

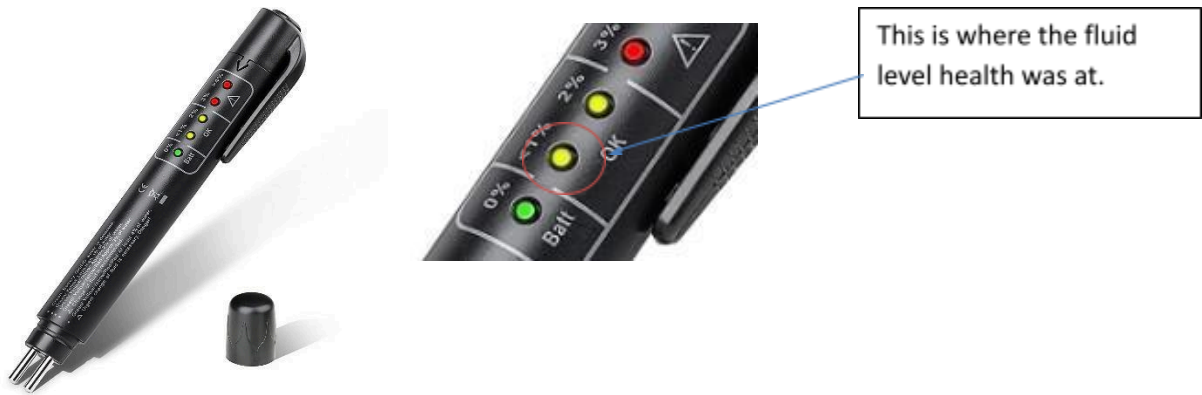
After the test drive, I brought the vehicle back to the shop to take a look at all of the brakes and rotors. Before doing that, I wanted to test the brake fluid since the customer was concerned about its condition. Using a brake fluid tester, the test showed that it had about 1% of water in it, which is okay, so the car didn't need a brake flush. Below is an image copy from Amazon of a brake fluid pen tester from VXSCAN that's similar to what was used to test:

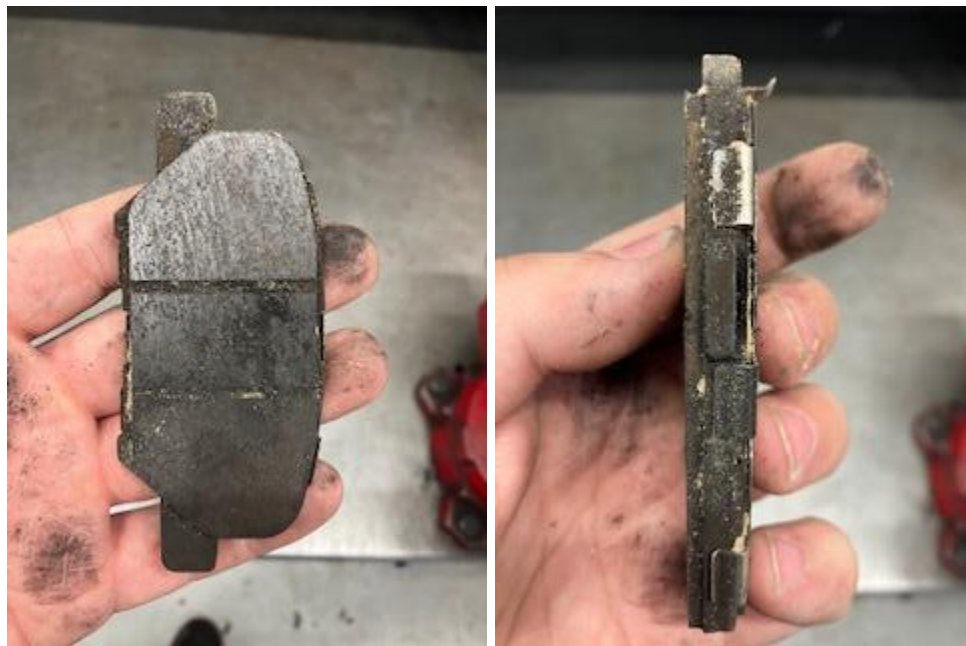
Looking at the front brakes and rotors, they were in good condition and didn't show any signs of wear. The front brakes measured at 7mm and not 3mm or below, so they were within specifications. The rear brakes on the other hand were at 1mm, so they definitely needed to be replaced. Below are pictures of the actual brakes from the rear:

Since the tests showed that the rotors could be resurfaced, I sent the rotors over to the brake lathe and resurfaced both rear rotors. While they were being resurfaced, I took the time to compress both brake caliper pistons, so that they would be ready to reinstall. Once the rotors were finished resurfacing, I installed the rotors and new brakes. I added some lubricant on the brakes, so that there wouldn't be any squealing coming from the brakes. After that, I reinstalled the tires and torqued the lug nuts to specification listed on ProDemand.

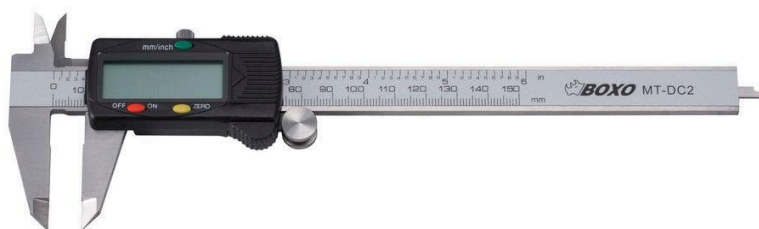
Next thing I needed to take a look at were the rear rotors thickness and runout to determine whether the rotors can be resurfaced or if they need to be replaced. Using calipers to measure rotor thickness. I measured at 4-different points of the rotors and showed the average thickness of the rotors were at 85-mm. The specifications for maximum thickness are set to 78-mm, so they were well within specs. Below is an image copied from boxousa.com of the digital calipers used to measure:

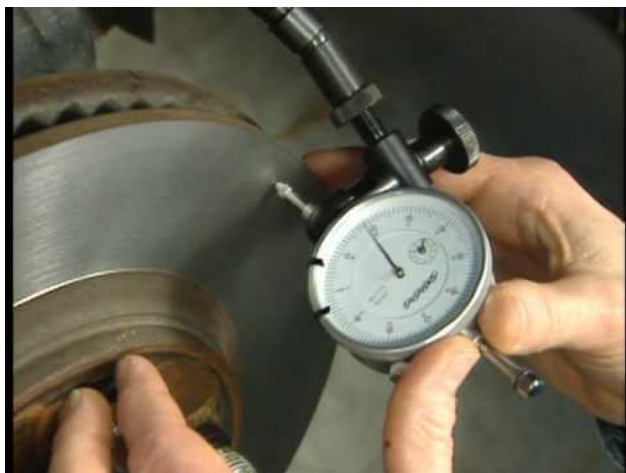
After measuring rotor thickness, I used a dial indicator to measure rotor runout and the test showed that there was less than 4-thousandths of runout, so they were safe to resurface. Below is a visual representation from BrakeAlign on YouTube demonstrating how I used the dial indicator to measure runout:
