# Dairy Green Ltd

CFL - Jardine

## **Drop Test Results: CFL - Jardine, Effluent Pond, 2 - 3 June 2023**

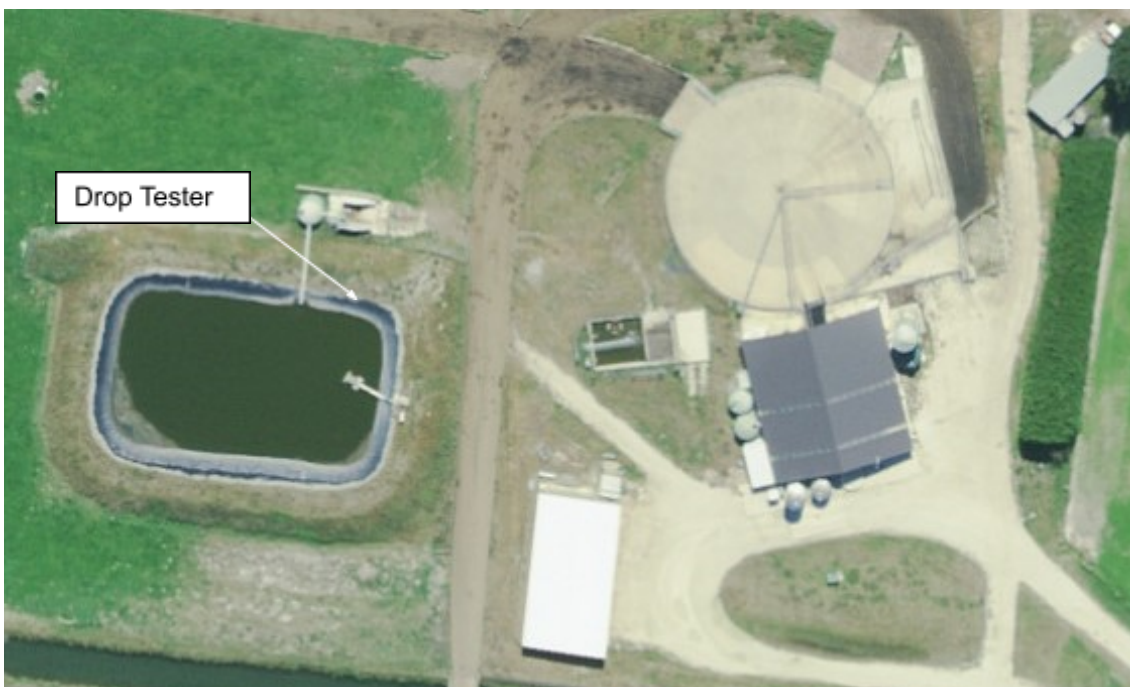
The total pond catchment area was 16 % greater than the wetted area during the test.

The plans for the pond show a maximum design depth of 4.0 m including 0.5 m of freeboard. At the time of the test the liquid level was 0.6 m below the maximum design depth, i.e. 97 % full.

*Below is an aerial photo that shows the effluent pond. The laser drop test unit was installed at the north side of the pond, as marked.*

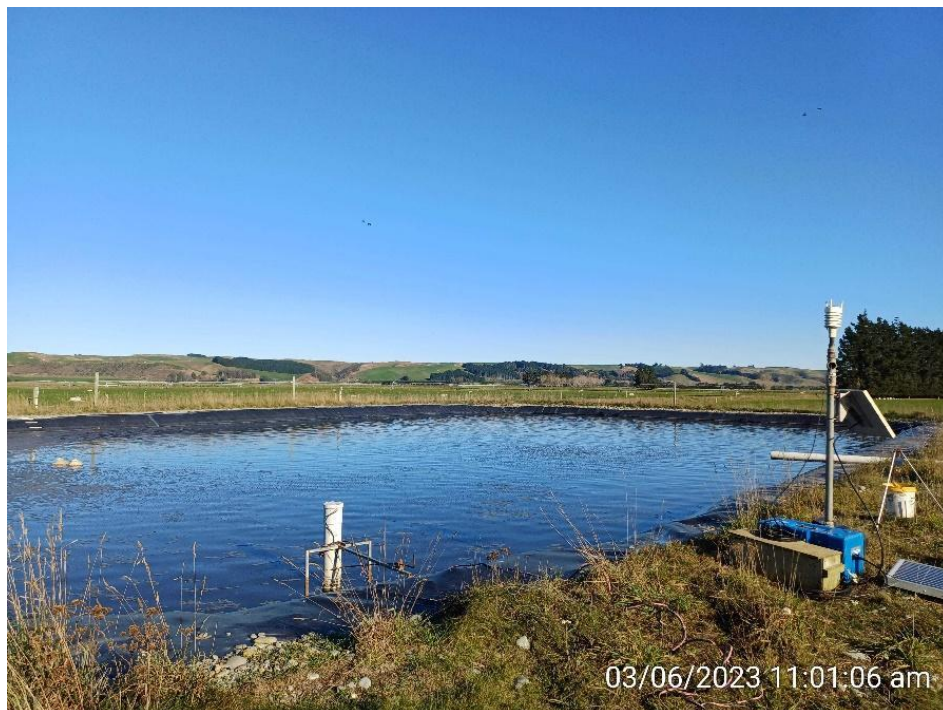
A laser distance measuring unit was set up vertically over the pond surface. A reflective disc was placed on the pond surface to ensure constant, repeatable readings.

The laser was set up within a PVC pipe which acts as a stilling well.

- When a period of 24 hours or more has lapsed the information is downloaded and the results interpreted.
- The GPS location of the pond and equipment set up is recorded. For this test the equipment was located at **E1435655 N5022962**, at the north side of the pond.

*Laser at the north side of the pond.*
