FINAL REPORT  
INTERNSHIP  
NOVEMBER 2007 – FEBRUARY 2008  
BAOBAB TRUST  
MOMBASA / KENYA

**OLE FEURER**  
UNIVERSITY OF APPLIED SCIENCES ZURICH  
INSTITUTE OF NATURAL RESOURCE SCIENCES  
DEVELOPMENT COOPERATION AND ENVIRONMENTAL ENGINEERING

## 2 Project 1: Terracing Nguuni

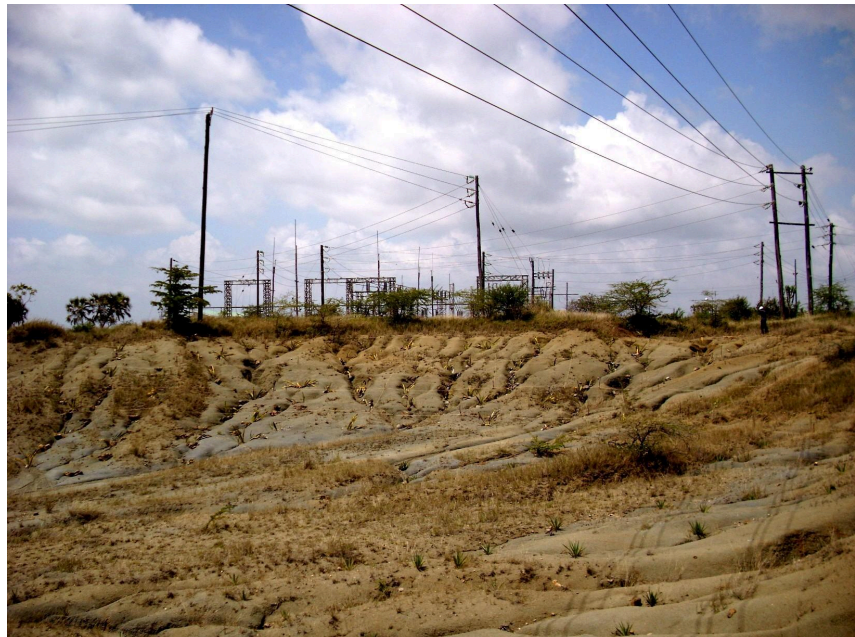
*Picture 1: Overview of the rehabilitated quarry slope near Nguuni*

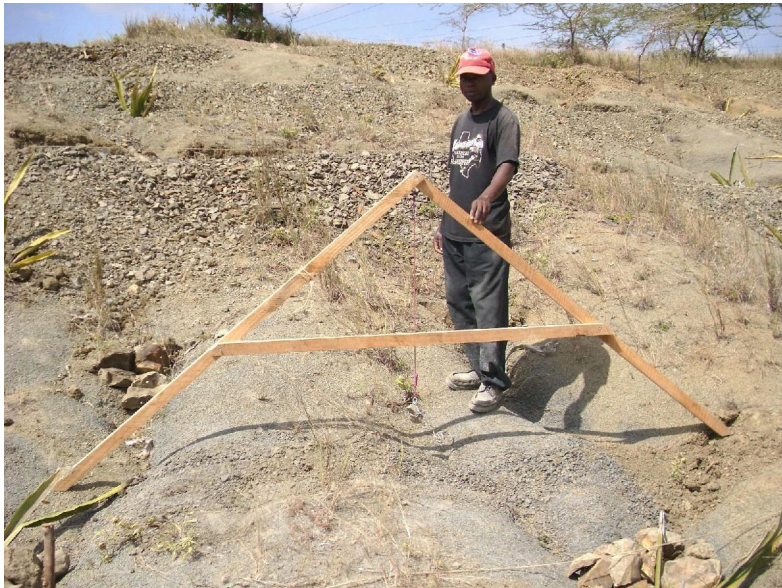
Picture 3: The use of an A-frame to identify the contour line

The actual positioning of the trenches was made with a so called A-frame, which is a very simple tool for maintaining the level. First, it is estimated how many rows of trenches is needed, as their vertical difference should be around 1.5 metres. This means that they get the closer together the steeper the slope gets. At the designated site, we established four complete rows on the entire length and some two smaller rows on the top area to retain initial runoff.

After having marked the starts of each row with a wooden pole, one can use the A-frame to allocate the next pole. It is advisable to implement this method as well to the local communities. It was found that some of the trenches dug at local farming site are not very exact.

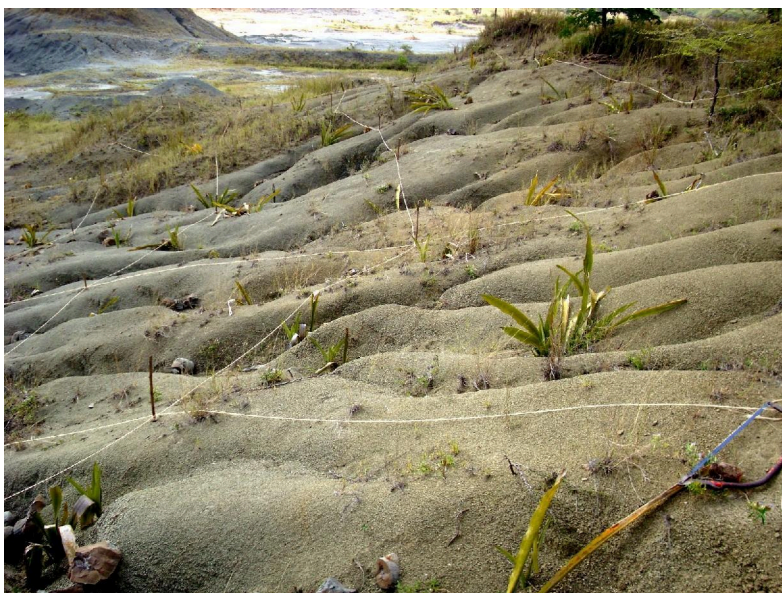
Picture 4: Preparing the excavations by marking with sisal twine

As it is difficult to determine the exact contour line while excavating at the same time, the entire slope was marked with sisal string by forehand. This allows comparing the four lines of trenches from the distance and helps to maintain the contour.

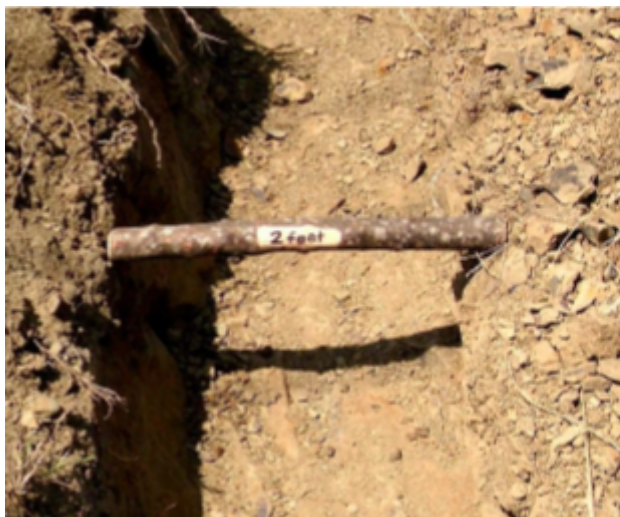
Picture 6: Wooden measuring pole  
gullies

Maintaining the measurements of the trenches during excavation work has proven to be tricky. As the workers got paid by each metre they have dug with the need dimensions, they automatically made sure that the trenches didn't get too deep or too wide. To make absolutely clear what the dimension will have to be and that there are no discussions or arguments during the periodical payments, I have made a wooden measure which was exactly 2 feet. As the workers were proceeding with their trenches they could check their own work independently.

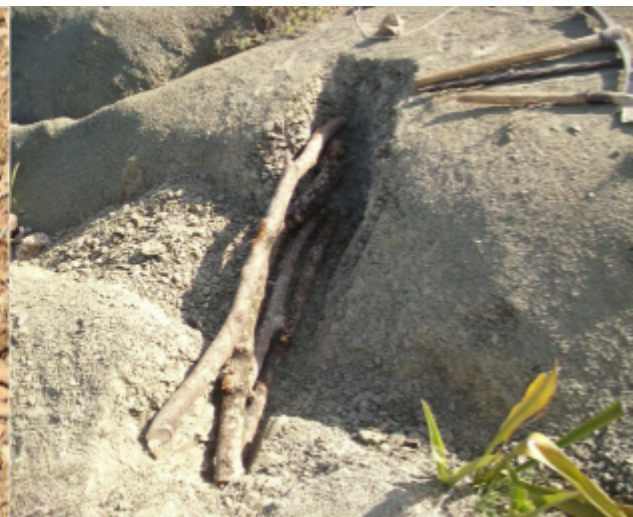
Picture 7: Reinforcement of trenches across

On the picture can be seen that the site has already been eroded quite heavily before the implemented measures. The continuous water runoff has created gullies all over the slope. These have made it more difficult to build stable and long-lasting trenches. To prevent the trench walls across such gullies from being damaged due to water pressure, they have been reinforced with wooden poles. The poles came from a Neem tree which was cut down on the experimental Shamba (Farm) of the Baobab Trust. Neem wood is known to last very long as it gets hardly affected by insects or fungi for a long period of time. It was made sure, that all the stems were completely covered with soil as to protect the wood additionally. Also one has to make sure that the side walls covering these reinforcements are shaped with a flat angle. Otherwise they get uncovered very quickly.

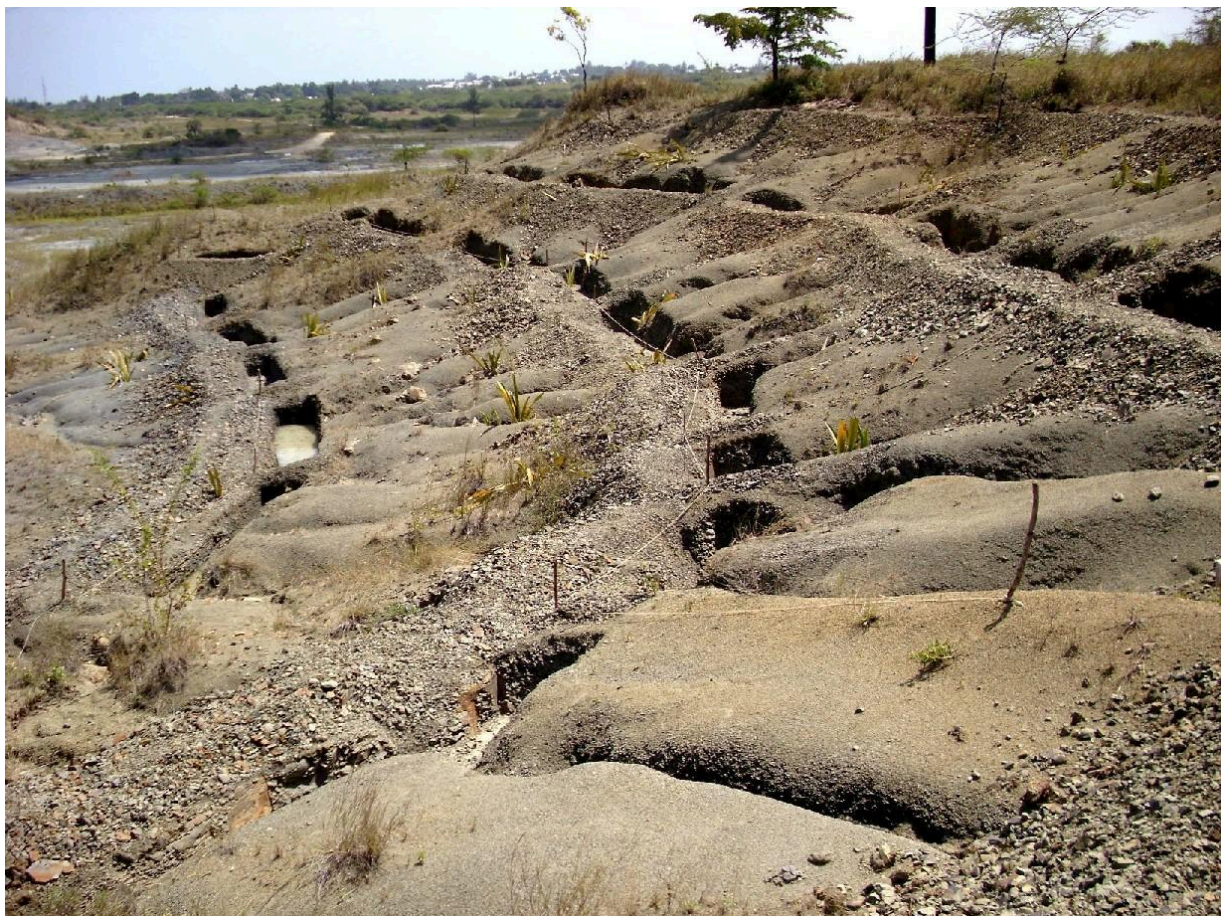
*Picture 8: The terraced slope at Nguuni after excavations. The first row starts right at the top*

The estimated length of trenches was 179 metres. While completing work, some 6 metres of additional trenches were excavated (adjustments).

Total length of terraces: 185 metres

Amount of rows: 4 complete rows plus 9 metres at the top end of slope

Surface of impact: 1350 m<sup>2</sup>

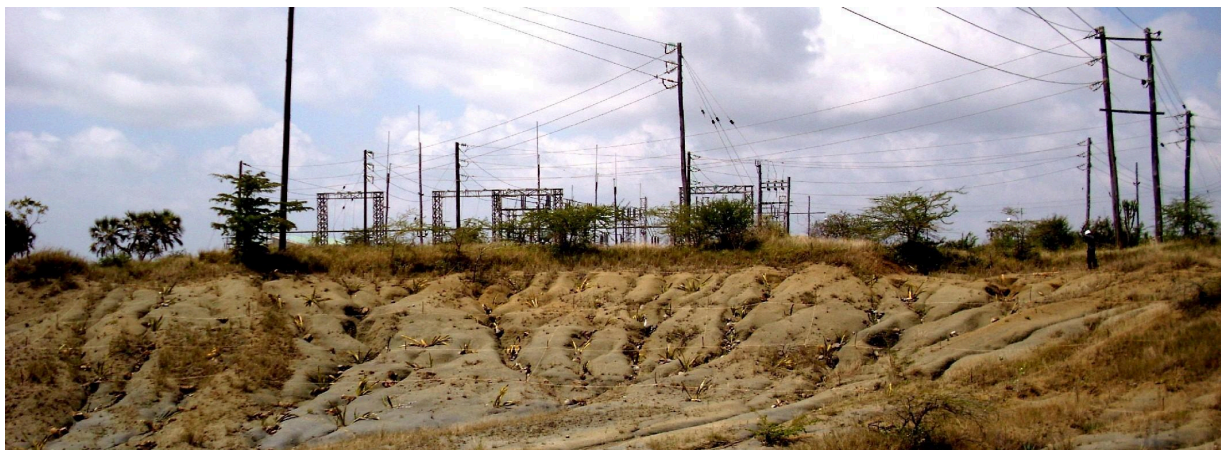
*Picture 9: Before excavations; 23. November 2007*

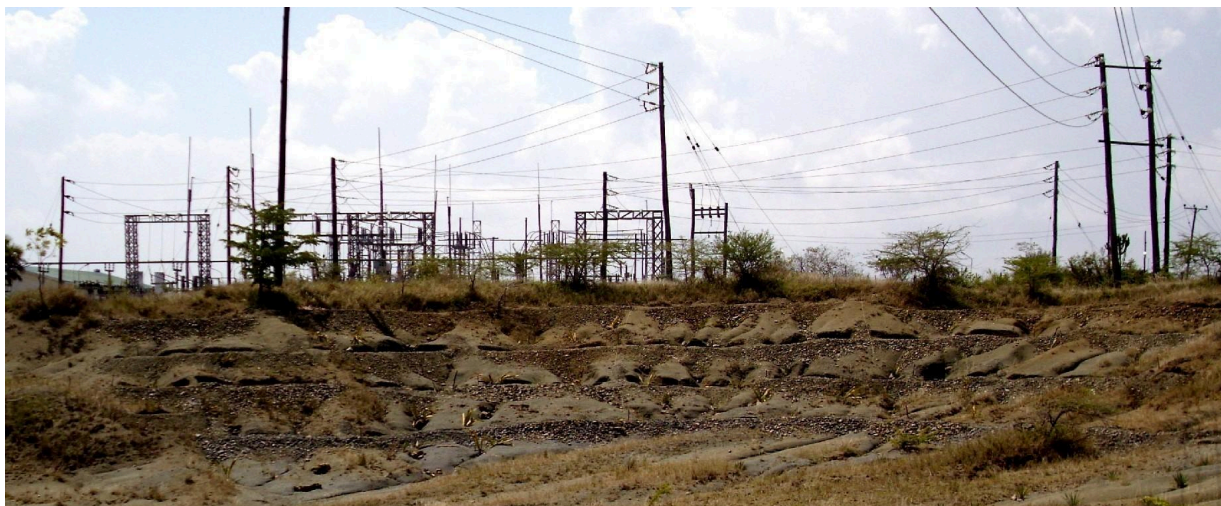
*Picture 10: After completing excavations; 14. December 2007*

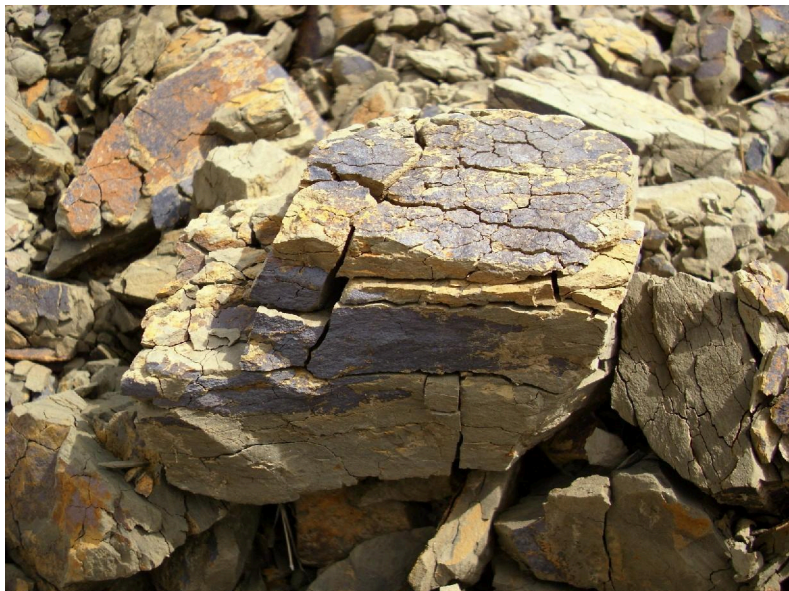
Regarding the ground structure, the majority of the treated area consists of a fine layer of surface soil (ca. 1 cm; very little or no organic compounds), whereas the material underneath consist of stones or rocks. During the excavations works it has been observed that the deposited ground material changes its structure very fast as soon it gets exposed to the sun. This means that the dams along the excavated

trenches are changing *Picture 11: The ground materials becomes weathered quickly*

from solid rocks to smaller soil particles. This indicates that the Vetiver Grass and trees might be able to access the minerals relatively easy from the ground soil, as long as they get some quality soil (compost) to start with.

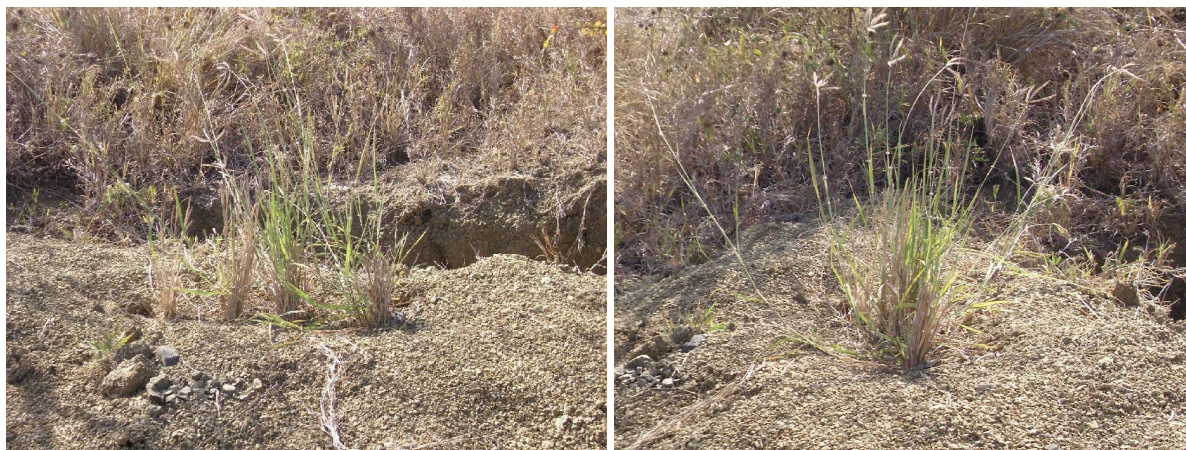
*Picture 12 and 13: Planting trial with local grass on top of a terrace contour*

The plants have been transplanted only with the soil which stuck to the roots. Watering was done four times during the following three weeks. As the pictures show, two out of four units have established well despite the harsh environmental conditions and minimal planting practice.

I decided to conduct a small planting experiment to assess the growing conditions the Vetiver hedges will be confronted with. Four units of a local grass were transplanted directly onto the overburden of one of the trenches. The grass was chosen because its initial location resembles the conditions on the site quite well (direct sun exposure, sloped ground, dry). It was then planted on one of the upper trenches where the excavated ground material has already been fractioned into smaller particles.

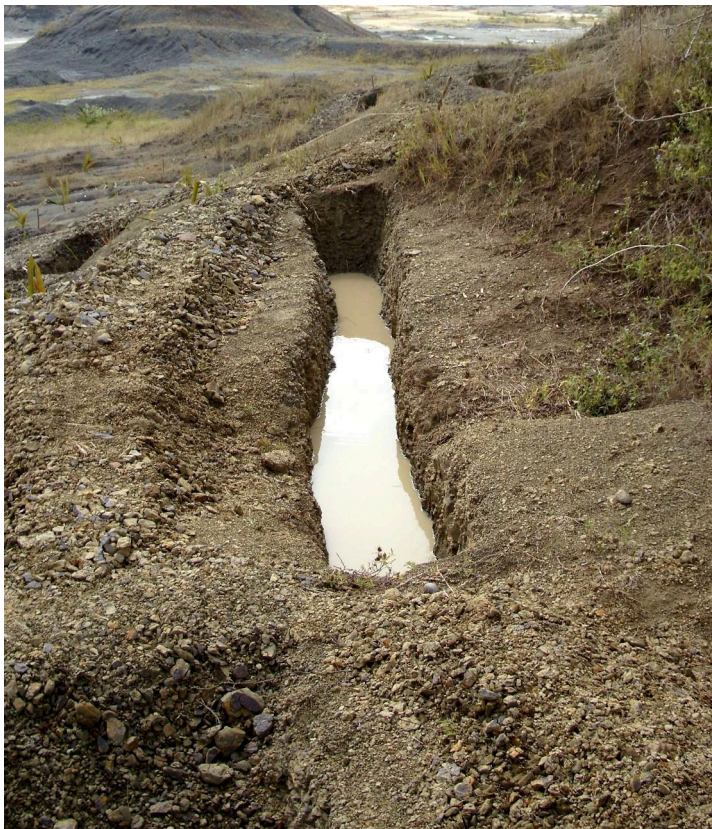
Recent rainfalls in the area have shown that the trenches retain the surface runoff very well. In addition, the amount of fine soil which was deposited already during these minor rainfalls indicates, that the decision to increase the dimension of the trenches was correct. One of the most important facts which has to be taken into account is, that the restoring of an already eroded slope is much more costly, more complicated and more likely to fail than protecting a slope right after it has been established.

*Picture 14: The trenches retain surface runoff well and the excavated ground material breaks weatjers omtp samller particles.*

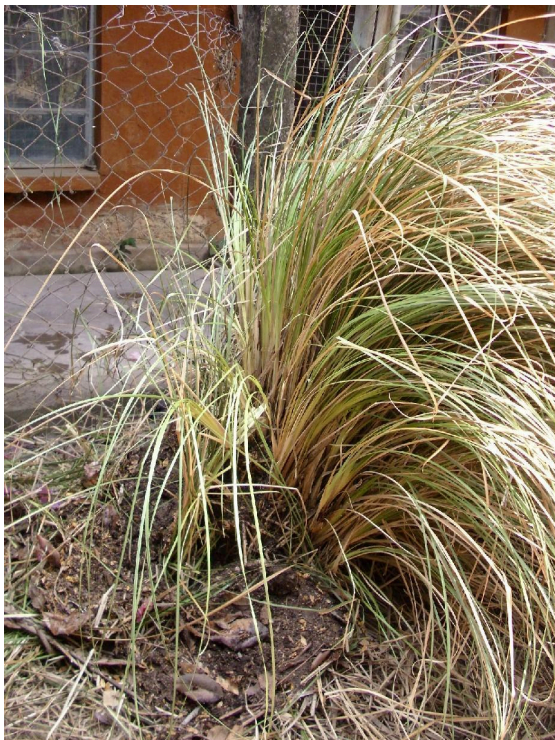
Picture 15: The stock of Vetiver Grass found at the Baobab Trust office

The stock of Vetiver Grass found at the Baobab Trust has been brought here by Dr. Haller several years ago. Its provenance is Tanzania.

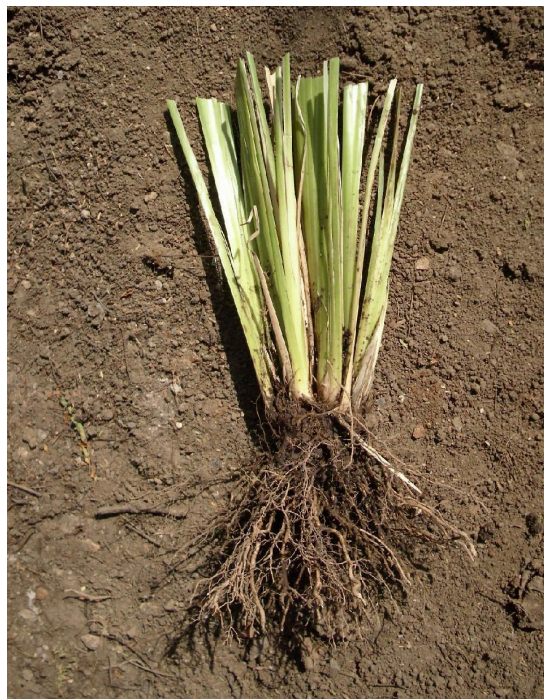
Picture 16: A group of Vetiver tillers  
growth

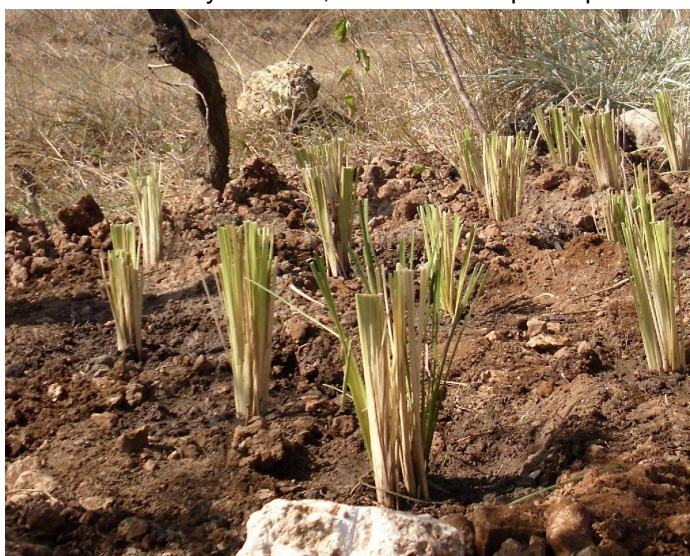
Picture 18: The tillers get pruned and planted in groups  
said

According to literature, the amount of tiller multiplication is increased when the Vetiver plant is regularly pruned to a length of 40 centimetres. The minimal time the plants should stay at the nursery is about three months. Each plant can be divided in subunits, where one part gets planted in the field and the other part goes back into the planting bed.

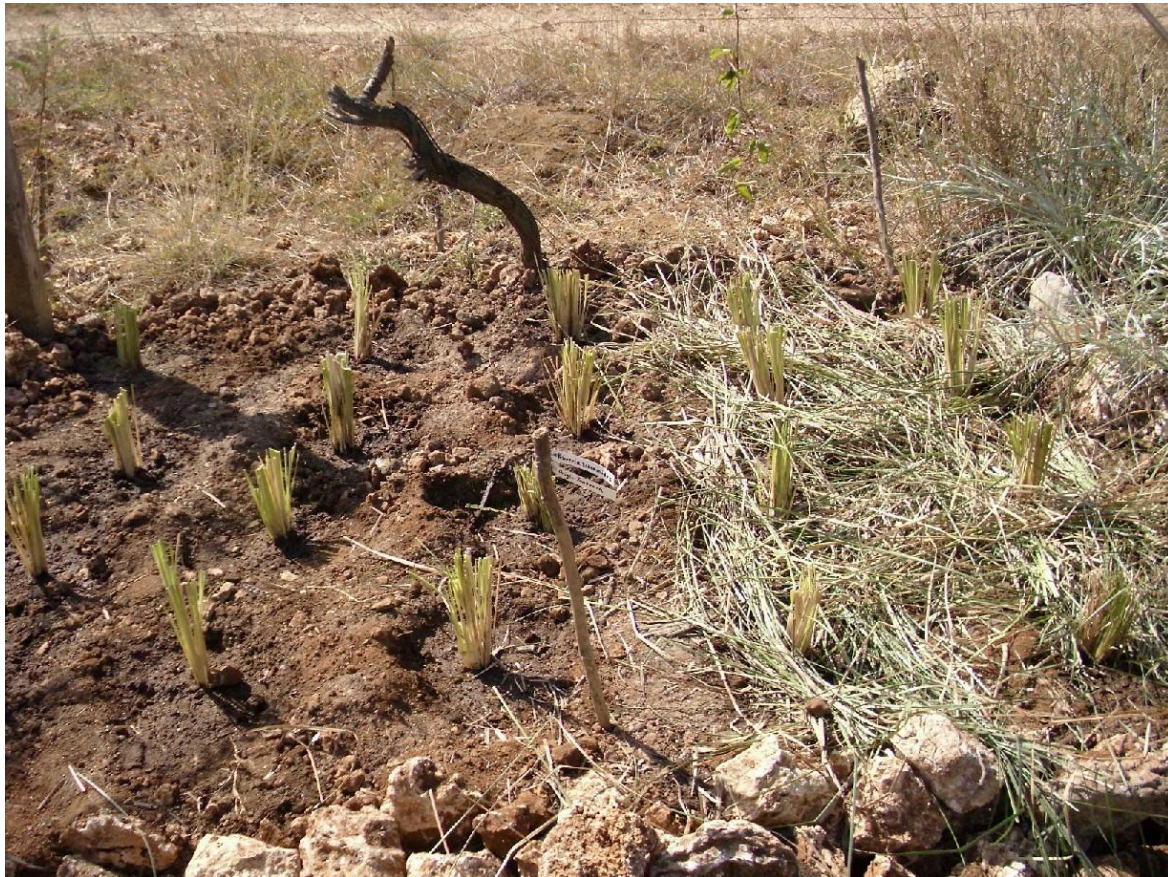
The material which was cut off from the tiller during pruning was used to mulch 40% of the planting bed. Mulching is

to decrease the loss of water due to evaporation and to improve the microclimate on the surface around the plant. A further advantage should be that herbs are slowed down in their growth. Additionally the plants can use the decomposing mulch as nutrient. The partial use of mulch will enable to assess whether the effect is significant or not.

Picture 19: The established Vetiver Grass nursery. Part of it got mulched with the pruned leaves
