"Road Safety Audit: A Case Study of Ahmedabad City" A PROJECT REPORT

3.2 Base Location Map

Figure 1 Satellite View of Stretch Shilaj to Thol

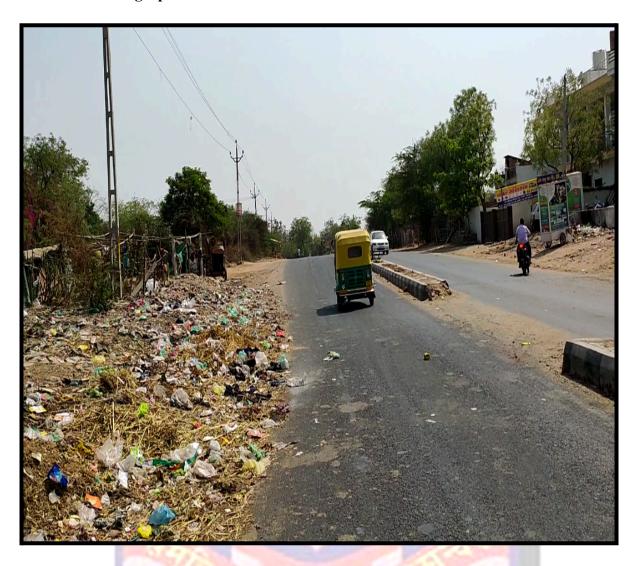
Figure 17 Garbage accumulation on side of the reduces width of the road and due to it shoulder width is not visible, center is not provided and damaged median

- 8. Broken signs should be replaced with new signs and broken median should be repaired. Median should be provided where there is no median.
- 9. Separate provision for the cyclists should be provided.

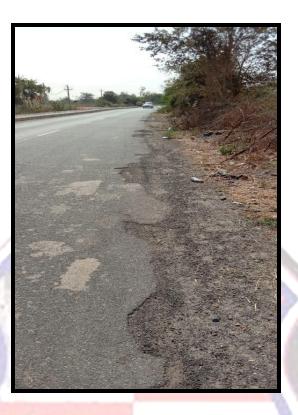
Figure 18 No shoulder width is provided, no fences are provided for safeguard against trees and turning movement

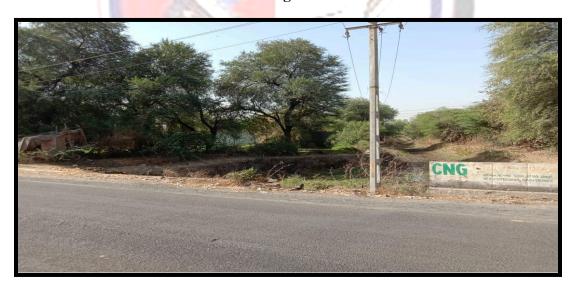
Figure 19 No fences are provided for safety against falling due to deep depression on the side of the road and center line is not provided

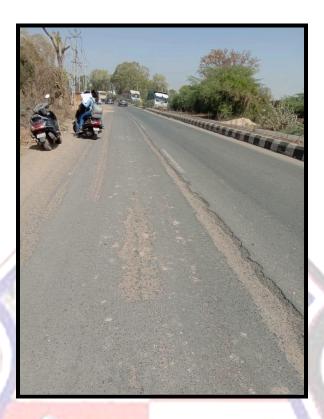
Figure 20 Longitudinal cracking and uneven alignment of road

- 14. The width of the road should be increased to increase the carriageway capacity.
- 15. The road should be properly maintained to reduce the defects on the road like potholes, rutting, polished aggregate etc.

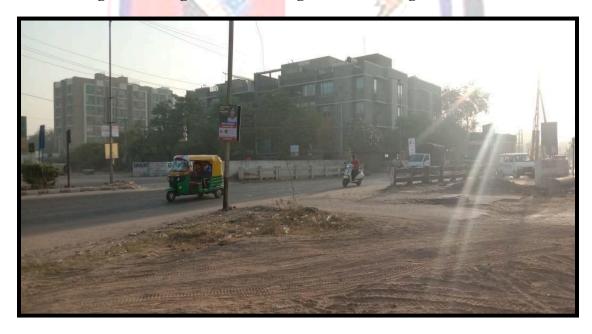
Figure 21 Shoulder width is not provided, full length fences are not provided and huge area under land acquisition reducing road width

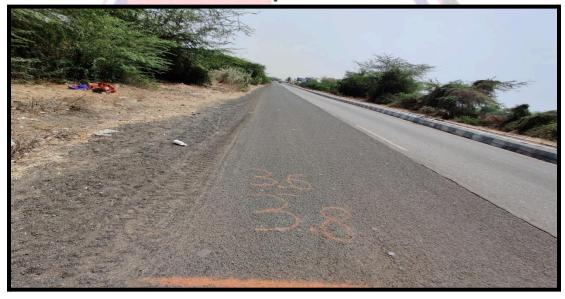
Figure 23 Shoulder width is not provided, fences are not provided for safety against trees

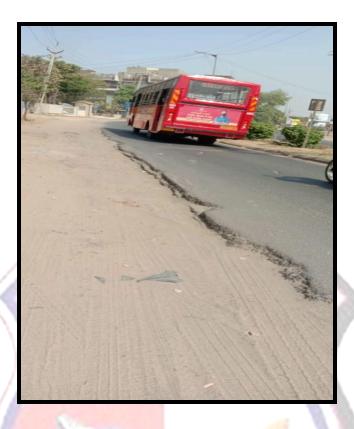
Figure 24 Shoulder width is not provided, reduced width for road due to side defects, edge cracking and no center line is provide

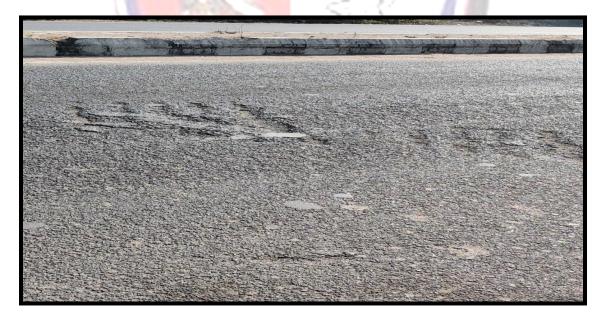
Figure 25 Raveling of pavement, center line is not clearly visible

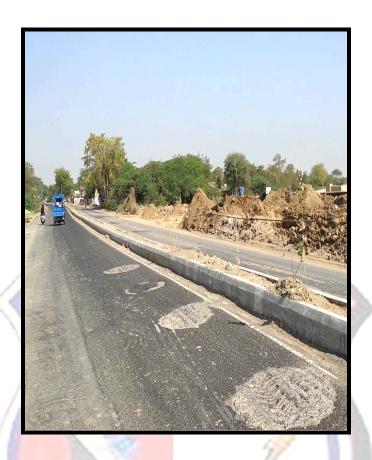
Figure 26 Defective pavement, no center line and shoulder width is provided

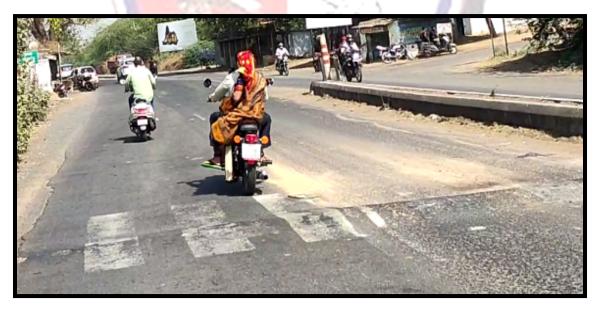
Figure 27 Bump width is less and not clearly visible, shoulder width not provided and polished aggregate

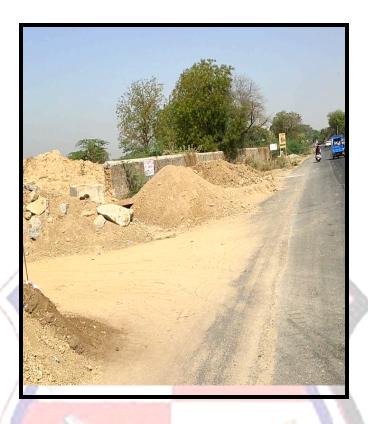
Figure 28 Loose construction materials of the site are stacked on the road without protection and shoulder width is not provided

- 6. Stacking of the loose material like gravel and sand on the roadway should be cleared which otherwise decreases the skid resistance.
- 7. At intersections proper signs, markings and channelizing islands should be provided.

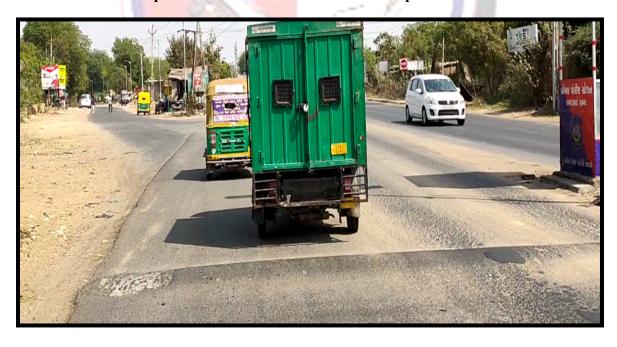
Figure 29 Bump marking is not provided, no intersection is provided at junction of road, no warning signals are provided

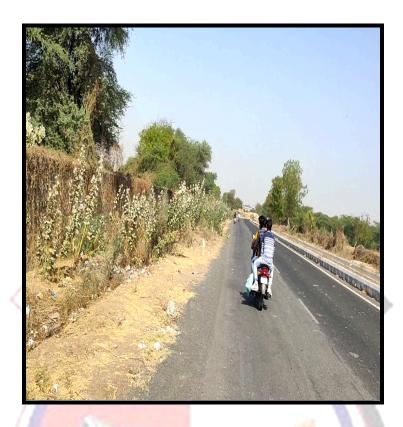
Figure 30 Shoulder width is not provided, guard rails for safety against trees is not provided and uneven road surface

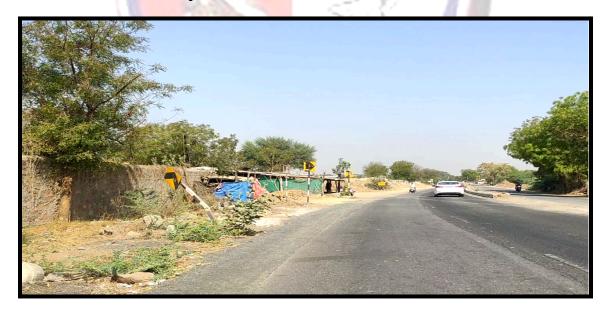
Figure 31 Signs are broken, center line is not clearly visible, shoulder width is not provided and road is poorly maintained as growing shrubs are reducing road width

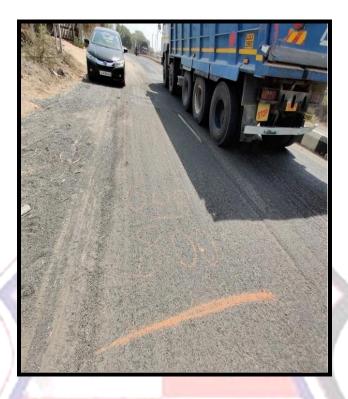
Figure 32 Wrong side moving vehicles, loose gravel on side of the road and no shoulder width provided

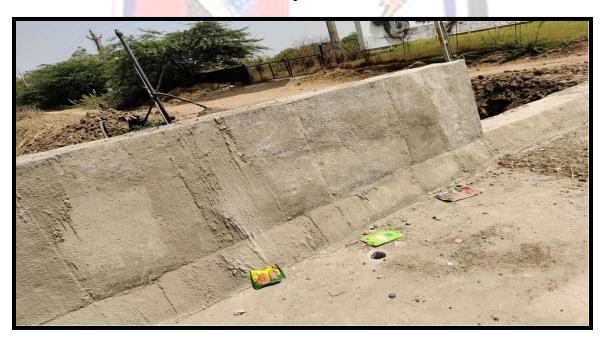
Figure 33 Fences are not provided for the full length of the depression due to which part of deep depression is open which can be prone to falling of the vehicle

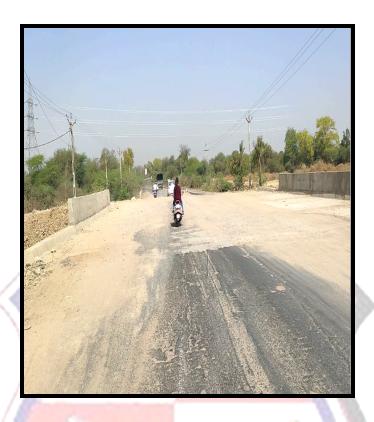
Figure 34 Poor road condition with depression and loose sand on the road which reduces skid resistance

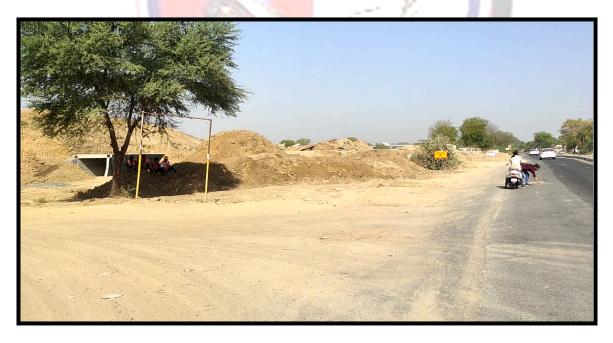
Figure 35 No protection of steel sheets provided on the road side construction site, no cautionary signs are provided and center line and shoulder width are absent

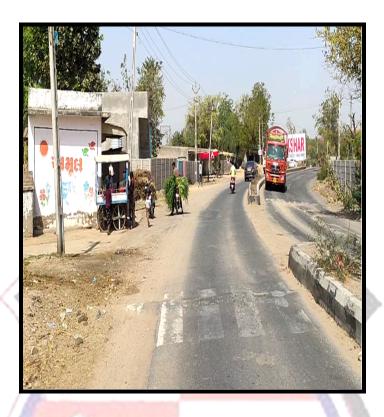
Figure 36 Poorly maintained road reducing road width, due to absence of shoulder width vehicles are parked unevenly on road side causing obstruction to moving traffic, no center line is provided and damaged median

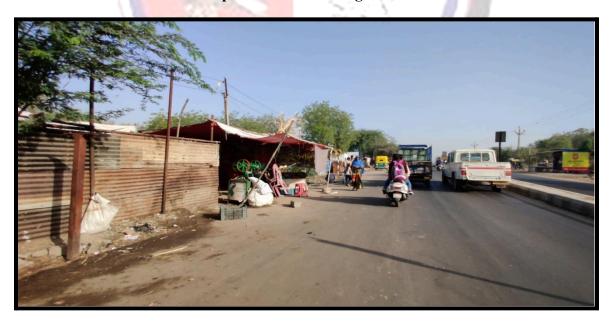
Figure 37 Shoulder width and center line are not provided and illegal shops on road sides reduces road width

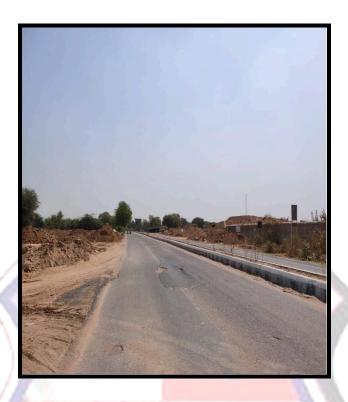
Figure 38 Potholes on the road, No shoulder width and center line are provided, stacking of loose soil on road side

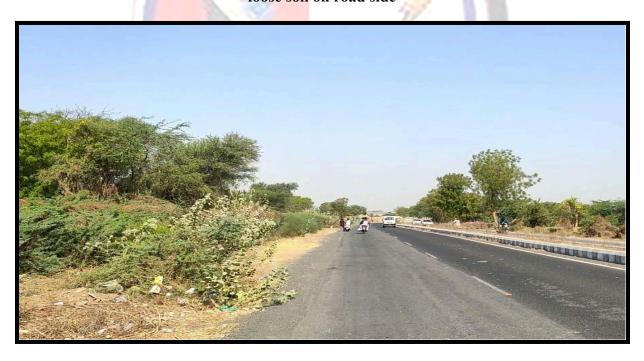
Figure 39 Guard rails for safety against trees is not provided, Shoulder width is not provided, uneven road surface, Center line width is improper
