<u>Teardown Toyota Prius G9060-47190</u> ref 220103 <u>Click Here for Additional Photos</u>

EVSE Charger Make, Model - Toyota 120v 12 Amp G9060-47190

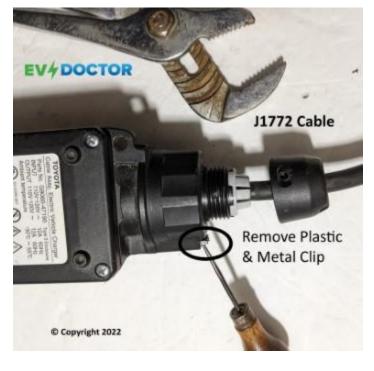
Looks like the power transformer contacts have pulled out of the case.

Initial Inspection - Does not power up, Ground pin missing on AC plug, Open case,

EVSE Failure Symptom - Dropped now won't turn on, no lights and ground prong broke

NOTE: screws missing outside and inside, Remove AC Cord and J1772 cord. Remove

electronics, Reconnect AC Cord, CAUTION: the J1772

cord is polarized but can be installed improperly.
